Report on
Updated Contamination Assessment

Jumping Creek Estate
Lot 5, DP1199045, Greenleigh, NSW

Project 88224.03
March 2019

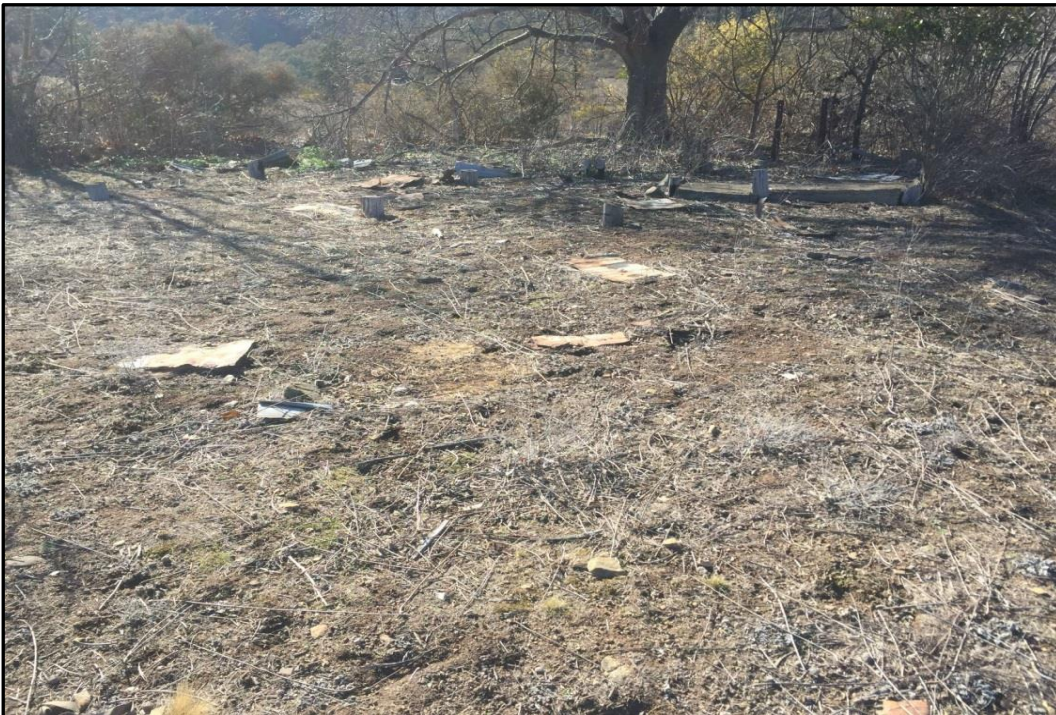
- Building and demolition rubble comprised corrugated metal sheet, brick and concrete boulders was scattered on the ground surface.
- Low wooden posts were observed driven into the ground.

Photo 6: View of sheep dip area, showing waste material, looking south

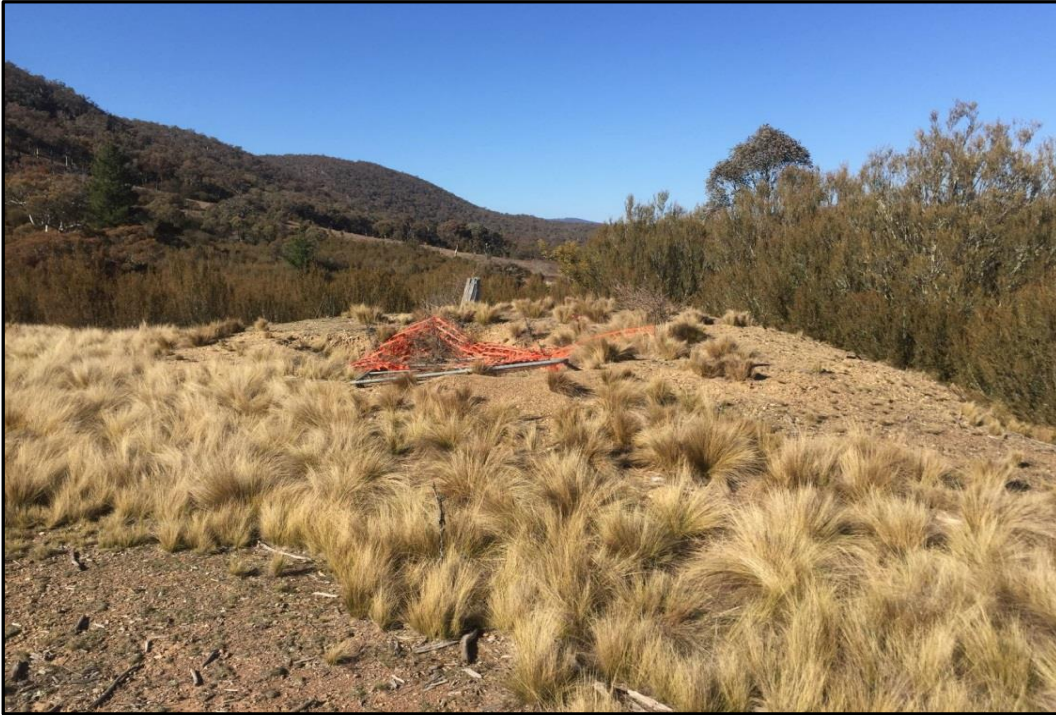
- The mine site comprised an open shaft with stockpiled spoil present on the eastern, southern and western sides of the shaft.
- A wire gate and hi-vis marrier mesh had been placed over the open shaft in an attempt to make the shaft safe.
- The depth of the shaft was measured to be greater than 6 m deep.
- Sparse grass cover was present in the vicinity of the shaft.
- The mine shaft appeared in similar condition to that noted in the Coffey Stage 3 assessment report.
- There was no evidence that any remediation works had been undertaken in this area.

Photo 7: View of shaft at Mine site 1, looking to the south

- *The removal or management of physical hazards (such as mine shafts or other structures) associated with these areas;*
- *Removal and landfill disposal (or on-site management) of stockpiles of rock and soils and other loose potentially contaminated materials in the Mine Site areas; and*

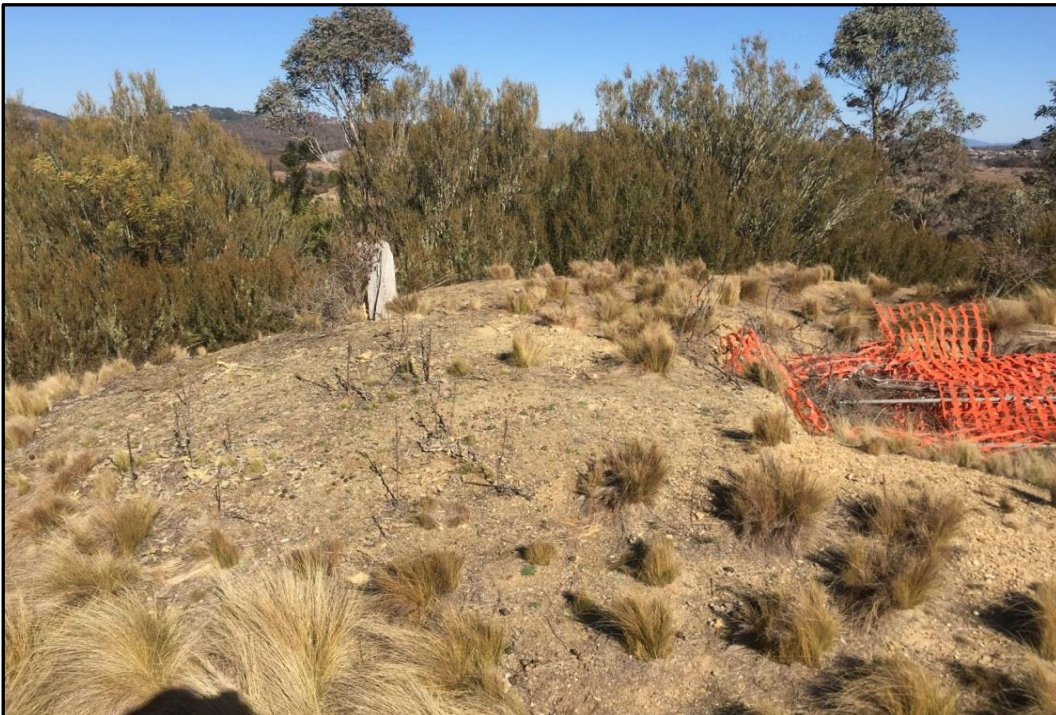
Photo 8: View of shaft and stockpiled spoil at Mine Site 1, looking west

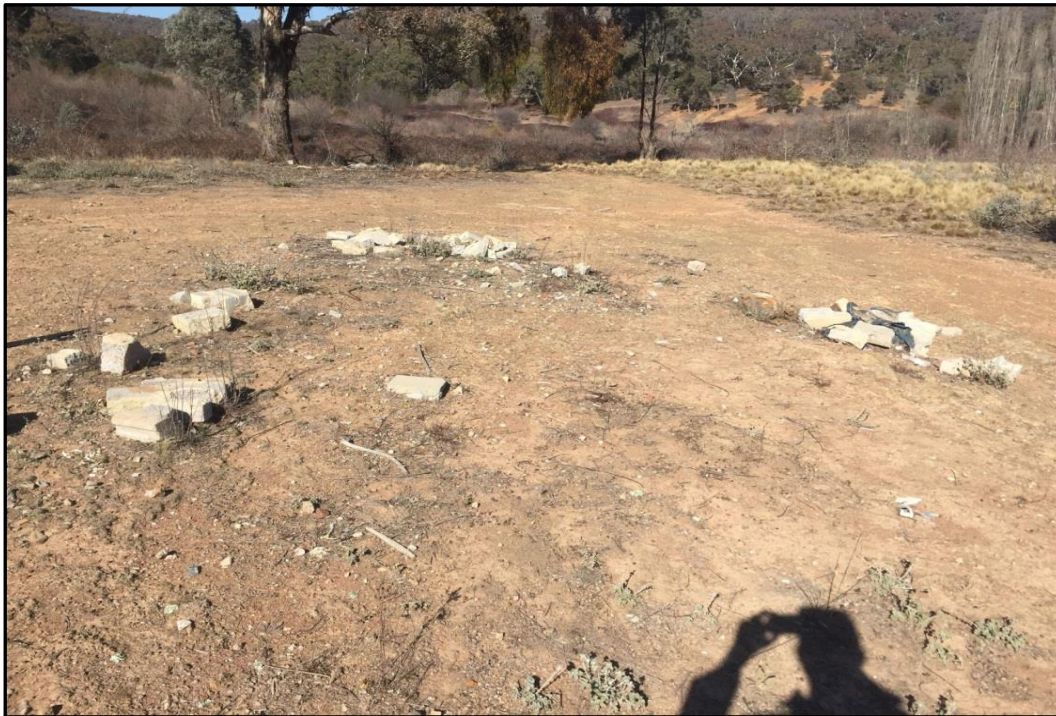
- Anthropogenic wastes were scattered across most areas of the site. Wastes ranged from piles of building and demolition wastes, burned car bodies, small stockpiles of soil and general household wastes. A small stockpile located on the ridge-line in the north-west of the site was observed to contain pieces of asbestos containing material.

Photo 9: View of typical waste material encountered during inspection

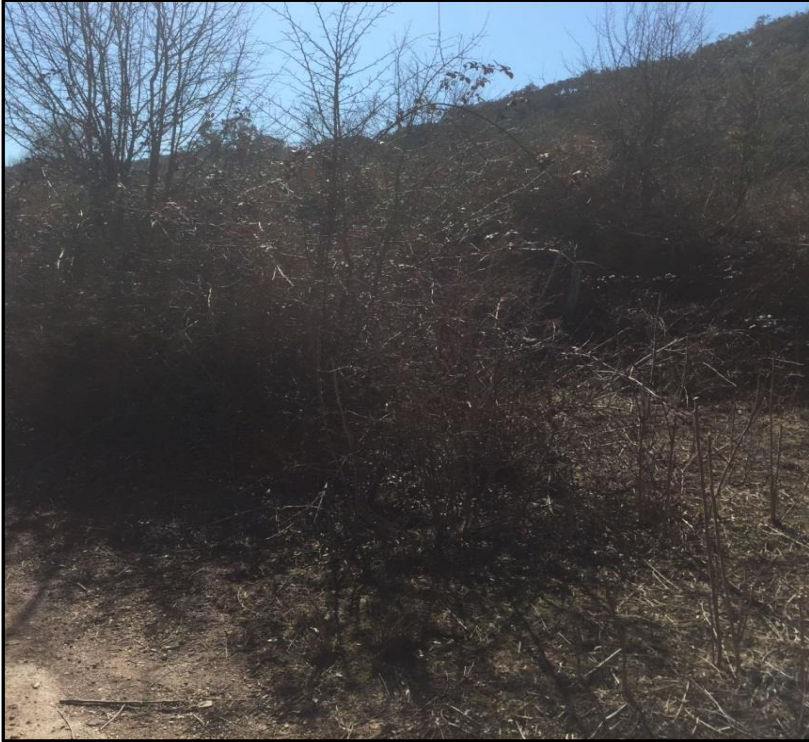
- The remains of the kiln building were heavily overgrown with weeds and only parts of the structure could be observed.
- The parts of the structure observed appeared consistent with photographs presented in the Coffey Stage 3 assessment report.
- No evidence of any remediation works having been undertaken in the area was noted.
- The limestone quarry was noted in the south-east corner of the site on the lower eastern slopes of the Jumping Creek valley.
- The quarry was approximately 60 m, 15 m wide and 5 m deep. A car body was present within the quarry area.
- Large stockpiles of spoil were present to the west of the quarry.

Photo 13: View of the kiln area looking to the north-east

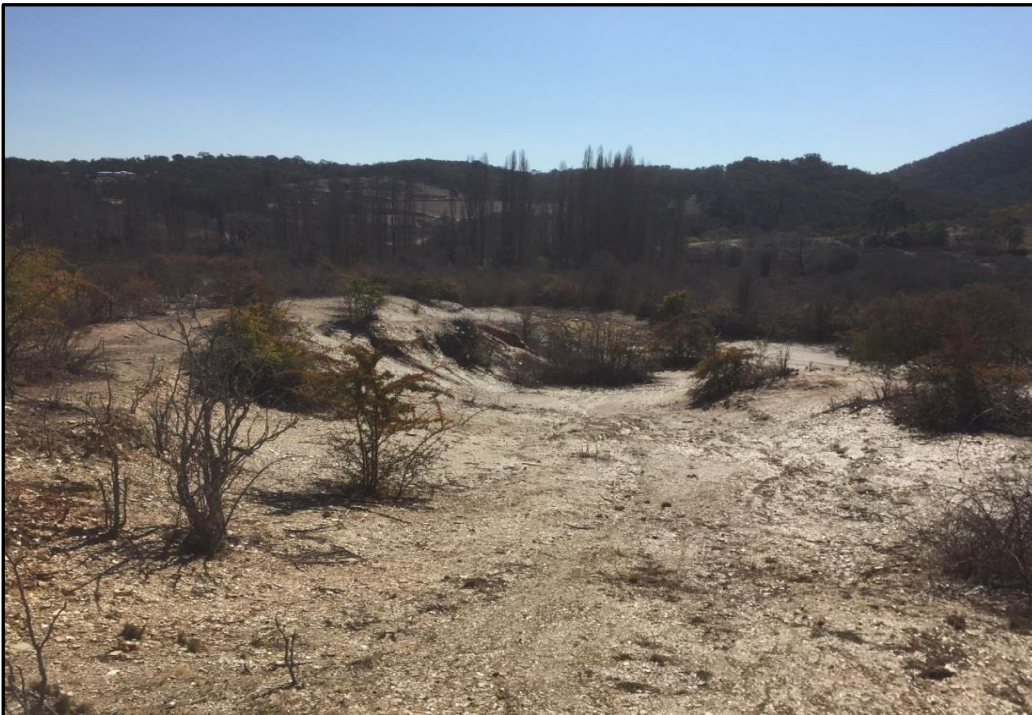
- No evidence of any remediation works was evident, stockpiled spoil was still present in the area and no evidence of any capping material having been placed at the site was observed.

Photo 14: View of Mine Site 4 looking to the north, open pits in the foreground

- *Restriction of access to the Mine Site 3 and Mine Site 4 areas in the short term to avoid unhealthy exposures to metal concentrations in these areas, as well as unsafe conditions associated with mine shafts, adits and other structures;*

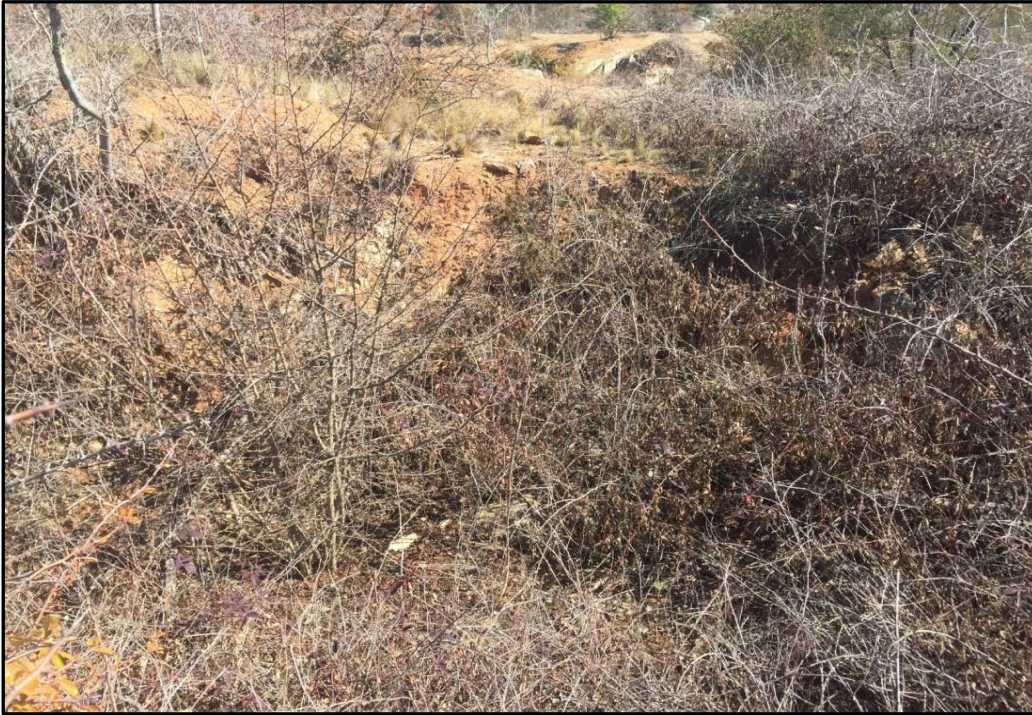
Photo 15: View of Mine Site 4, open trench excavation

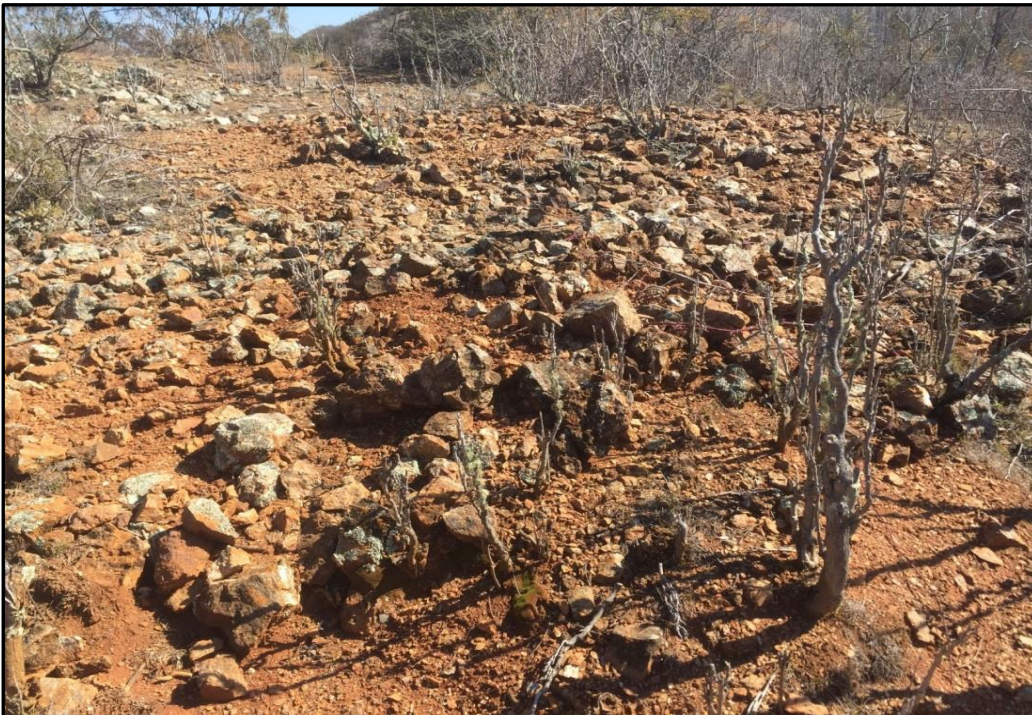
Photo 16: View of Mine Site 4, stockpiled spoil

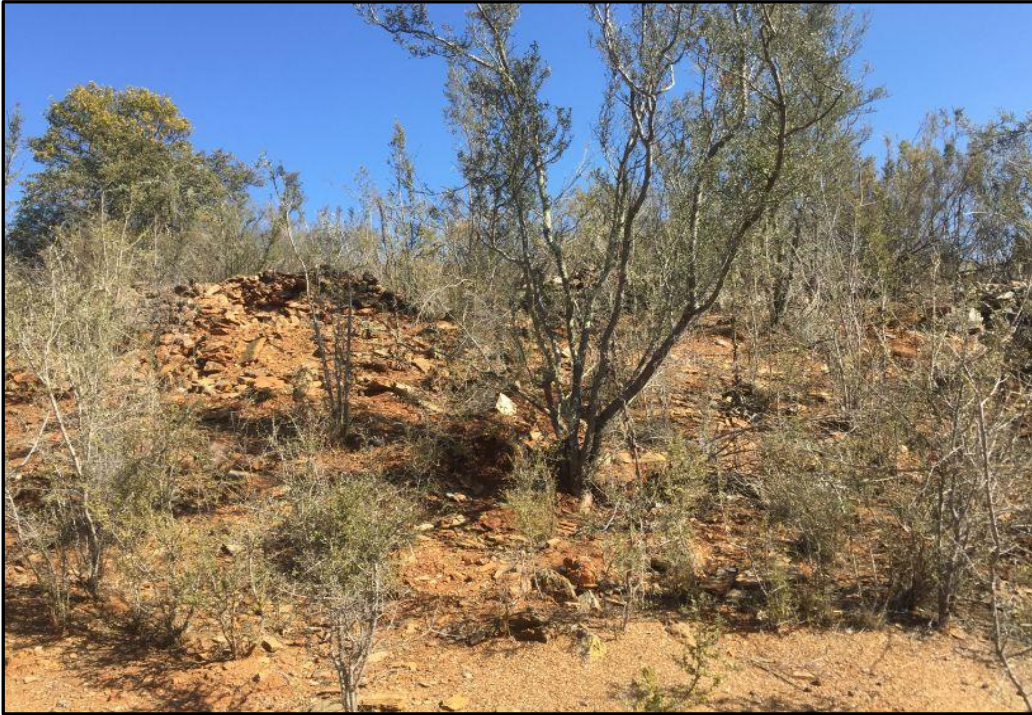
Photo 17: View of Mine Site 4, stockpiled spoil

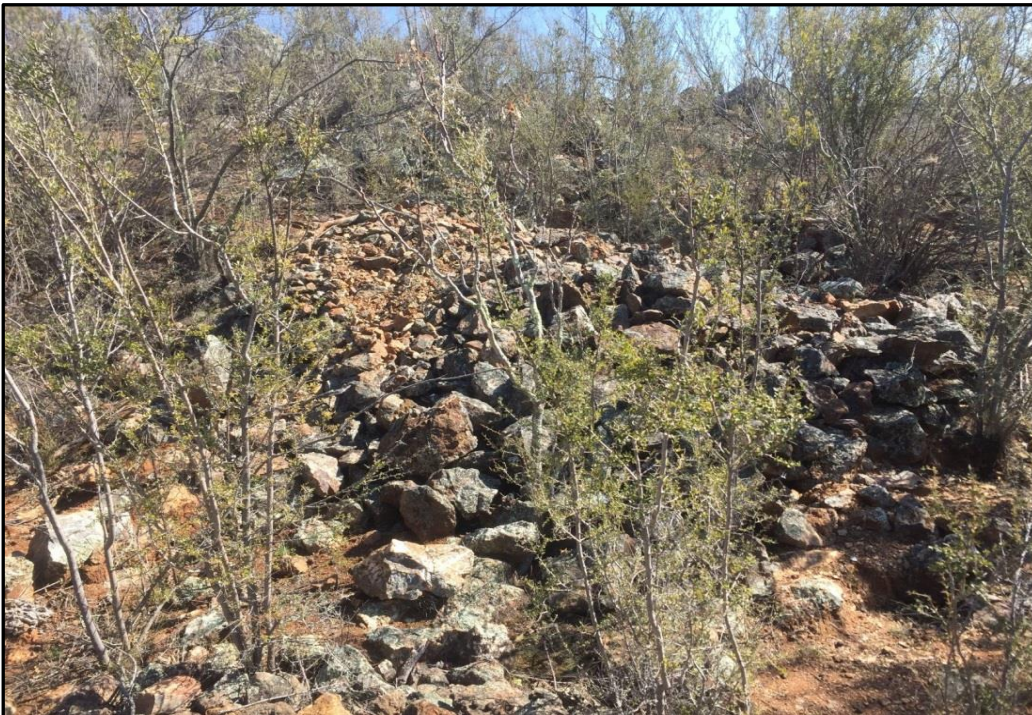
Photo 18: View of Mine Site 4, stockpiled spoil

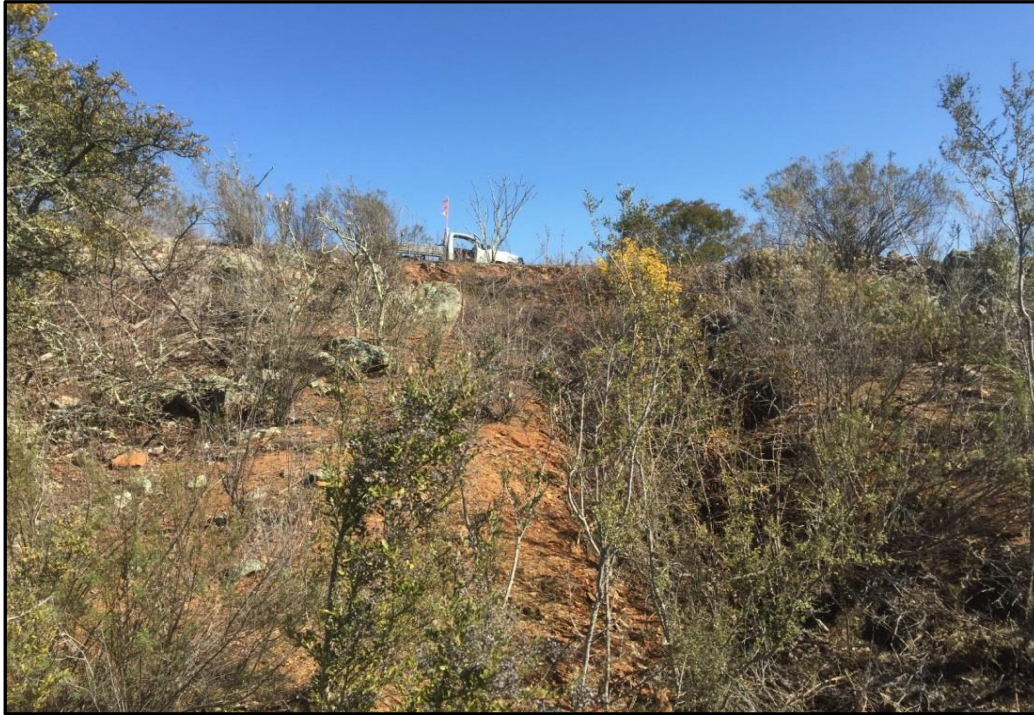
- An adit was located in the eastern part of the disturbed ground on the lower eastern slope. The opening of the adit was overgrown, but it was observed that the adit opened into a passage, however, it was not possible to ascertain the length of the adit. It should be noted that the entrance to the adit was similar in appearance to a photograph of a mine shaft presented in the Coffey Stage 3 assessment report.

Photo 19: View of Mine Site 4, open trench excavation, above adit entrance

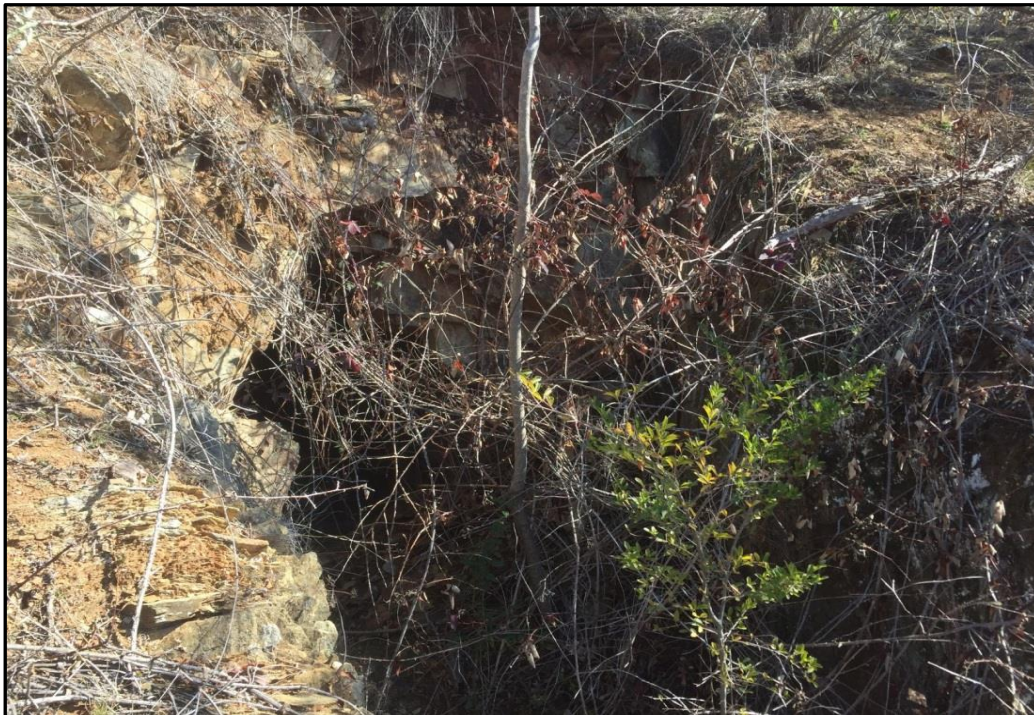
Photo 20: View of Mine Site 4 , adit entrance, looking to the west

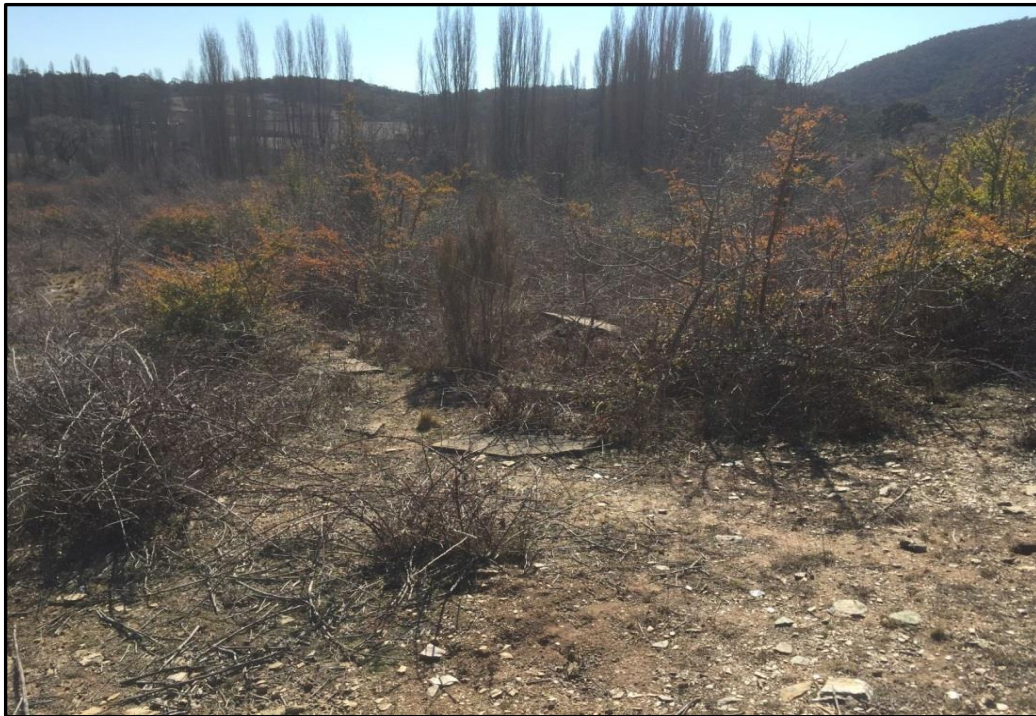
- Evidence of former structures was observed including concrete slabs and low courses of brickwork. Several reinforced concrete troughs were observed throughout the area. The troughs were approximately 1.5 m long and 0.5 m wide. Building and demolition rubble was present throughout the area, including brick, metal, concrete and timber fragments. Timber posts driven into the ground were also present. Remnants of an above ground storage tank were also present, which appeared to be filled with waste materials.

- No evidence of any remediation works having been undertaken in the area was noted.

Photo 22: View of Mineral Processing area, scattered building rubble

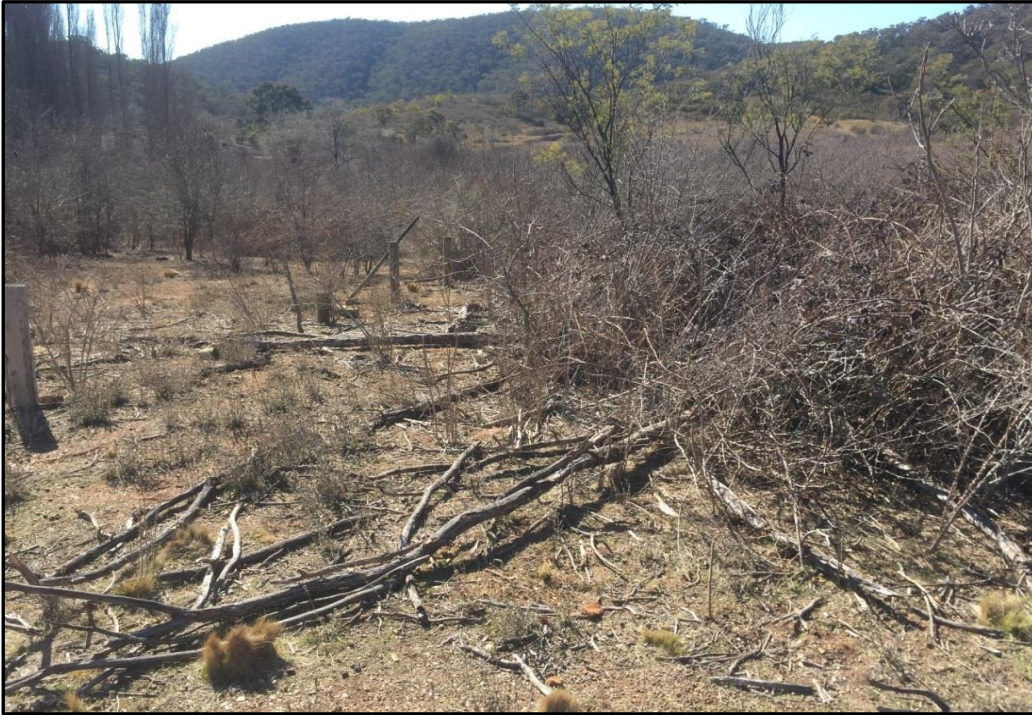
Photo 23: View of Mineral Processing area, scattered building rubble

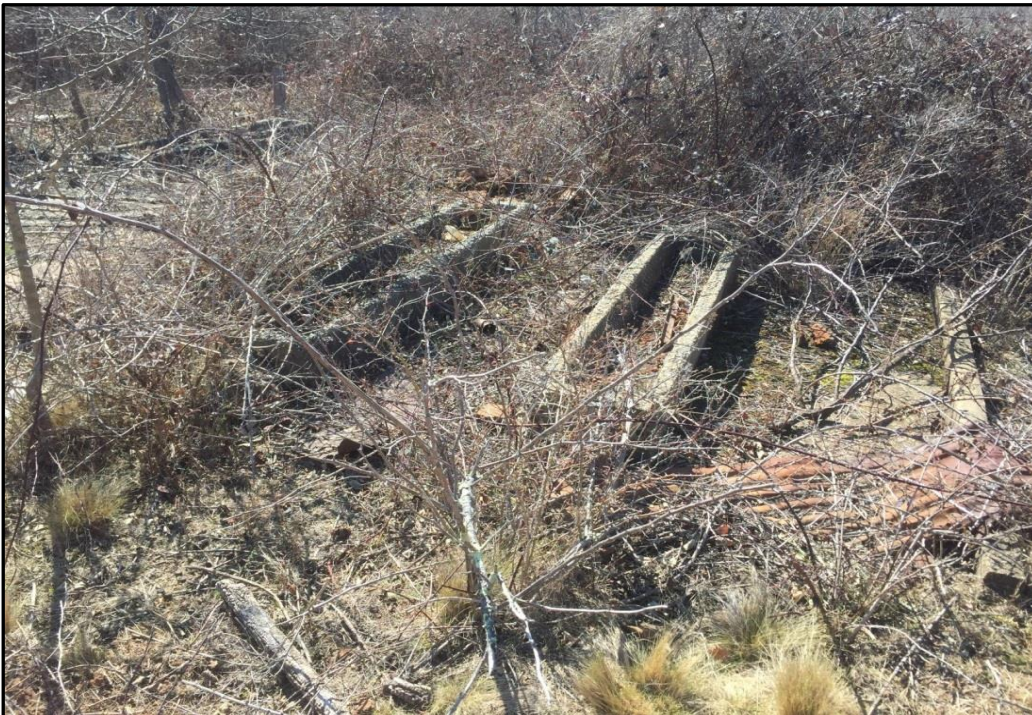
Photo 24: View of Mineral Processing area, example of concrete troughs

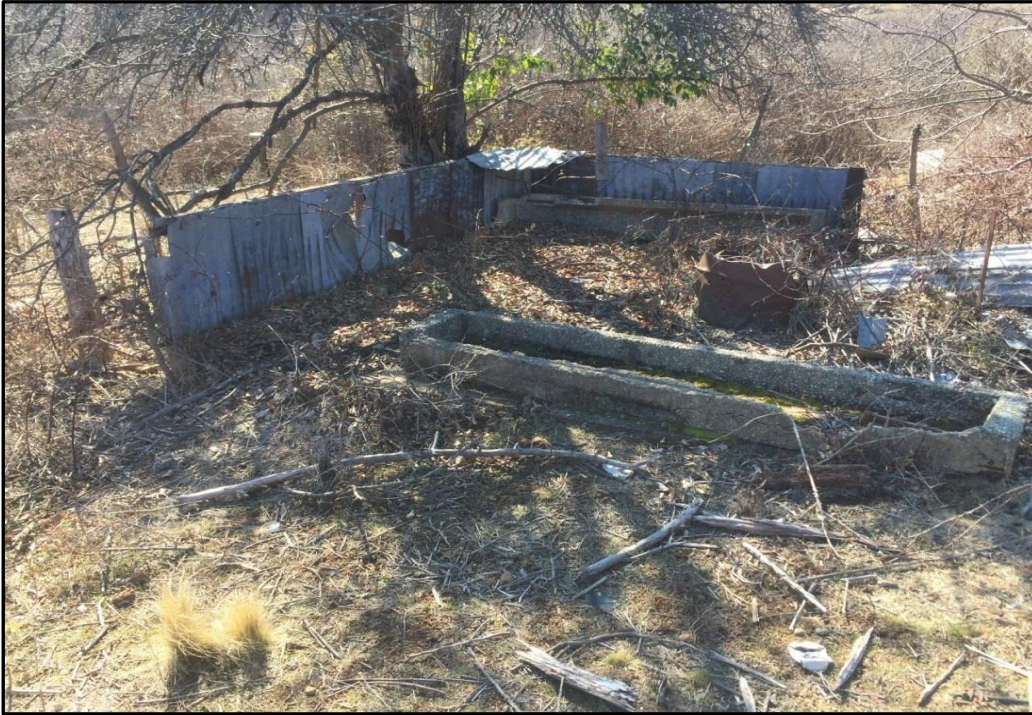
Photo 25: View of Mineral Processing area, remnant buildings

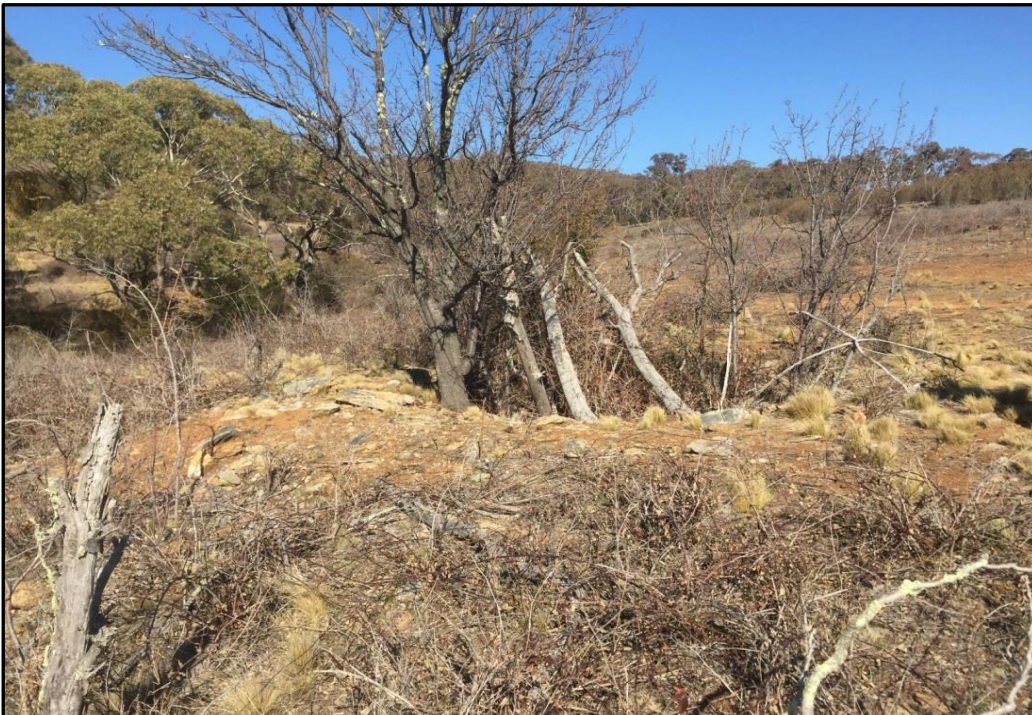
- The mine site comprised an open shaft with stockpiled spoil present on the eastern, southern and western sides of the shaft. The shaft had not been in-filled.
- Trees and weeds were observed to be growing out of the shaft.
- The depth of the shaft was measured to be greater than 6 m deep.
- Weeds (bramble) were present on the stockpiled spoil.
- Three monitoring wells were observed, the locations of which were consistent with those detailed in the Coffey Stage 3 assessment report.
- The shaft had not been in-filled and there was no evidence that any remediation works e.g. a capping layer, had been undertaken in the area.

Photo 26: View of Mine Site 3 open shaft, looking to the south

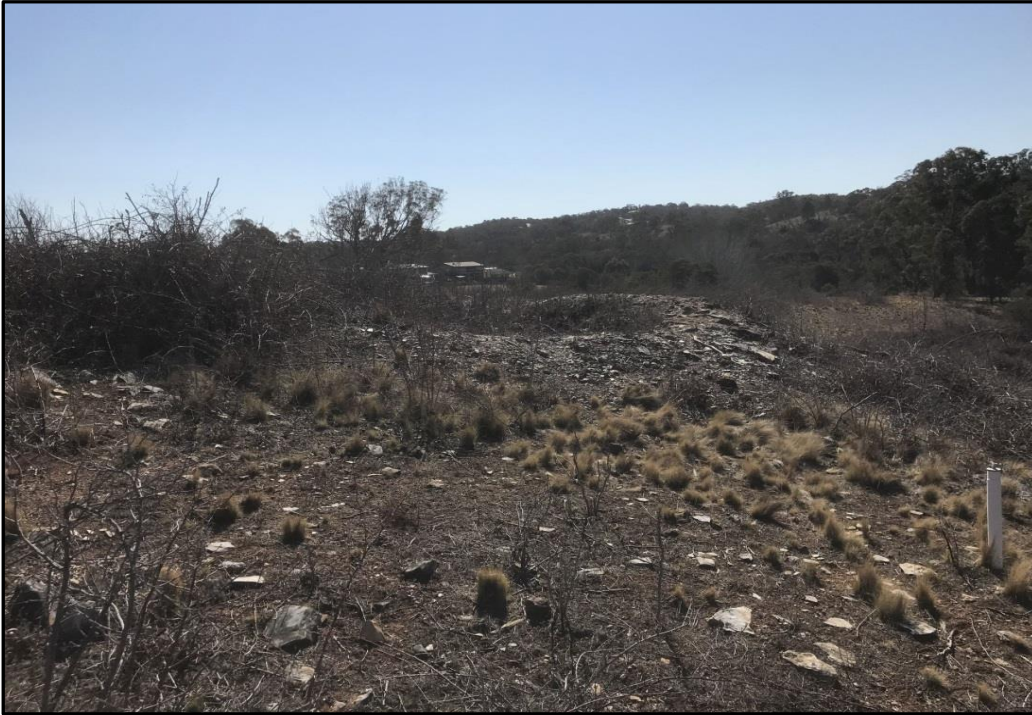
Photo 27: View of Mine Site 3, open shaft, looking to the north-west

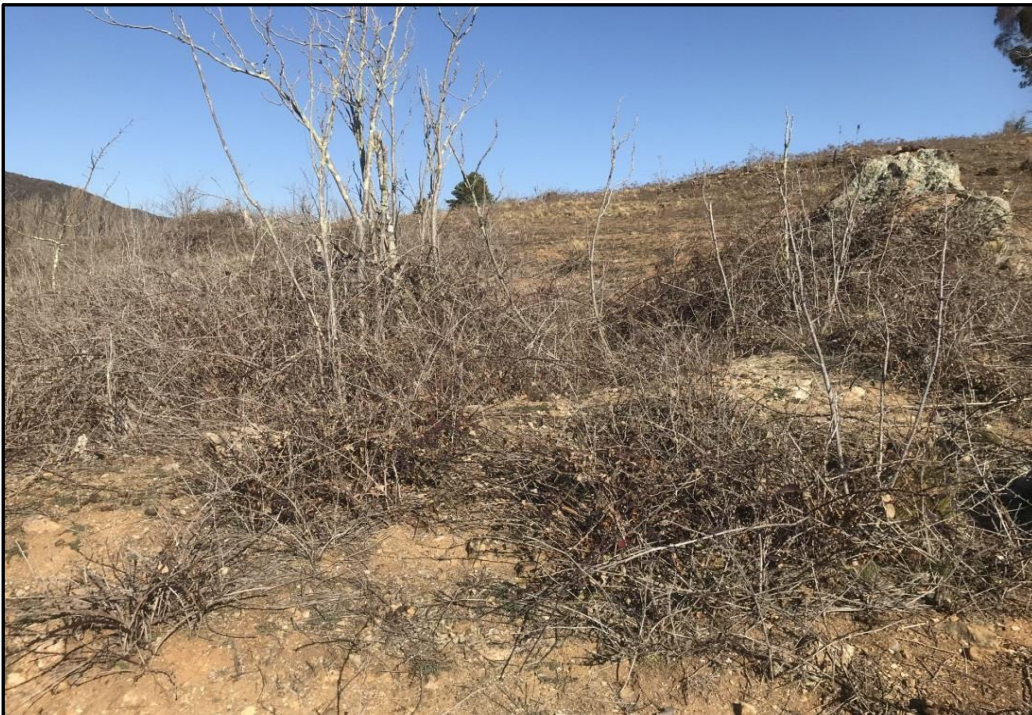
Photo 28: View of additional mine shaft in north-west of the site, within north-west of the development

Further intrusive investigation is also recommended, including assessment of the additional mine site identified in the north-western part of the site to assess the impacts from potential contamination resulting from mining activities in the site.

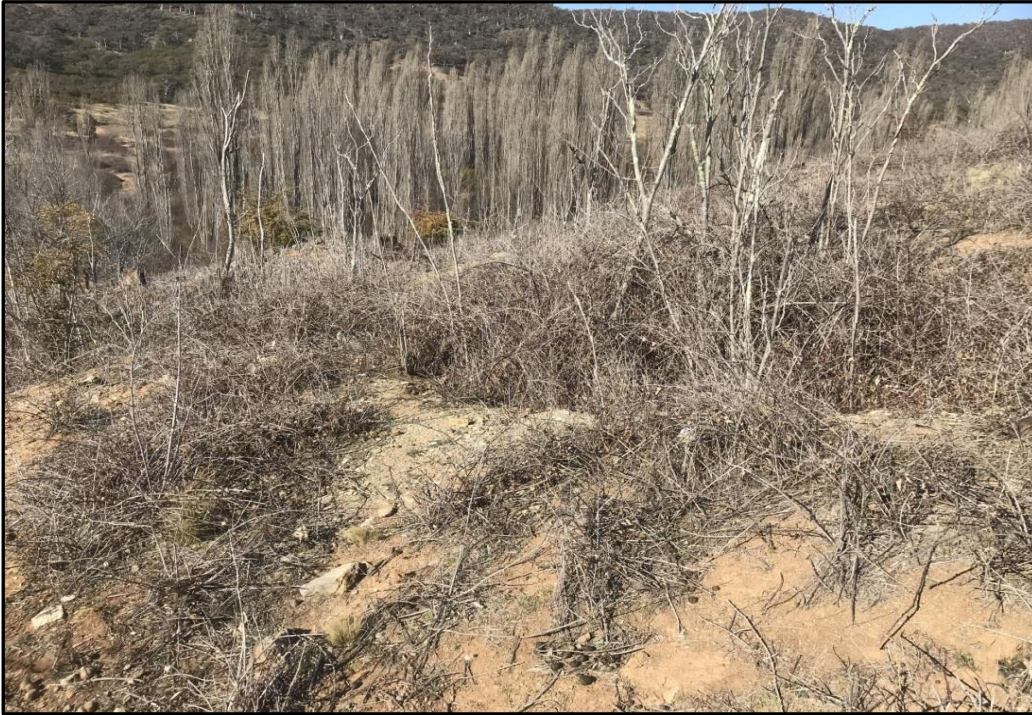
Photo 29: View of additional mine shaft in north-west of the site, within north-west of the development

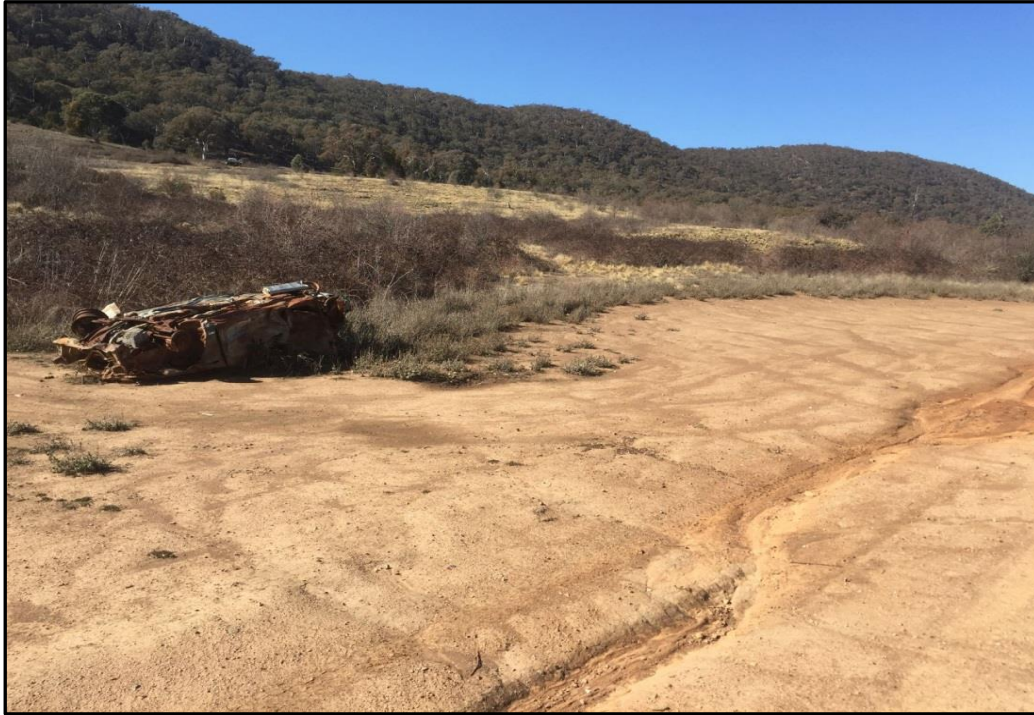
Photo 35: View of example car bodies scattered across the site

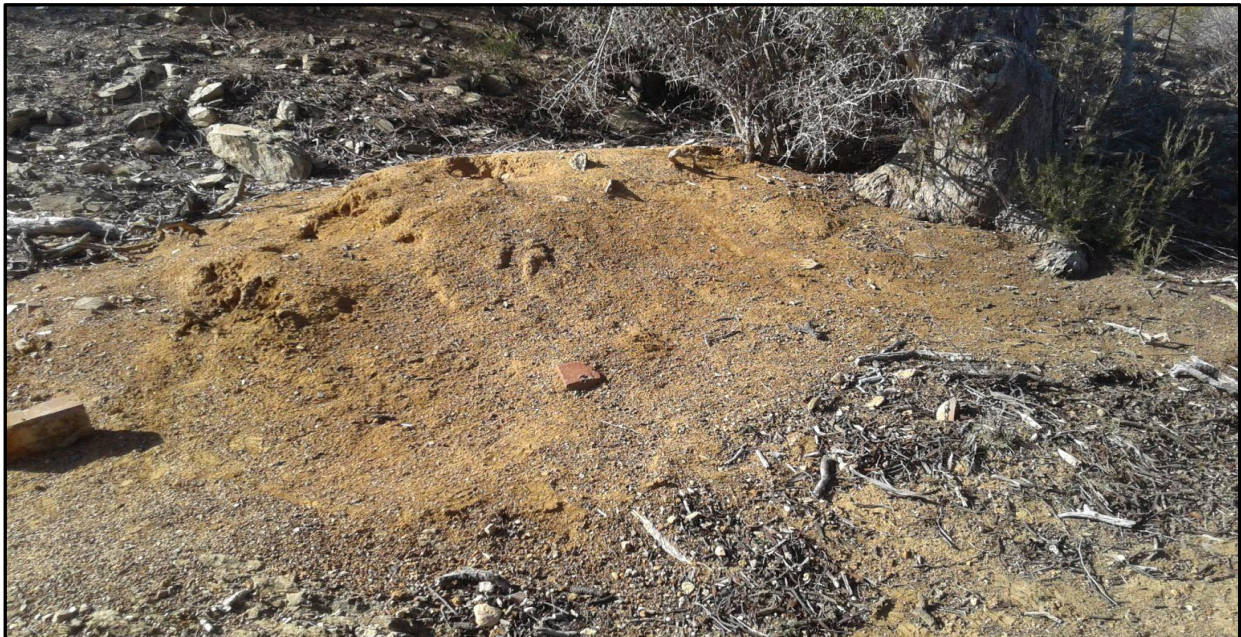
Photo 36: View of small stockpile in east of the site containing asbestos material
