TRAIL MANAGEMENT PLAN

JUMPING CREEK ESTATE

QUEANBEYAN NSW

30 May 2019

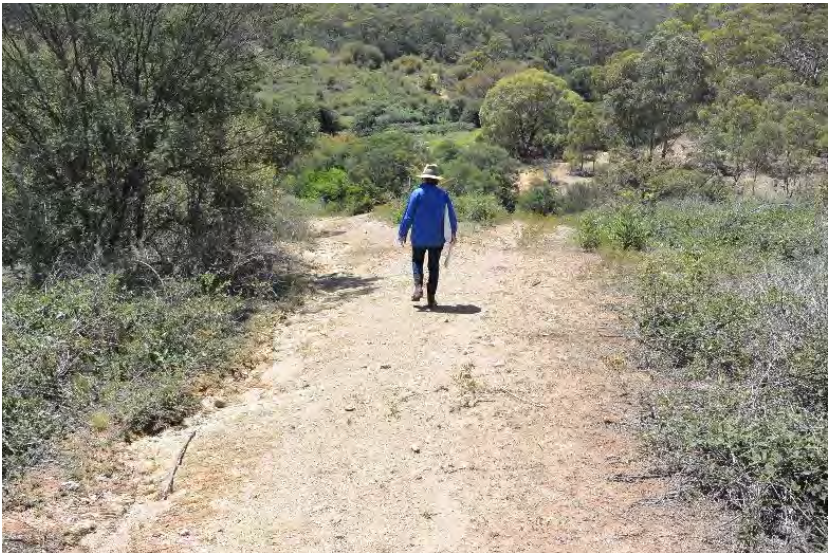
</div> <p>DSC 3826: Relatively stable all-weather surface</p>

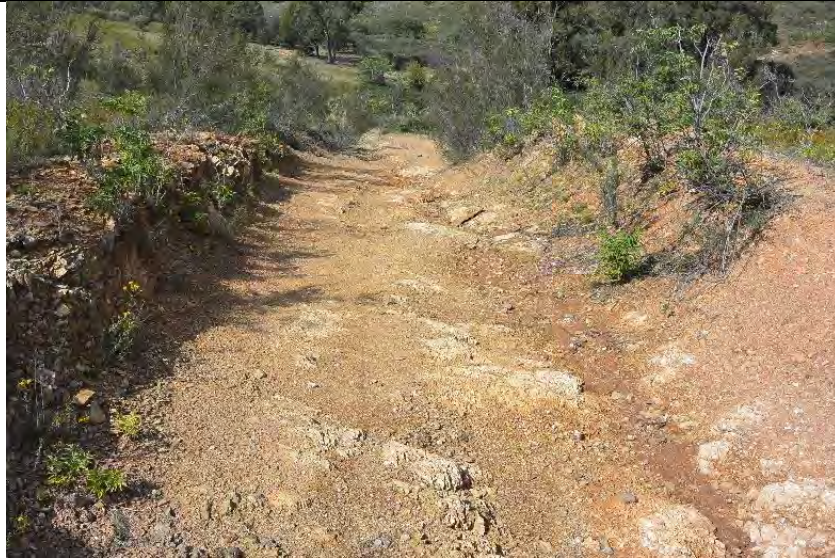
DSC 3799: Deeply incised trail concentrating run-off

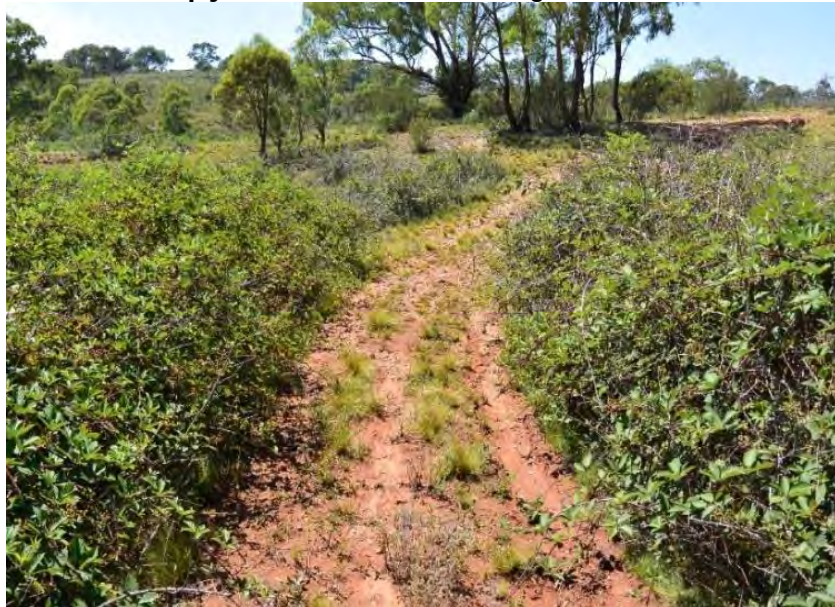
DSC 3822: Reasonably good condition trail on river flats

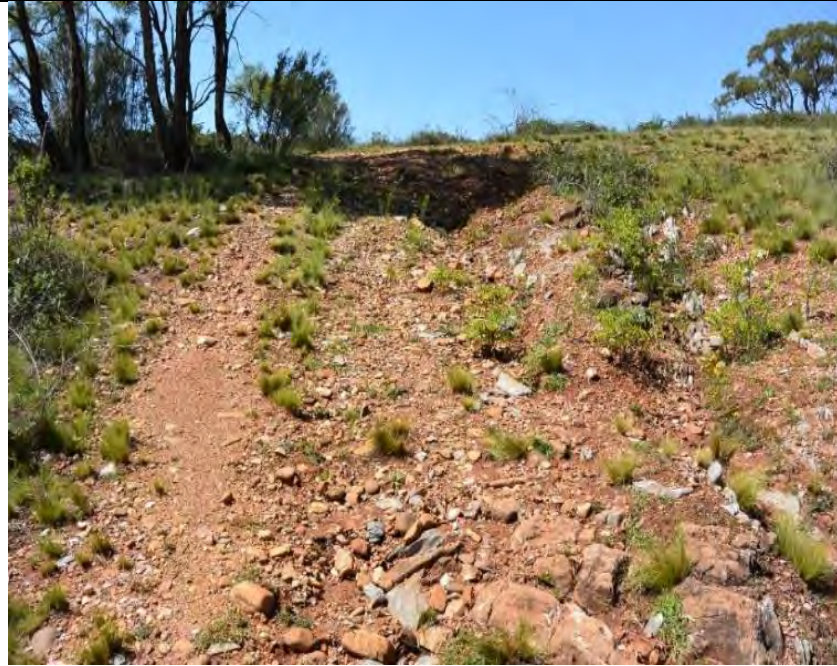
DSC 3823: Moderate-sloping sections upslope of the river flats require permanent drainage structures

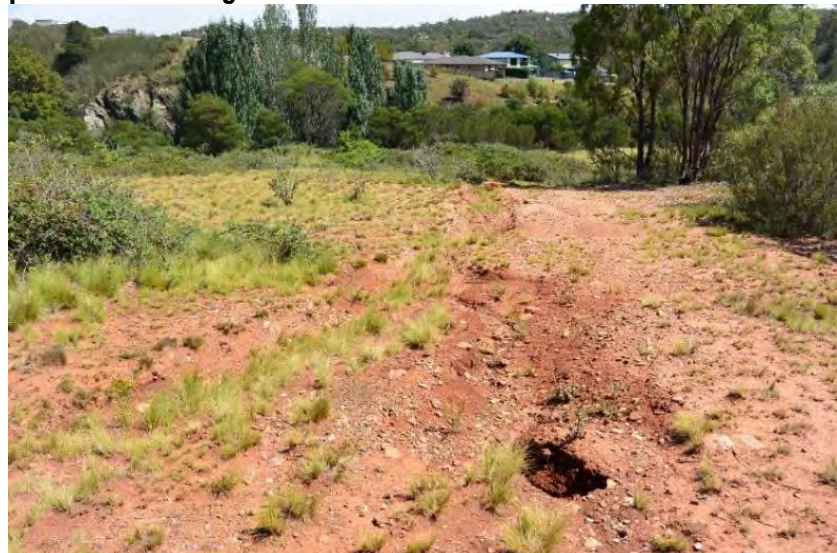
DSC 3824: Permanent crossover banks required to limit concentration of runoff

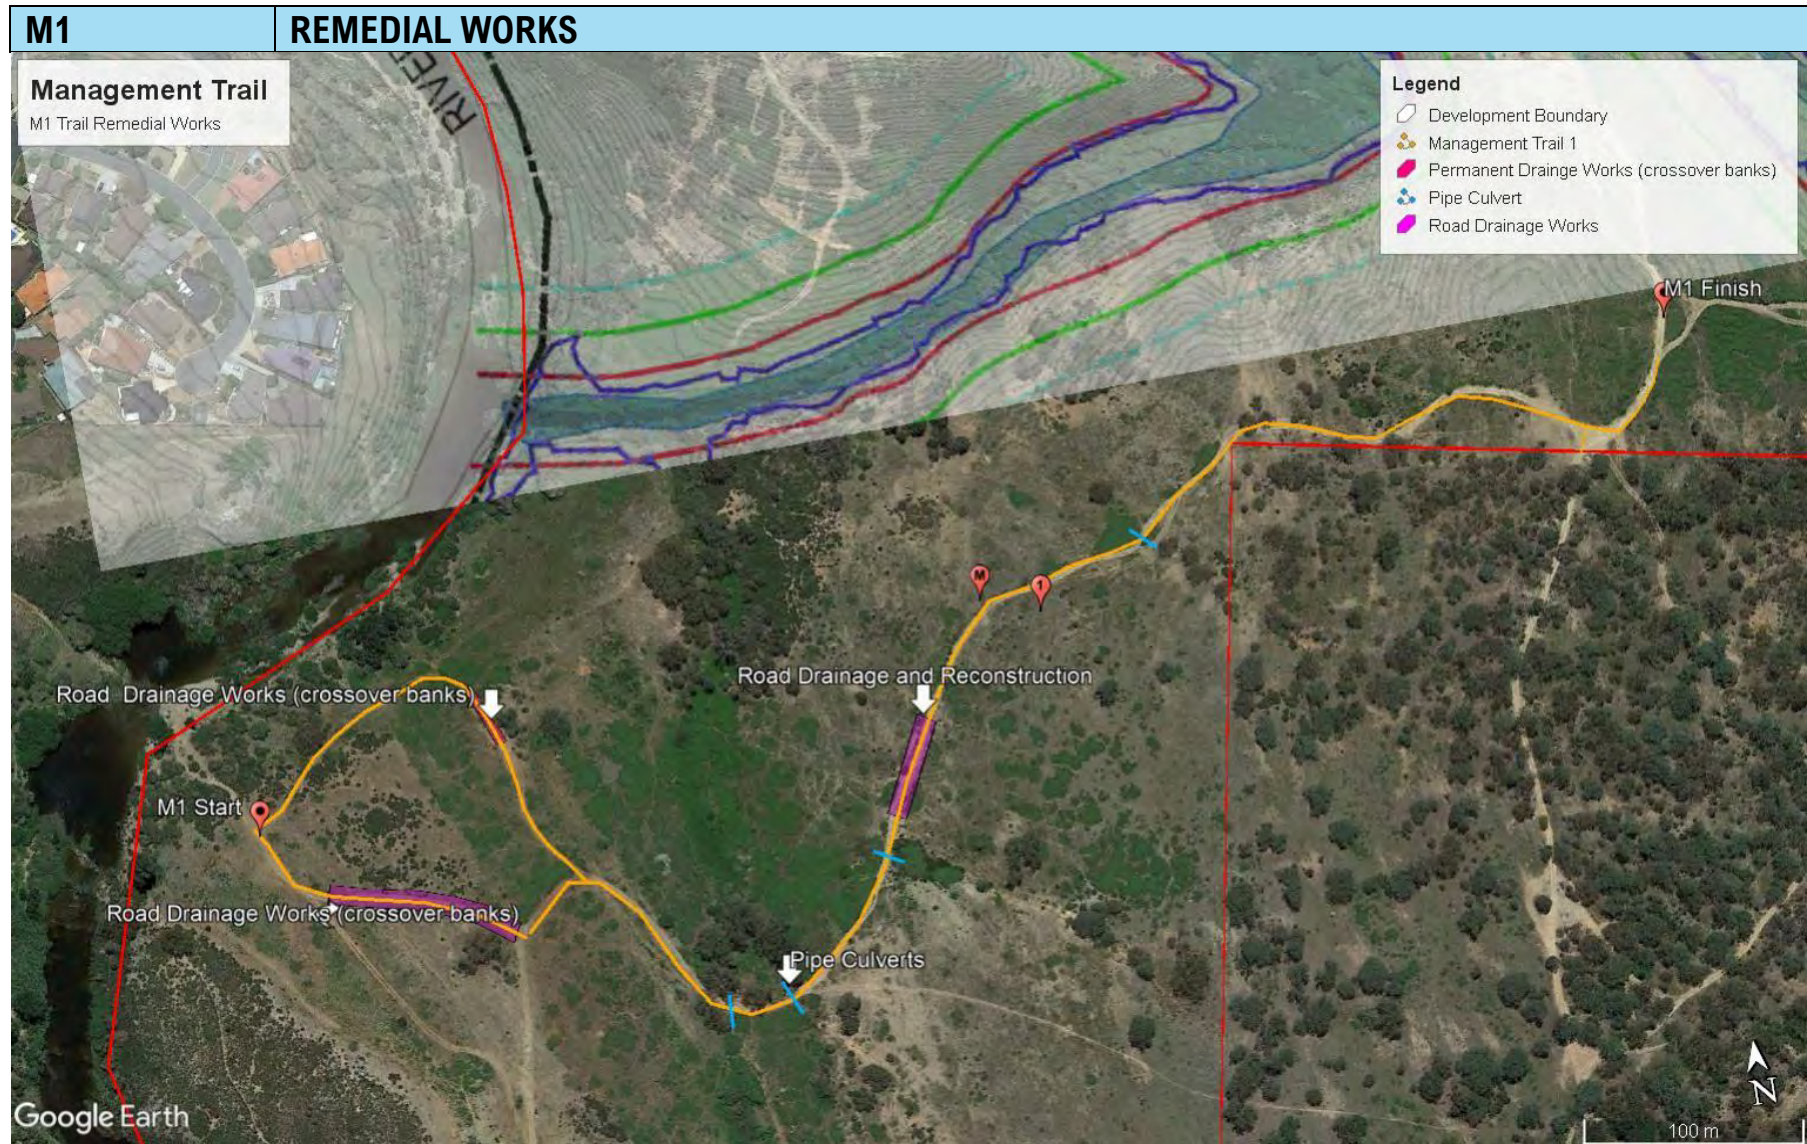
Figure 4: Trail M1 Remedial Works

M1 - DESCRIPTION	
SITE REF & LOCATION	DESCRIPTION AND SITE PICTURES
<p>Start Lat 35.378022 Lon 149.249556</p> <p>End Lat 35.376803 Lon 149.2569</p>	<p>The M1 Trail provides a strategic east-west linkage across the southern portion of the property. It provides the main connectivity through the area to be managed primarily for ecological and passive recreational activities. The trail links with the formal road network through connection with M3 at the northern end.</p> <p>This is a sensitive environmental area and the Vegetation Management Plan recommends active weed and feral animal management as well as strategic revegetation. All of these activities will be facilitated by the access provided by this trail. The trail will also provide emergency vehicle access to the riparian area adjacent to the Queanbeyan River which may be a focal point for passive recreational activities.</p> <p>The main section of the trail is generally in good condition. There are small sections associated with steeper grades and existing erosion, which will require significant reforming and shaping including road drainage work, refer Figures DSC 3825-7 & DSC 3799. Where the trail intersects minor drainage depressions pipe culverts will need to be installed, refer Figure 4.</p> <p>The loop section of the trail is in reasonably good condition in the lower section which parallels the Queanbeyan River along the river flats and has limited definition. The moderately sloping section upslope of the river flats will require some permanent drainage works to prevent concentration of flows along rehabilitated sections.</p> <div style="text-align: center;">

M1	REMEDIAL WORKS																														
<p>Culverts (4) Lat 35.379039 Lon 149.251736</p> <p>Lat 35.379022 Lon 149.252081</p> <p>Lat 35.378503 Lon 149.252644</p> <p>Lat 35.377383 Lon 149.254161</p>	<p>Concrete pipe culvert structures will need to be installed at all points where upslope drainage concentrates and cross Trail M1. The indicative locations for these structures are provided in Figure 4 and coordinates are provided in column 1 of this table. Additional locations requiring the installation of culverts may be identified during construction.</p> <p>Pipe culverts will generally need to include concrete headwalls at upslope and downslope ends. To achieve the design culvert grades some inlets may need to be cut into the ground level. In these instances, a concrete drop inlet structure should be used to reduce the chance of erosion upstream of the structure.</p>																														
<p>Major drainage and road surfacing</p> <p>SECTION 1 Start Lat 35.377553 Lon 149.250736 End Lat 35.377806 Lon 149.250811</p> <p>SECTION 2 Start Lat 35.378286 Lon 149.249878 End Lat 35.378578 Lon 149.250756</p> <p>SECTION 3 Start Lat 35.378353 Lon 149.252756 End Lat 35.377956 Lon 149.252989</p>	<p>There are three sections of Trail M1 that will require major reshaping and the installation of major road drainage works, refer Figure 4 and associated coordinates. These areas have eroded, are deeply rutted creating a hazard to traffic, and degrading downstream water quality due to erosion and sedimentation. The road surface needs to be reshaped to create a trafficable surface profile and road drainage structures installed including crossover banks and mitre/table drains. The design and spacing of these features should conform to the <i>NSW RFS Fire Trail Design, Construction and Maintenance Manual</i>. Spacing for drainage features varies depending on soil type and slope as explained below.</p>

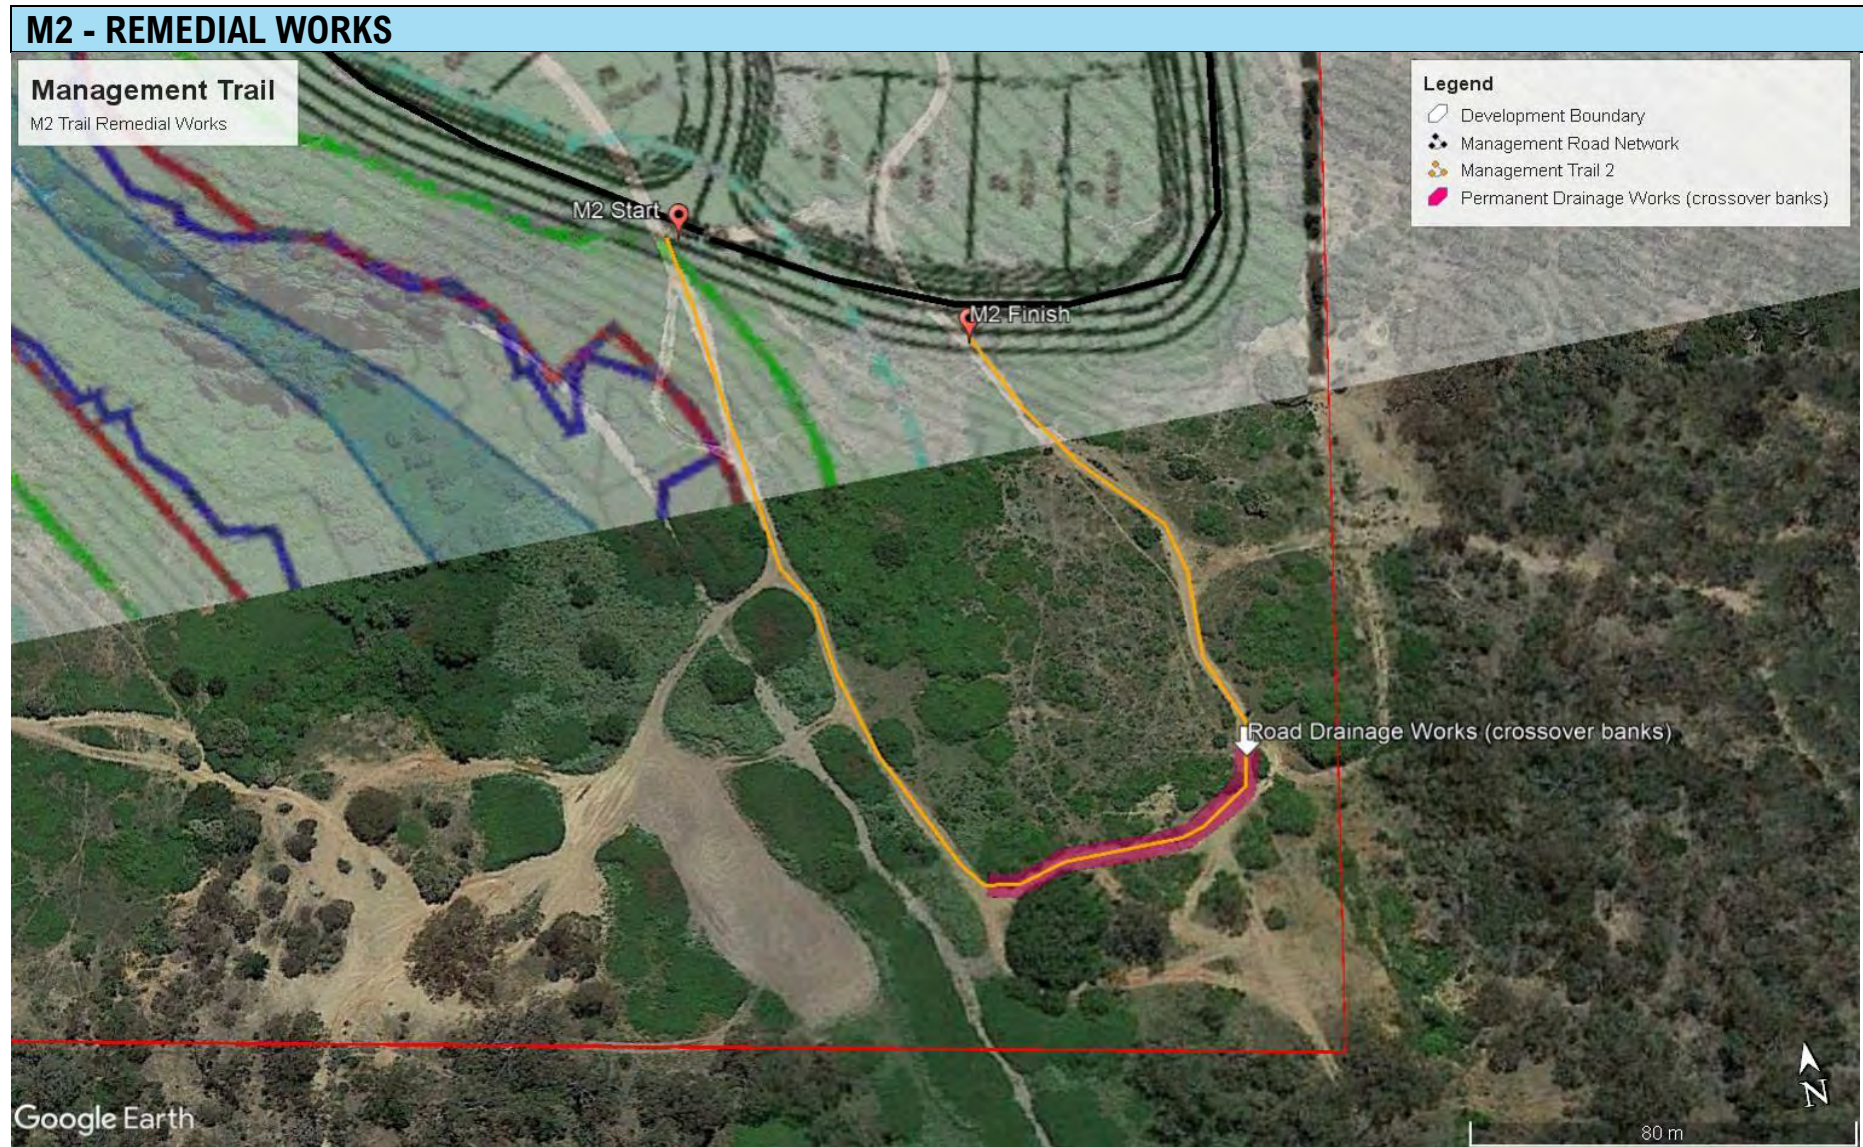
Figure 5: Trail M2 Remedial Works

M2 - DESCRIPTION	
SITE REF & LOCATION	DESCRIPTION AND SITE PICTURES
<p>Start Lat 35.376108 Lon 149.259031</p> <p>End Lat 35.376675 Lon 149.259639</p>	<p>Trail M2 provides the short-looped access road into the south east corner of the property. This access will facilitate land management activities along the southern and eastern boundaries which required intensive weed and vegetation management.</p> <p>The trail is in good condition where it runs parallel to the downslope creek as it runs almost on the contour with a low grade. The short section which loops from the upper section to the lower section (near the mine site), is on a steeper grade and has extensive areas of erosion requiring some road drainage measures. The entire trail is currently not an all-weather trail with bare earth surface which may become un-trafficable and erodible when wet. There are multiple parallel trails in the area which can be consolidated once Trail M2 is formalised, refer Figure 5.</p>

M2	REMEDIAL WORKS
<p>Road drainage crossover banks</p> <p>Start Lat 35.377436 Lon 149.259453</p> <p>End Lat 35.377256 Lon 149.260097</p>	<p>The looped section of the M2 Trail is moderately sloping and includes areas of existing wheel rut erosion and will require the installation of trail drainage works, refer Figure 5 and site coordinates. The trail surface needs to be drained regularly and drainage structures to be installed should include crossover banks. The design and spacing of these features should conform to the <i>NSW RFS Fire Trail Design, Construction and Maintenance Manual</i>.</p>
<p>All weather surface</p> <p>Start Lat 35.376108 Lon 149.259031</p> <p>End Lat 35.376675 Lon 149.259639</p>	<p>The entire length of Trail M2 should be trafficable in all-weather conditions, refer Figure 5. The trail should be topped with a suitable gravel surface. Crossfall drainage is suitable for the sections of trail constructed along the contour as the area is low slope and built on <i>in-situ</i> soil material, refer below.</p>

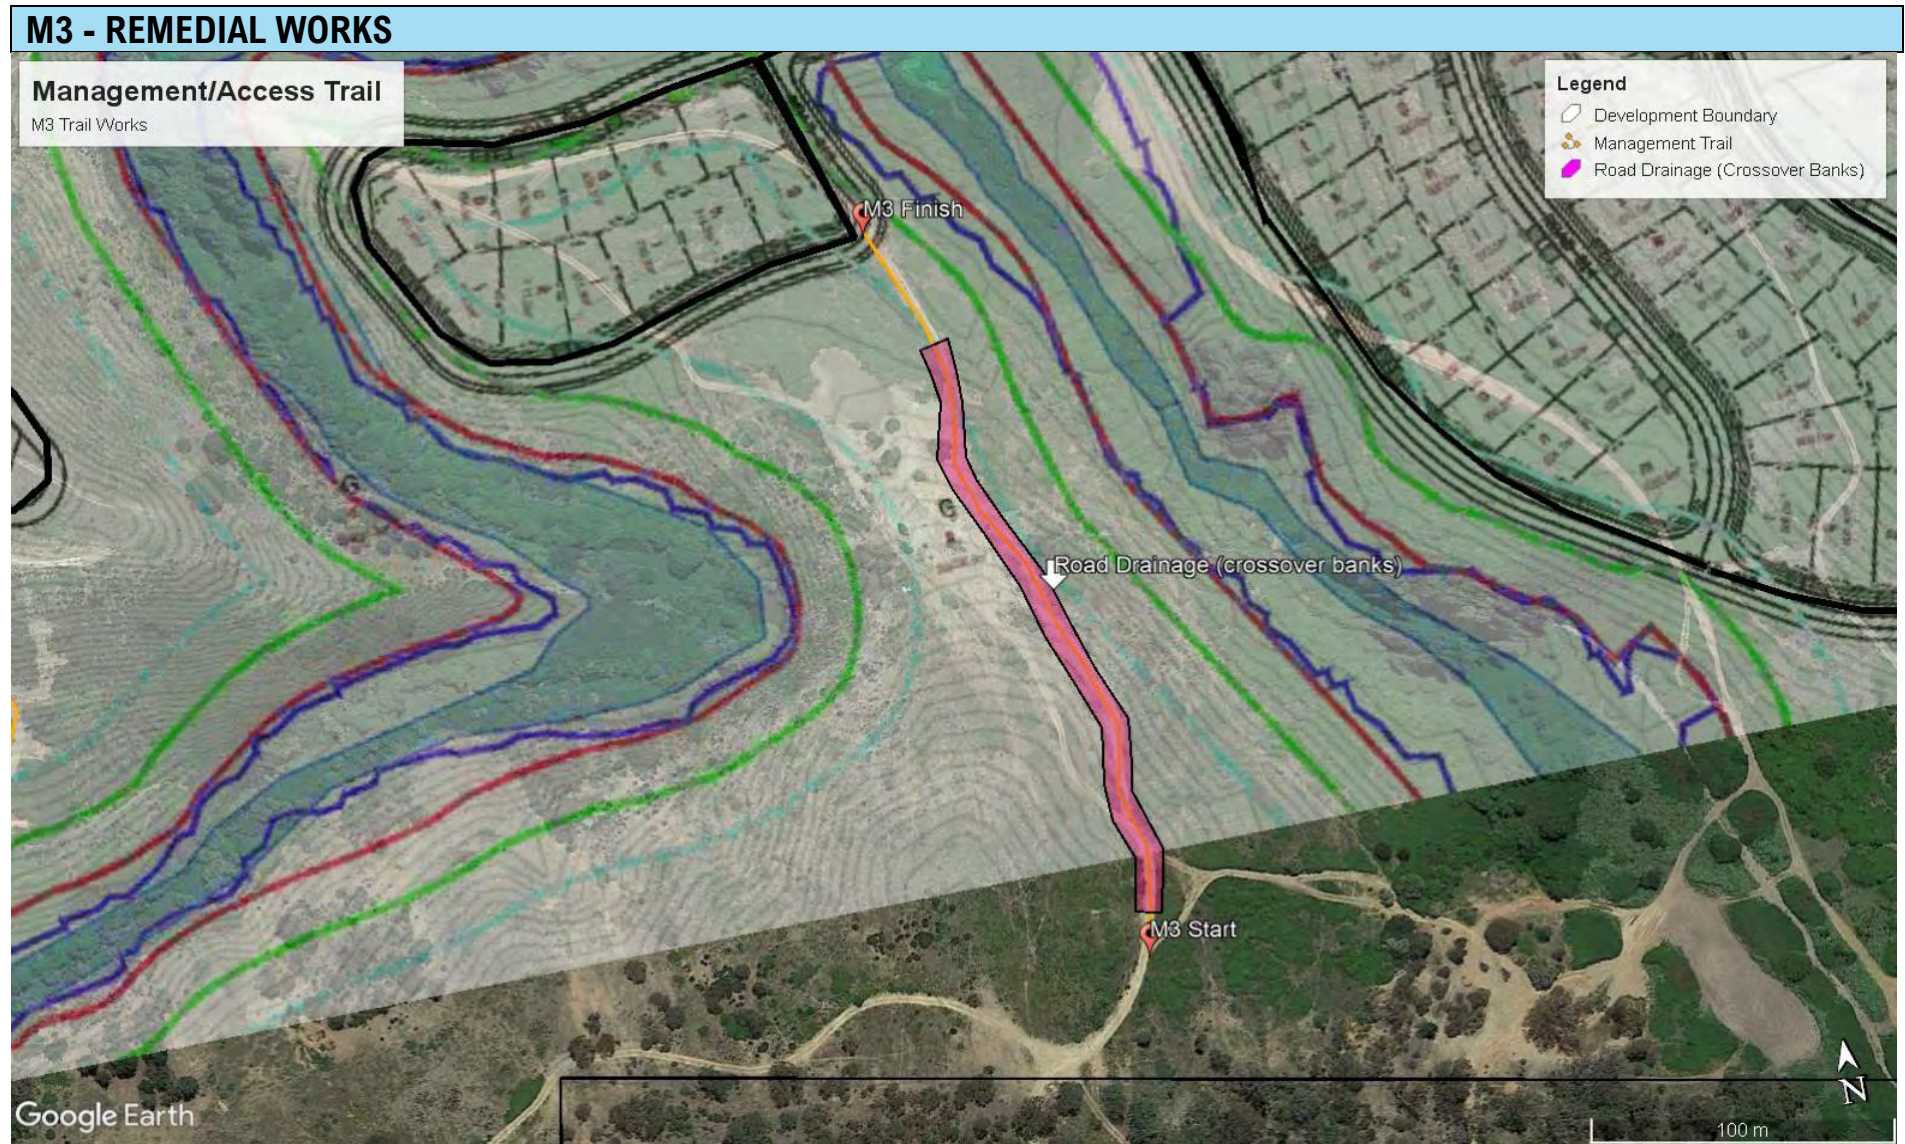
Figure 6: Trail M3 Remedial Works

M3 - DESCRIPTION	
SITE REF & LOCATION	DESCRIPTION AND SITE PICTURES
<p>Start Lat 35.376794 Lon 149.25675</p> <p>End Lat 35.374672 Lon 149.256303</p>	<p>The M3 Trail provides a linkage between the F1 Trail and the area of housing development proposed between the creeks. This will provide an alternative point of access/egress from this area during a bushfire emergency and will also facilitate land management activities in the riparian area along the creek. This trail will also provide access to the erosion control activities proposed in the old quarry site as detailed in the Erosion Control Plan.</p> <p>The trail is in reasonable condition with limited erosion in the steeper section leading up to Trail F1. These areas require trail drainage works. The trail surface is generally all-weather due to the underlying shale bedrock. A small section towards the junction with the formal road network at the northern end may require an all-weather gravel surface to be installed, refer Figure 6.</p> <div data-bbox="451 772 1295 1328" data-label="Image"> </div> <p>DSC 3793: Steeper section of Trail M3 requiring drainage works</p> <div data-bbox="451 1366 1295 1921" data-label="Image"> </div> <p>DSC 3794: Shale bedrock providing all-weather surface</p>

M3	REMEDIAL WORKS
<p>Road drainage (crossover banks)</p> <p>Start Lat 35.376853 Lon 149.256893</p> <p>End Lat 35.375040 Lon 149.256495</p>	<p>The section of moderate sloping trail leading down from Trail F1 will require the installation of trail drainage works, refer Figure 6 and coordinates provided in column 1. The trail surface needs to be drained regularly and drainage structures to be installed may include crossover banks and mitre/table drains. The design and spacing of these features should conform to the <i>NSW RFS Fire Trail Design, Construction and Maintenance Manual</i>.</p>

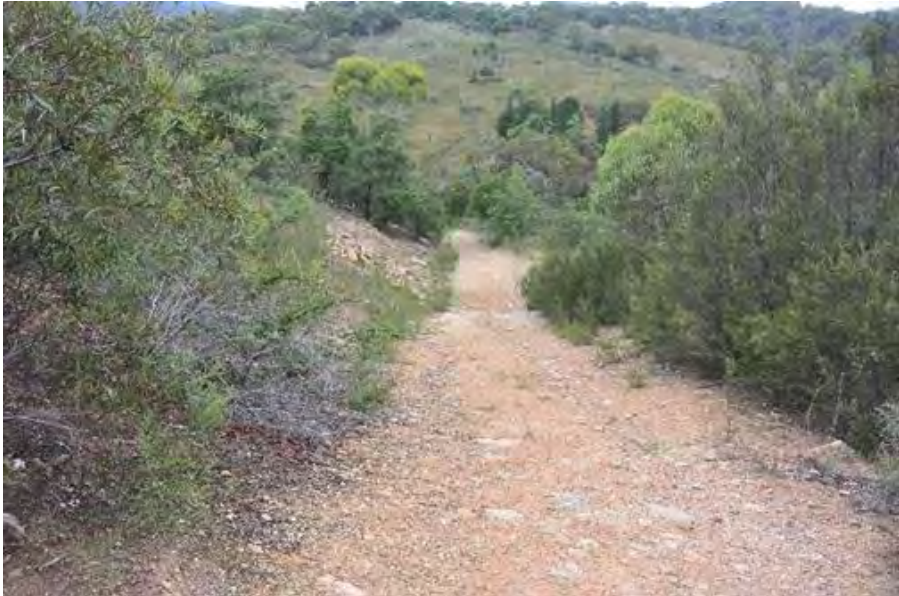
</div> <p>DSC 3765: Steep sections of trail protected by multiple crossover banks</p> <div style="text-align: center;">

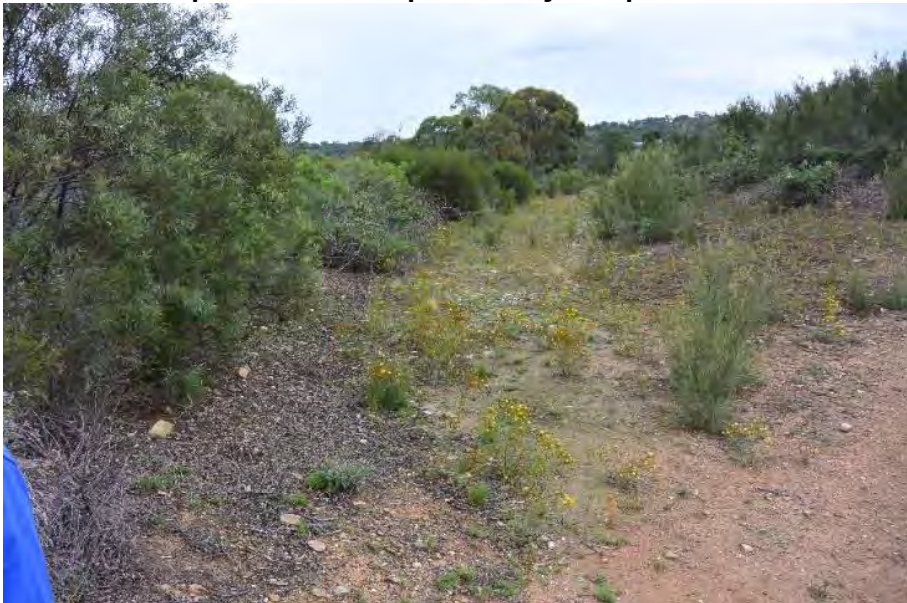
</div> <p>DSC 3766: Crossover banks draining from the trail</p>

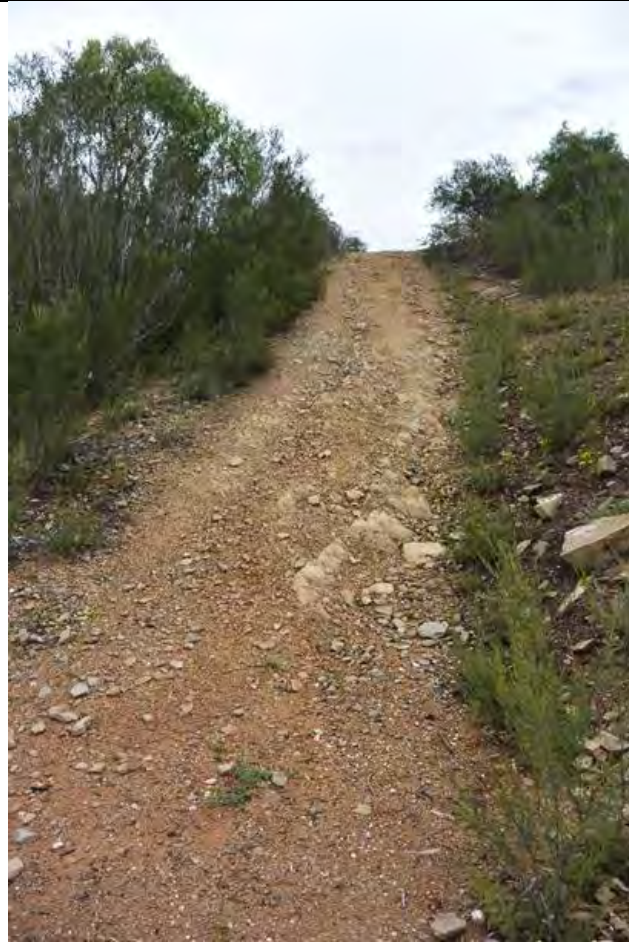
DSC 3768: Minor wheel rut erosion

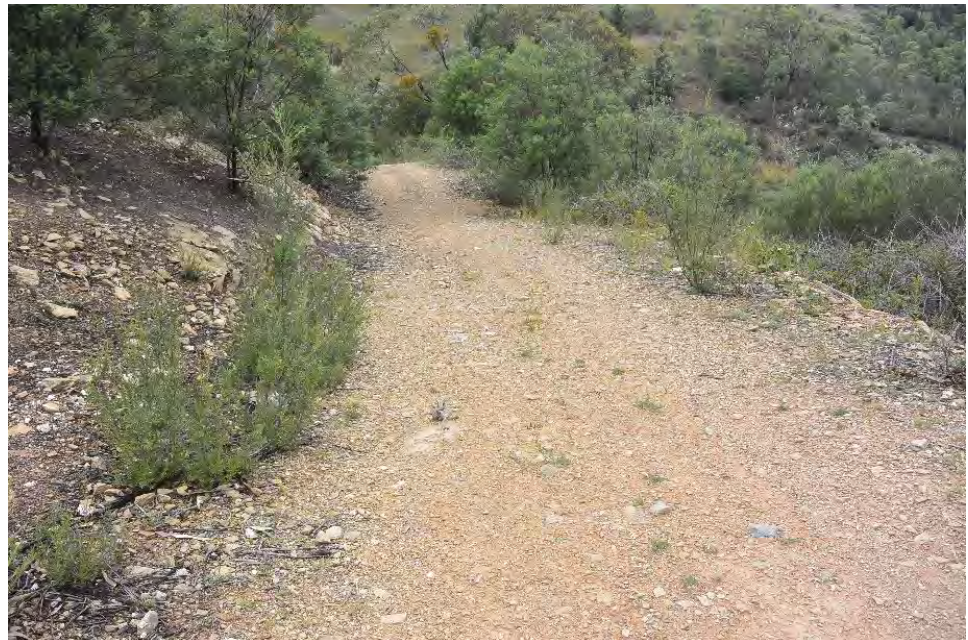
DSC 3769: Trail in general good condition with all-weather surface

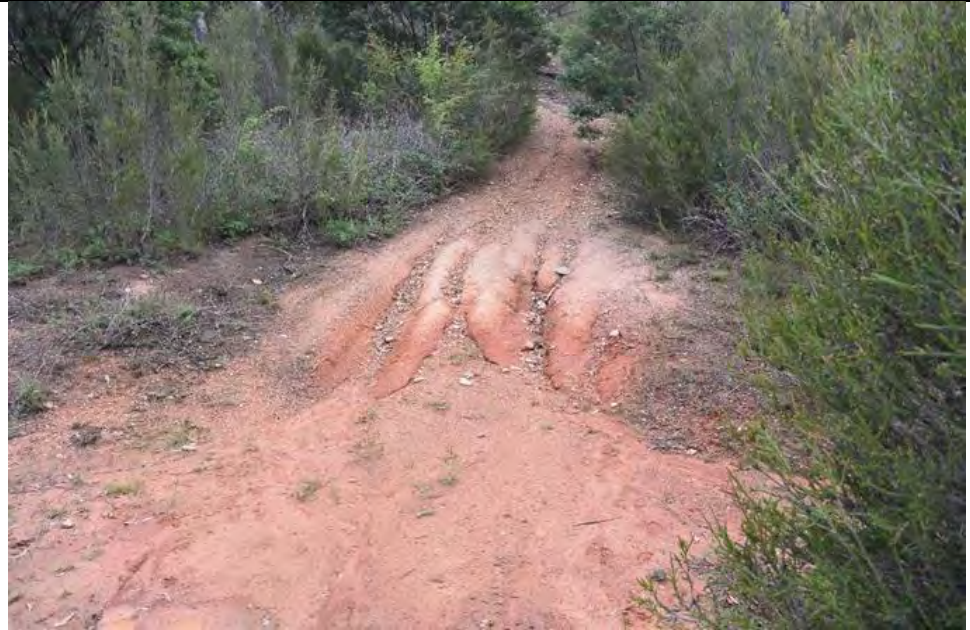
DSC 3770: Wheel rut erosion and deposition in channel of crossover

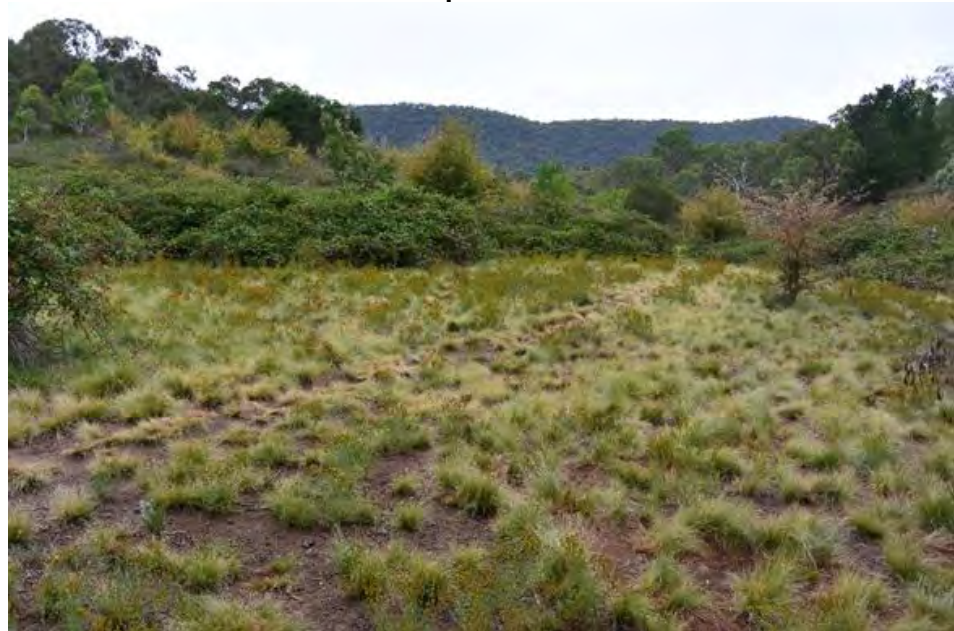
DSC 3773: Creek flat location for new turnaround bay

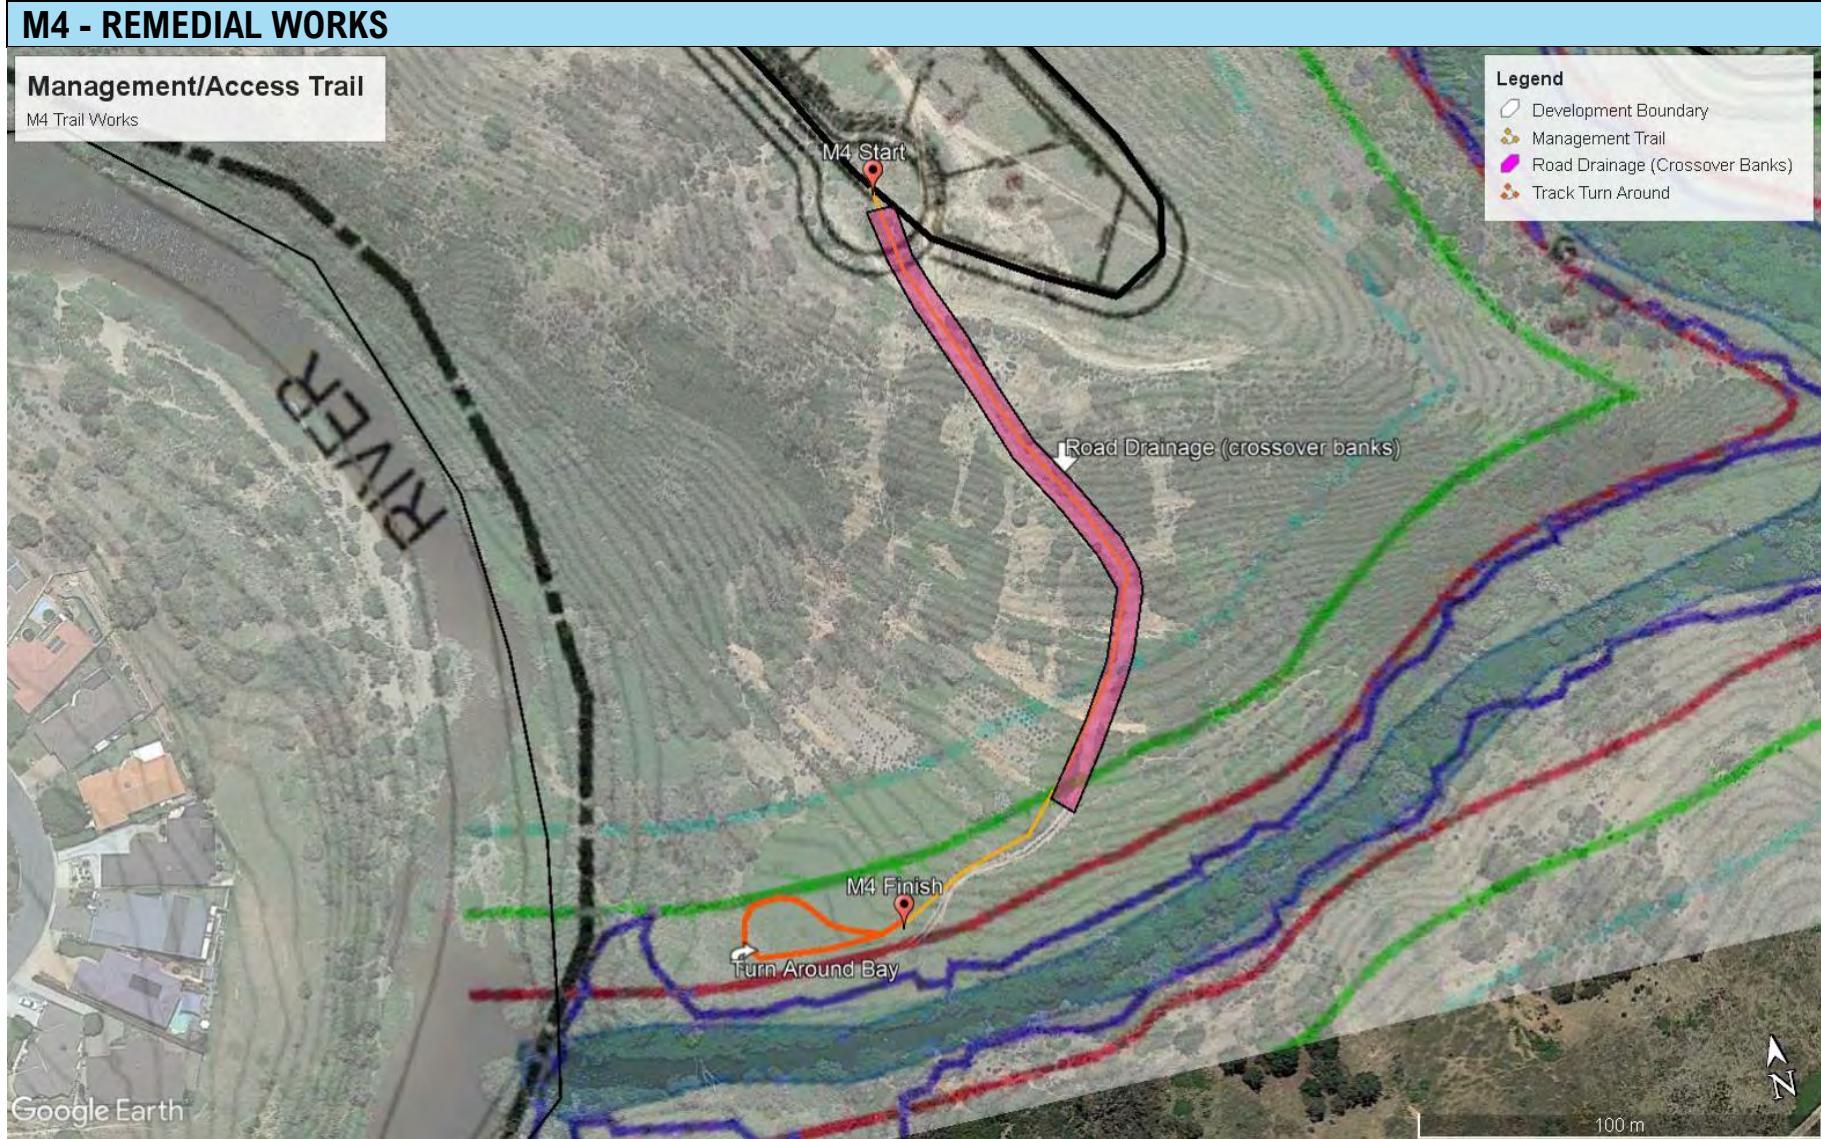
Figure 7: Trail M4 Remedial Works

M4 - DESCRIPTION	
SITE REF & LOCATION	DESCRIPTION AND SITE PICTURES
<p>M4</p> <p>Start Lat -35.374716 Lon 149.252499</p> <p>End Lat -35.376324 Lon 149.252194</p>	<p>Trail M4 links the formal road network to the area around the junction of the Creek with the Queanbeyan River. The trail traverses a very steep slope leading down the creek flats. Access to the riparian zone will enable weed control and feral animal control measures in the Vegetation Management Plan to be implemented in this area. The trail will also provide an opportunity for passive recreational activities such as walking and bike riding.</p> <p>The trail is in relatively good condition and extensive erosion control measures have been implemented which are reducing erosion on the very steep sections of trail. There are minor sections where wheel ruts have eroded and sediment has built up in the channel of downslope crossover banks, refer DSC 3768 & DSC 3770 and Figure 7.</p> <div style="text-align: center;">

M4	REMEDIAL WORKS
<p>Road drainage (crossover banks)</p> <p>Start Lat -35.374758 Lon 149.252533</p> <p>End Lat -35.376146 Lon 149.252681</p>	<p>The M4 Trail is in generally good condition with extensive road drainage structures already in place. These structures will require maintenance and sediment in channels will need to be cleaned out periodically to ensure adequate drainage and maintain trafficability of the trail. The minor wheel rut erosion can be addressed through filling with gravel.</p>
<p>Turn around bay</p> <p>Site Lat -35.376322 Lon 149.251928</p>	<p>A new turnaround bay will be constructed in the level area on the creek flats, refer Figure 7 and column 1. The turnaround bay will have a radius sufficient for large four-wheel drive vehicles and will include drainage and an all-weather surface.</p>

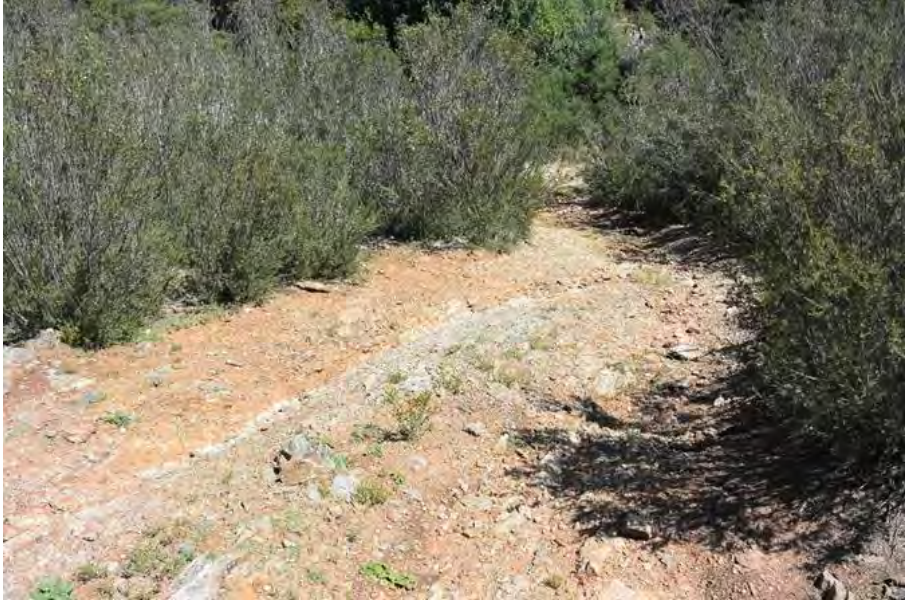
<p>DSC 3816: Deeply rutted trail leading to Queanbeyan River</p>

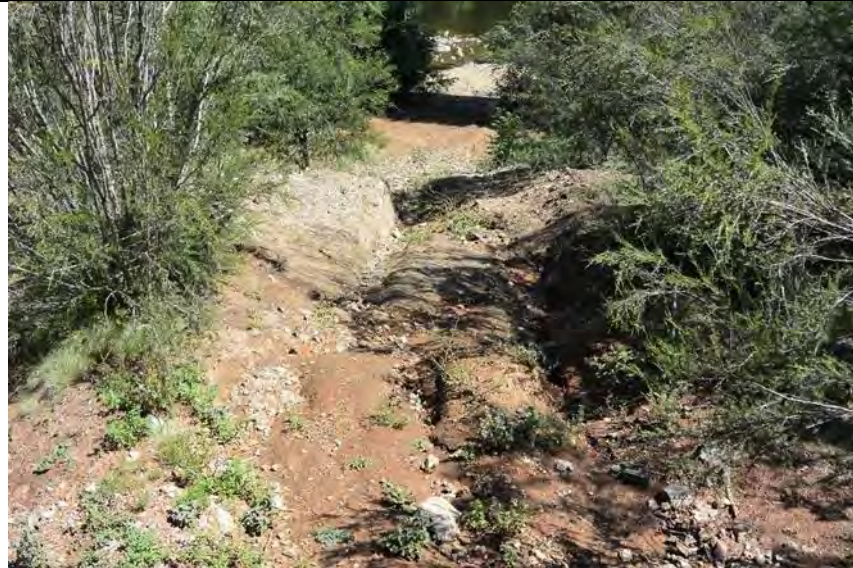
DSC 3818: Wheel ruts leading to sediment plume in Queanbeyan River

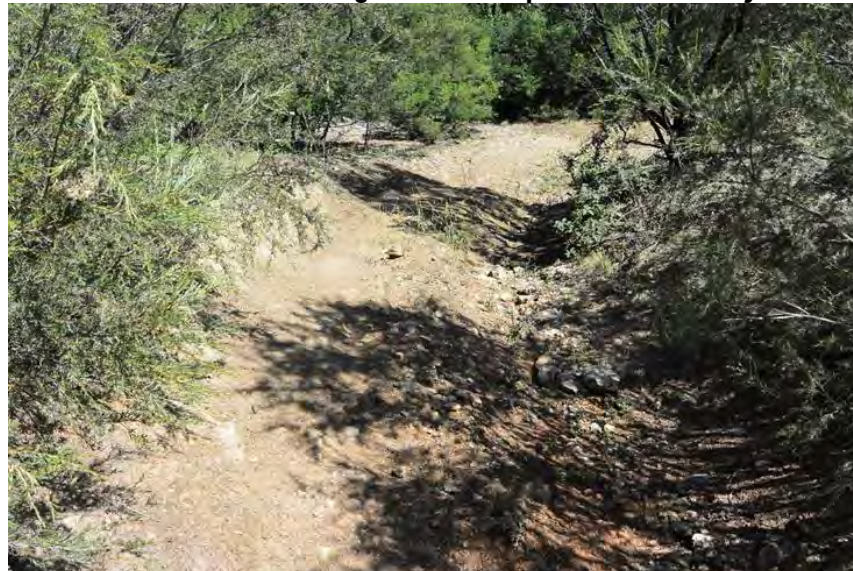
DSC 3819: Trail section to be decommissioned and rehabilitated

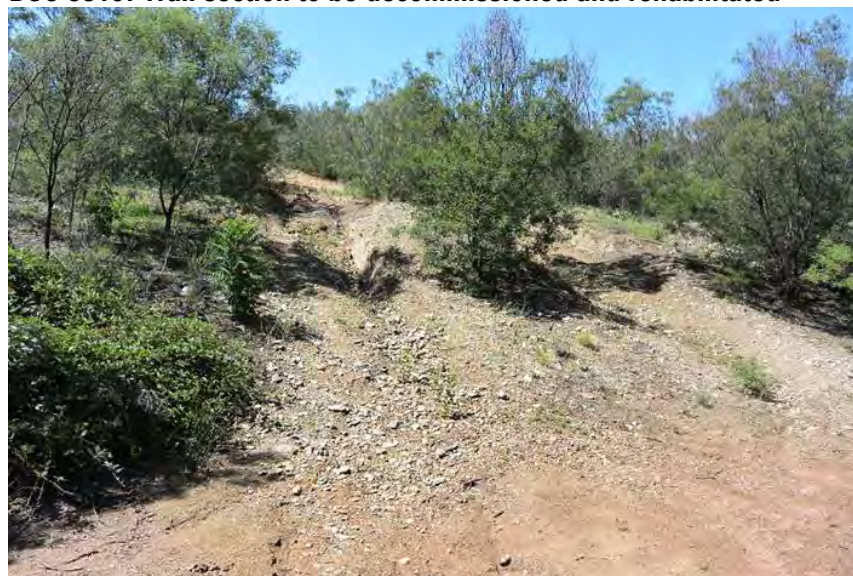
DSC 3820: Rehabilitation area to be contour ripped and revegetated

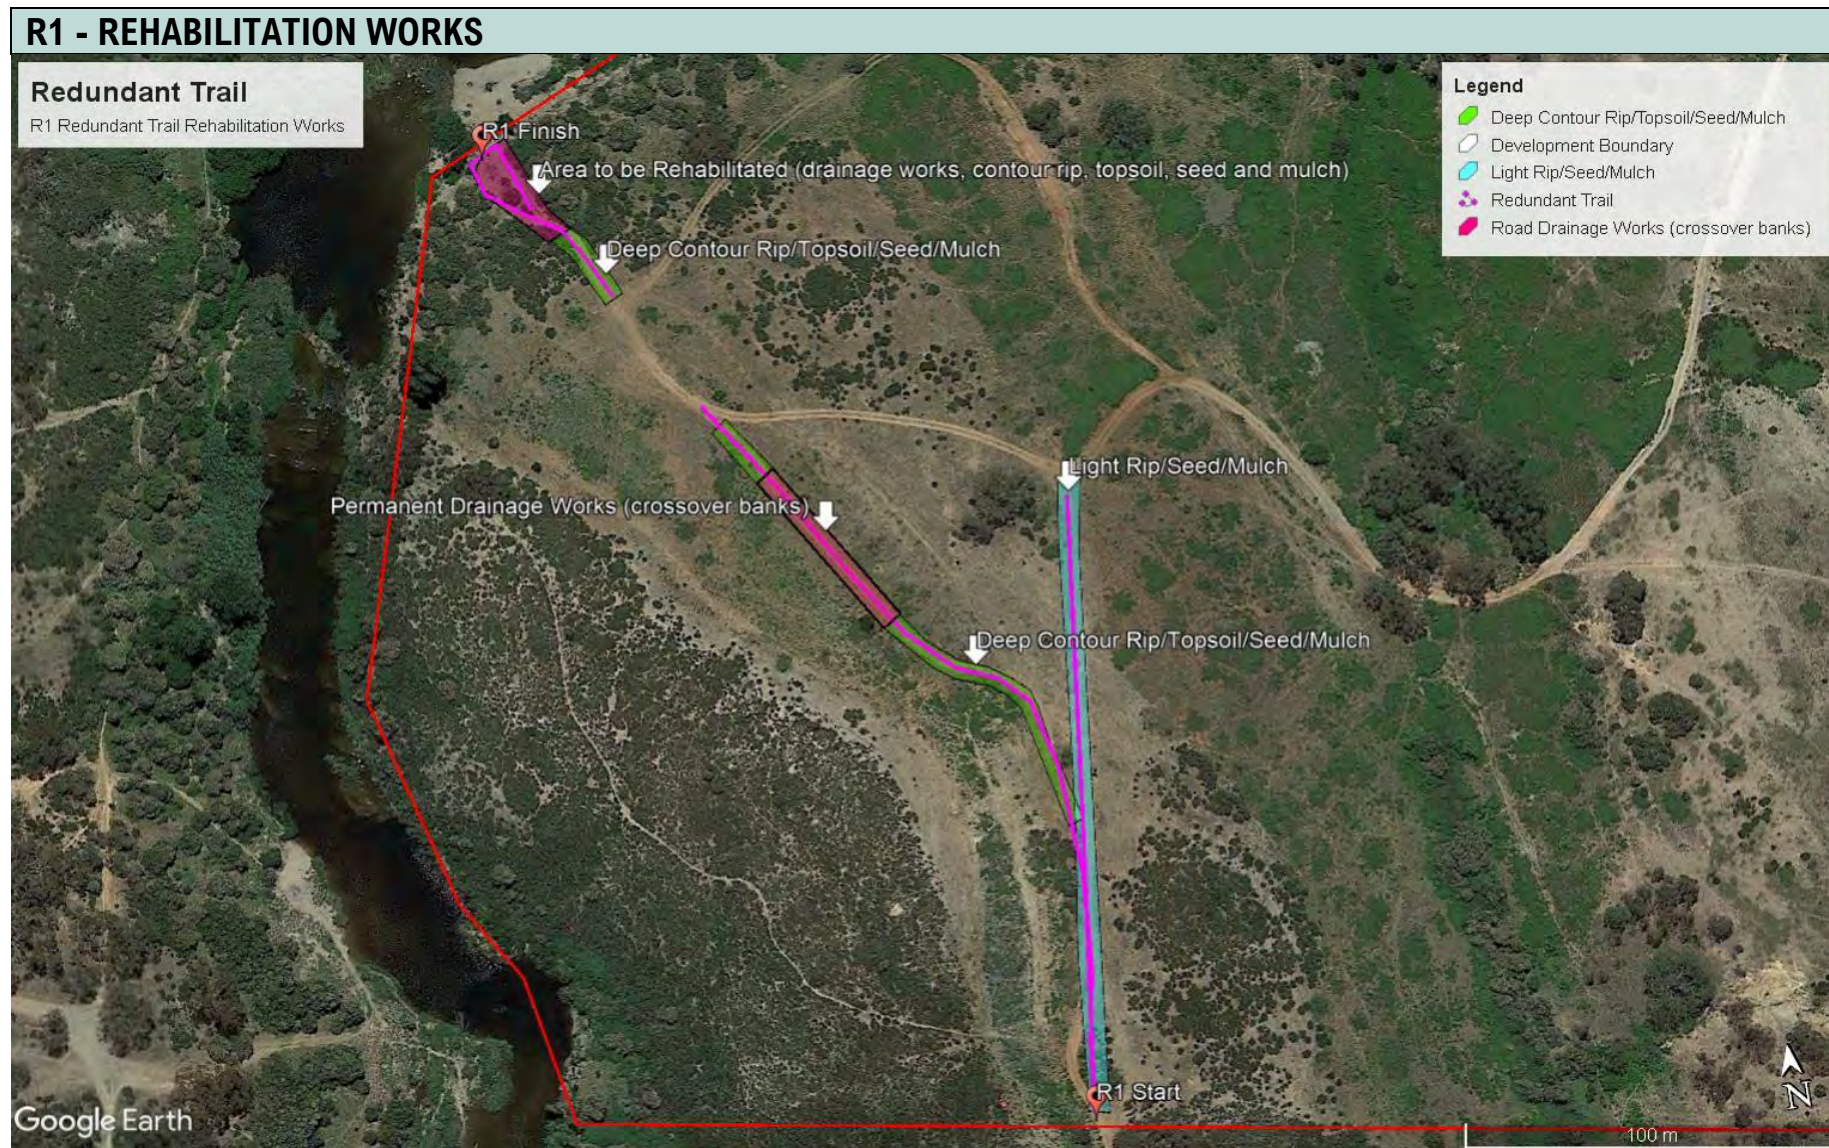
Figure 8: Trail R1 Rehabilitation Works

R1 - DESCRIPTION	
SITE REF & LOCATION	DESCRIPTION AND SITE PICTURES
<p>R1</p> <p>Start Lat 35.380172 Lon 149.250536</p> <p>End Lat 35.377594 Lon 149.249217</p>	<p>Trail R1 runs from the southern property boundary towards the western boundary at the Queanbeyan River. The trail terminates at Queanbeyan River adjacent to an area used for swimming and fishing. The trail provides access to the riparian zone of the Queanbeyan River and the southern side of the major creek which drains the development site.</p> <p>The section of the trail along the ridge running north from the southern boundary is in reasonably good condition. Erosion is generally restricted to the steeper slopes immediately upslope of the Queanbeyan River. This area is heavily eroded and deeply rutted, refer Figures DSC 3816, 3818, 3819 & 3820 and Figure 8.</p> <p>A large sediment plume has been created in the Queanbeyan River downslope of the eroded area. This material will be mobilised in the next flood event creating downstream problems. The very steep section immediately upslope of the River will require extensive rehabilitation to address the erosion and sedimentation problems, refer Figure8. The long moderate sloping trail section leading to the eroded area will also require permanent drainage works to reduce the ongoing risk of erosion.</p>

R1	REMEDIAL WORKS
<p>Deep contour rip / topsoil / seed / mulch</p> <p>Start Lat 35.379433 Lon 149.250653</p> <p>End Lat 35.378875 Lon 149.250222</p> <p>Start Lat 35.378461 Lon 149.249908</p> <p>End Lat 35.378328 Lon 149.249806</p> <p>Start Lat 35.377981 Lon 149.249556</p> <p>End Lat 35.377811 Lon 149.2494</p>	<p>Trail R1 should be totally rehabilitated. Two sections will require deep ripping the trail on the contour (level) to increase infiltration. In sections which are eroded additional topsoil material should be imported to bring the surface up to natural ground level and create a free draining profile. The ripped and topsoiled area should be seeded with an appropriate species mix which recognises the species listed in the Vegetation Management Plan. Fast growing cover crop species with sterile seed may be used to provide a rapid groundcover to protect from erosion. The seeded area should be covered with a light mulch to further limit erosion and promote germination. The use of soil ameliorants and fertiliser to assist in revegetation should be determined through soil testing.</p>

<p>Permanent drainage works (crossover banks)</p> <p>Start Lat 35.378864 Lon 149.250219</p> <p>End Lat 35.378467 Lon 149.249919</p>	<p>The long moderately sloping trail section, refer Figure 8, should include permanent drainage structures (crossover banks) to ensure the rehabilitated trail section drains and runoff does not concentrate. The design and spacing of these features should conform to the <i>NSW RFS Fire Trail Design, Construction and Maintenance Manual</i> although some allowance can be made for the lower runoff rates expected from the rehabilitated trail.</p>
<p>Rehabilitate deeply eroded section</p> <p>Start Lat 35.377819</p>	<p>The section immediately upslope of the Queanbeyan River which has severely eroded will be decommissioned and rehabilitated, refer Figure 8 and coordinates.</p> <p>Rehabilitation will involve the installation of a crossover bank upslope of the erosion to divert run-on water away from the area. The eroded area will be deep ripped on the contour and shaped to reduce concentration of runoff. The area will then be topsoiled prior to seeding and mulching. Species to be sown should reflect the species list provided in the Vegetation Management Plan although the use of sterile cover crop to provide rapid groundcover protection from erosion</p>
