TRAIL MANAGEMENT PLAN

JUMPING CREEK ESTATE

QUEANBEYAN NSW

30 May 2019

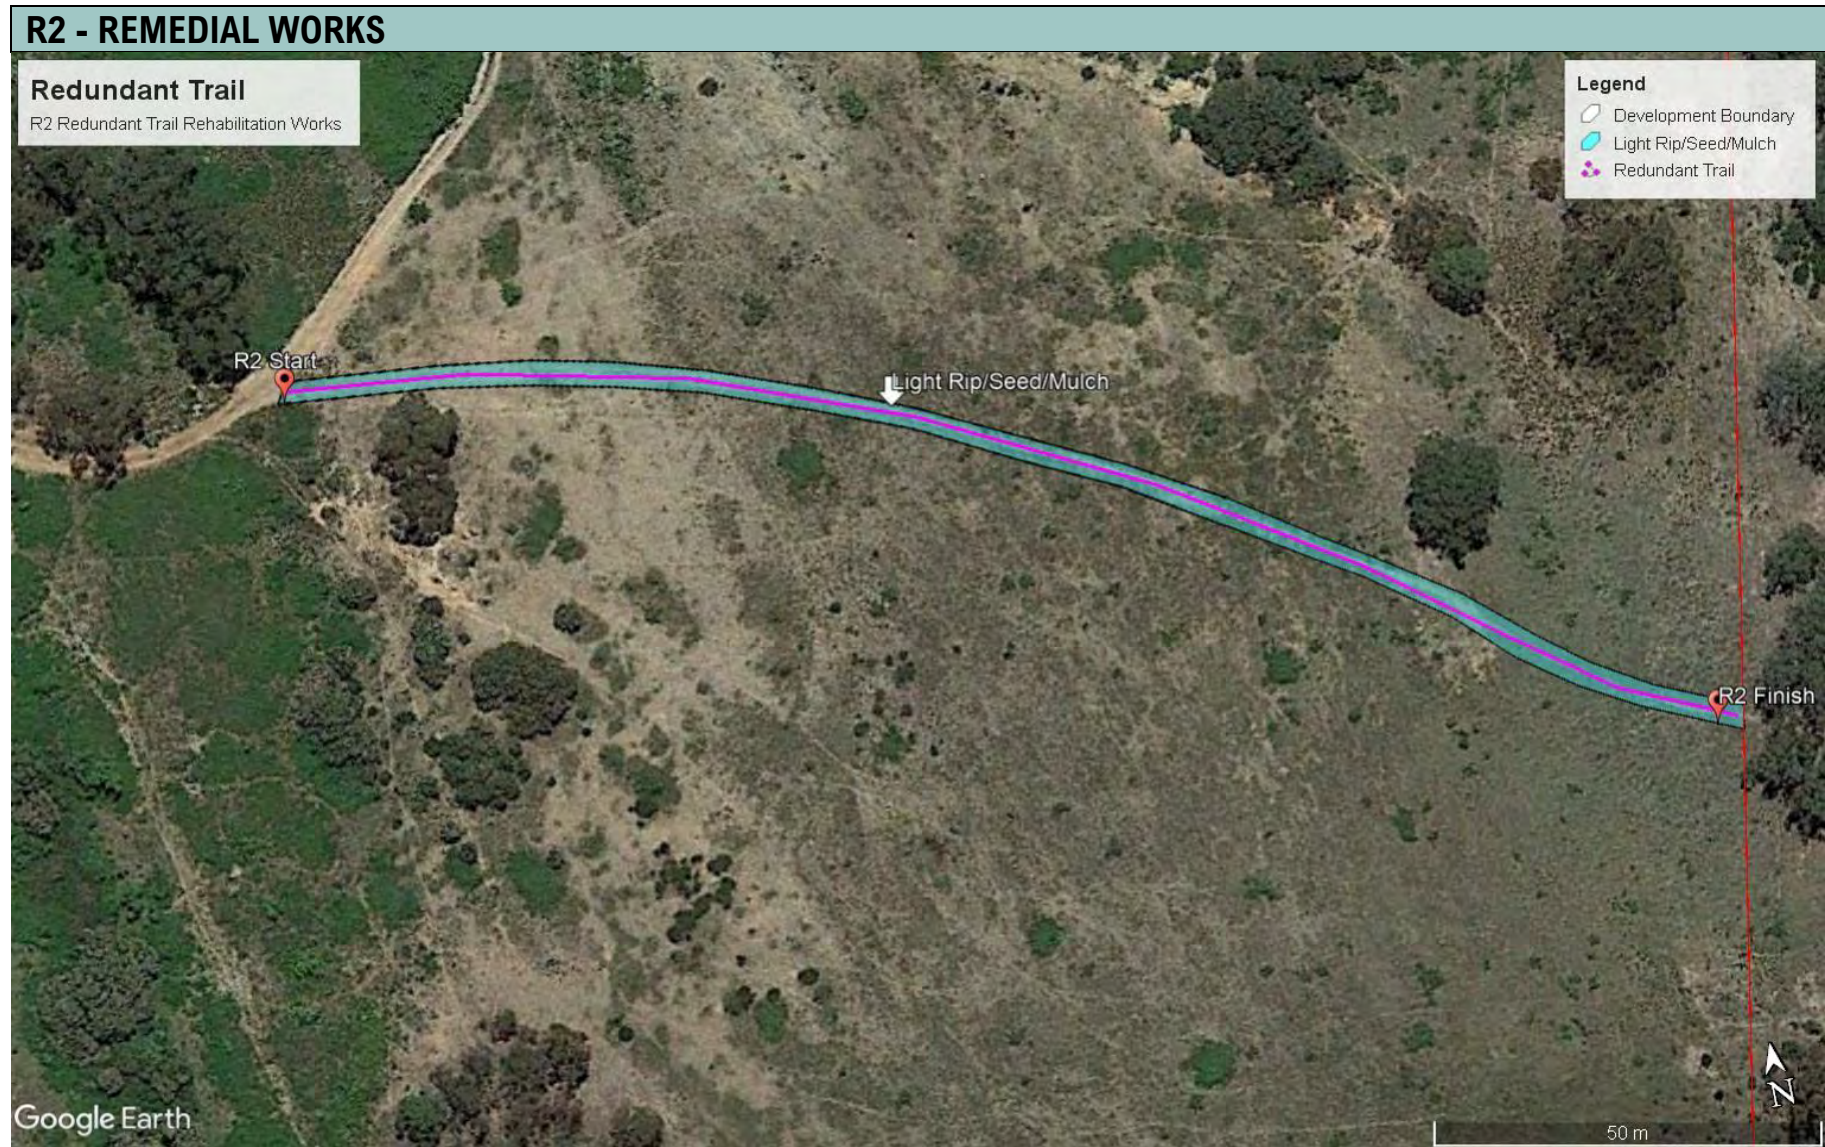
Figure 9: Trail R2 Rehabilitation Works

R2 - DESCRIPTION	
SITE REF & LOCATION	DESCRIPTION AND SITE PICTURES
<p>Start Lat 35.379017 Lon 149.252156</p> <p>End Lat 35.379708 Lon 149.254058</p>	<p>The R2 Trail links M1 with the to the eastern boundary. This access track is informal and is essentially redundant.</p> <p>The trail is in good condition and there is little active erosion. The trail lacks definition in places and the surface is not in all-weather condition, refer Figure 9.</p>   <p>DSC 3804: R2 Trail in good condition</p>   <p>DSC 3805: Poorly defined R2 Trail</p>

R2	REMEDIAL WORKS
<p>Light rip / seed / mulch</p> <p>Start Lat 35.379017 Lon 149.252156</p> <p>End Lat 35.379708 Lon 149.254058</p>	<p>Rehabilitation along the entire length of this track low slope section which parallels the Queanbeyan River and consists of River flats, refer Figure 9, should involve very light cultivation type ripping of the trail to increase infiltration and provide a seed bed. The ripped area should be seeded with an appropriate species mix which recognises the species listed in the Vegetation Management Plan. Fast growing cover crop species with sterile seed may be used to provide a rapid groundcover to protect from erosion. The seeded area should be covered with a light mulch to further limit erosion and promote germination.</p>

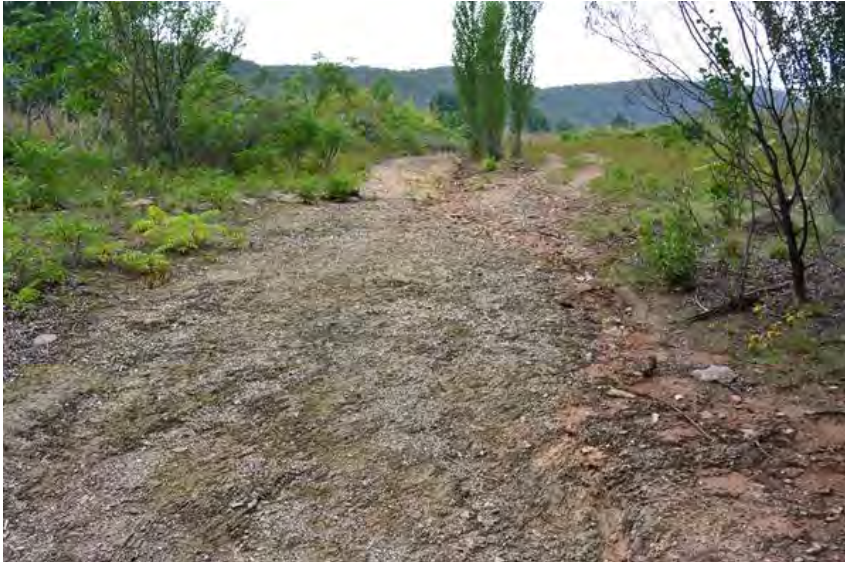
<p>DSC 3786: Trail sections leading to the creek crossing</p>

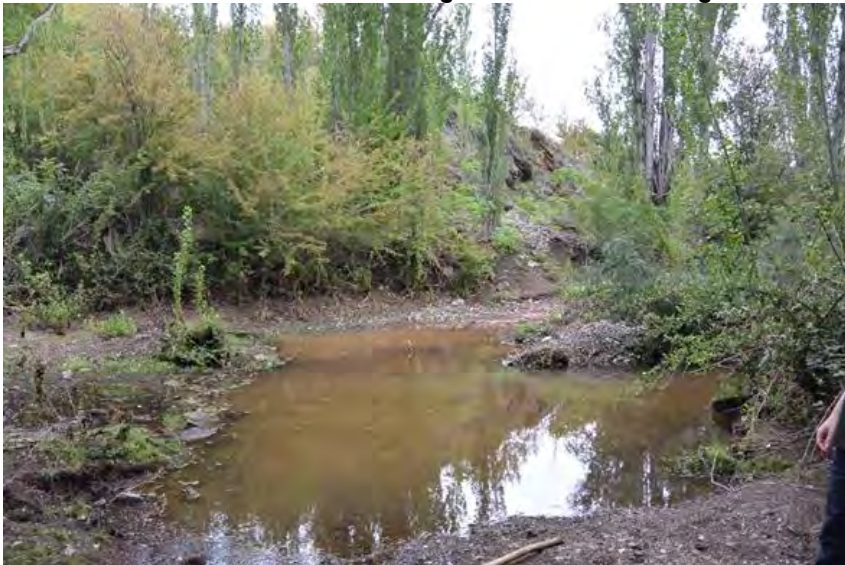
<p>DSC 3785: Creek crossings will require upslope permanent drainage features</p> </div>

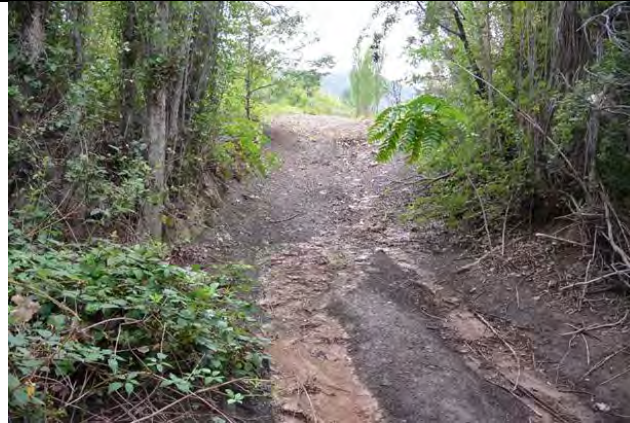
DSC 3784: Location for creek drainage structure

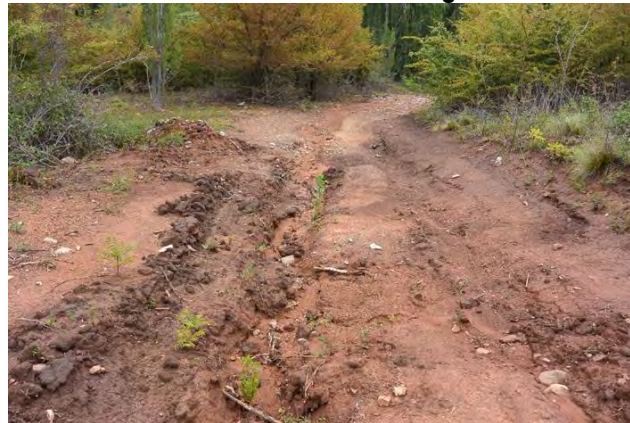
DSC 3781: Deeply rutted areas will require building up with topsoil

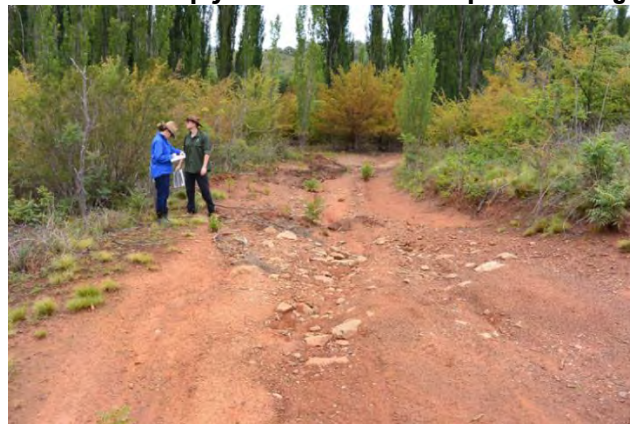
DSC 3780: existing trail will be deep ripped prior to revegetation

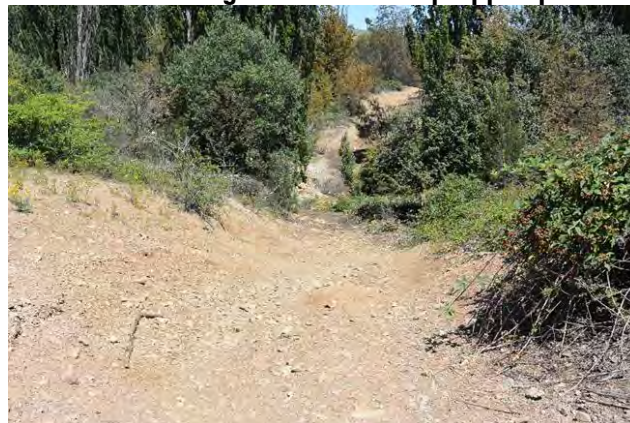
DSC 3842: The second creek crossing to be rehabilitated

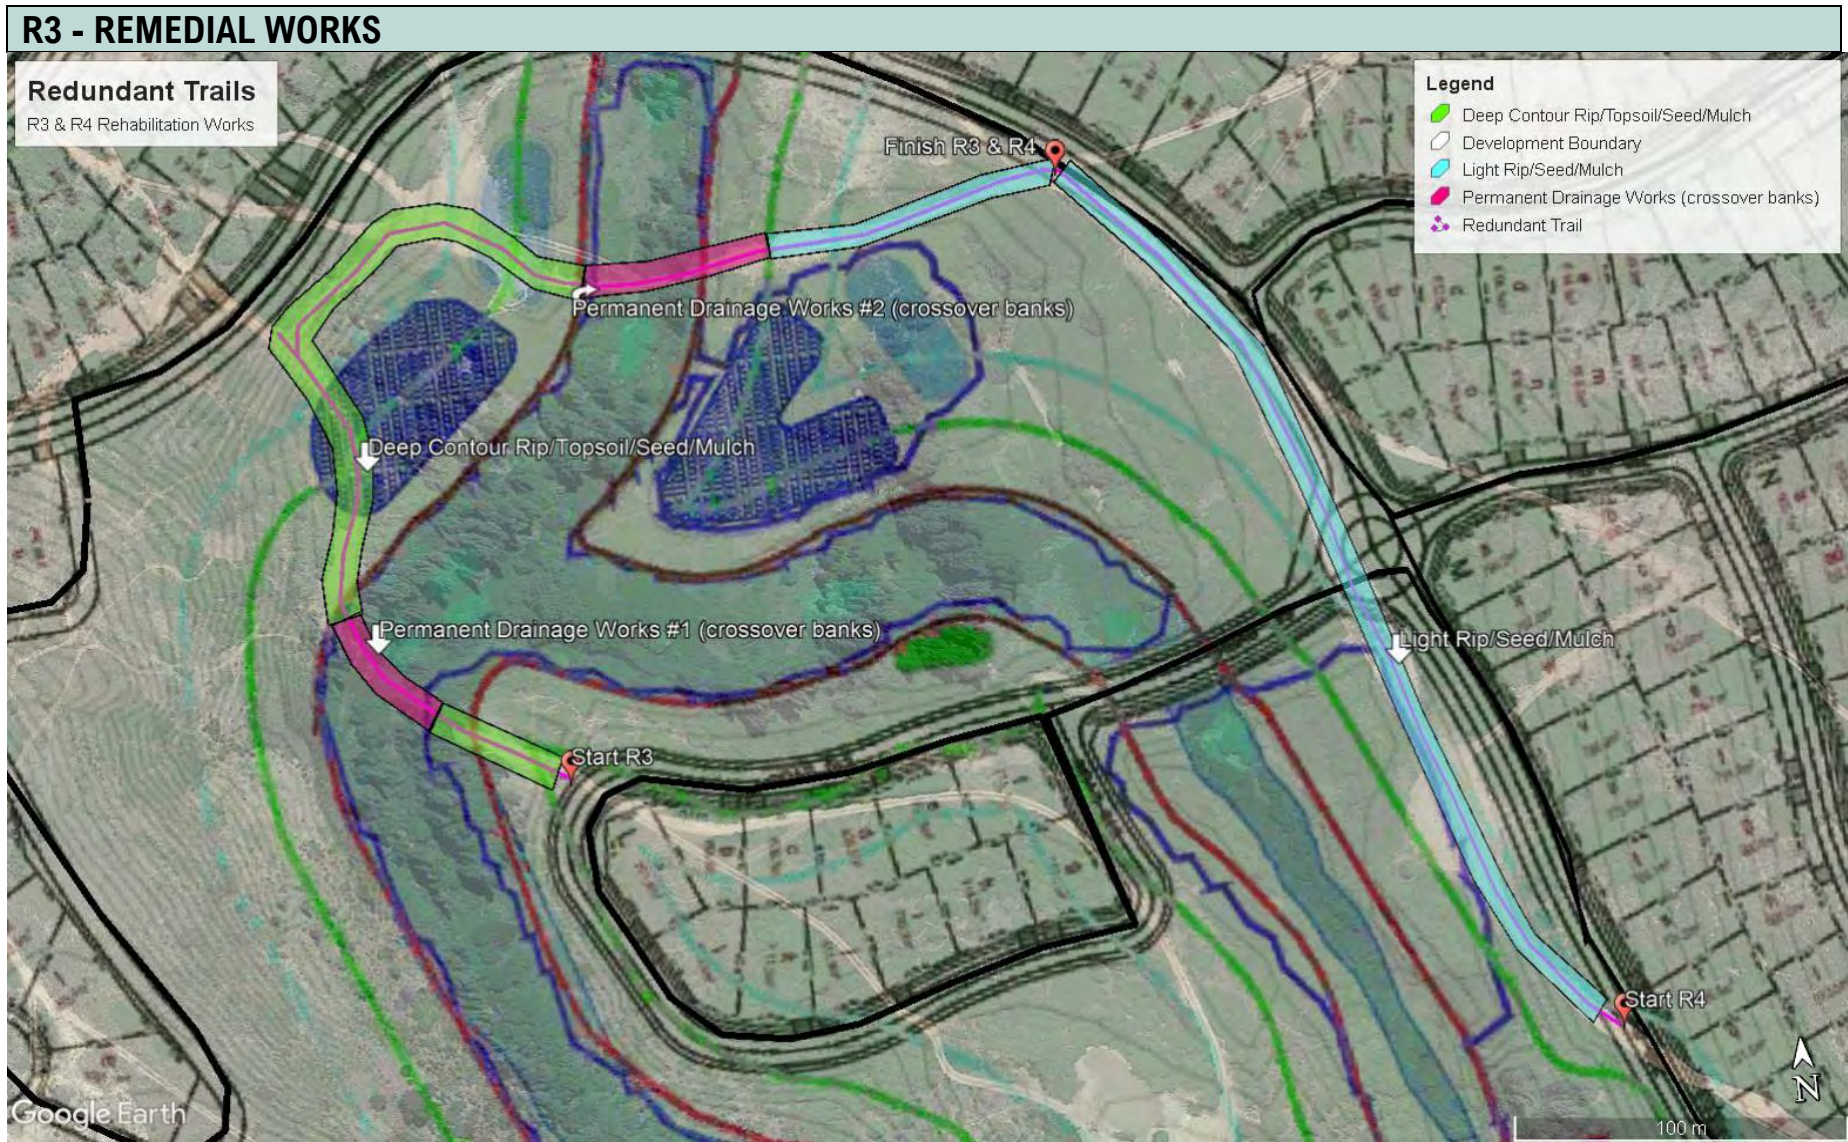
Figure 10: Trail R3 Rehabilitation Works

R3 - DESCRIPTION	
SITE REF & LOCATION	DESCRIPTION AND SITE PICTURES
<p>Start Lat 35.374142 Lon 149.254481</p> <p>End Lat 35.3726222222 Lon 149.256261</p>	<p>Trail R3 joins the proposed housing area between the creeks with the formal road network and includes two major creek crossings. The linkage is made redundant by the formal road network. The removal of the two creek crossings will also be beneficial to the stability of the riparian zone and water quality.</p> <p>The trail is in poor to fair condition with deeply eroded and rutted sections contributing sediment directly to the creek. These sections will require extensive rehabilitation including reshaping and topsoiling prior to revegetation. There is a small section on the eastern side of the creek which is in fair condition and will require a less intensive rehabilitation effort. The creek crossings will require the installation of permanent drainage structures as part of the rehabilitation, to reduce the potential contribution of sediment to the watercourse, refer Figure 10.</p> <div style="text-align: center;">

R3	REMEDIAL WORKS
<p>Deep contour rip / topsoil / seed / mulch</p> <p>Start Lat 35.374146 Lon 149.254461</p> <p>End Lat 35.372636 Lon 149.256257</p>	<p>Trail R3 should be totally rehabilitated. Rehabilitation along the severely eroded sloping sections, refer Figure 10, should involve deep ripping the trail on the contour (level) to increase infiltration. In the sections which have eroded, additional topsoil material should be imported to bring the surface up to natural ground level and create a free draining profile. The ripped and topsoiled area should be seeded with an appropriate species mix which is consistent with the Landscape Plan. Fast growing cover crop species with sterile seed may be used to provide a rapid groundcover to protect from erosion. The seeded area should be covered with a light mulch to further limit erosion and promote germination. The use of soil ameliorants and fertiliser to assist in revegetation should be determined through soil testing.</p>

<p>Permanent drainage works (crossover banks)</p> <p>#1 Start Lat -35.373933 Lon 149.254060 End Lat -35.373645 Lon 149.253805</p> <p>#2 Start Lat -35.372810 Lon 149.254688 End Lat -35.372749 Lon 149.255309</p>	<p>The creek crossing section, refer Figure 10, should include permanent drainage structures (crossover banks) located immediately upslope of the steep trail sections leading to the creek crossing. Similar structures will be required on both sides of the creek crossing. These drainage structures should direct runoff to a well vegetated safe disposal area. The design of these features should conform to the <i>NSW RFS Fire Trail Design, Construction and Maintenance Manual</i>.</p>
<p>Light rip / seed / mulch</p> <p>Start Lat -35.372749 Lon 149.255309</p> <p>End Lat -35.372636 Lon 149.256257</p>	<p>Rehabilitation along the low slope trail section east of the creek crossing, refer Figure 10, should involve very light cultivation type ripping of the trail to increase infiltration and provide a seed bed. The ripped area should be seeded with an appropriate species mix which is consistent with the Landscape Plan. Fast growing cover crop species with sterile seed may be used to provide a rapid groundcover to protect from erosion. The seeded area should be covered with a light mulch to further limit erosion and promote germination.</p>

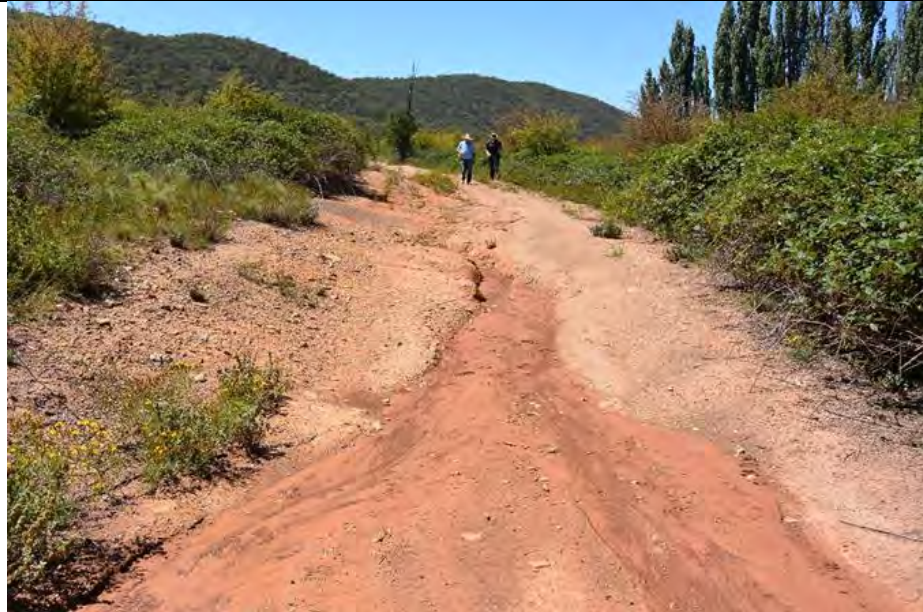
DSC 3838: Small section of moderate slope and limited erosion

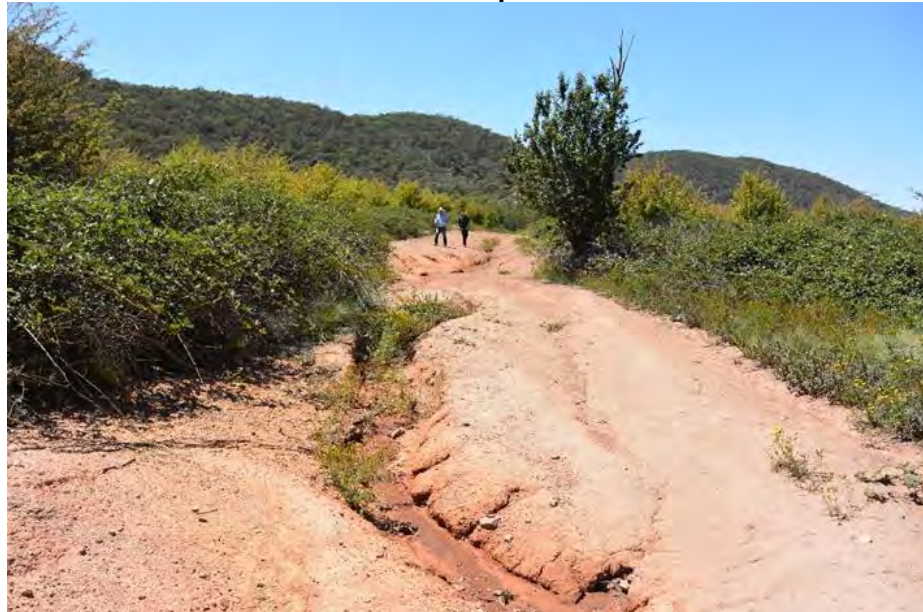
DSC 3837: Minor erosion on sloping sections of trail

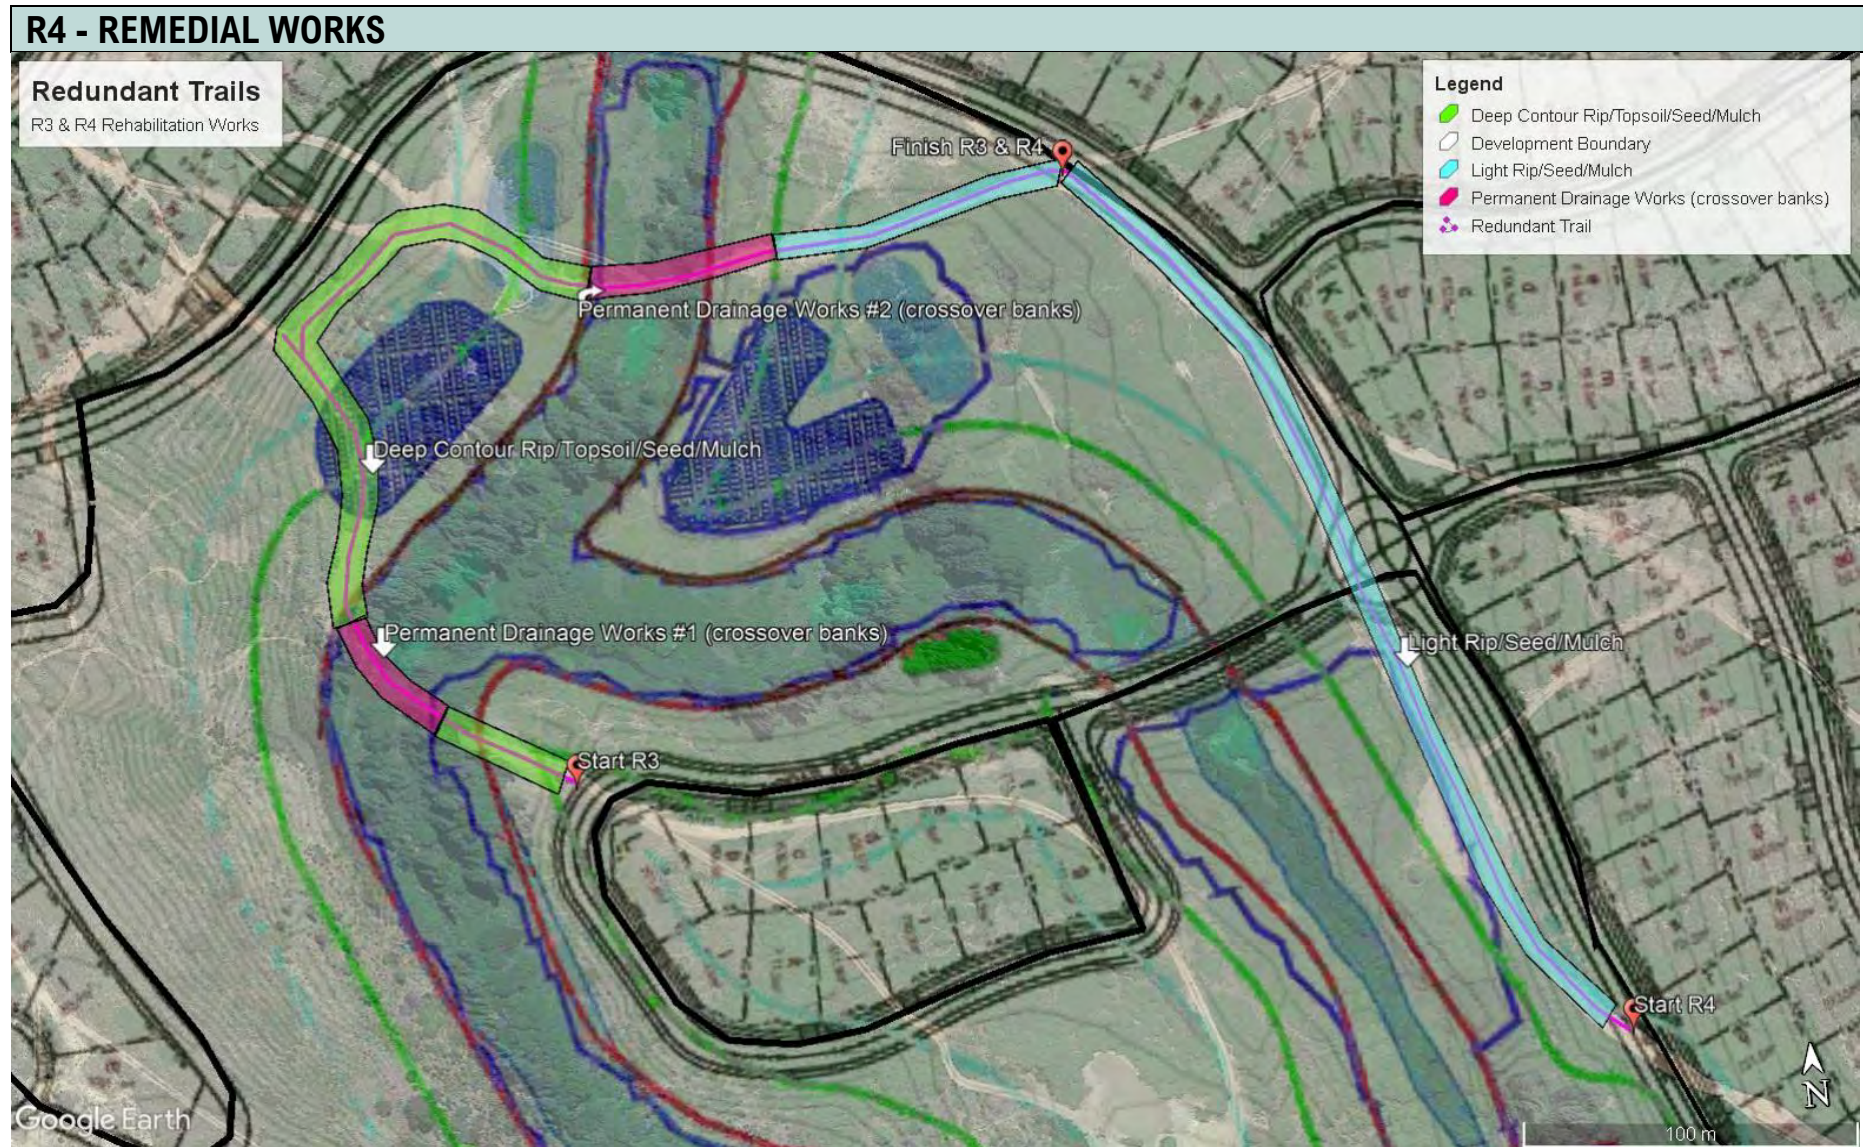
Figure 11: Trail R4 Rehabilitation Works

R4 - DESCRIPTION	
SITE REF & LOCATION	DESCRIPTION AND SITE PICTURES
<p>Start Lat 35.375080 Lon 149.257840</p> <p>End Lat 35.372636 Lon 149.256257</p>	<p>Trail R4 is immediately adjacent to the formal road network and parallels the creek on the eastern side. The construction of the formal road network will make this trail redundant, refer Figure 11.</p> <p>The trail is in poor condition with deep wheel ruts and water ponding in several areas. Rehabilitation of the trail will require reshaping of these areas to create a free draining landscape. Soil depth in these areas is reasonable and additional topsoil will not be required.</p>   <p>DSC 3841: Areas of water ponding on the trail</p>   <p>DSC 3840: Deep wheel ruts and water ponding along the trail</p>   <p>DSC 3839: Low slope trail will require minimal rehabilitation</p>

R4	REMEDIAL WORKS
<p>Light rip / seed / mulch</p> <p>Start Lat -35.375080 Lon 149.257840</p> <p>End Lat -35.372636 Lon 149.256257</p>	<p>Rehabilitation along the low slope trail section east of the creek crossing, refer Figure 11, should involve very light cultivation type ripping of the trail to increase infiltration and provide a seed bed. The ripped area should be seeded with an appropriate species mix which is consistent with the Landscape Plan. Fast growing cover crop species with sterile seed may be used to provide a rapid groundcover to protect from erosion. The seeded area should be covered with a light mulch to further limit erosion and promote germination.</p> <p>Short areas of erosion, refer Figures DSC 3837-8, will require reshaping as part of light ripping, to create a free draining landscape.</p>

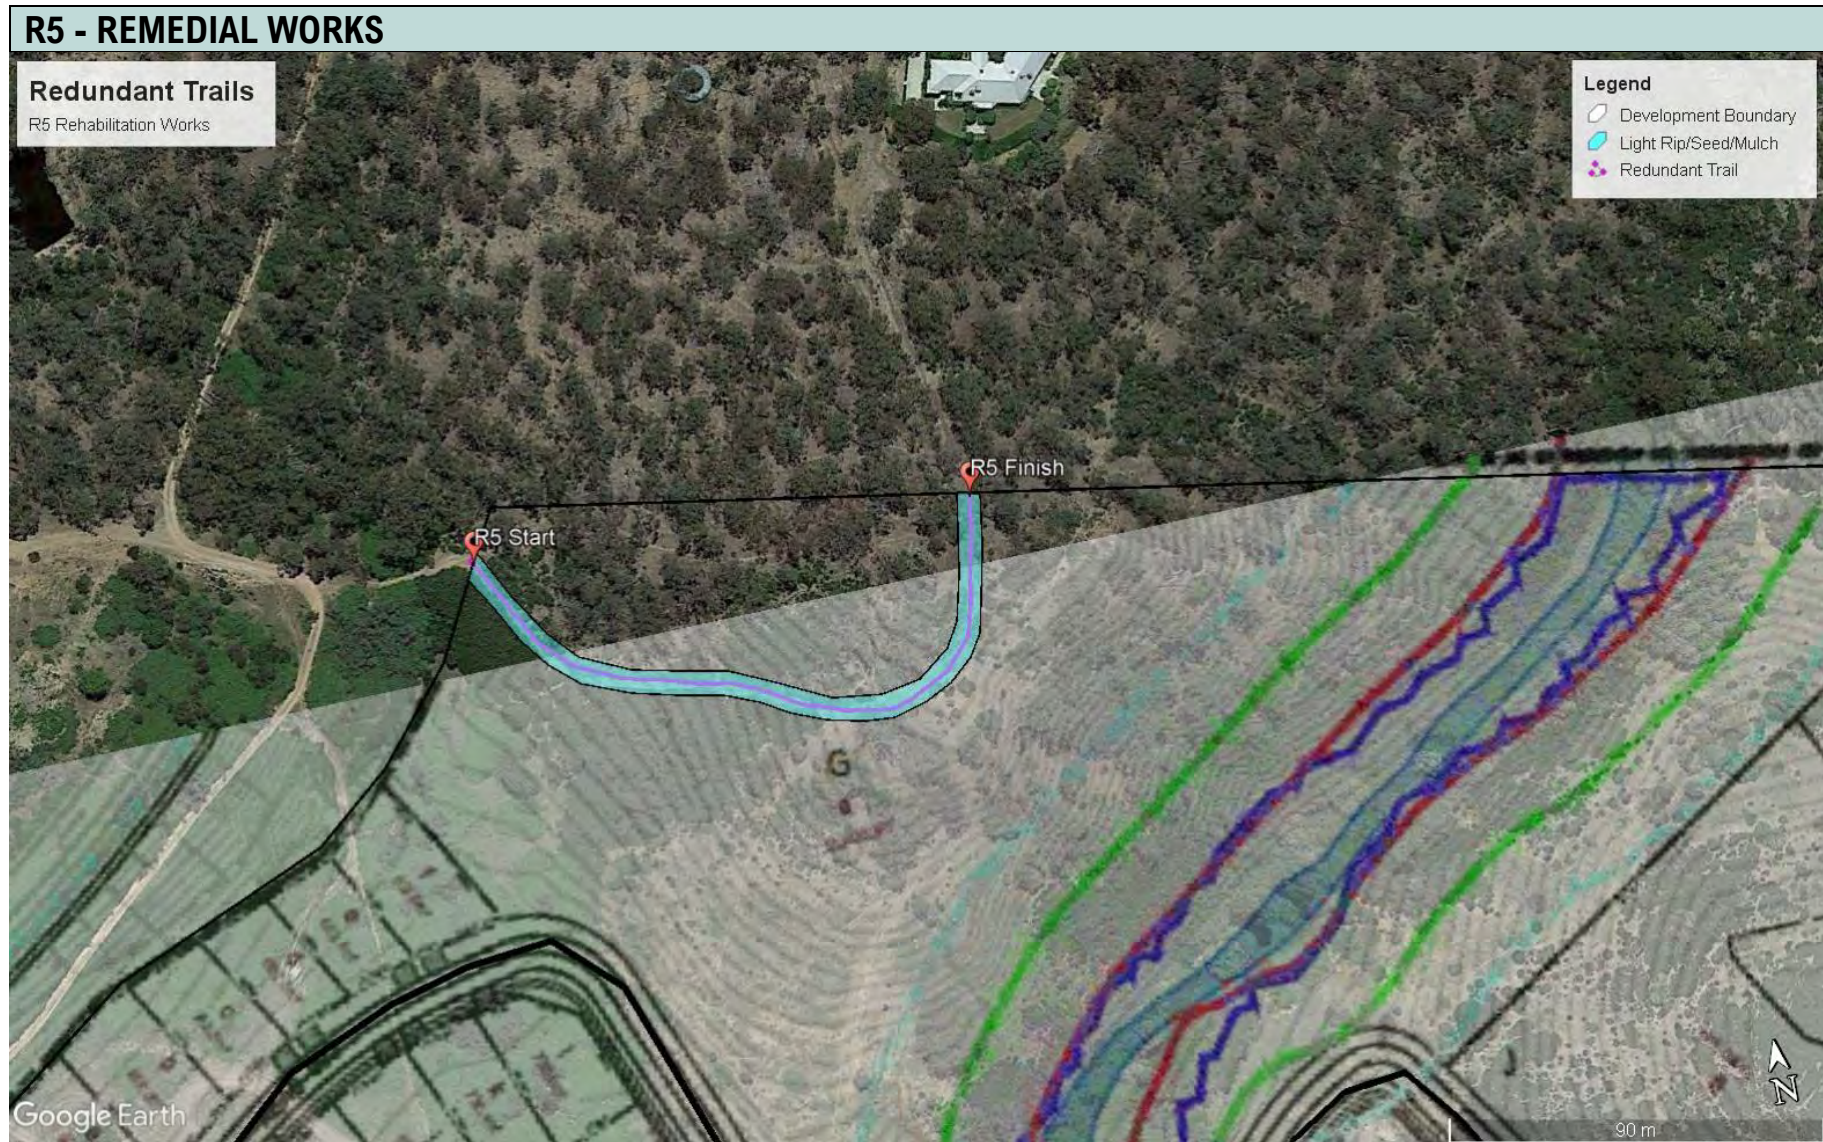
Figure 12: Trail R5 Rehabilitation Works

R5 - DESCRIPTION	
SITE REF & LOCATION	DESCRIPTION AND SITE PICTURES
<p>Start Lat 35.369619 Lon 149.254166</p> <p>End Lat 35.369677 Lon 149.255499</p>	<p>Trail R5 is part of an access trail between the Ellerton Drive Extension boundary and the existing dwelling on the adjacent property to the north of the development. The trail will be made redundant by the construction of Ellerton Drive which will provide alternative access point to the property, refer Figure 12.</p> <p>The trail is in reasonable condition with minor erosion along wheel ruts in the moderately sloping areas.</p> <div style="text-align: center;">

R5	REMEDIAL WORKS
<p>Light rip / seed / mulch (all R5)</p> <p>Start Lat -35.369619 Lon 149.254166</p> <p>End Lat -35.369677 Lon 149.255499</p>	<p>Rehabilitation along the trail, refer Figure 12, should involve very light cultivation type ripping of the trail to increase infiltration and provide a seed bed. The ripped area should be seeded with an appropriate species mix which is consistent with the Vegetation Management Plan.</p> <p>Fast growing cover crop species with sterile seed may be used to provide a rapid groundcover to protect from erosion. The seeded area should be covered with a light mulch to further limit erosion and promote germination.</p> <p>Short areas of wheel rut erosion will require minor reshaping as part of light ripping, to create a free draining landscape</p>

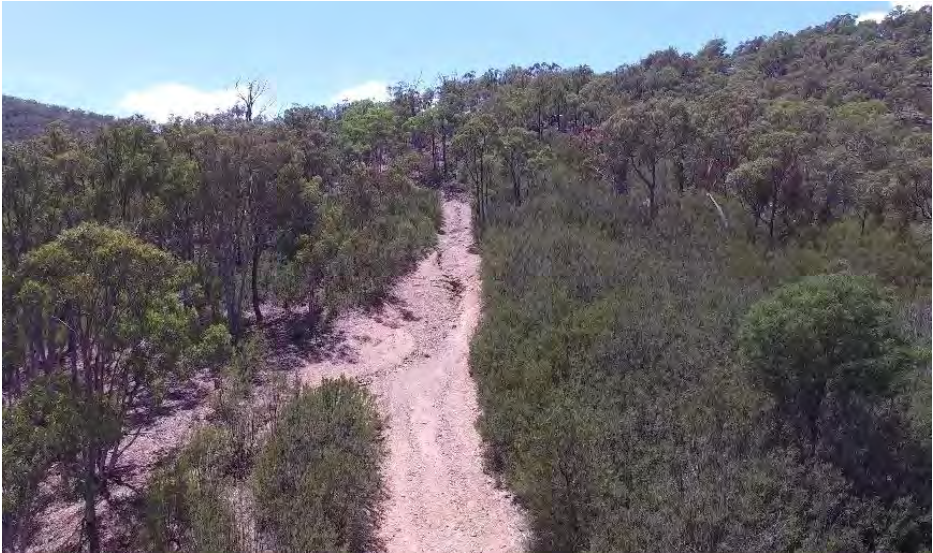
</div> <p>DJI 0001_R6: Deeply rutted steep trail sections</p>

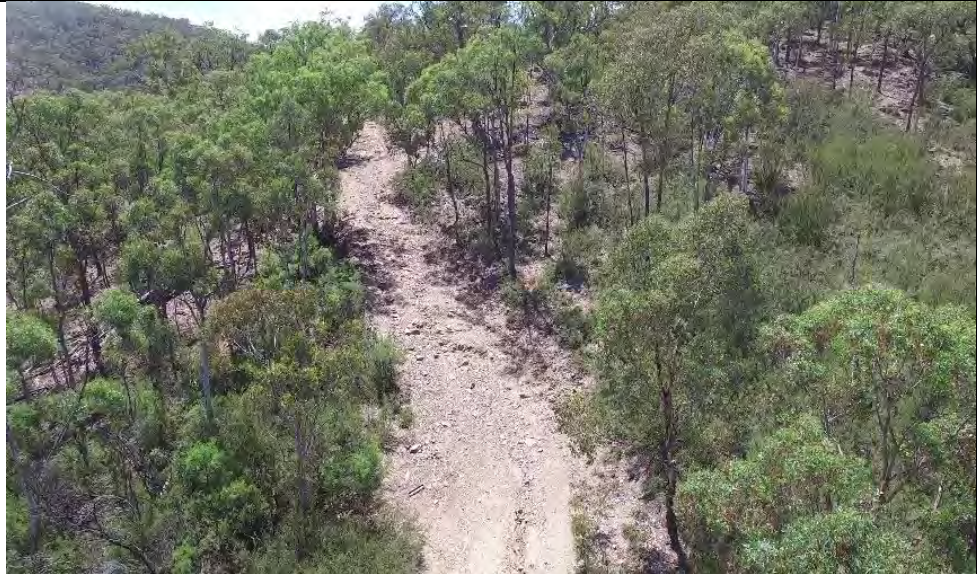
DJI 0002_R6: Extensive areas of loose cobble and gutters

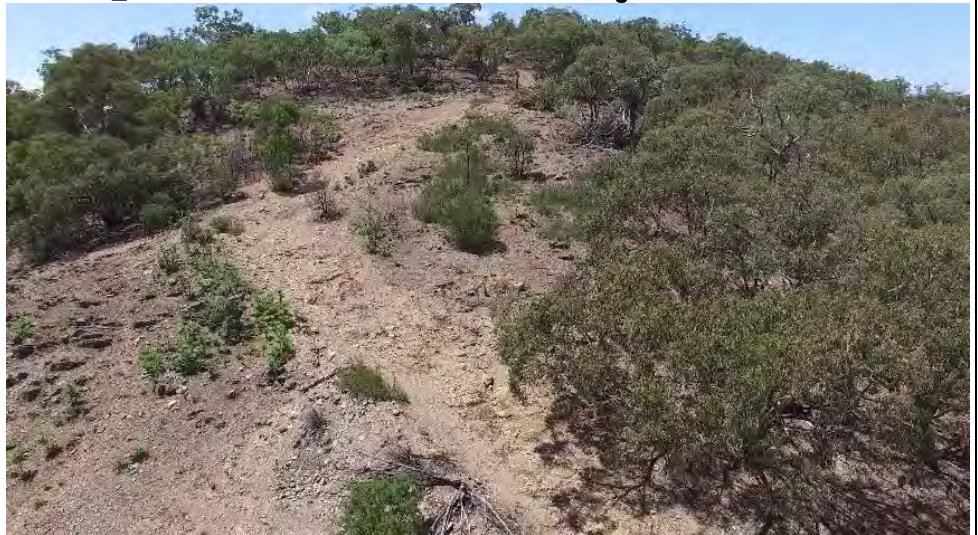
DJI 0003_R6: Extensive areas of outcropping rock near the eastern boundary

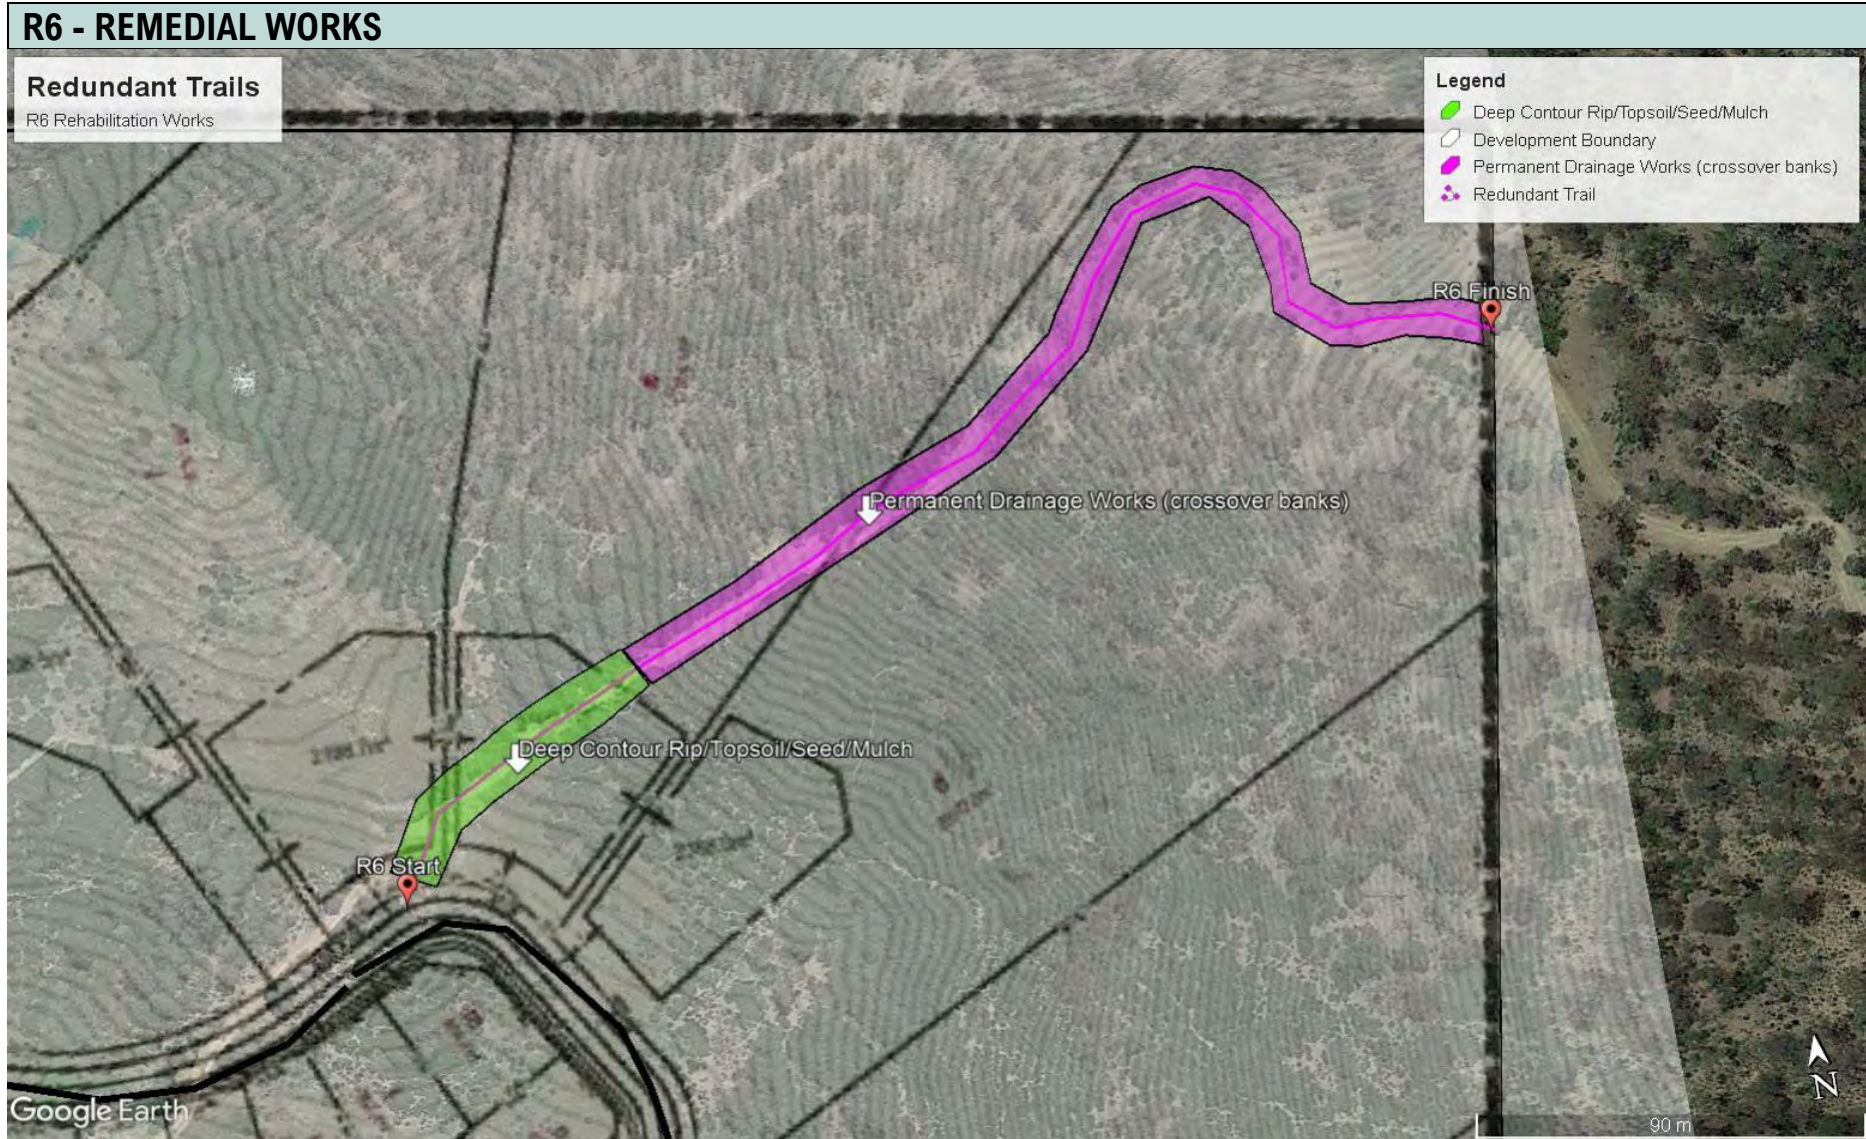
Figure 13: Trail R6 Rehabilitation Works

R6 - DESCRIPTION	
SITE REF & LOCATION	DESCRIPTION AND SITE PICTURES
<p>Start Lat -35.371747 Lon 149.258497</p> <p>End Lat -35.370862 Lon 149.261463</p>	<p>The R6 Trail provides a strategic link (via the formal road network) between the existing fire trail to the east (on Cuumbeun Nature Reserve) and the F1 Trail, which traverses the property from East to South West. The Trail is marked on maps of the local area and has existed for a long time. The trail transects one of the large lots in the north east of the development and will be made redundant by the construction of the formal road network with linkage to Ellerton Drive.</p> <p>The Trail is generally in poor to fair condition and will require significant rehabilitation works including permanent road drainage works in the form of graded banks, refer Figures DJI 0001-3_R6 and Figure 13.</p> <div style="text-align: center;">

R6	REMEDIAL WORKS
<p>Permanent drainage works (crossover banks)</p> <p>Start Lat -35.371747 Lon 149.258497</p> <p>End Lat -35.370862 Lon 149.261463</p>	<p>The moderate to steeply sloping trail section, refer Figure 13, should include permanent drainage structures (crossover banks) to ensure the rehabilitated trail section drains and runoff does not concentrate. The design and spacing of these features should conform to the <i>NSW RFS Fire Trail Design, Construction and Maintenance Manual</i> although some allowance can be made for the lower runoff rates expected from the rehabilitated trail.</p>
<p>Deep contour rip / topsoil / seed / mulch</p> <p>Start Lat -35.371747 Lon 149.258497</p> <p>End Lat -35.370862 Lon 149.261463</p>	<p>Trail R6 should be totally rehabilitated. Rehabilitation along the severely eroded sloping sections, refer Figure 13, should involve deep ripping the trail on the contour (level) to increase infiltration. In the sections which have eroded, additional topsoil material should be imported to bring the surface up to natural ground level and create a free draining profile. The ripped and topsoiled area should be seeded with an appropriate species mix which is consistent with the Landscape Plan. Fast growing cover crop species with sterile seed may be used to provide a rapid groundcover to protect from erosion. The seeded area should be covered with a light mulch to further limit erosion and promote germination. The use of soil ameliorants and fertiliser to assist in revegetation should be determined through soil testing.</p>

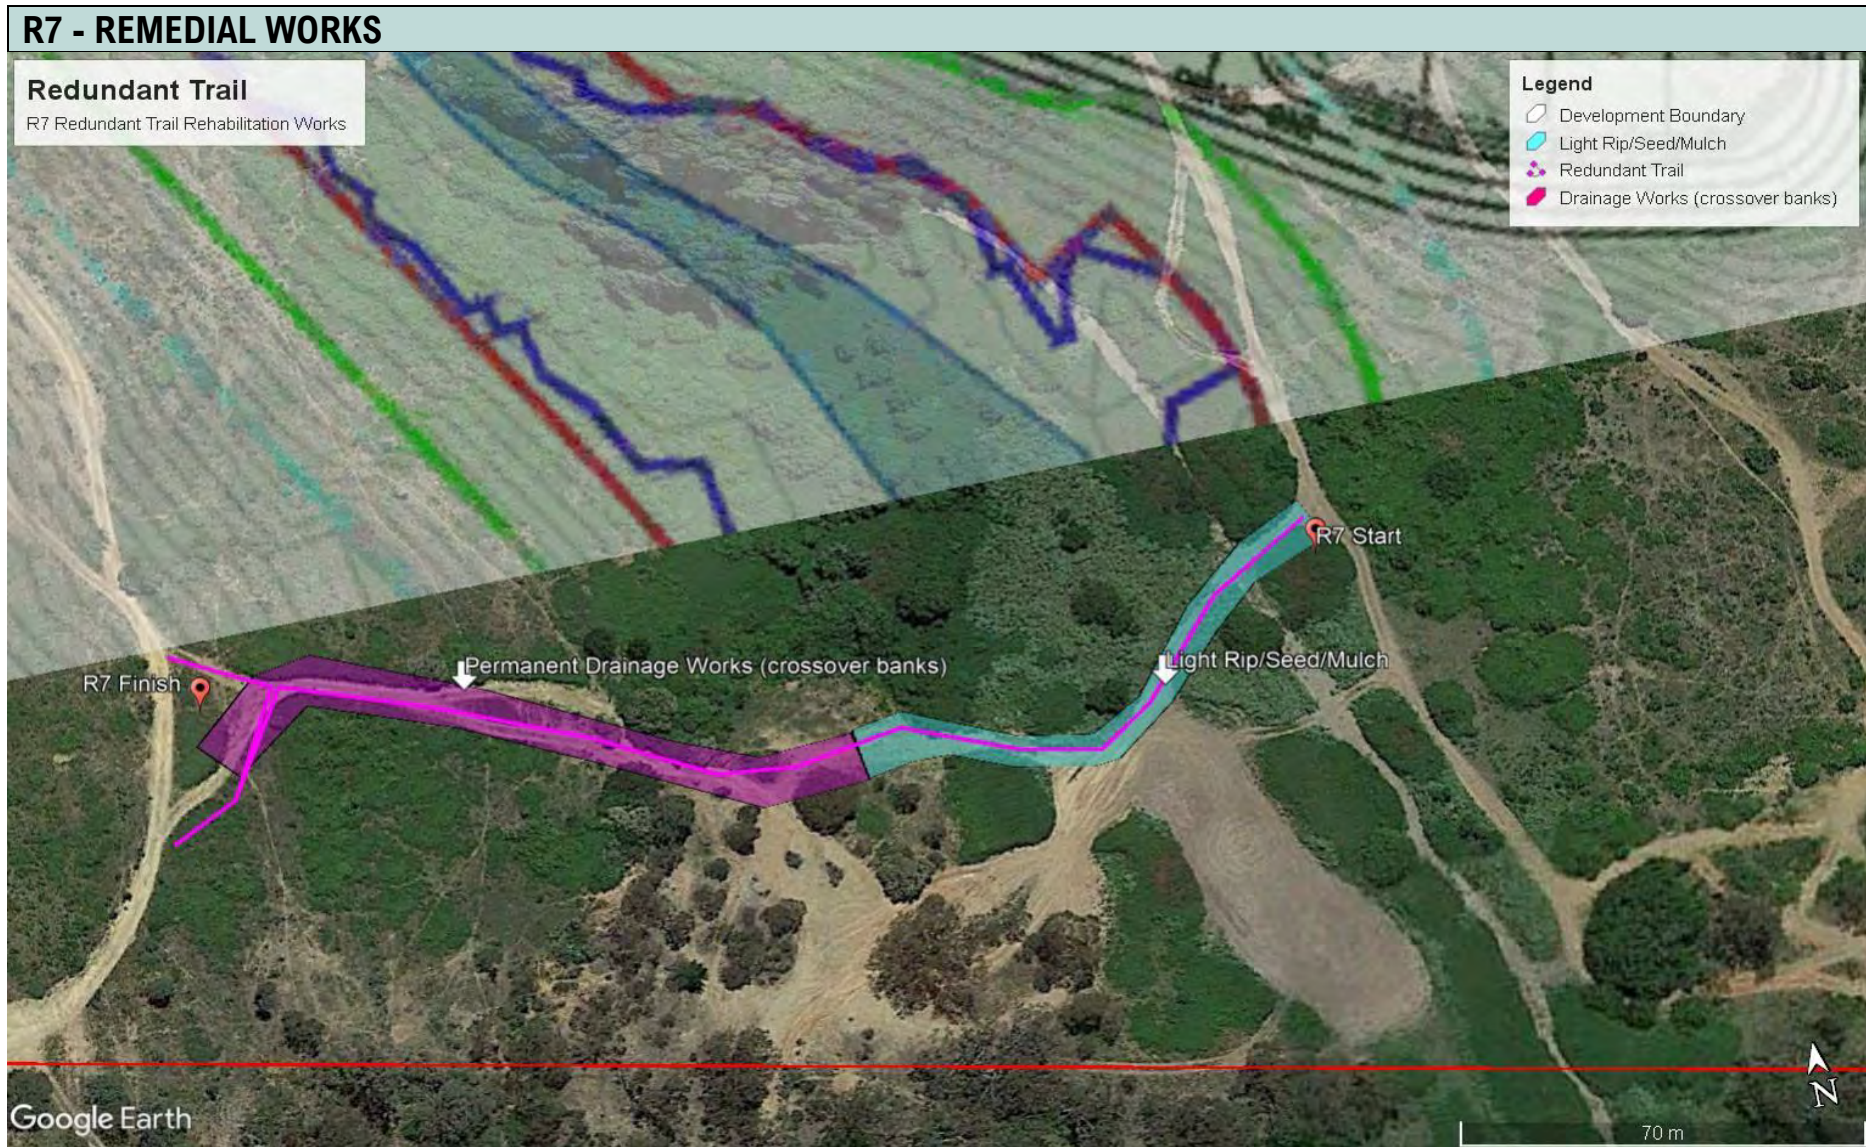
Figure 14: Trail R7 Rehabilitation Works

R7 - DESCRIPTION	
SITE REF & LOCATION	DESCRIPTION AND SITE PICTURES
<p>Start Lat 35.376847 Lon 149.259111</p> <p>End Lat 35.376786 Lon 149.256964</p>	<p>The R7 Trail creates an east west link between the M2 and M3 Trails. This trail is severely eroded and includes a major creek crossing at the eastern end, prior to joining with M2, refer Figure 14. The trail is redundant due to the access provided by M1 and M3 to the west and M2 and the formal road network to the east. The topography and creek crossing also make the trail impractical to upgrade to a suitable standard for retaining as part of the management trail network.</p> <p>The current condition of the trail is generally poor and will require significant rehabilitation works including permanent drainage measures in the form of crossover banks, refer Figures DSC 3825 & 3827 and Figure 14.</p> <div data-bbox="446 737 1279 1291" data-label="Image"> </div> <p>DSC 3825: Deeply rutted section of trail</p> <div data-bbox="446 1325 1279 1864" data-label="Image"> </div> <p>DSC 3827: Eroded table drain</p>

R7	REMEDIAL WORKS
<p>Permanent drainage works (crossover banks)</p> <p>Start Lat 35.377075 Lon 149.258206</p> <p>End Lat 35.376878 Lon 149.256975</p>	<p>The moderate to steeply sloping trail section, refer Figure 14, should include permanent drainage structures (crossover banks) to ensure the rehabilitated trail section drains and runoff does not concentrate. The design and spacing of these features should conform to the <i>NSW RFS Fire Trail Design, Construction and Maintenance Manual</i> although some allowance can be made for the lower runoff rates expected from the rehabilitated trail.</p>
<p>Light rip / seed / mulch (all R5)</p> <p>Start Lat 35.376778 Lon 149.2591</p> <p>End Lat 35.377075 Lon 149.258206</p>	<p>Rehabilitation along the trail, refer Figure 14, should involve very light cultivation type ripping of the trail to increase infiltration and provide a seed bed. The ripped area should be seeded with an appropriate species mix which is consistent with the Vegetation Management Plan.</p> <p>Fast growing cover crop species with sterile seed may be used to provide a rapid groundcover to protect from erosion. The seeded area should be covered with a light mulch to further limit erosion and promote germination.</p> <p>Short areas of wheel rut erosion will require minor reshaping as part of light ripping, to create a free draining landscape</p>
