Visual Tree Assessment Report
For
Various Trees on the corner of
Molonglo and Malbon Streets Bungendore NSW

Report Author	Steve Griffiths Level 5 Arborist Treeworks (ACT/NSW) Pty Ltd
Phone	+61 2 6282 1244
Report Date	20 February 2019

Job	425653 Reference# PUO26126
Site Address	Corner Molonglo and Malbon Streets Bungendore NSW
Client	Queanbeyan-Palerang Regional Council (QPRC)
Client Contact	Lisa Wrona: Tree Manager Officer and Neil Hancock
Contact Phone	02 6285 6144 0407 238 554
Commission Brief	<p>The author of this report has:</p> <ul style="list-style-type: none">• visited the site• observed the health of 10 trees• provided a Visual Tree Assessment (VTA)• addressed present risk management of the trees• provided recommendations and a Tree Management Plan. <p>The retainment of all 10 trees, T1-T10 of various genus, is to be in accordance with:</p> <p><i>Australian Standards; <u>Pruning of amenity trees</u> AS 4373-2007 also AS 4970-2009</i></p>

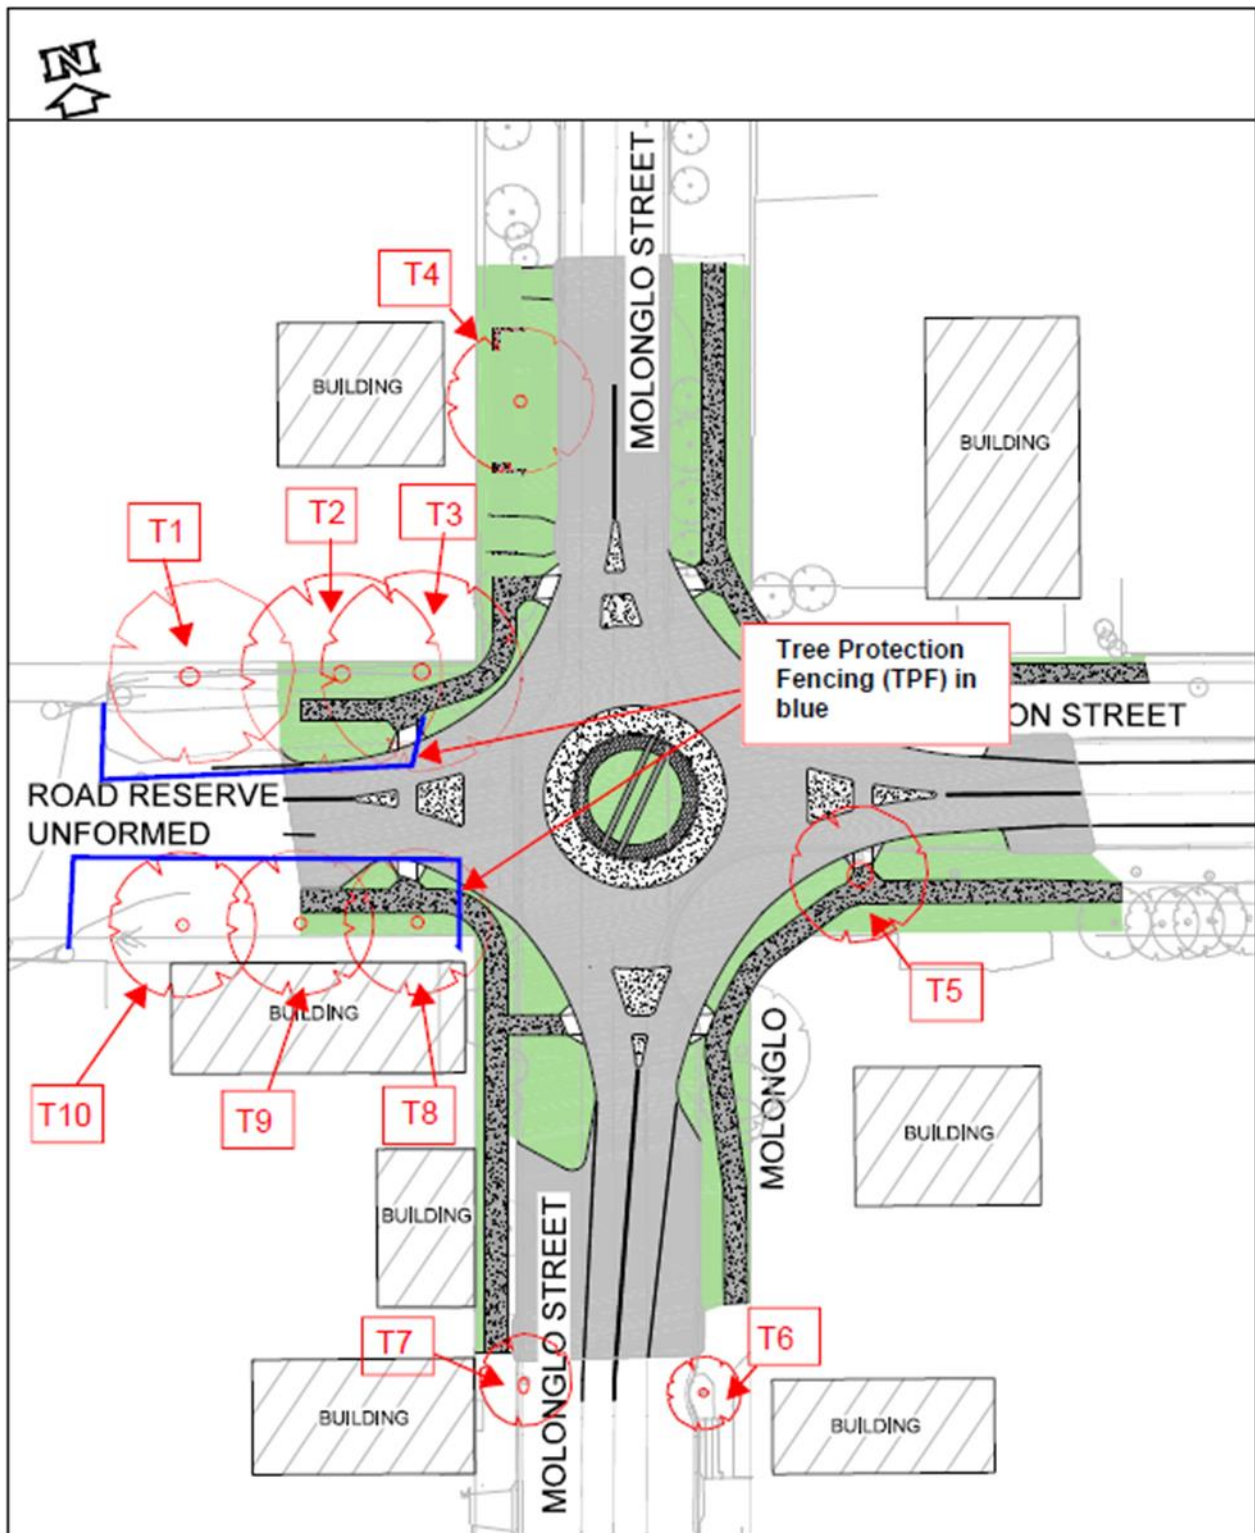
Figure 1. Recommended Positioning of Temporary TPF

Due to the proximity of some trees, their TPF cannot be installed. TPF are marked in blue lines.

1.3.2 Preserving as much of the TPZ as possible during all phases of this develop is important for all 10 trees. Tree Protection Fencing (TPF) is to be put in place and not to move until the post-construction phase. TPF is needed for trees T4, T5, T6 and T7. Refer to *Recommended Tree Protection Fencing* illustration on page 13.

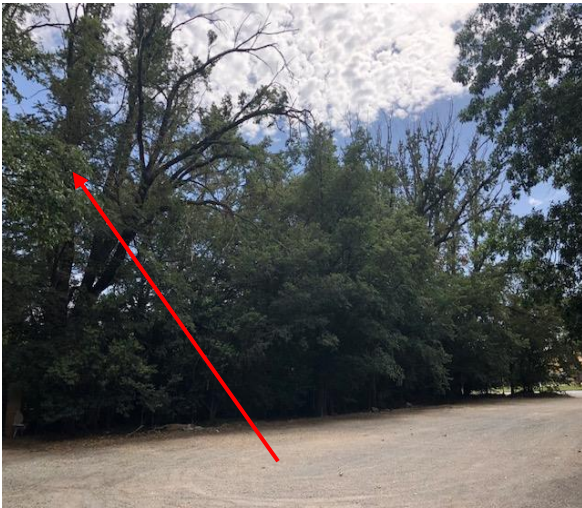
Figure 2. T1 *Ulmus procera*

T 1	<i>Ulmus procera</i> (English Elm)		
TPZ = 14.64 m (radius from trunk centre)	Condition; Fair	SRZ = 3.8m (radius)	RPA = 673.34m ²
<p>This English Elm is one of three veteran Elm trees in this report. It is normal for veteran trees to senescence (age) and there is a lot of deadwood in the upper canopy, some greater than 160mm in diameter. This deadwood will need to be removed. This tree has Elm Leaf Beetle <i>Xanthogaleruca luteola</i>, throughout. This is also the case for the other Elm trees T2, T3 and T7. This pest is showing signs of <i>second instar larvae</i> on the underside of the leaves which greatly harms these trees. This coleoptera bug depletes the tree's ability to photosynthesize. Five years of this infestation will deplete the tree of its starch supply and kill it. We recommend a stem injection of Imidacloprid around the base of these four trees as soon as possible. Stem injecting is the best methodology due to the creek nearby. There are lots of tree suckers in and around trees T1, T2 and T3. If at all possible, these should be left.</p> <p>Useful Life Expectancy (ULE) is 40 years at this stage.</p> <p>Parking under the trees TPZ (carpark) is acceptable providing pod foundation are laid down with porous cement, in this TPZ.</p>

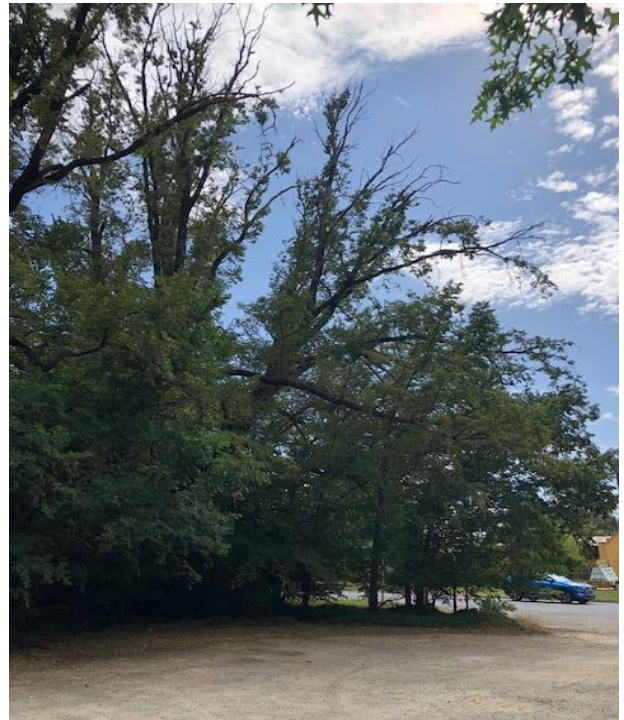
Figure 4. T3 *Ulmus procera*

T3	<i>Ulmus procera</i> (English Elm)		
TPZ = 15m (radius from trunk centre)	Condition; Fair	SRZ = 4.61m (radius)	RPA = 706.86m ²
<p>This English Elm is similar to T2 in this report. T3 also requires the removal of deadwood due to findings of senescence (aging) in upper canopy. This deadwood will need to be removed due to concerns of pedestrian traffic below. This tree, just like T1, T2 and T7, has Elm Leaf Beetle <i>Xanthogaleruca luteola</i> throughout. We recommend the stem injection of <i>Imidacloprid</i> around the base of the tree as soon as possible. There is some bark included forks findings (compression unions) in the tree, and there is a history of branch failures throughout the tree. No weight reduction is required, but rather retain as many green leaves as possible. There to be no more dumping of green grass clipping in or around the tree's TPZ, as this draws nitrogen out of the soil.</p> <p>Useful Life Expectancy (ULE) is 40 years at this stage.</p> <p>Tree Protection fence (TPF) will be needed to prevent heavy vehicles parking or storage of material in the Tree Protection Zone (TPZ). A layer of 75mm of mulch is to be laid by hand, not machinery. Great care is to be taken conducting any construction under this tree, minimal vibration and rolling is to be applied in the TPZ and SRZ of this tree in construction and post-construction stages. There is to be a spotter to watch out for tree branch damage. There is to be no unnecessary cutting of branches, but rather lifting the branches with rope, then released when finished. Pipes can be laid within the trees TPZ providing pipes are laid as tunnel boring at a depth of 500mm or hydro vac method a half pressure. Water can flow into a water garden then into creek by ways of gaps in the kerb - see picture on page 21. All footpath foundations are to be of pod foundations and of a permeable surface. There is to be no added nitrogen fertiliser within the TPZ area of this tree for at least three years to allow time for this tree to recover following the removal of the Elm Leaf Beetle and gain a supply of needed starch.</p> <p>The creek system that passes on the northern side of this tree must be retained and continue to allow stormwater through as normal using open kerbing (see page 21).</p>

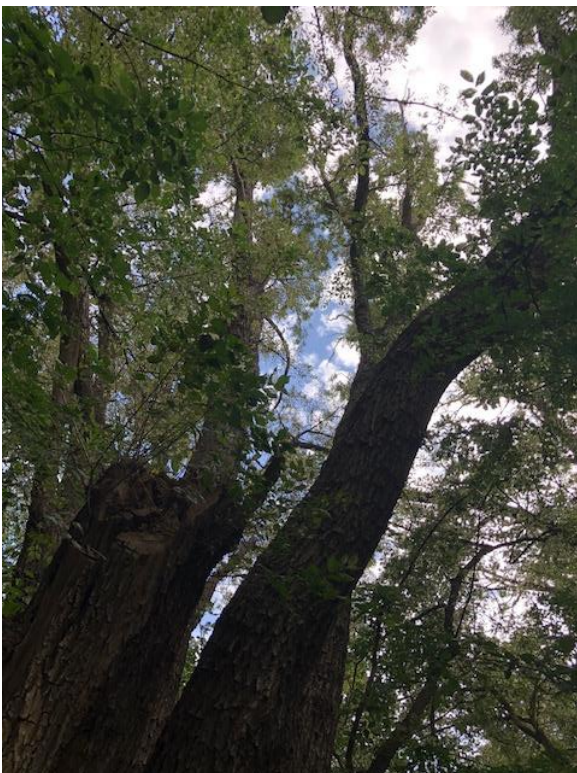
Figure 3. T2 *Ulmus procera*

T 2	<i>Ulmus procera</i> (English Elm)		
TPZ = 15m (radius from trunk centre)	Condition; Fair	SRZ = 3.92m (radius)	RPA = 706.86m ²
<p>This English Elm is similar to the other veteran Elm trees in this report. T2 requires the removal of deadwood due findings of senescencing (aging) in upper canopy. This deadwood will need to be removed. This tree has Elm Leaf Beetle <i>Xanthogaleruca luteola</i> throughout. We recommend the stem injection of Imidacloprid around the base of the tree as soon as possible. There are signs of slime flux, which is to be monitored as it can lead to carbohydrate depletion within the tree, and signs of mechanical damage at base, which appears fine. This decurrent (branches extending downwards) shaped tree has a natural suppression or a codominant crown class – the tree has adapted to this over time. If there are changes or reduction in water irrigation, the tree will not cope.</p> <p>Useful Life Expectancy (ULE) is 40 years at this stage</p> <p>Tree Protection Fencing will be needed to prevent heavy construction vehicles parking or storage of material in this TPZ. A layer of 75mm of mulch is to be laid by hand, not machinery. Care is to be taken in the post-construction stage where there will be the introduction of soils, lawn and footpaths. All foundations are to be of pod foundations and of a permeable surface. There is to be no introduction of nitrogen fertiliser within the</p>

T2	<i>Ulmus procera</i> (English Elm)		
TPZ = 15m (radius from trunk centre)	Condition; Fair	SRZ = 3.92m (radius)	RPA = 706.86m ²
<p>TPZ area of this tree for at least three years, as this allows time for the tree to recover from the Elm Leaf Beetle and regain a supply of needed starch levels.</p> <p>The creek system that passes on the northern side of this tree must be retain and to continue to allow stormwater through as normal, open kerbing is needed here on these three trees that are in a row. See photo of open kerbing on page 21.</p>

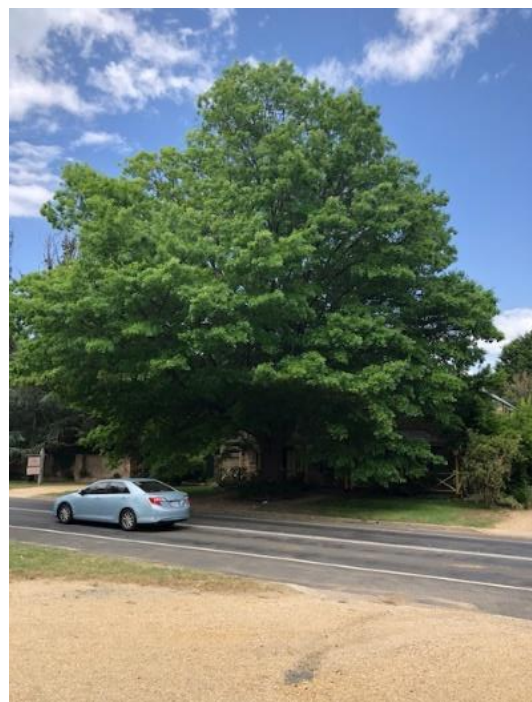
Figure 5. T4 *Quercus pulustris*

T4	<i>Quercus pulustris</i> (Pin Oak)		
TPZ = 13.08m (radius from trunk centre)	Condition; Good	SRZ = 3.62m (radius)	RPA = 537.48m ²
<p>This Pin Oak is of good health and has been well maintained. There are findings of improper lopping many years ago, and tree has recovered well with endo epicormic attachments. There is also natural bracing in the tree which should never be removed. Tree branches are also rubbing on the stone building.</p> <p>This tree is of a mature age, about 50 years old and there is no reason why it can't live for another 100 years. Great care is to be taken when laying the bitumen; minimal vibration and rolling is to be applied in the TPZ and SRZ in the post-construction stage. There is to be a spotter watching for possible tree branch damage and exhaust burn from large machinery. There is to be no unnecessary cutting of branches, but rather lifting the branches with rope, then released when finished. There is to be no trench digging for storm water pipes within any of these trees' TPZ. Minimal disturbance within the TPZ is 13m radius from centre of trunk.</p>

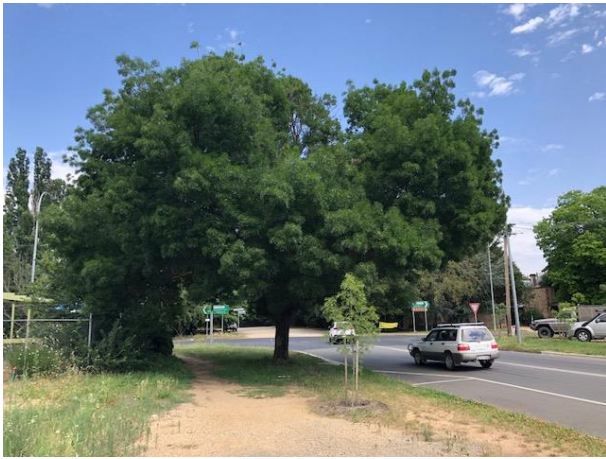
Figure 6. T5 *Fraxinus oxycarpa*

T5	<i>Fraxinus oxycarpa</i> (Desert Ash)		
TPZ = 8.52m (radius from trunk centre)	Condition; Good	SRZ = 3.17m (radius)	RPA = 228.05m²
<p>This Desert Ash is of good health and has been well maintained, considering it's surrounded mostly by a hard pan area. There are findings of epicormics, which are just minor stress signs, most likely due to compacted soils nearby. This tree is of a semi-mature age, about 40 years old and there is no reason why it can't live for another 50 years. Great care is to be taken when laying the bitumen; minimal vibration and rolling is to be applied in the TPZ and Structural Root Zone (SRZ) of this tree in the post-construction stage. There is to be a spotter watching for tree branch damage. There is to be no unnecessary cutting of branches, but rather lifting the branches with rope, then released when finished. The depth of the tree's roots are only 500mm from ground surface. Hydrovac or tunnel boring is acceptable within the trees TPZ.</p>

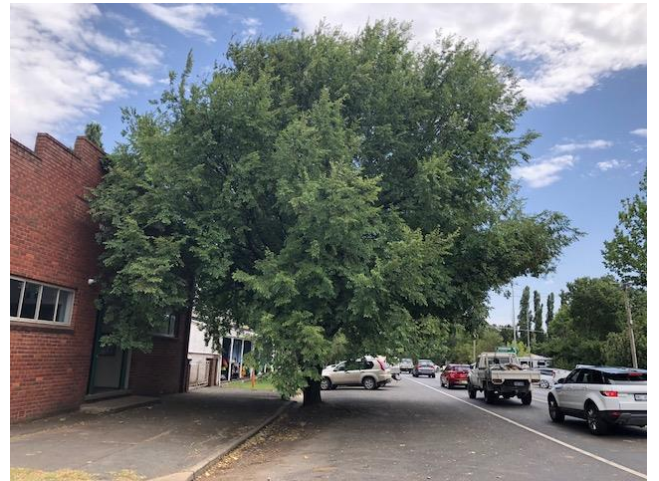
Figure 8. T7 *Ulmus sp.*

T7	<i>Ulmus procera</i> (English Elm)		
TPZ = 10.08m (radius from trunk centre)	Condition; Good	SRZ = 3.12m (radius)	RPA = 319.21m²
<p>This English Elm is surrounded by hard pan area of bitumen and concrete with exposed roots being constantly damaged. It is in good shape but has a minor infestation of Elm Leaf Beetle <i>Xanthogaleruca luteola</i>, which will be dealt with prior to the stress this tree will receive during this construction around its TPZ.</p> <p>Life expectancy is 40 years, providing situations to the tree's TPZ is not changed too much. Trunk and possibly branch protection, in the form of wooden boards and strapping, is needed for this tree. See diagram on page 20. Branches are low and may require a canopy lift to allow easier access. Due to the proximity to road, footpath and shop, TPF is not viable, however watering of this tree is needed just like the others. Parking of vehicles is allowed near the tree's TPZ area providing there is a porous pod foundation with minimal vibration and compaction allowed. The root zone of this tree is 10.08m radius from central tree's trunk.</p>

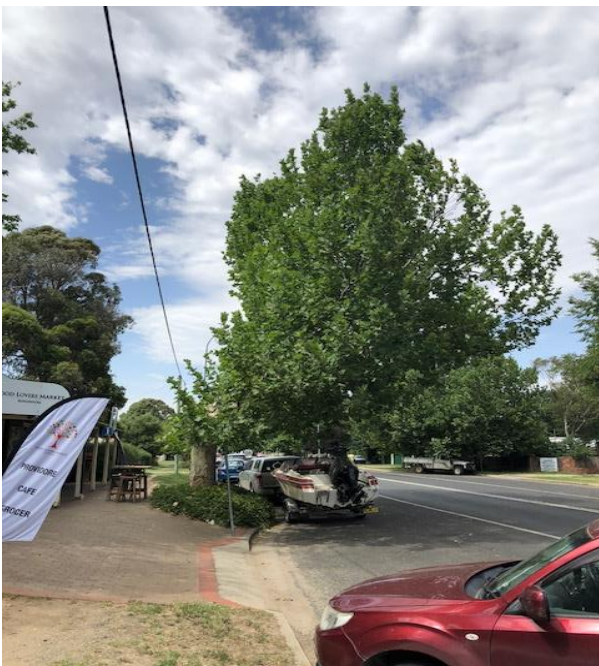
Figure 7. T6 *Platanus sp.*

T6	<i>Platanus</i> (London Plane)		
TPZ = 8.16m (radius from trunk centre)	Condition; Fair	SRZ = 2.97m (radius)	RPA = 209.18 m²
<p>This London Plane has a bundle of low voltage powerline cables nearby. Over the years the tree has been trimmed away from these cables creating a very lopsided tree. There are findings of fungal decay where these cuts have been made. There are many hollows in the tree which is good for arboreal animals but could pose a problem in tree structure stability.</p> <p>Life expectancy is less than 30 years, with consideration for its replacement in a few years. This tree is of a semi-mature age and has a lot more growing to do. Perhaps a <i>Lagerstroemia indica</i> (Crepe Myrtle) would be a more suited genus tree to replace it with.</p> <p>Trunk and branch protection in the form of wooden boards and strapping, is needed (see diagram on page 20). Due to the proximity to the road, footpath and shop, TPF is not viable, however watering of this tree is needed just like the others. Parking of vehicles is allowed near the tree's TPZ area providing there is a porous pod foundation with minimal vibration and compaction allowed. The root zone of this tree is 8.16m radius from central tree's trunk.</p> <p>Recommend a Level 5 Arborist to assess and inspect tree hollows severity in two years' time.</p>

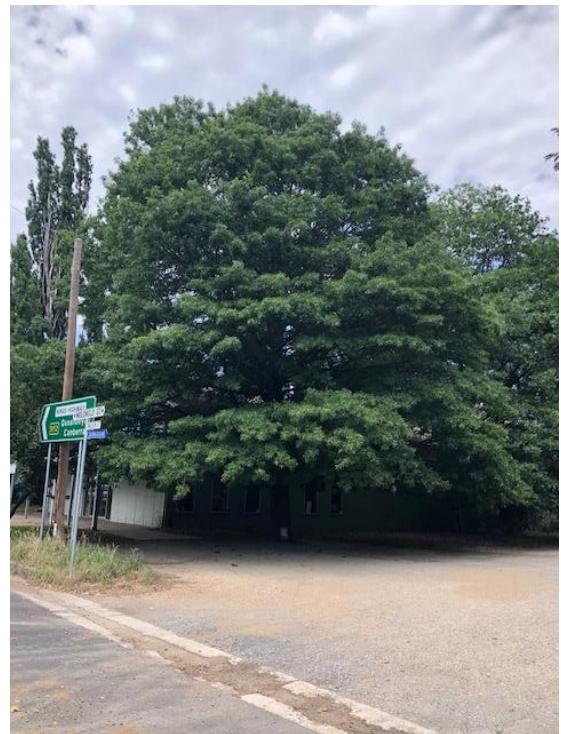
Figure 9. T8 *Quercus pulustris*

T8	<i>Quercus pulustris</i> (Pin Oak)		
TPZ = 9.6m (radius from trunk centre)	Condition; Good	SRZ = 3.17m (radius)	RPA = 289.53m²
<p>This Pin Oak has most of its TPZ compacted due to vehicles parking under the tree. The proposed construction will help this tree and help prevent vehicles parking close to trunk and under its canopy. Due to this compaction, an aeration of soil and mycorrhizae treatment is required prior to commencement of works: a treatment to improve the health of trees by soil decompaction and introduction of <i>mycorrhizal fungi</i> and other supplements into the soil. Forking, spiking and hand-digging or sub-soil aeration using compressed air injection equipment, can also be utilised as well as hand drilling method. TPF is needed for around part of this tree's TPZ and area mulched and regularly watered. There is minimal Oak Leaf Minor infestation and no action is needed at this stage to rid this pest.</p>

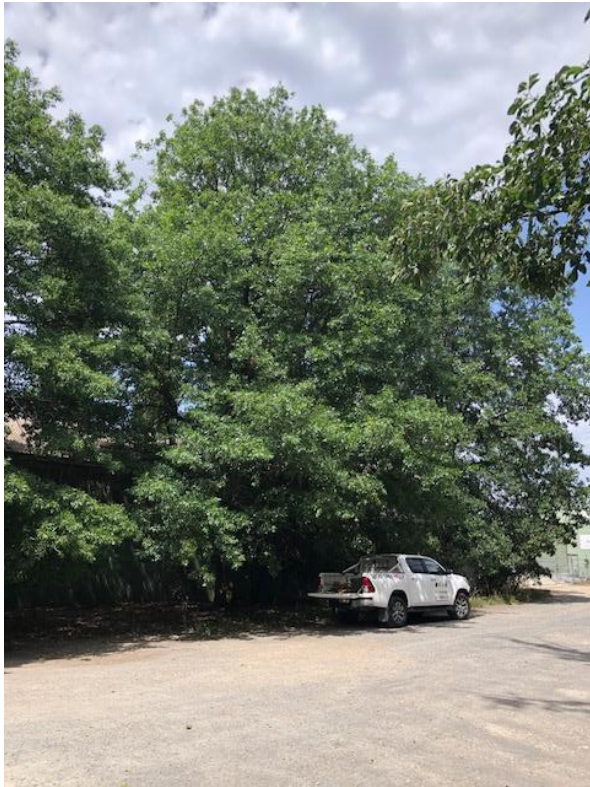
Figure 10. T9 *Quercus pulustris*

T9	<i>Quercus pulustris</i> (Pin Oak)		
TPZ = 9.24m (radius from trunk centre)	Condition; Fair	SRZ = 3.17m (radius)	RPA = 268.22m²
<p>This Pin Oak is in the middle of a row of three Oak trees and is showing lots of deadwood greater than 40mm in diameter, which is also encroaching on to the building. It is in a fair condition with good structural unions. Due to the visual stress of the tree, it is important to leave as much of its TPZ undisturbed, as present vehicle compaction is only 3m from the tree trunk, bearing in mind, the TPZ is 9.24m (radius) from central trunk. TPF and Terravent procedure is required prior to commencement of works. Mulch is to be laid down and the tree to be regularly watered.</p> <p>There will be a lot of post-activity around the tree's trunk. Tree trunk protection is required.</p>

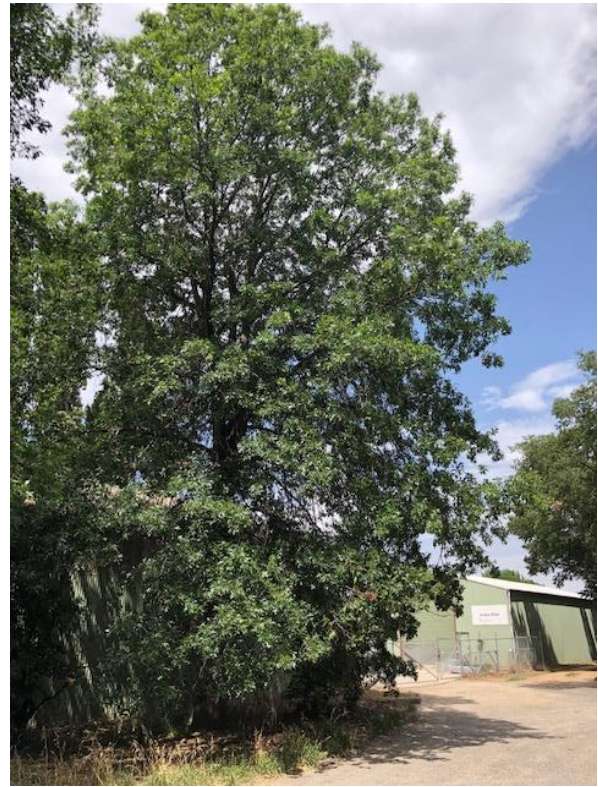
Figure 11. T10 *Quercus pulustris*

T10	<i>Quercus pulustris</i> (Pin Oak)		
TPZ = 7.92m (radius from trunk centre)	Condition; Fair	SRZ = 2.98m (radius)	RPA = 197.06m²
<p>This Pin Oak is the smallest of the trees in this row and also appears to have a lot of dead branches which should be removed prior to construction activity. It is in a fair condition with good structural unions. It is important to leave as much of TPZ undisturbed, bearing in mind the TPZ zone is 7.92m (radius) from the central trunk. Terravent procedure is required prior to commencement of works. Mulch is to be laid down and tree to be regularly watered.</p> <p>There will be a lot of post-activity around the tree's trunk. Tree trunk protection is required.</p>
