EROSION CONTROL PLAN

Jumping Creek QUEANBEYAN

Version 3

29 January 2019

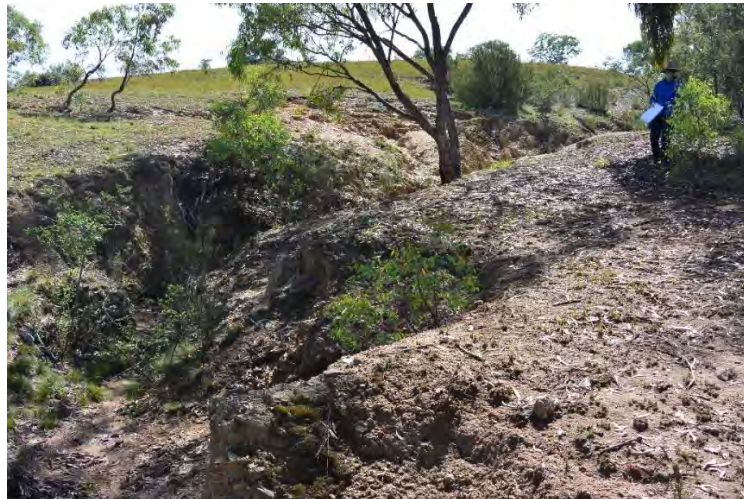
<p>Lat -35.380413° Lon 149.253317°</p>	<p>Minor gully and bank erosion associated with a minor drainage depression. Site has reasonable vegetation cover of native trees and shrubs. Small active gully heads and small areas of bare eroding bank.</p>	<p>Moderate erosion</p>	<p>Low – Moderate (potential for natural regeneration)</p>	<p>Seed and mulch areas of bare bank where this is actively eroding. Where run-on water is not a problem light cultivation (hand cultivation or small scarifier) may assist in providing a seed bed for revegetation. Species selection should reflect species list in Vegetation Management Plan.</p>

DSC 3806: Small areas of bare eroding bank

SITE REF	REMEDIATION WORKS REQUIRED
E1	Lightly rip on the contour (where there is no run-on water), then seed and mulch bare eroding banks.
E2	Construct earth diversion bank upslope of gully head to divert flows around the site. Lightly rip on the contour below the diversion bank, then seed and mulch.
E3	Construct earth diversion bank upslope of gully head to divert flows around the site. Lightly rip on the contour below the diversion bank, then seed and mulch.
E3 A,B,C	<p>A- Lightly rip on the contour (where there is no run-on water), then seed and mulch bare eroding banks.</p> <p>B- Construct earth diversion bank upslope of gully head to divert flows around the site. Lightly rip on the contour below the diversion bank, then seed and mulch.</p> <p>C- Lightly rip on the contour (where there is no run-on water), then seed and mulch bare eroding banks.</p>
E5	Construct earth diversion bank upslope of the old quarry site to divert run-on water away from site. Deep rip the area on the contour and spread imported topsoil where erosion has reached subsoil. Revegetate by seeding and mulching. Plant macrophytes in the backwater of the sediment detention basin at the downslope end of the quarry.

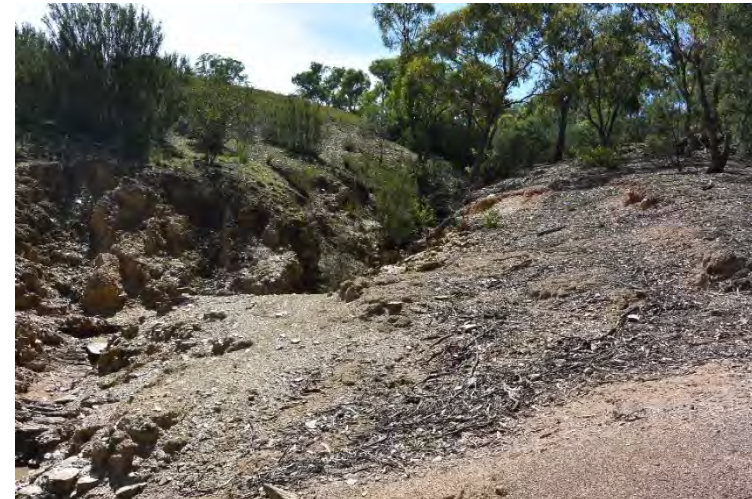
DSC 3807: Small active gully heads in gully line

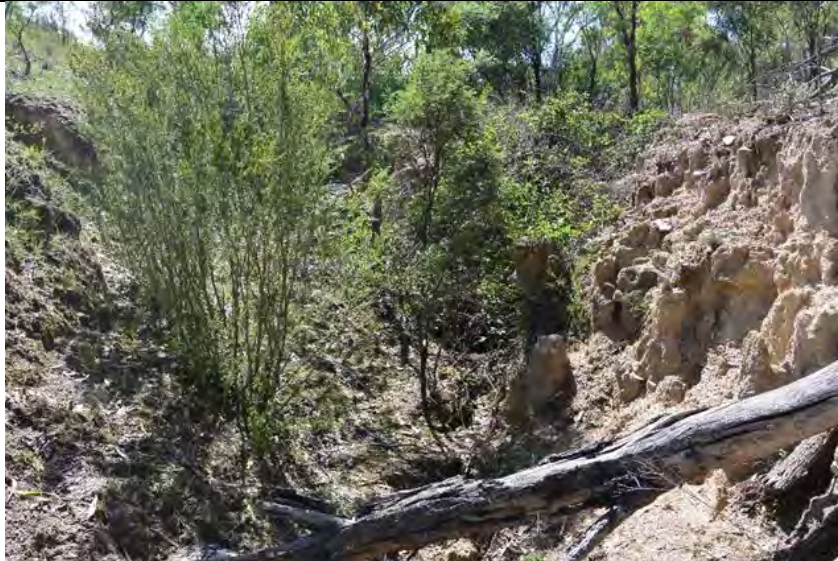
DSC 3808: Actively eroding vertical creekbank

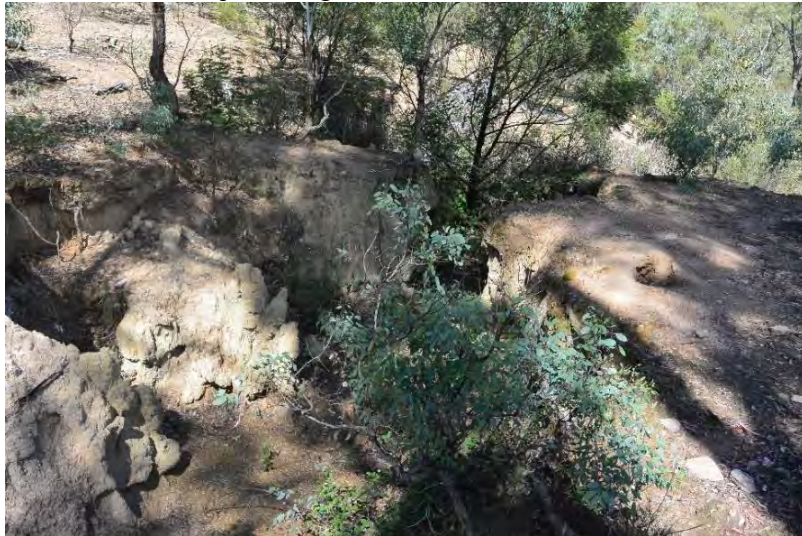
DSC 3810: Areas of eroding bank collapsing into creek bed

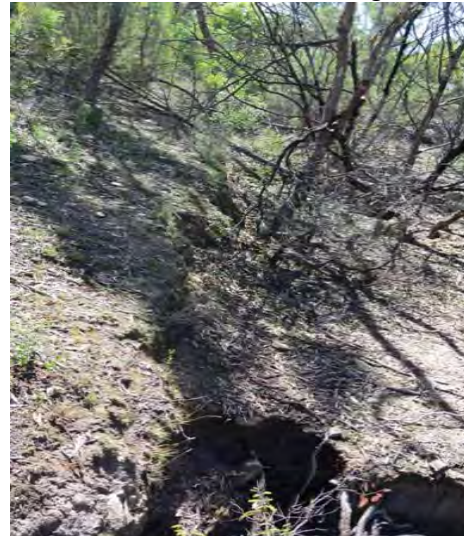
DSC 3811: Small active gully head

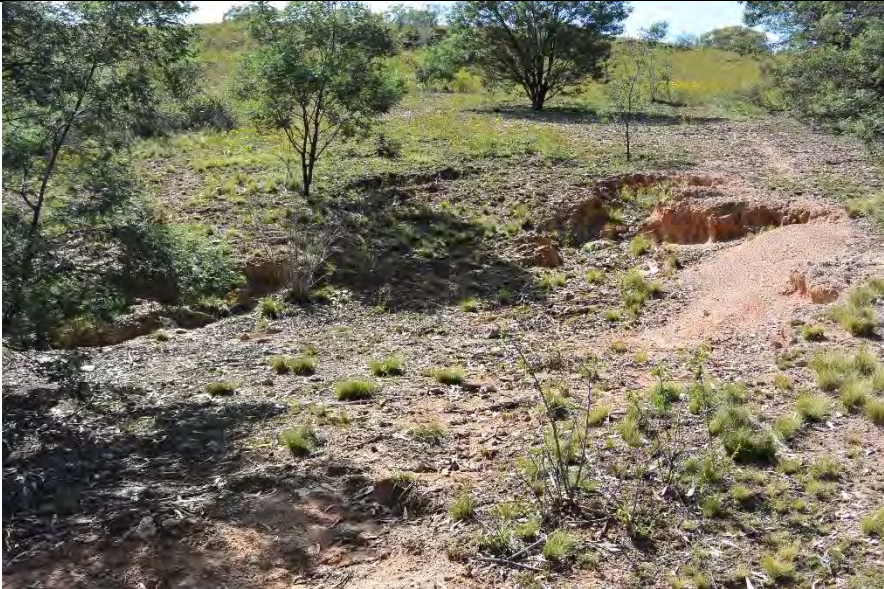
<p>Lat -35.378787° Lon 149.252293°</p>	<p>Eroding gully head in small drainage depression.</p>	<p>Moderately active gully head.</p>	<p>Low to medium priority (small depth of gully may naturally regenerate overtime)</p>	<p>Construct a small earth diversion bank upslope of the gully head to divert runoff in the drainage depression around the active gully head. Lightly rip the area around the gully head below the diversion bank, then seed and mulch the area with suitable species mix, consistent with the Vegetation Management Plan.</p>

<p>DSC 3803: Small active gully head in base of drainage depression</p>

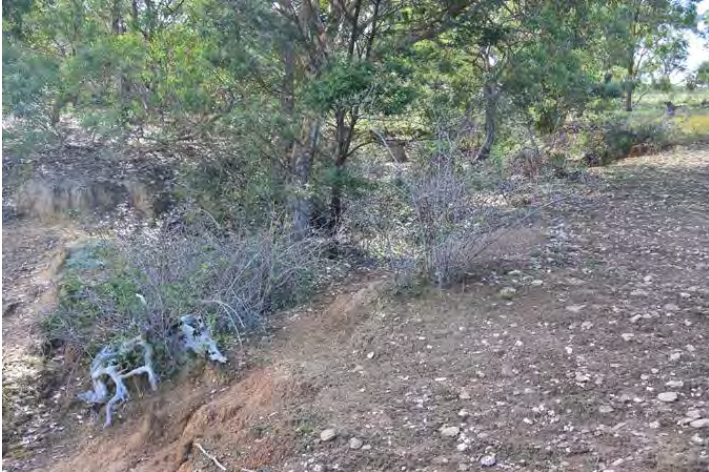
<p>Lat -35.378787° Lon 149.252293°</p>	<p>Gully and bank erosion in minor drainage depression</p>	<p>Moderately active</p>	<p>Medium priority (significant length of eroding bank and active gully head)</p>	<p>Construct a small earth diversion bank upslope of the active gully head and divert runoff around the active gully head site. Lightly scarify areas of bare and eroding bank and seed and mulch the area with suitable species from the Vegetation Management Plan.</p>
<div style="display: flex; justify-content: space-around;"> <div style="text-align: center;">

<p>DSC 3801: Long section of active bank erosion</p> </div> <div style="text-align: center;">

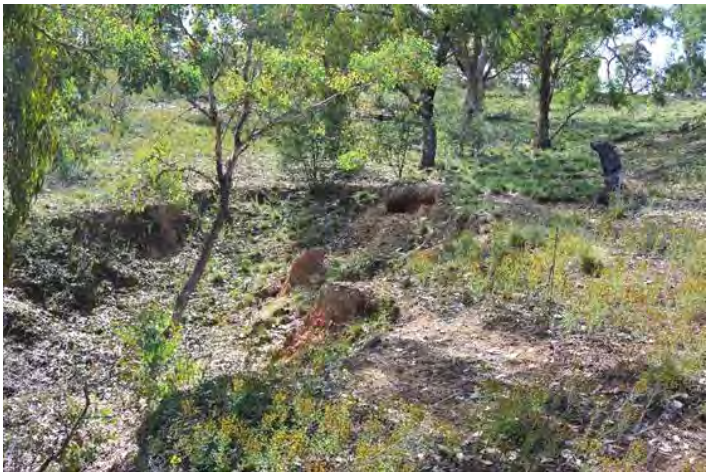
<p>DSC 3802: Active gully head at the top of the gully line</p> </div> </div>

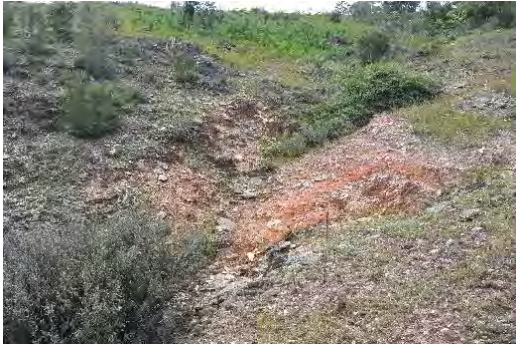
<p>E3A: Stable gully head</p>	<p>Stable</p>	<p>Low</p>	<p>Lightly scarify the surface then seed and mulch areas of bare gully and bank</p>
<p>E3B</p> <p>Lat -35.377410 Lon 149.254253</p>	<p>Small area of gully erosion in minor drainge depression</p>

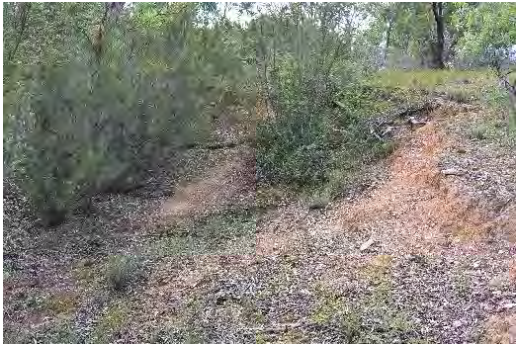
<p>E3B: Active minor gully head</p>	<p>Minor active gully erosion</p>	<p>Low to medium</p>	<p>Construct small earth diversion bank upslope of gully head. Lightly scarify the area below the diversion bank then seed and mulch areas of bare earth</p>

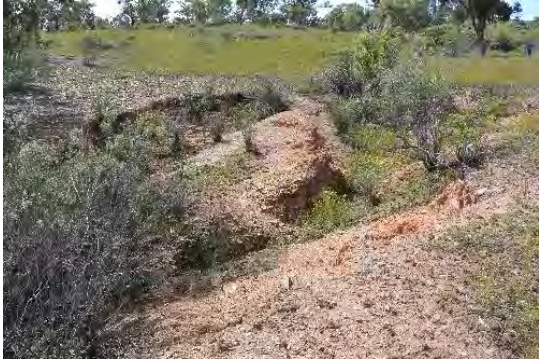
<p>E3C Lat -35.376763 Lon 149.253822</p>	<p>Small area of gully and bank erosion in minor drainage depression</p>

<p>E3C: Active gully head and banks</p>	<p>Minor active gully and bank erosion</p>	<p>Medium</p>	<p>Lightly scarify the area below the gully head and along the areas of bare bank, then seed and mulch areas</p>
---	---	--	---------------	--

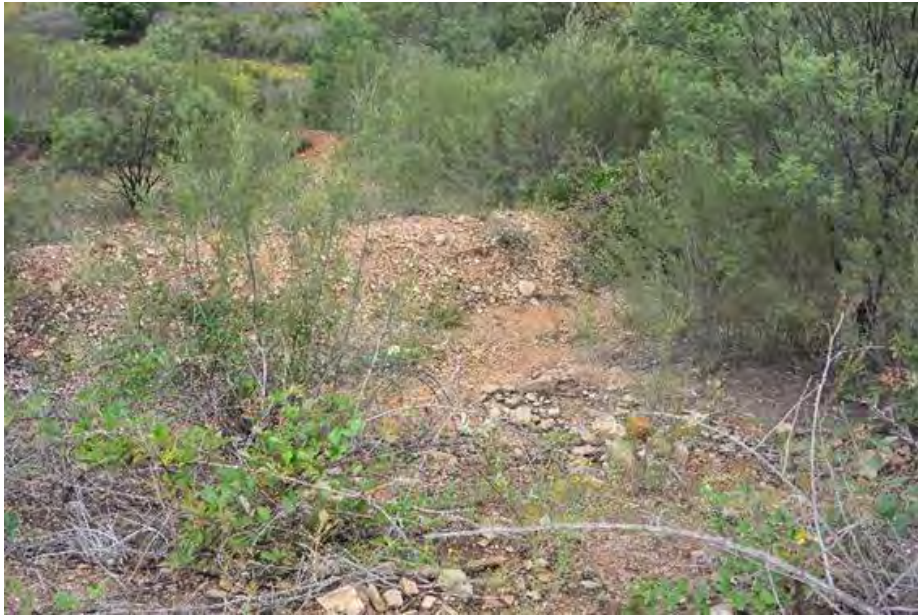
DSC 3770: Deposition in erosion bank channels

SITE REF	EROSION WORKS
E4	Maintain the existing erosion control earthworks by cleaning out bank channels and topping up bank freeboard.

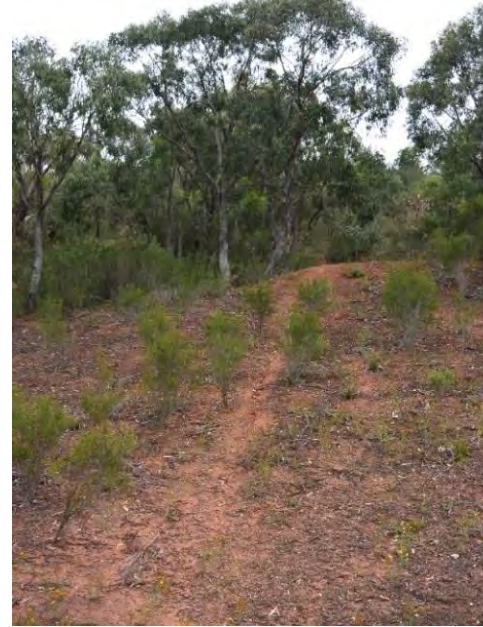
DSC 3775: Tracks eroding bank freeboard

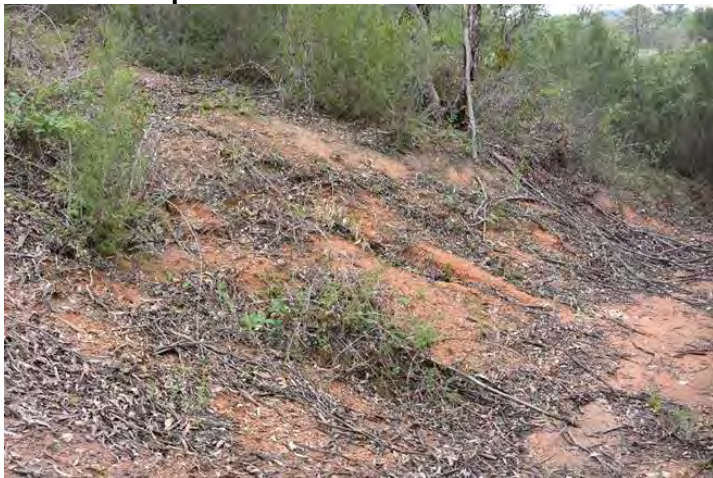
DSC 3777: Minor erosion on back batter of erosion control bank

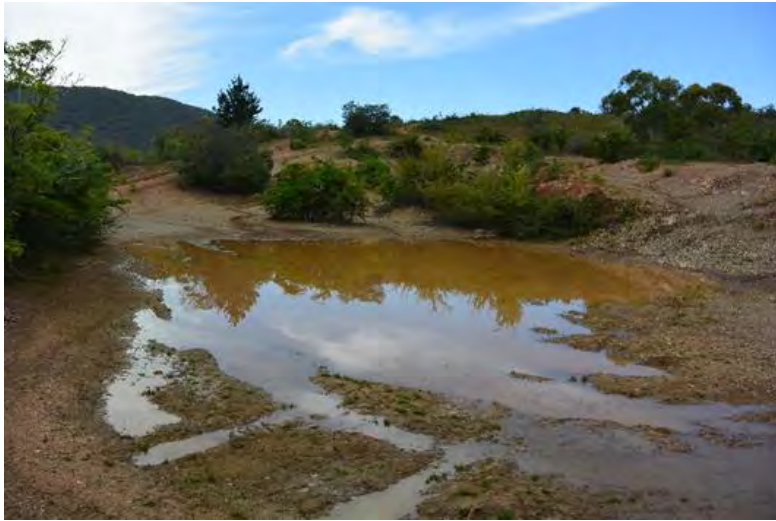
DSC 3789: Quarry site ponding water in the base

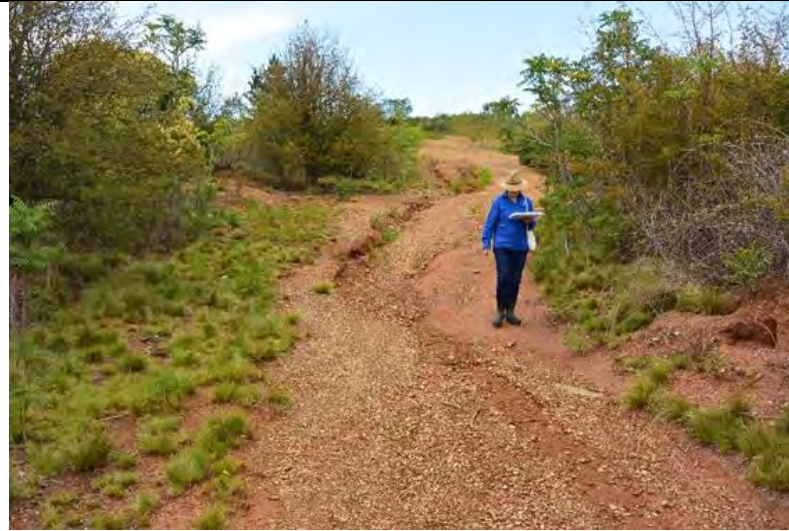
DSC 3781: Eroding trails leading into the quarry site

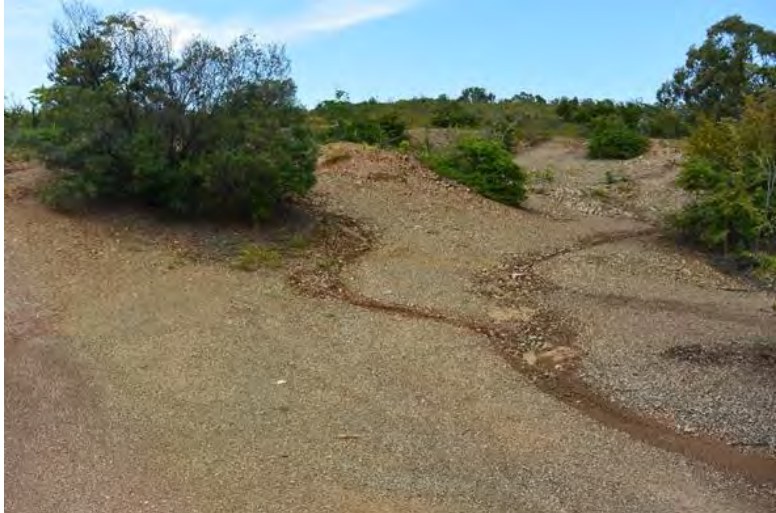
DSC 3790: Sheet and rill erosion across the quarry site

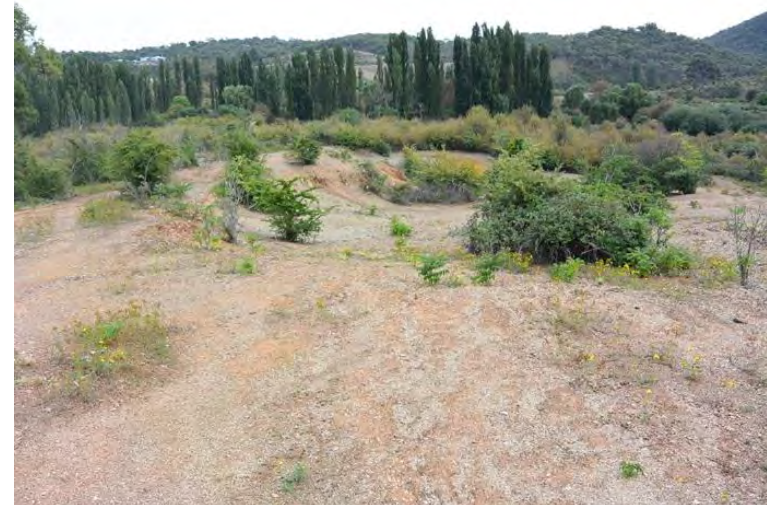
DSC 3792: Diversion of upslope runoff will prevent clean water entering the site and exacerbating erosion and sediment mobilisation

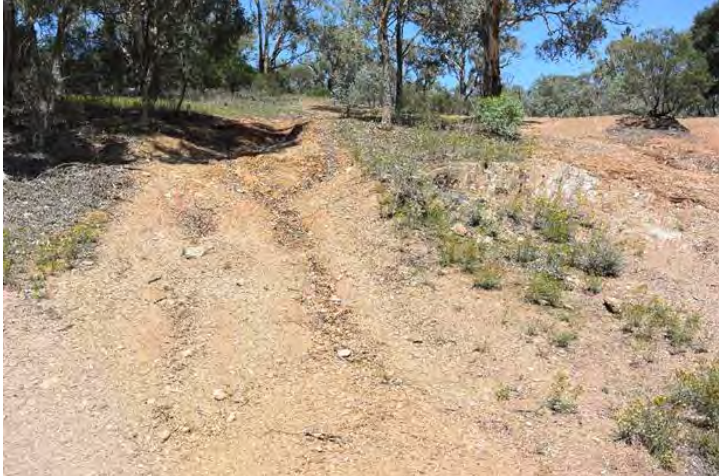
E6 – Erosion Area				
SITE REF & LOCATION Lat/Long	DESCRIPTION	STATUS Active (Severe, Moderate, Minor) or Stable	REMEDIATION PRIORITY High/Medium/Low	REMEDIATION OPTION
<p>E6</p> <p>Lat -35.376894° Lon 149.258879°</p>	<p>Extensive area of sheet and rill erosion formed by the concentration of track and trails and vehicle traffic on steep slopes. Includes an extensive area of bare creek flats below flood level</p>	<p>Active moderate to severe erosion.</p>

<p>DSC 3830: Extensive bare area with sheet and rill erosion</p>	<p>High (large extent of erosion and proximity to creek resulting in direct mobilisation of sediment to watercourse)</p>	<p>Construct an earth diversion bank to direct upslope runoff away from the site. Construct multiple graded banks across the site to control local water and convey this to a safe disposal area. Shape and deep contour rip the site below and between banks. Where possible import topsoil and spread on areas which have eroded to the subsoil level. Seed the area with suitable species, refer Vegetation Management Plan. Mulch all bare seeded areas to reduce erosion and promote germination.</p>

E6	Construct earth diversion bank upslope of the eroded area to divert run-on water away from site. Construct graded banks (three) across the eroded area to intercept local run-off water and convey to a safe disposal area. Deep rip the area on the contour and spread imported topsoil where erosion has reached subsoil. Revegetate by seeding and mulching.
E7	Deep rip the area on the contour and spread imported topsoil where erosion has reached subsoil. Revegetate by seeding and mulching.

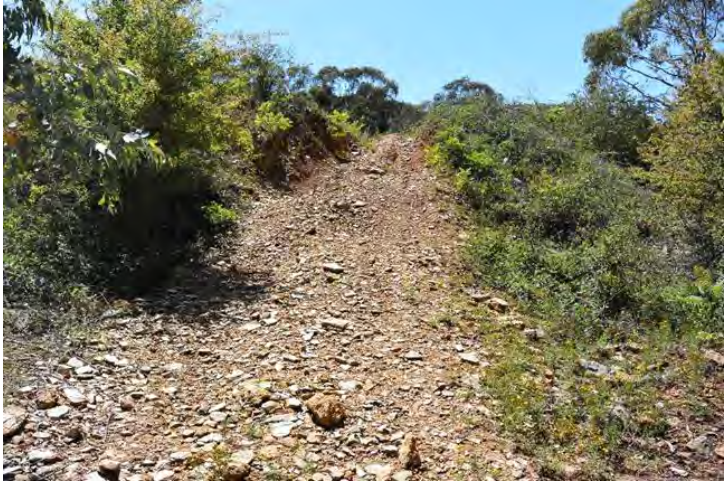
<p>Lat -35.377149° Lon 149.259884°</p>	<p>Moderate to steep sloping site with a concentration of trails and old mine/quarry site creating bare areas of sheet and rill erosion.</p>	<p>Active areas of minor to moderate erosion</p>	<p>Medium (localised sites requiring intervention to stabilise)</p>	<p>Decommission redundant trails and divert runoff away from these sites with minor trail crossover banks. Deep contour rip the site and where possible import topsoil and spread on areas which have eroded to the subsoil level. Seed the area with suitable species, refer Vegetation Management Plan. Mulch all bare seeded areas to reduce erosion and promote germination.</p>
<div style="display: flex; justify-content: space-around;"> <div style="text-align: center;">

<p>DSC 3831: Erosion of steep redundant trails</p> </div> <div style="text-align: center;">

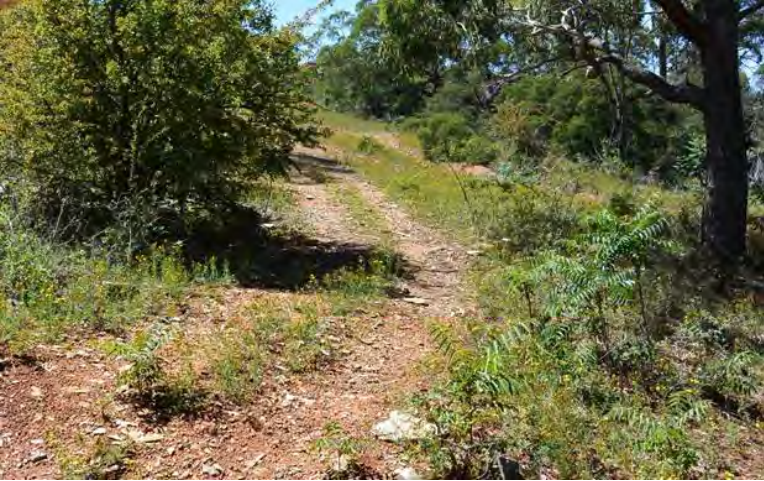
<p>DSC 3832: Concentration of trails causing erosion</p> </div> </div>

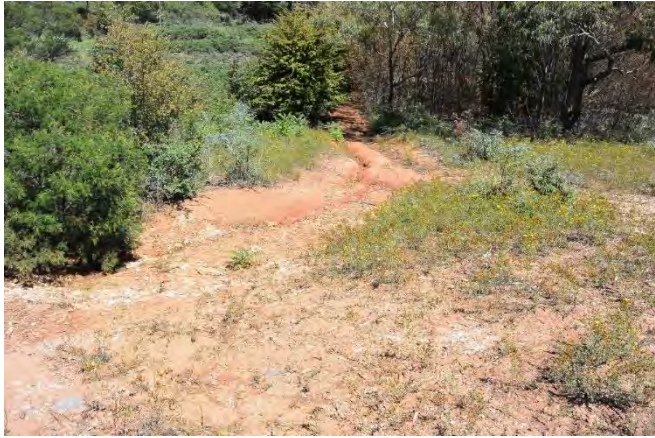
DSC 3833: Sheet and rill erosion across the site

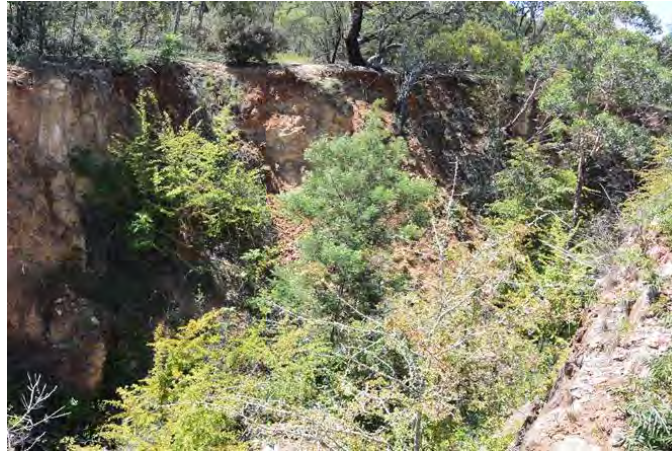
DSC 3834: Mine/quarry site adjacent to the eastern boundary

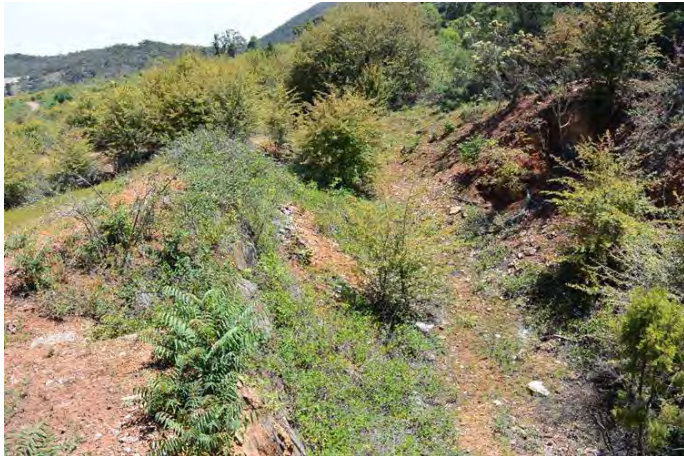
DSC 3835: Eroding vertical edges on old mine site.

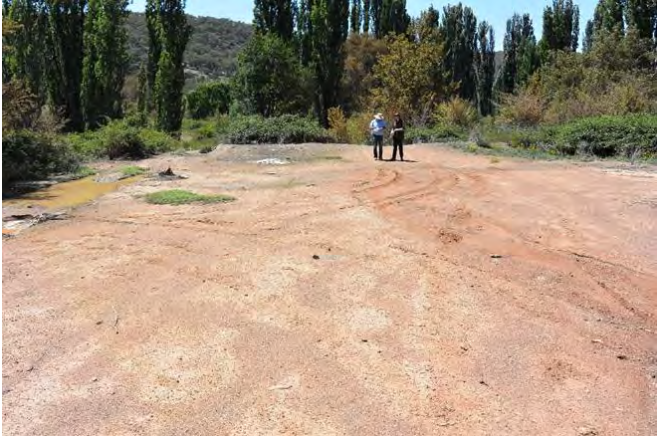
<p>Lat -35.372430° Lon 149.254476°</p>	<p>Extensive area of sheet and rill erosion formed by the concentration of track and trails and vehicle traffic on moderate slopes.</p>	<p>Active moderate erosion</p>

<p>DSC 3844: Large area of bare sheet erosion</p>

SITE REF	EROSION WORKS
E8	Construct an earth diversion bank upslope of the eroded area. Deep rip the area on the contour and spread imported topsoil where erosion has reached subsoil. Revegetate by seeding and mulching. NB: The eastern portion of this area will become a sediment basin in Phase 2 of the development and therefore erosion control works should be concentrated upslope of this area and completed in conjunction with the construction of the basin.
E9	Fill and vegetate mine adits and any other bare areas by capping with coarse ballast rock then topsoiling, seeding and mulching.

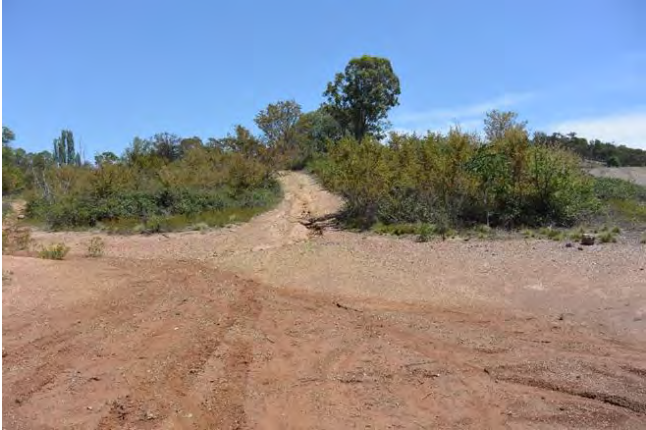
<p>DSC 3845: Sedimentation from upslope track erosion</p>	<p>Medium (active sheet and rill erosion with close proximity to the creek)</p>	<p>Construct an earth diversion bank to direct upslope runoff away from the site. Shape and deep contour rip the site below the bank. Where possible import topsoil and spread on areas which have eroded to the subsoil level. Seed the area with suitable species, refer Landscape Plan. Mulch all bare seeded areas to reduce erosion and promote germination.</p> <p>NB: The eastern portion of this area will become a sediment basin in Phase 2 of the development and therefore erosion control works should be concentrated upslope of this area and completed in conjunction with the construction of the basin.</p>

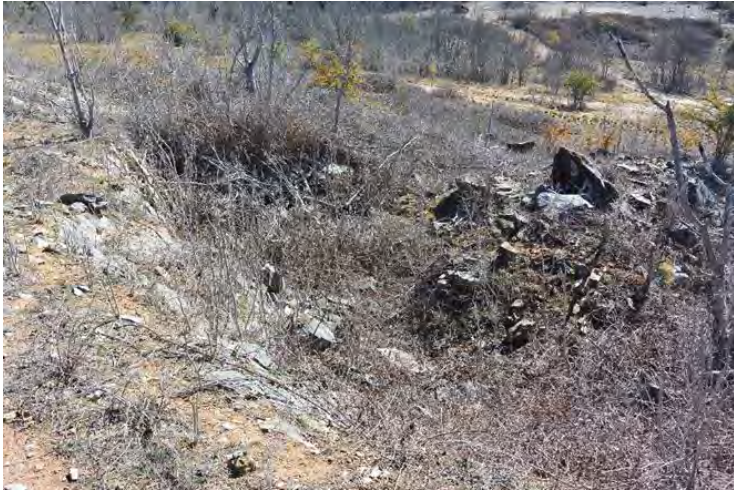
<p>Lat -35.375432° Lon 149.252395°</p>	<p>Historical mine site with small areas of bare ground and various mine adits. Largely vegetated however still presents a safety hazard</p>	<p>Stable (minor erosion risk but active safety risk)</p>

<p>DSC 3010: Mine adits revegetated with blackberries</p>	<p>High (safety risk and potential risk with surface water accessions into mine adits creating potential groundwater issues)</p>	<p>Mine adits should be back filled with coarse ballast material then capped with topsoil and revegetated with appropriate species, refer Landscape Plan. Any bare areas associated with the previous mining activity should be capped with coarse ballast rock (to create a hydraulic break and prevent capillary rise in soils) then topsoiled and seeded. Seeded areas should be mulched to reduce erosion and promote germination.</p>

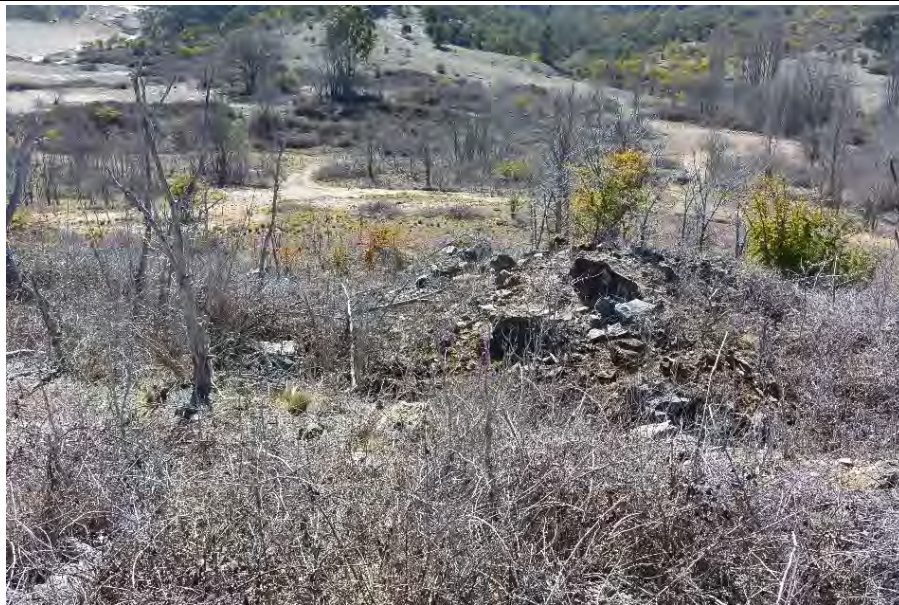
DSC 3011: Areas of mine spoil material stockpiled on surface

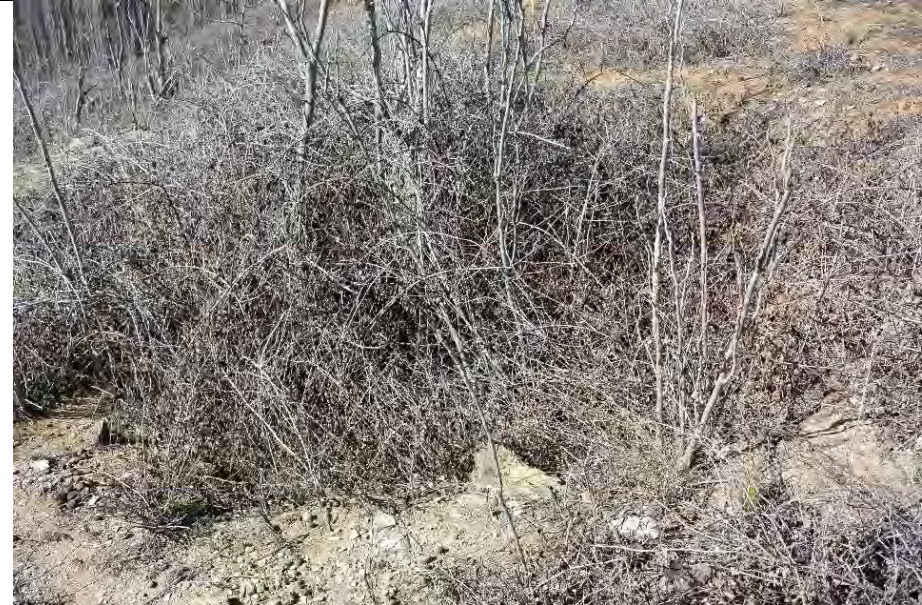
DSC 3012: Partially obscured mine adit creating safety hazard
