### QUEANBEYAN-PALERANG REGIONAL COUNCIL ORDINARY MEETING OF COUNCIL

ITEM 9.13 MONARO RAIL TRAIL

ATTACHMENT 1 MONARO RAIL TRAIL: TRAIL DEVELOPMENT PLAN STAGE 1A

# MONARO RAIL TRAIL TRAIL DEVELOPMENT PLANS

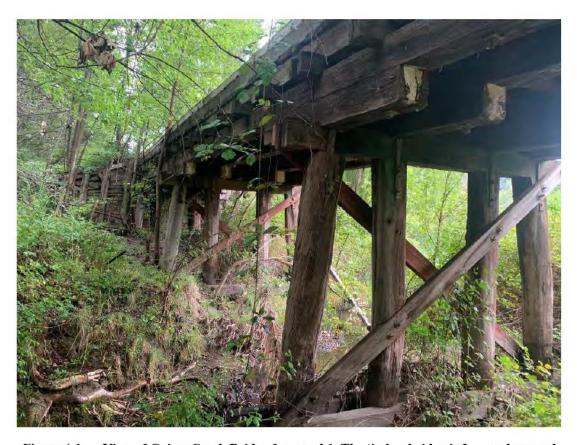
Figure 4-1: View of Guises Creek Bridge from end 1. The timber bridge is 3 spans long and approximately 24m metres long (8 metre spans). Note at all bents each girder has a corbel. Note that the corbels and girders are dimension timber when typically, they will be round log. At the time of inspection there was only water underneath span 2 with an approximate depth of 0.5m. There is a large amount of vegetation growth around the timber bents which keeps the moisture content of the timber high. When the moisture level in the timber is above 22%, decay-causing fungi can start to grow; when the moisture content drops below this level, the fungi become dormant, and decay will be arrested until the moisture content rises again. It is noted that a resin treatment has been used to fill existing cavities in majority of the girders. Note the rounded drip edge on the corbels. A positive detail. However, plenty of poor detailing vertical fasteners originating from the top of the girders are in use.

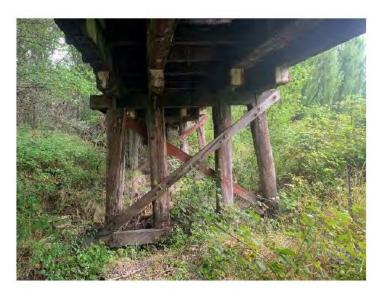
Figure 4-2: View of the typical timber pile bent configuration. The bent is comprised of 4 driven piles, single timber head stocks and corbels. The bent is also supported by a double cross bracing system with sashes at halfway and timber wales at the bottom. Overall, the timber bents were found to be in a poor to very poor condition. Note the surface brown rot fruiting bodies on the faces of some of the cross braces -orange brown colour.

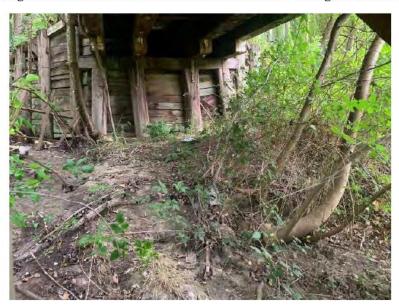
Figure 4-3: Both abutments consist of 4 timber piles, timber headstock, timber corbels and timber sheeting. It was noted that the bottom section of several piles has started to undergo decay. Note abutment sheeting is rotted and failing. Timber pile and sheeting wing walls present on both sides of each abutment. Once the moisture content in the timber elements reaches 22%, decay causing fungi are activated and the decay process begins. Large trees need to be cleared as their root systems apply lateral pressure on the substructure elements as will the branches and trunks on super structure elements.

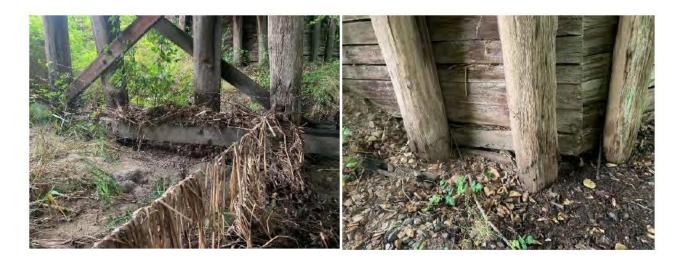
Figure 4-4: The bottom sections of the timber piles were determined to be a 'hotspot' for decay, this is caused by the moisture retained by debris increasing the moisture content in timber members. Sapwood decay in the timber piles is photographed on the right-hand side. Refer to Section 4.1 below for a full list of recommended repair options for refurbishment to a pedestrian/cycle bridge.

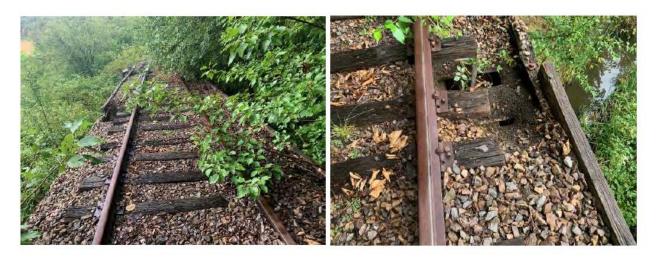
Figure 4-5: The timber transoms were found to be in a very poor (unsafe) condition. The timber ballast tray side walls and rock ballast were in poor condition with erosion of material found in several locations. If the bridge was to be repurposed for pedestrian and cycle use the timber transoms, railway line and rock ballast would need to be removed. Depending on the condition the existing ballast tray side boards they can left in place to act as a kerb/kick rail in the re-purposed bridge. To meet the current standards and Australian codes; vertical balustrade panels and a 1.4m high cycle rail will need to be installed. Note: Significant vegetation growth. The ballast tray will provide a great subgrade for the walking track.

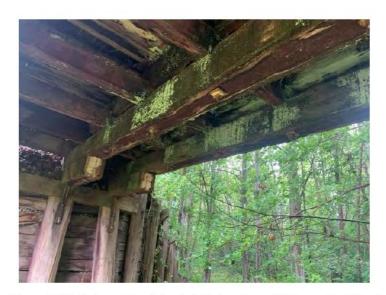
Figure 4-6: View of 2/4 girders. Consists of 4 girder lines which are double stacked with the top girder serving as a lateral bearer beam end stabilizer as well increasing the elevation of the ballast tray floor. All girders exhibited major water stains and decaying fungal growth.

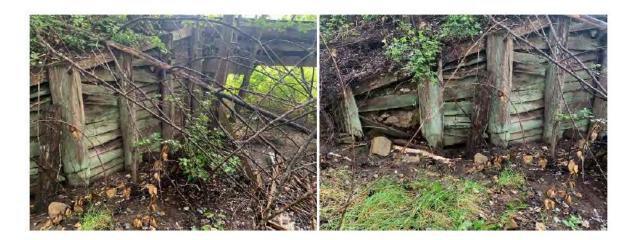
Figure 4-8: The timber wingwalls have undergone significant deterioration with timber sheeting completely rotted and failing in several locations. Due to this the walls' ability retain the approach fill material is poor leading to erosion and excessive loading.

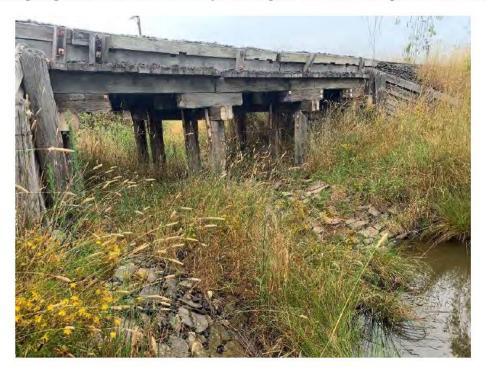
Figure 5-1: The top image shows a general view of the minor 10m Bridge from an abutment. The timber girder under bridge consists of 3 spans of 3.3m. Each bent consists of 4 driven timber piles and a single headstock. Headstocks are attached to the piles using a vertical steel bracket on either side. Note kerb support completely split vertically through middle.

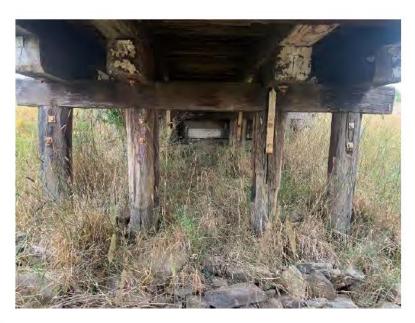
Figure 5-2: General configuration of each pile bent. Large vegetation growth and cobbles located around the base of piles. All piles were found to be in very poor condition with large splits and sapwood decay are present in majority of piles, predominately at ground level. Excess vegetation growth leads to an increase in moisture content within timber members resulting in accelerated decay.

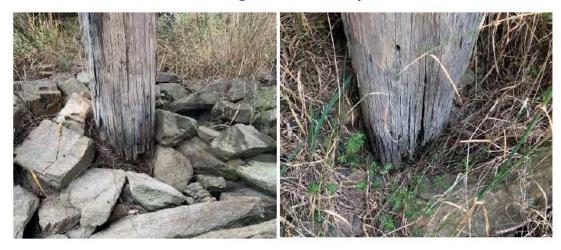
Figure 5-3: View of piles at PB1, pile 3 and PB2 pile 4, both are in very poor condition and were found to be completely decayed at ground level and hanging freely above ground.

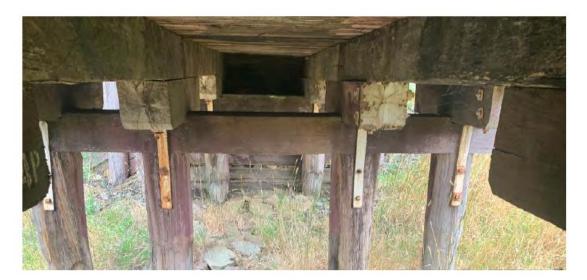
Figure 5-4: View from in between internal girders, all girders were found to be in fair condition with no major deterioration present. Corbels and bent caps were found to be in fair to poor condition throughout with evidence of minor decay present. Brief NDT testing was completed using non-destructive methods, such as EPHOD® Stress Wave Technology. Refer to Appendix A for more information of this type of testing method. Readings for girders were found to be between 300-500μs, Corbels – 400-100μs and caps 300-800μs. This is the time taken for the compression wave to travel across the section of the member tested. This was recorded on most elements and aids in verifying the condition of the elements. The pile tops are in better condition due to the use of horizontal connectors with side plates.

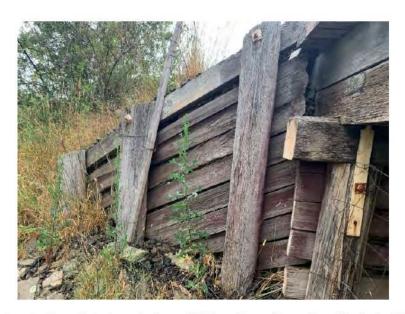
Figure 5-6: A view of abutment wingwall. The wingwall was found to be in fair to poor condition with minor deterioration present throughout all components. Minor deformation was present at top of wall due to bearing load of ballast.

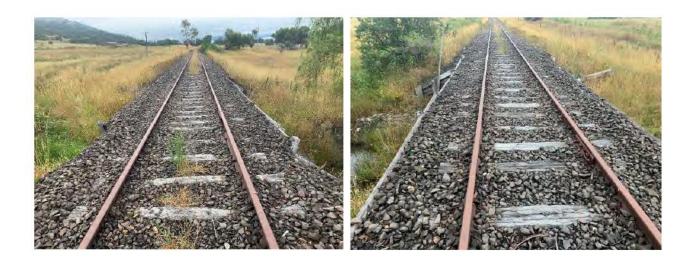
Figure 5-8: Top view of rock ballast looking in opposite directions. The rock ballast was found to be in fair condition with no major erosion present, no holes were found in bridge decking. Transoms were found to be in fair to poor condition with moderate deterioration and decay found.

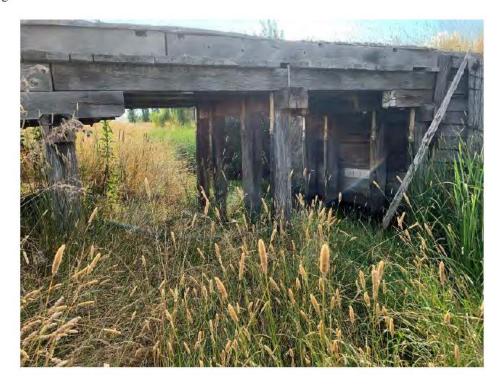
Figure 6-1: General view of Lobbs Hole Creek Bridge from the side of the bridge. The Creek that flows underneath span 1 at the time of inspection was flowing very slowly/still. The configuration of the bridge is a girder under and consists of 3 spans, 2 abutments and 2 pile bents. The span length is 3m equating to a total length of 12m. Note: abutment 1 and abutment corbels as does one of the bents.

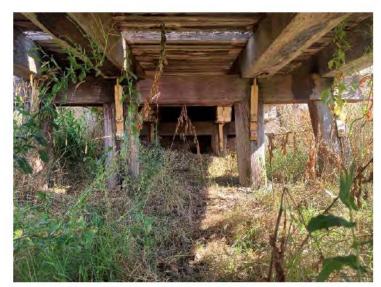
Figure 6-2: View of the typical timber pile bent configuration with each bent varying in height. The bent comprises of 4 driven piles a capsule (cap) and at bent 2 4 corbels located directly underneath girders. Overall, the timber bents were found to be in fair to poor condition. Note: large Wombat hole at abutment 2 between pile 2 and 3 and the significant amount of vegetation growth surrounding the substructure elements. Note that the use of horizontal bolts in the side plates have let to improved pile top condition. Also note the notches in the caps for the girders to drop into.

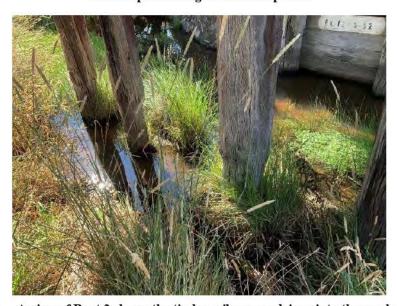
Figure 6-3: A view of Bent 2 shows the timber piles were driven into the creek. Significant sapwood decay is present in the lower length of each pile as seen by the noticeable change in cross section. This is seen as a length that is subject to temporary exposure to moisture which causes accelerated decay compared to constant saturation. Once the moisture content exceeds 22%, timber consuming fungi are activated, and the decay process begins. Refer to Figure 3-2 for a detailed description of how and where the decay occurs due to these vertical bolts.

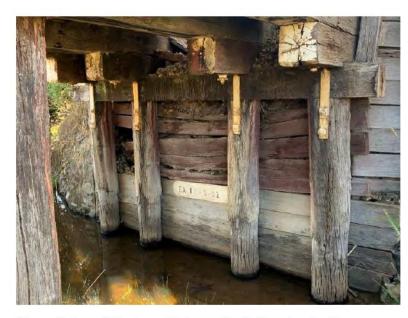
Figure 6-4: General view of Abutment 1 shows the timber sheeting in very poor condition as top half is failing and backfill material is eroding. Note: Hole in decking above abutment causing significant material loss from rock ballast above.

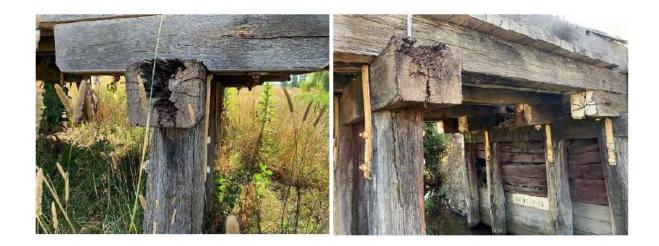
Figure 6-6: Above photos show the ends of the pile bent caps at PB1&2. Minor deterioration and cavities were found at all ends of caps. Overall, the caps were in poor condition. Brief NDT testing was completed at the mid length using non-destructive methods, such as EPHOD® Stress Wave Technology. Refer to Appendix A for more information of this type of testing method. Readings for bent caps were found to be between 200-1000µs. This is the time taken for the compression wave to travel across the section of the member tested. This aided in verifying the overall condition of the elements.

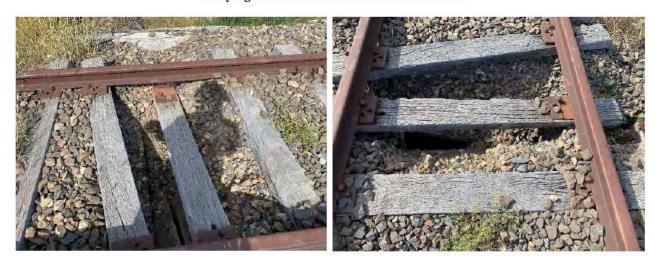
Figure 6-7: Above two photos show 2 of 3 deck collapses. The ballast tray floor boards are in very poor condition with major deterioration and rot present throughout.

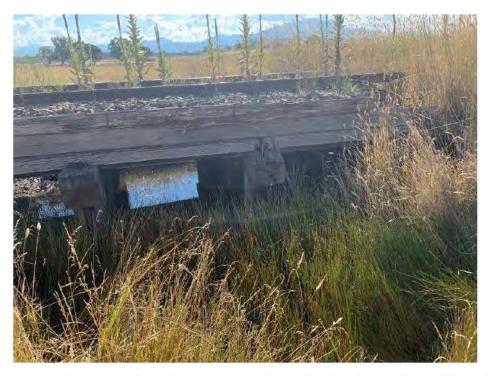
Figure 7-1: The image above shows a general view of the 7m minor bridge (Williamsdale Rd). The consists of 3 spans each span is 2m in length, substructure includes 2 pile bents and 2 abutments that each have 4 driven piles, a pile cap and 4 girders. At the time of inspection there was water approximately 0.5m deep in Spans 1-3. There is a large amount of vegetation growth around the substructure which keeps the moisture content high in the timber. When the moisture level in the timber is above 22%, decay-causing fungi can start to grow; when the moisture content drops below this level, the fungi become dormant, and decay will be arrested until the moisture content rises again.

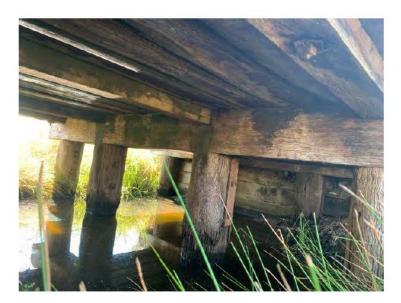
Figure 7-2: Shows the general configuration of the pile bents. Piles are approximately 1m high and in fair condition. Minor deterioration of sapwood is present at water level due to increased moisture content. Water stains and fungal growth present. Note: top plank in abutment sheeting has failed leading to erosion of backfill material.

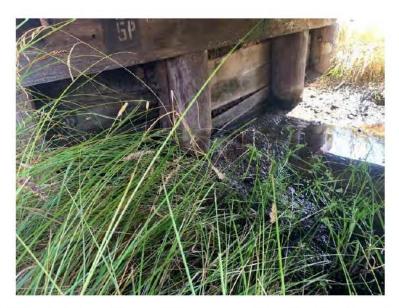
Figure 7-3: View of abutment 2, overall, in a poor condition. Sheeting planks have separated due to spiking to the pile backs in the breast wall, causing loss of fines in the approach fill material through gaps.

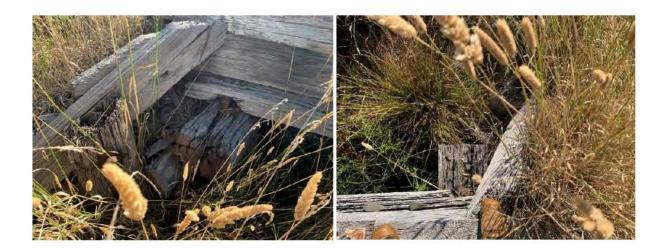
Figure 7-4: Top view of abutment cap connection. Cap is in very poor condition; severe deterioration is present in the ends and at the vertical connection. When a vertical connection is not sealed appropriately it exposes the heart wood to excess moisture accelerating decay. As seen in the photo a large crack is present at the end and a cavity is present at the top of the vertical connection.

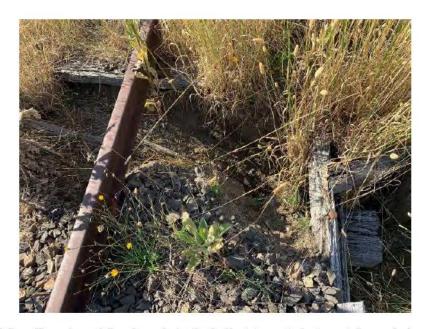
Figure 7-5: Top view of floorboards in the ballast tray at abutment. Large hole caused be abutment/ballast tray failure allowing significant erosion of ballast to occur.

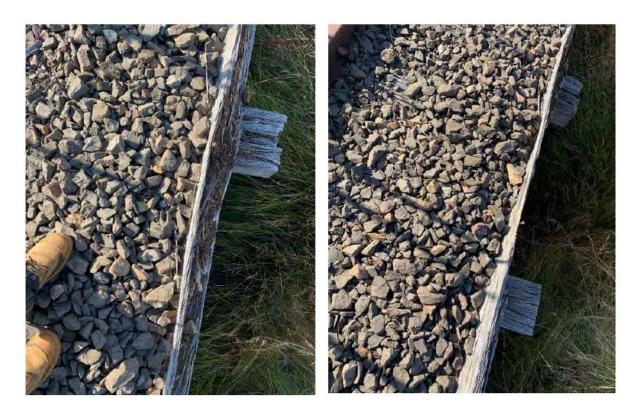
Figure 7-6: Above photos show a ballast tray side wall lengths that have completely rotted away, significantly reducing its ability to retain the ballast material.

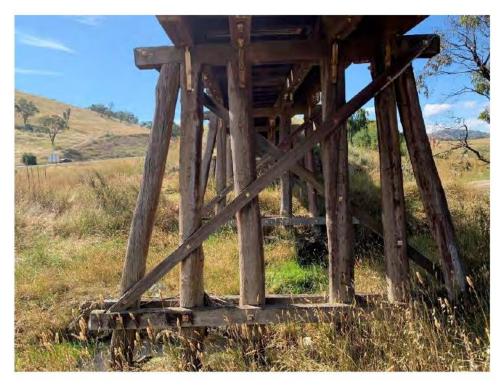
Figure 8-2: View of the typical timber pile bents configuration. The bents comprise of 6 driven piles (4 Plum piles directly under the girders and 2 batter piles on either side). Pile bent 2 and 3 are supported by cross bracing and timber wales at the bottom of the bent. Pile bent 3 was constructed on a concrete footing. The two abutments do not contain the cross bracing and wales. It was noted that the bottom section of several posts and timber cap wales have started to undergo decay. This can be expected due to the timber posts bearing directly on the concrete footing which typically has a high moisture content. Over time the timber post undergoes capillary action and draws up the moisture like a 'straw'. Once the moisture content in the timber elements reaches 22%, decay causing fungi are activated and the decay process begins. Overall, the timber bents were found to range from fair to very poor condition.

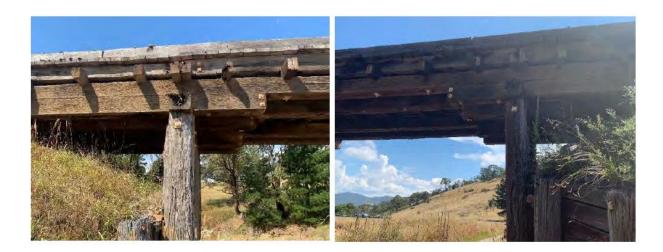
Figure 8-5: View of pile caps at PB1 & 4. Caps were found to be in very poor condition due to the significant cavities present in both ends of each cap. Note: The right photo also shows the backfill from PB4 pushing the breast wall forward.

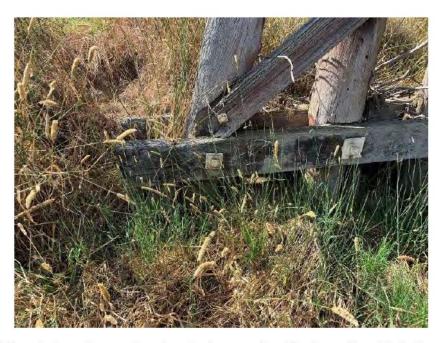
Figure 8-6: A view of a cross bracing plank connection. Plank was found to be in very poor condition as the end has completely decayed away to the connection point. Timber wales were found to be in poor condition with significant water stains and decay present throughout.

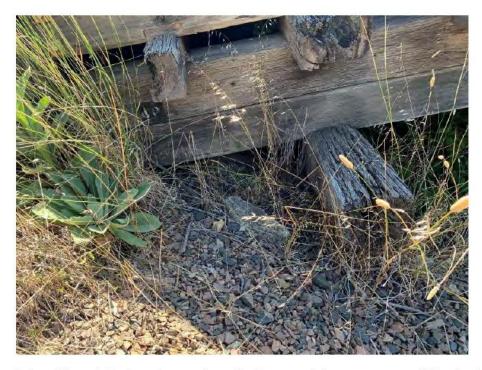
Figure 8-8: View of Abutment cap and spacing logs, cap is in very poor condition due to the large cavity and significant decay present at both ends. Spacing members were found to be in fair to poor condition with sapwood decay and cavities present.

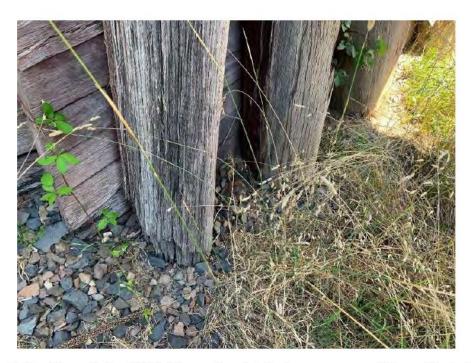
Figure 8-10: View of pile at PB4. Pile was found to be in very poor condition with significant decay present. Decay of approximately 50% of the cross section.

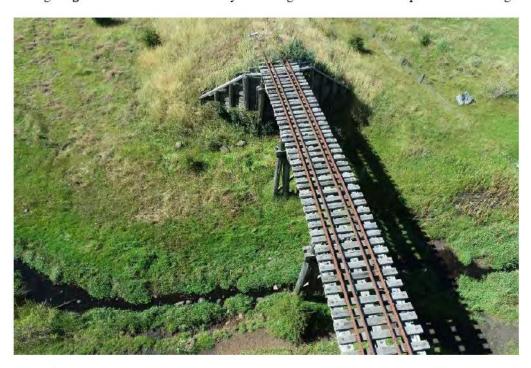
Figure 9-1: General view of Bobundara Creek Bridge from abutment 1 looking towards abutment 2. The timber bridge is 3 spans long and approximately 22.5 metres in length (7.5m spans). Note Bobundara creek runs underneath span 2 and is approximately 1m wide and 1ft deep. note the inner guard rail to prevent derailment leading to the train going off the bridge when train operations were occurring.

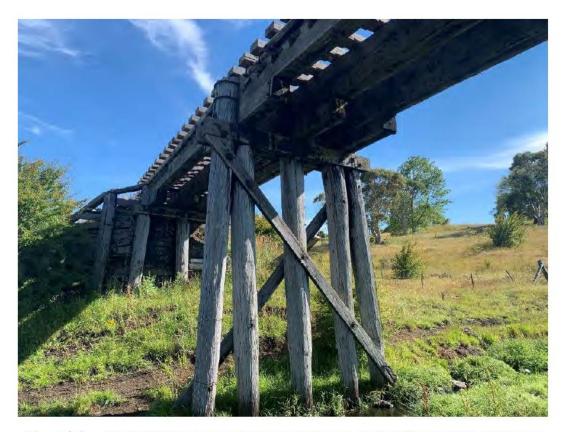
Figure 9-2: View of the timber pile bents configuration. PB 2 and 3 comprise of 5 driven piles (3 Plum piles directly under the girders and 2 batter piles on either side). Pile bent 2 and 3 are supported by cross bracing. The two abutments do not contain the cross bracing and are support by timber sheeting to retain backfill. It was noted that the bottom section of several posts has started to undergo decay. This can be expected due to the timber posts being exposed to increased moisture in overgrown vegetation, debris, and the nearby creek. Once the moisture content in the timber elements reaches 22%, decay causing fungi are activated and the decay process begins. Overall, the timber bents were found to range from poor to very poor condition.

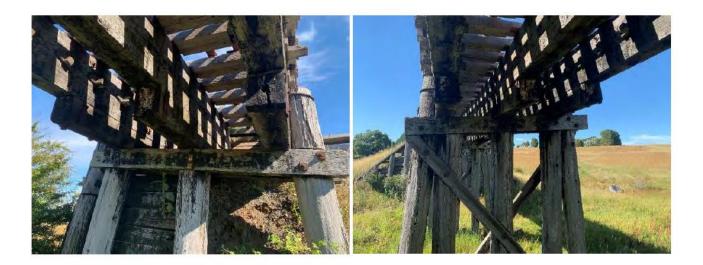
Figure 9-3: The images above show the substructure configuration. It is seen that double stacked girders have been used in addition to split headstocks and corbels. Both images show significant water stains and decaying of corbel ends. The left image identifies a large cavity present in the end of corbel 1 AB1. It was noted that AB1 sheeting has failed.

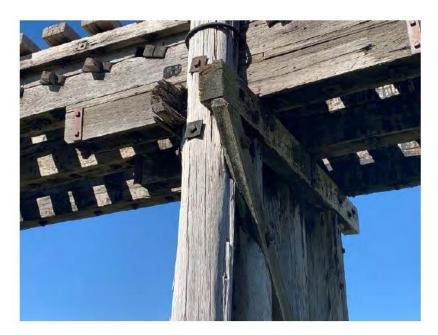
Figure 9-4: The images above show the condition of the split headstocks. The majority of headstocks were found to be in poor to very poor condition. The left member in the image above is completely decayed through the end and in very poor condition.

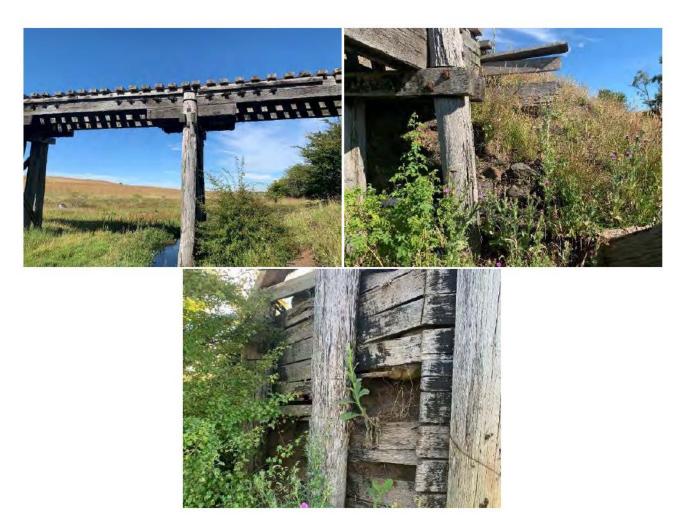
Figure 9-5: Large amounts of sapwood decay is present throughout the structure piles. It is recommended that this is monitored and removed appropriately.

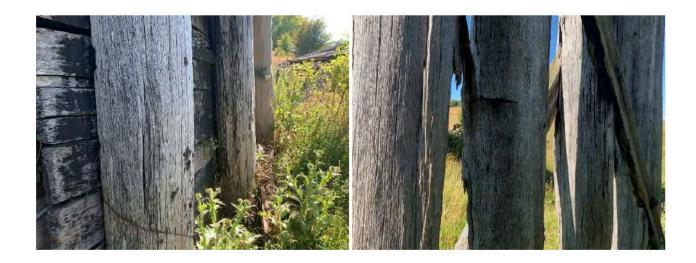
Figure 9-6: A view of two pile defects located at AB1 and PB2. The left image shows decay of sapwood forming a vertical cavity. The right image shows significant deterioration of sapwood (Peeling off).

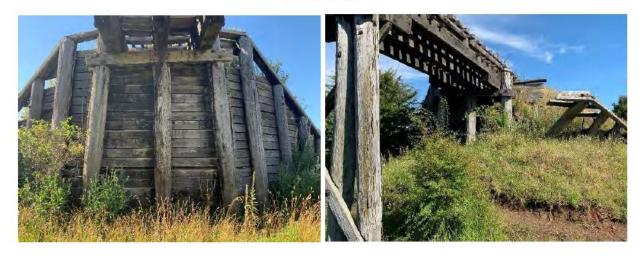
Figure 9-7: View of Abutment 1 and 2 and respective wingwalls. Abutment 1 breast/wingwall was found to be in poor condition due to the missing members and gaps between planks causing erosion of backfill. Abutment 2 was found to be in very poor condition with missing elements throughout and the right side wingwall had failed (collapsed).

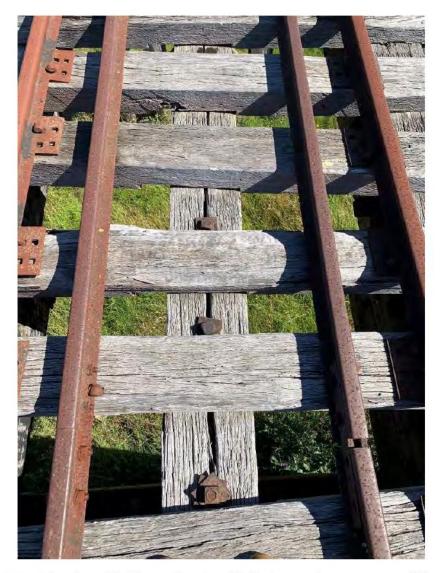
Figure 9-8: Top view of bridge surface, found to be in poor to very poor condition due to major vertical crack through the middle girder and major decay present in all other girder lengths. Vertical connections expose the bright wood to weathering and funnel watering, this leads to accelerated decay and higher moisture content. Transoms appear to be in fair to poor condition with no major decay or defects present. Note the smaller guard inner guard rail on this open deck railway bridge

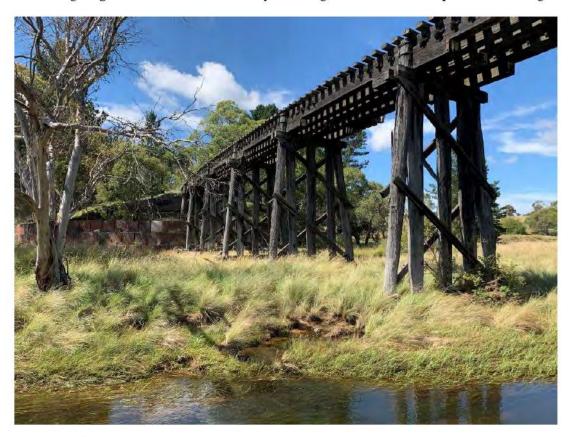
Figure 10-1: General view of MacLaughlin River Bridge from abutment 2 looking towards abutment 1. The timber bridge is 8 spans long and approximately 60 metres in length (7.5-8m spans). Note MacLaughlin River runs underneath span 3 and is approximately 3m wide and 0.7m deep. It was also noted that the bridge curved left and had appropriate camber. Note the double cross bracing on the bents as well the absence of a sash brace.

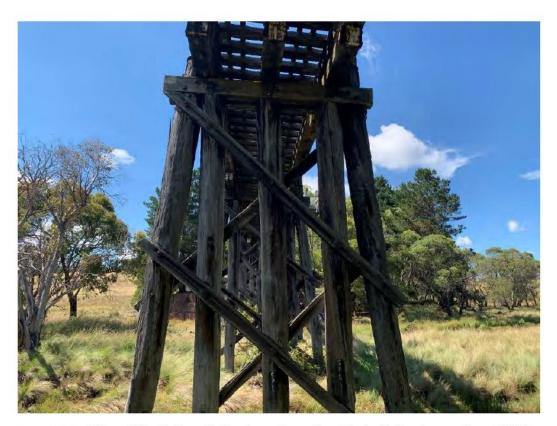
Figure 10-2: View of the timber pile bents configuration. Each pile bent comprises of 5 driven piles (3 Plum piles directly under the girders and 2 batter piles on either side) and are supported by double cross bracing ("X" at top and bottom of piles) and timber wales at the bottom. The two abutments do not contain the cross bracing and only exhibit 3 plum piles. It was noted that significant water stains were present on all timber members of each pile bent. This indicates a high moisture content, when timber elements reach 22%, decay causing fungi are activated and the decay process begins. Overall, the timber bents were found to range from fair to poor condition. Sapwood decay is present at on the piles within the image above. Note that the cross braces do not go all the way to the head stocks.

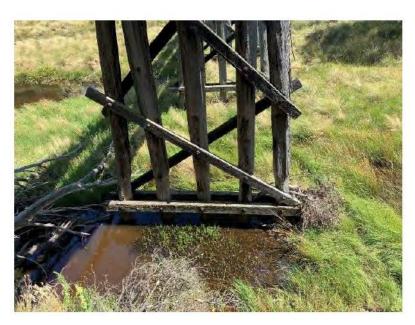
Figure 10-3: Significant decay is present on all piles in above image. Large decrease in pile cross-section on the bottom end of the piles located in the river (Body of water). Debris is caught up in the wales and surrounding areas of pile bents. It is recommended that deteriorated sapwood be removed appropriately.

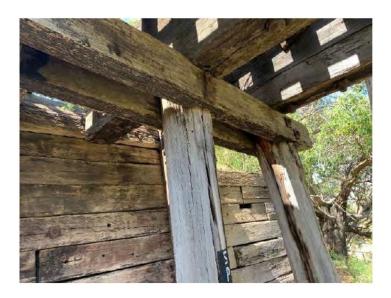
Figure 10-4: The images above show the condition of the split headstocks and the abutment breast wall. The headstocks were found to be in poor to very poor condition, exhibiting significant decay. The breast wall is in poor condition with missing members and weathered elements with splits and cracking throughout. Note: major vertical crack down middle pile exposing bright wood and acerating decay. Typically, these decay cracks are initiated by fastener systems

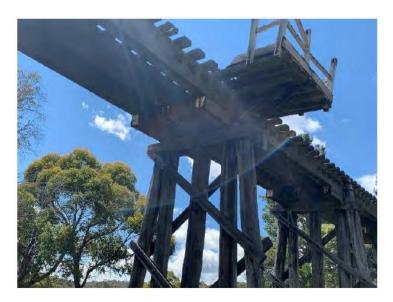
Figure 10-5: View of the walk out standing platform. Platform appears to be in poor to very poor condition with missing/failed members. This would not be safe to stand on. All timber appears to exhibit significant decay.

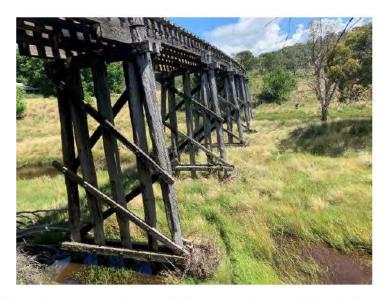
Figure 10-7: Above image shows the left curve and camber in the bridge. The bent configuration is also highlighted, it was noted that significant overgrown vegetation and debris build up was present at the base of all bents. This increases moisture retention leading to accelerated decay of the lower timber elements.
