**Aboriginal Heritage
Ellerton Dr Extension,
Queanbeyan**

APPENDIX K – LETTERS OF SUPPORT FOR METHODOLOGY FROM GRAEME DOBSON AND WALLY BELL (Second round consultation 2014)

Unexpected Archaeological Finds

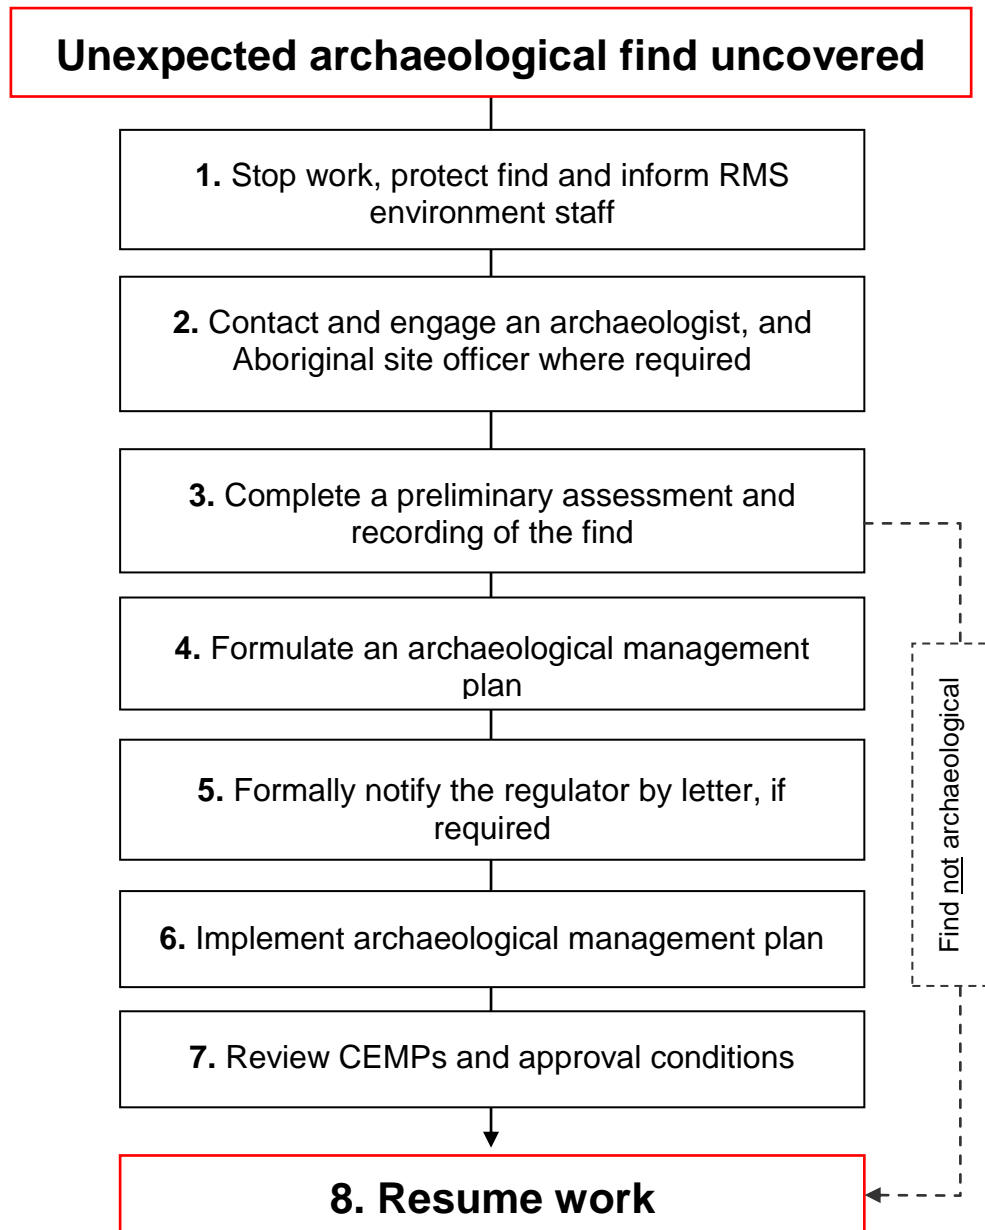
Figure 1: Overview of steps to be undertaken on the discovery of an unexpected archaeological find.

There are eight steps in the procedure. These steps are shown briefly in Figure 1 below and explained in detail in Section 7.

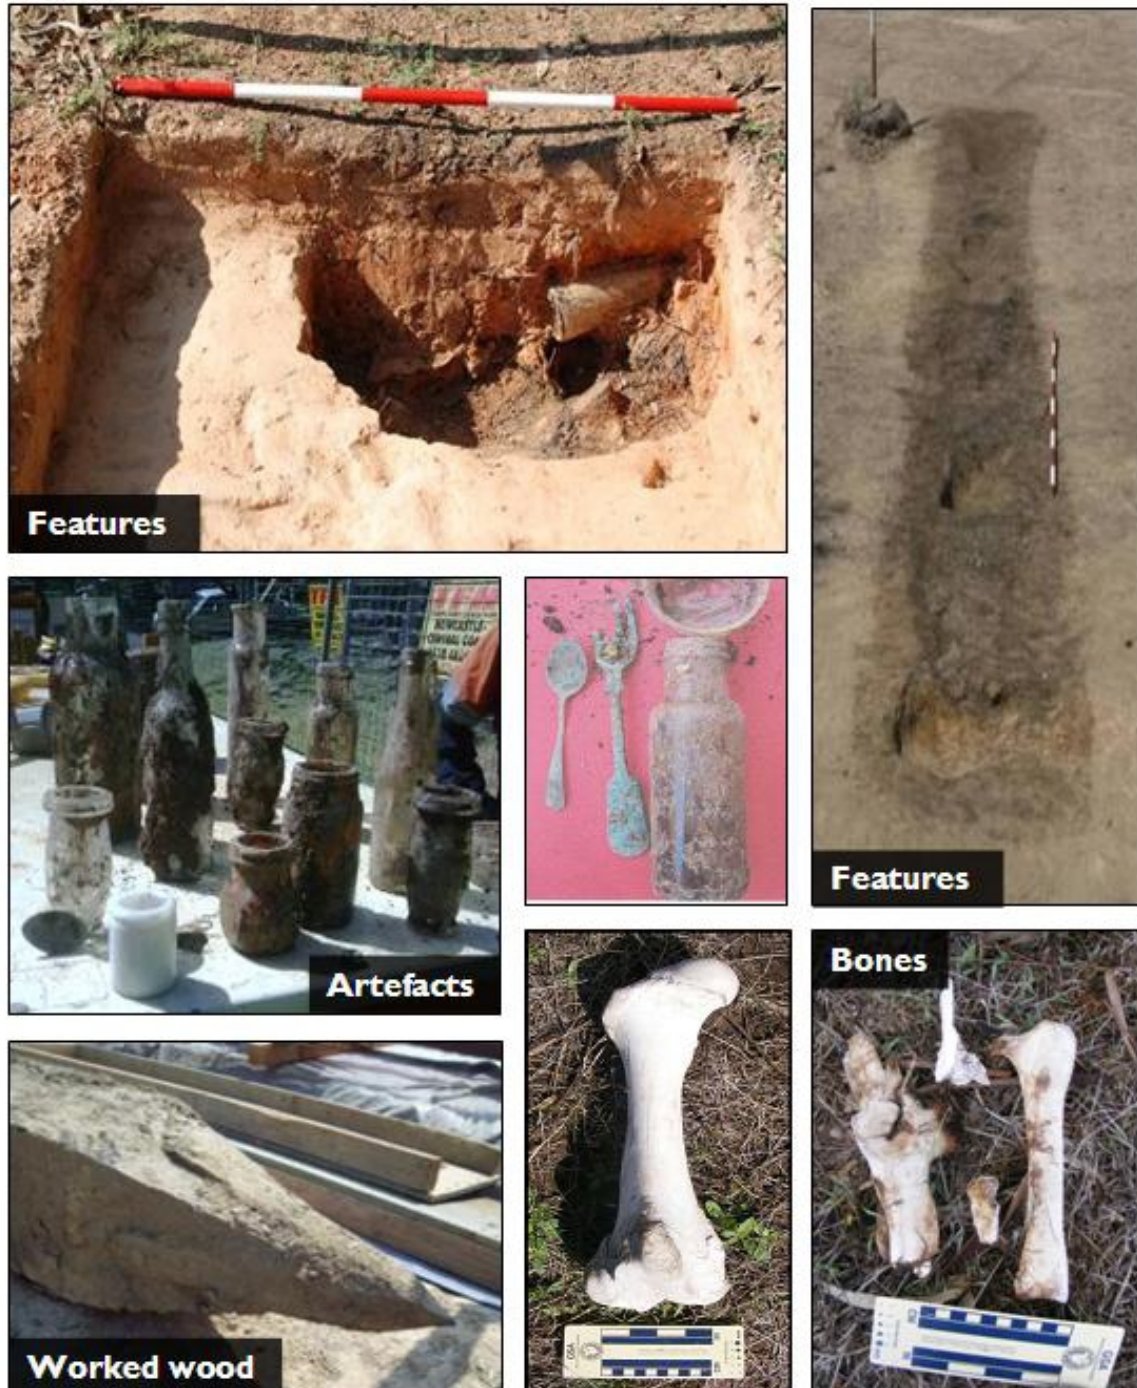
Top left hand picture continuing clockwise: Stock camp remnants (Hume Highway Bypass at Tarcutta); Linear archaeological feature with post holes (Hume Highway Duplication), Animal bones (Hume Highway Bypass at Woomargama); Cut wooden stake; Glass jars, bottles, spoon and fork recovered from refuse pit associated with a Newcastle Hotel (Pacific Highway, Adamstown Heights, Newcastle area).

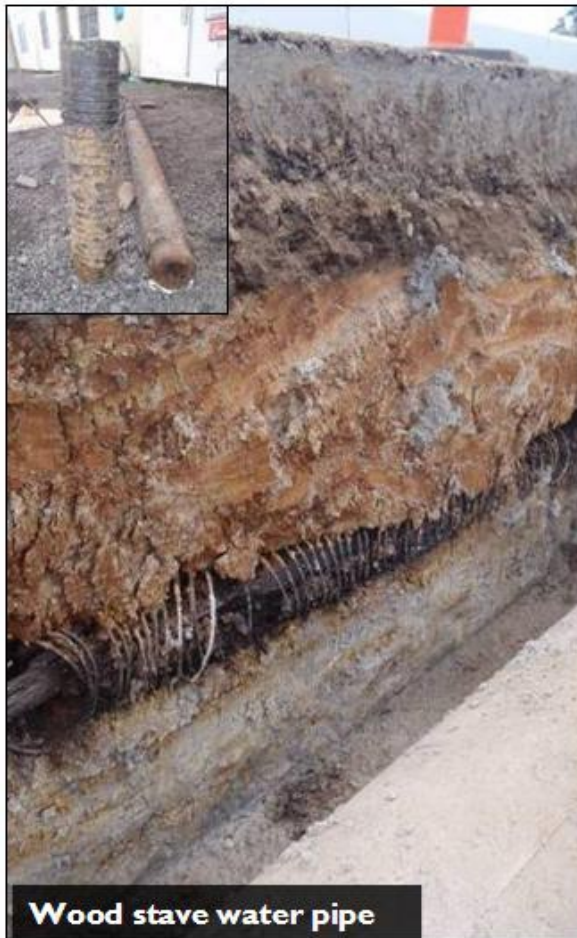
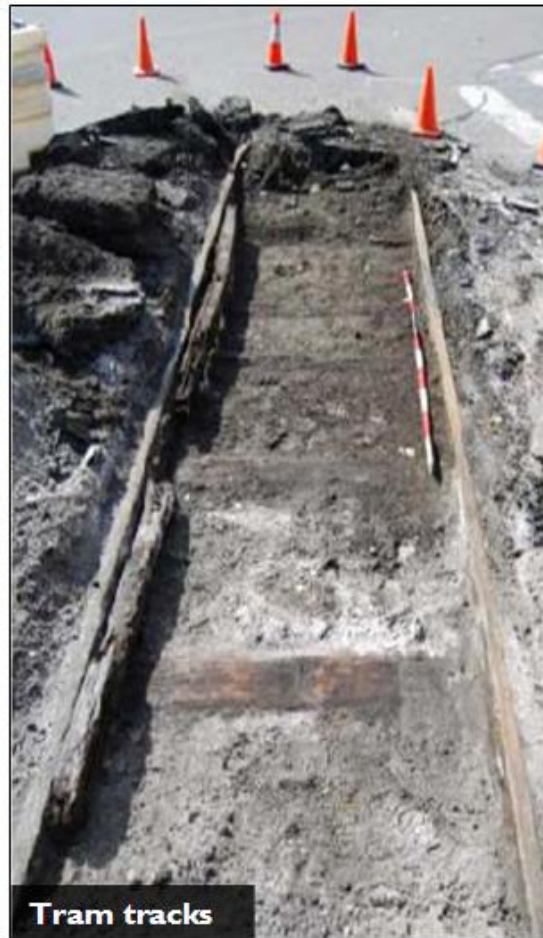
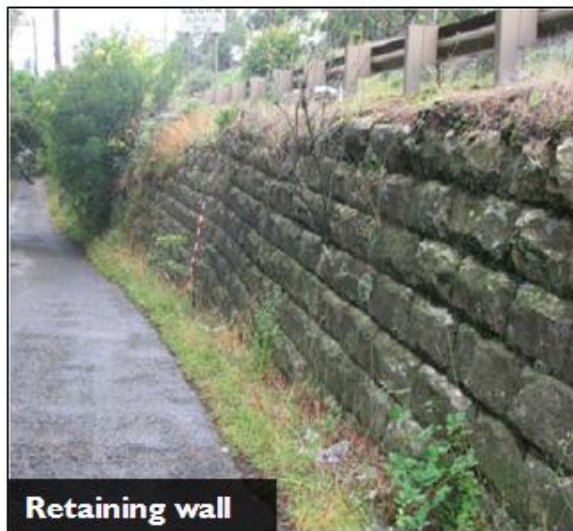
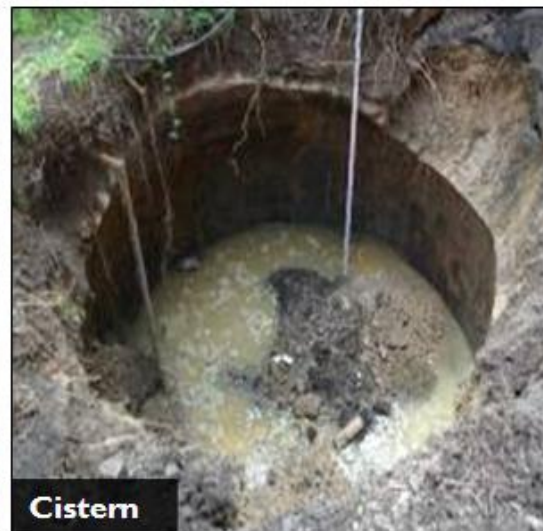
Top left hand picture continuing clockwise: Woodstave water pipe with tar and wire sealing (Horsley Drive); Tram tracks (Sydney); Brick lined cistern (Clyde); Retaining wall (Great Western Highway, Leura).

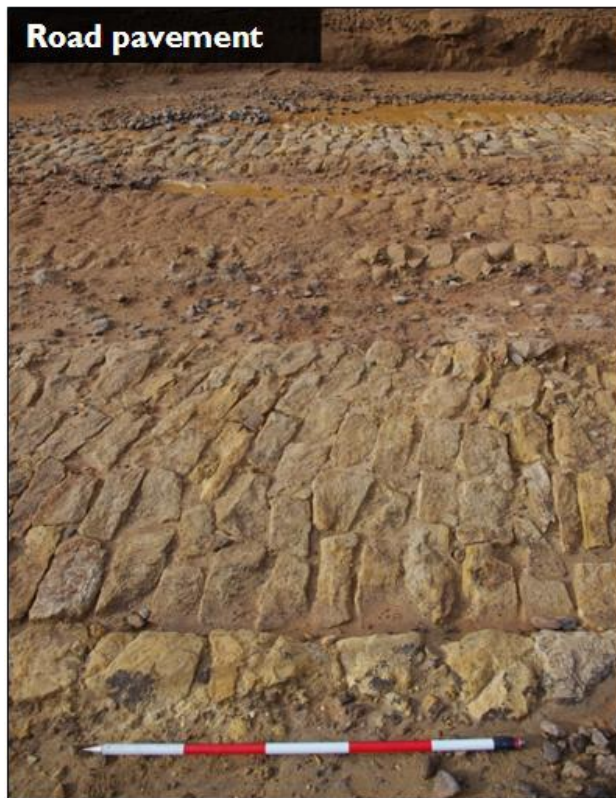
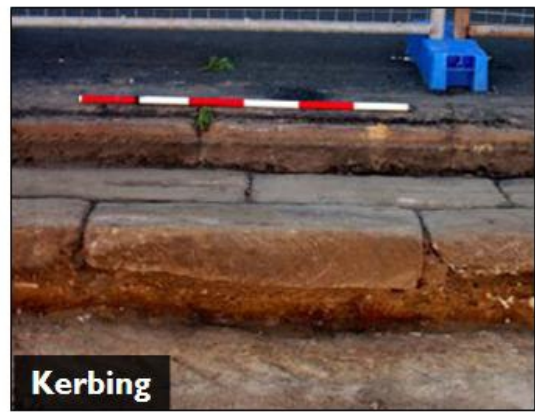
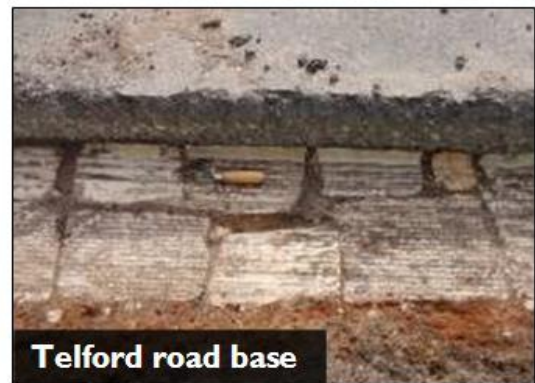
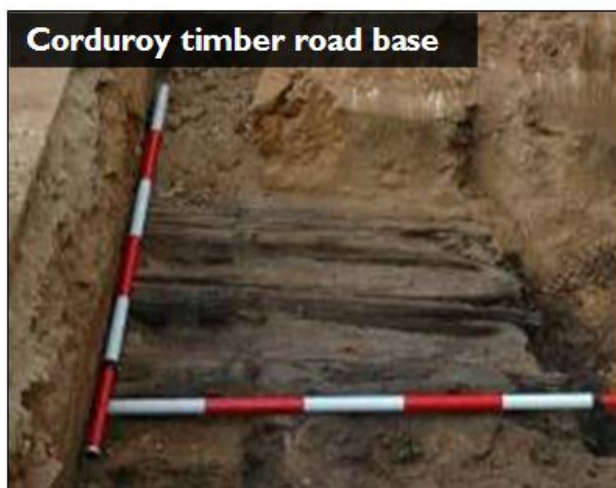
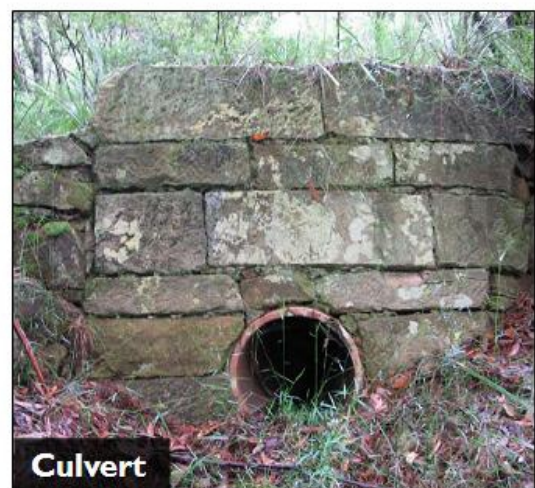
Top left hand picture continuing clockwise: Road pavement (Great Western Highway, Lawson); Sandstone kerbing and guttering (Parramatta Road, Mays Hill); Telford road (sandstone road base, Great Western Highway, Leura); Ceramic conduit and sandstone culvert headwall (Blue Mountains, NSW); Corduroy road (timber road base, Entrance Road, Wamberai).

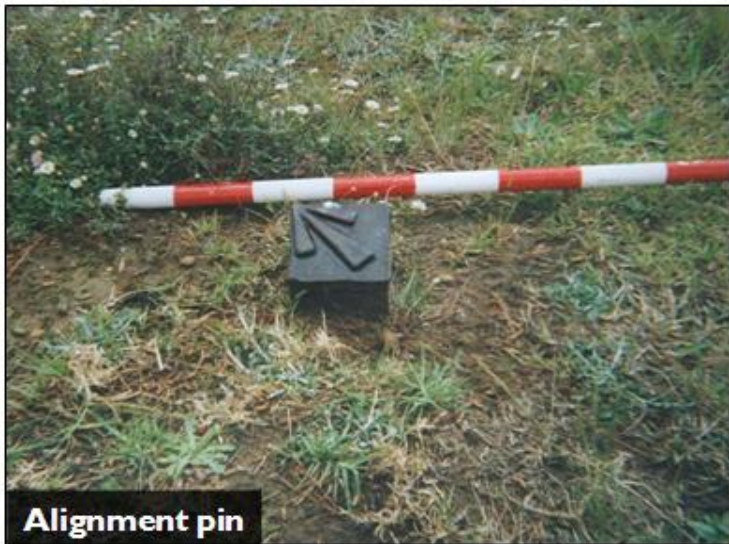
Alignment pin

Top left hand corner continuing clockwise: Alignment Pin (Great Western Highway, Wentworth Falls); Survey tree (MR7, Albury); Survey tree (Kidman Way, Darlington Point, Murrumbidgee); Survey tree (Cobb Highway, Deniliquin); Milestone (Great Western Highway, Kingswood, Penrith); Alignment Stone (near Guntawong Road, Riverstone). Please note survey marks may have additional statutory protection under the *Surveying and Spatial Information Act 2002*.

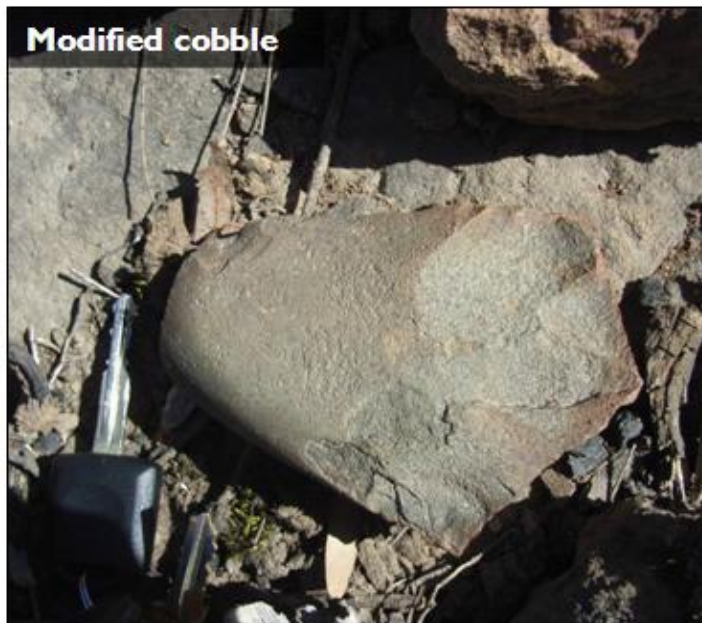
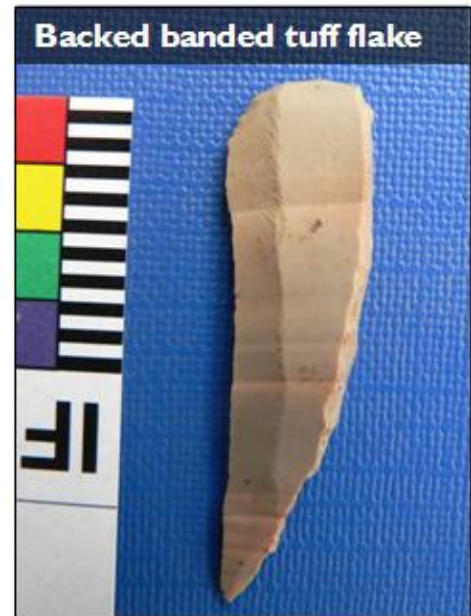
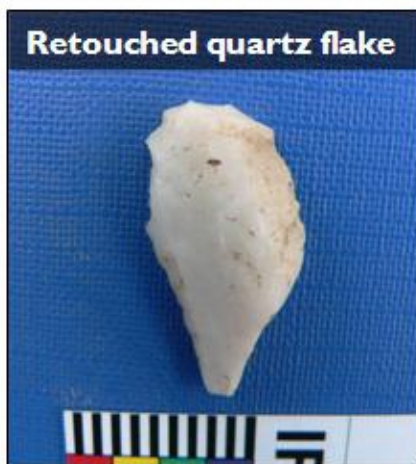
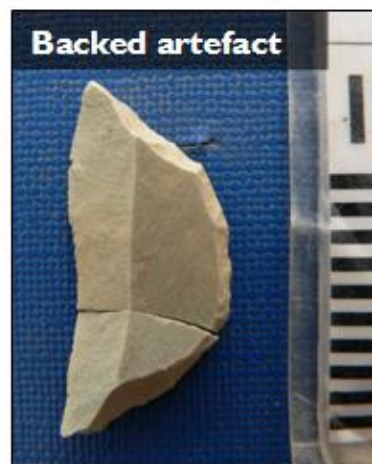
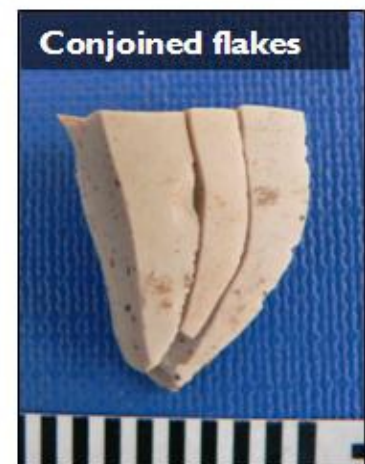
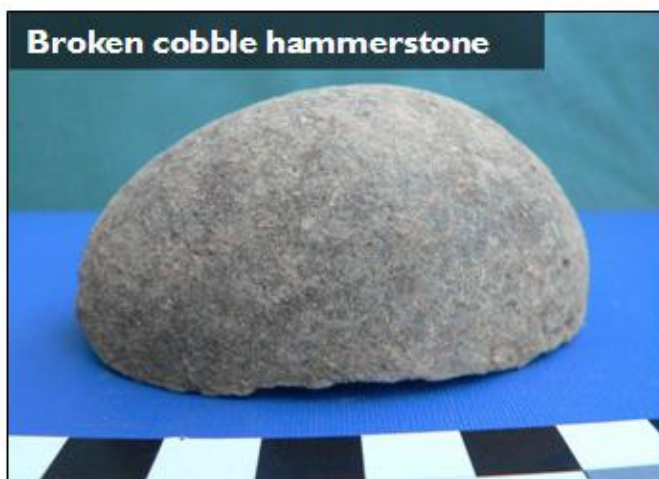
Top left hand corner: Culturally modified stone discovered on Main Road 92, about two kilometres west of Sassafras. The rest of the images show a selection of stone artefacts retrieved from test and salvage archaeological excavations during the Hume Highway Duplication and Bypass projects from 2006-2010.

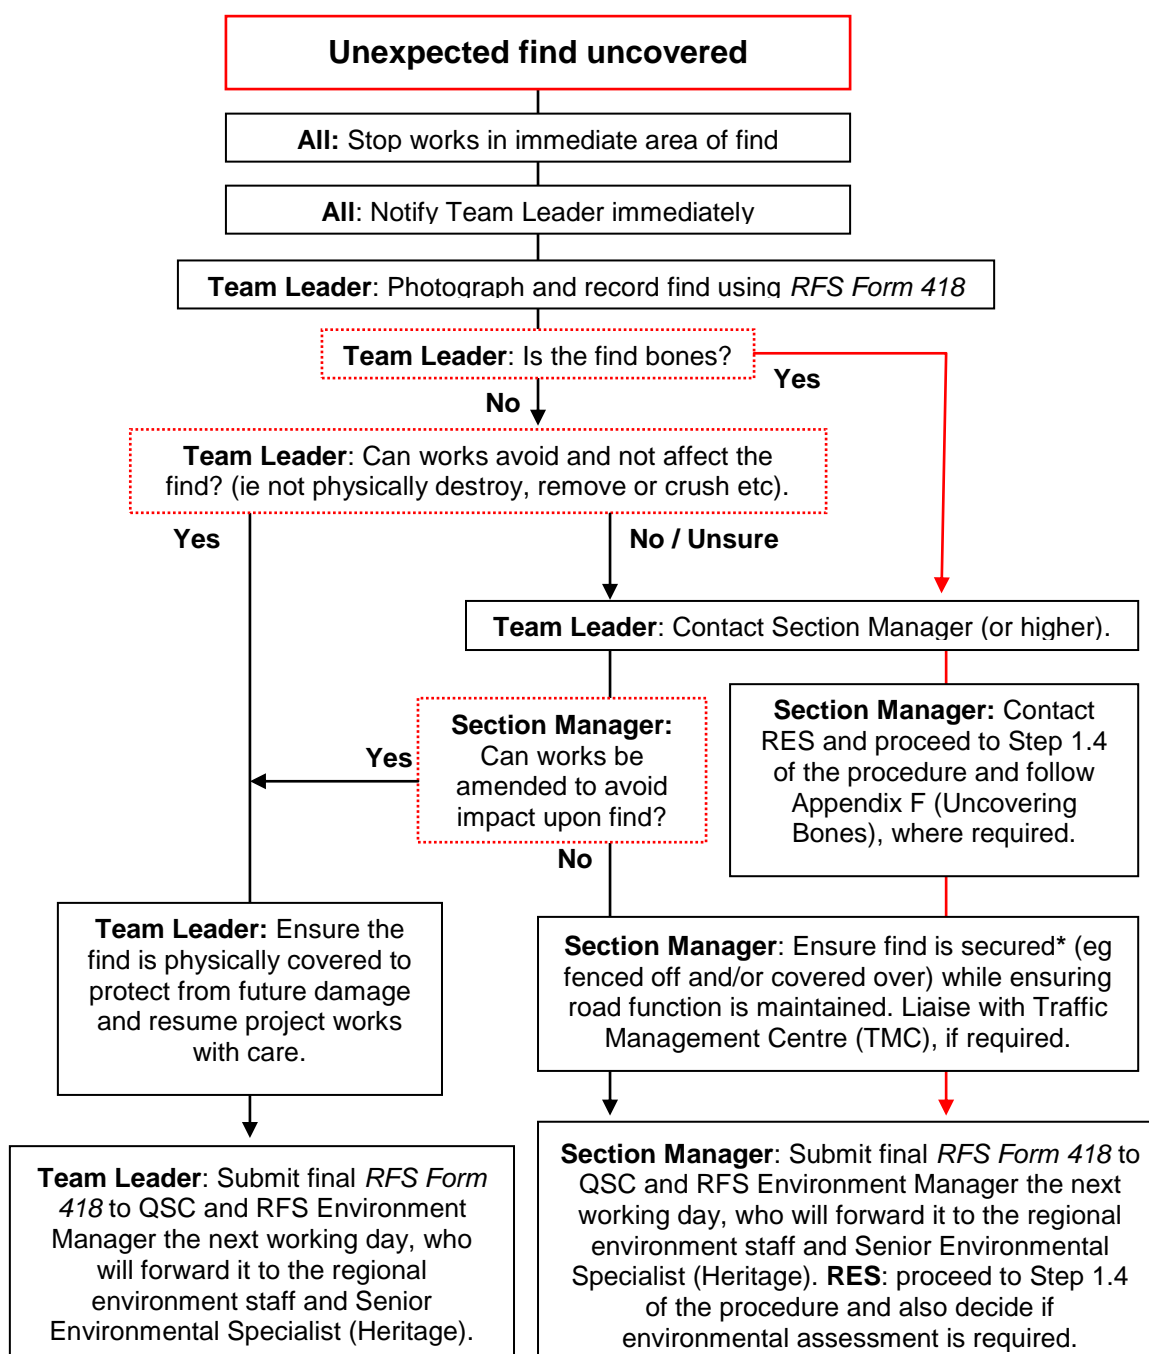
Road crews in RMS Road and Fleet Services (RFS) undertake routine maintenance works such as patching, cleaning, line marking and milling within the road reserve. In addition, these works are often undertaken at night on urban thoroughfares. A specific escalation protocol has been developed to ensure that disruption to traffic is minimised if an unexpected find is encountered when carrying out such maintenance works.

*Appropriate temporary covering of the find is something that protects it from further damage and that can be removed quickly the next day without damage from re-excavation. For example geofabric and loose, dry asphalt, or a metal plate. Certain unexpected finds (such as human remains) should not be covered with loose material as the re-excavation process is likely to

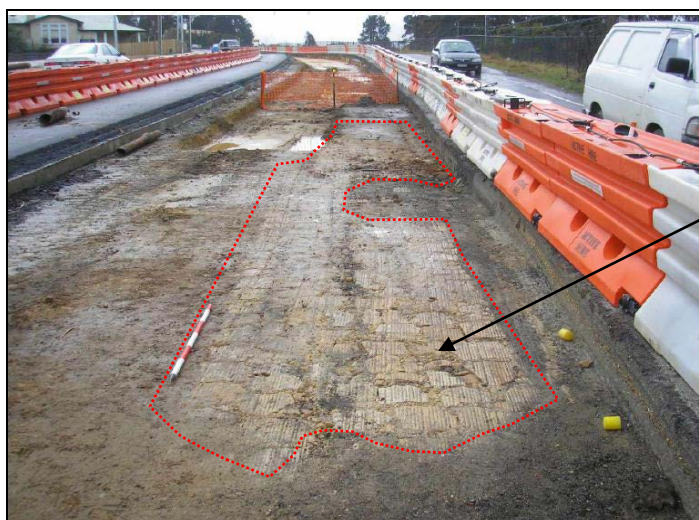
Figure 1: Telford road uncovered on the Great Western Highway (Leura) in 2008.

It is important to take a general photograph (Figure 1) to convey the location and setting of the find. This will add much value to the subsequent detailed photographs also required (Figure 2).

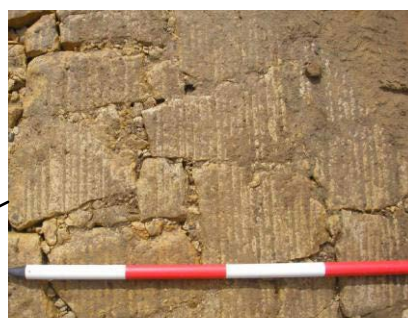
Figure 2: Close up detail of the sandstone surface showing material type, formation and construction detail. This is essential for establishing date of the feature.

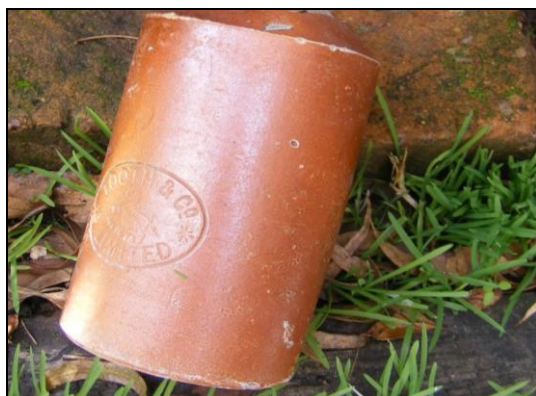
Figure 3: Ceramic bottle artefact with stamp.

Where unexpected finds (eg artefacts) have a distinguishing feature, close up detailed photographs must be taken of this, where practicable. See Figures 3 and 4 for examples.

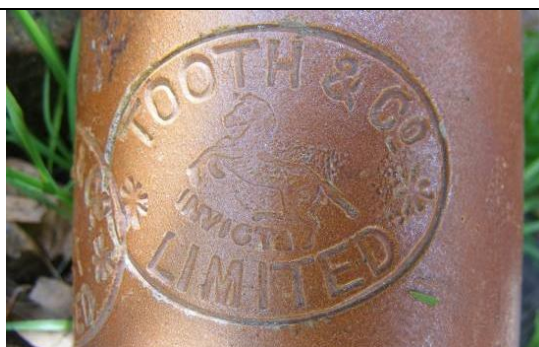
Figure 4: Detail of the stamp allows 'Tooth & Co Limited' to be made out. This is helpful to a specialist in gauging the artefact's origin, manufacturing date and likely significance.

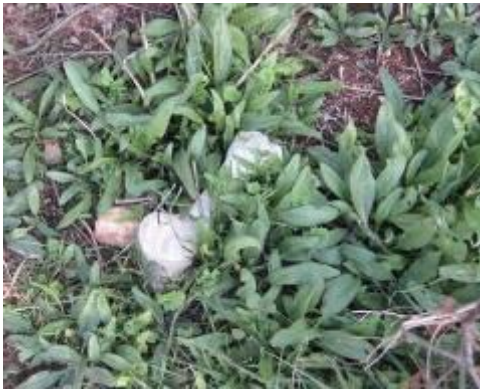
Figure 5: Bone concealed by foliage.

The majority of bones found on site will those of be recently deceased animal bones often requiring no further assessment (unless they are in archaeological context). However, if bones are human RMS must contact the police immediately (see Appendix F for detailed guidance). Taking quality photographs of the bones can often resolve this issue quickly. Heritage staff in Environment Branch can confirm if bones are human or non-human if provided with appropriate photographs. Ensure that photographs of bones are not concealed by foliage (Figure 5) as this makes it difficult to identify. Minor hand removal of foliage can be undertaken as long as disturbance of the bone does not occur. Excavation of the ground to remove bone(s) should not occur, nor should they be pulled out of the ground if partially exposed. Where sediment (adhering to a bone found on the ground surface) conceals portions of a bone (Figure 6) ensure the photograph is taken of the bone (if any) that is not concealed by sediment.

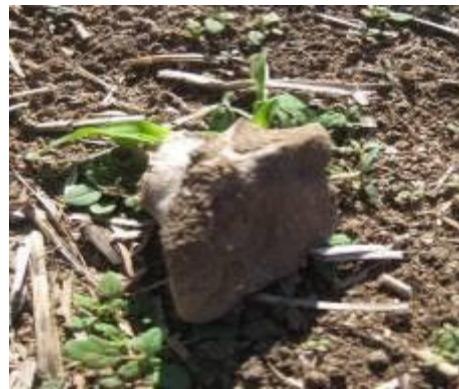
Figure 6: Bone covered in sediment

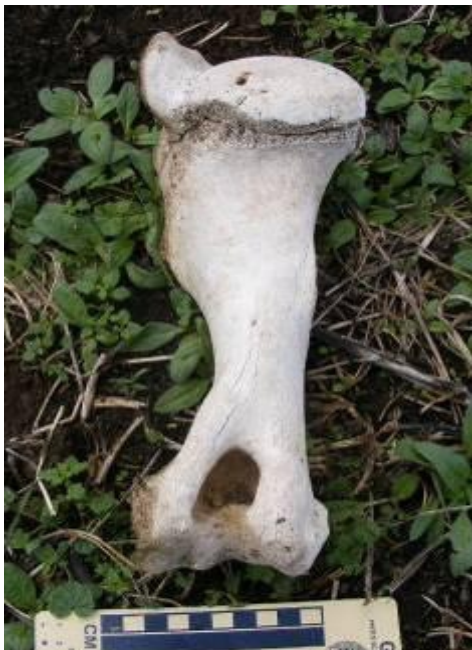
Figure 7: Photograph showing complete bone.

Ensure that all close up photographs include the whole bone and then specific details of the bone (especially the ends of long bones, the *epiphysis*, which is critical for species identification). Figures 7 and 8 are examples of good photographs of bones that can easily be identified from the photograph alone. They show sufficient detail of the complete bone and the epiphysis.

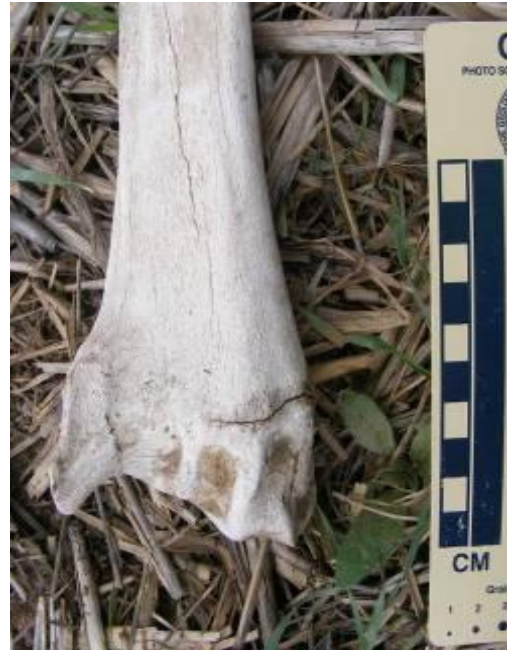
Figure 8: Close up of a long bone's epiphysis.

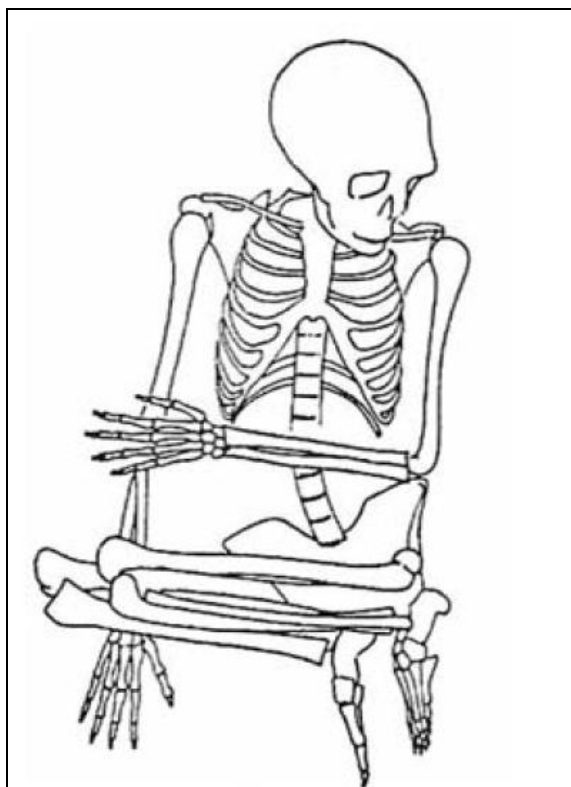
Figure 1: Schematic of a complete skeleton that is 'obviously' human¹².

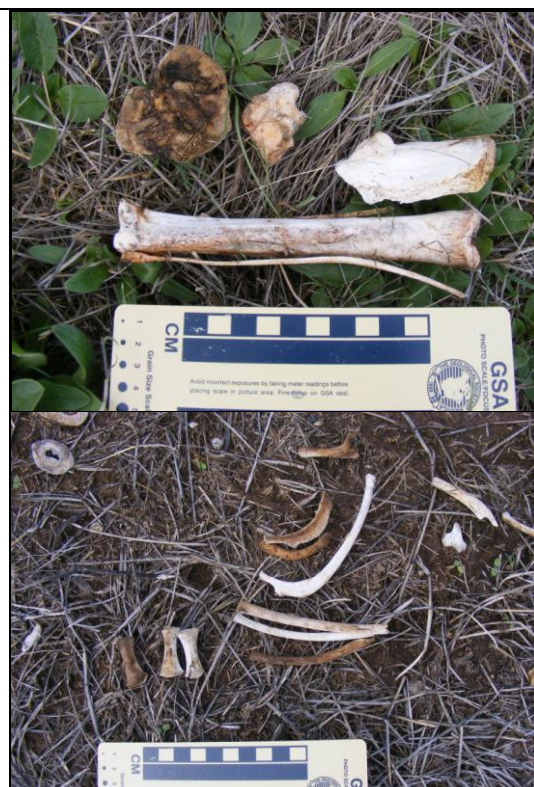
Figure 2: Disarticulated bones that require assessment to determine species.

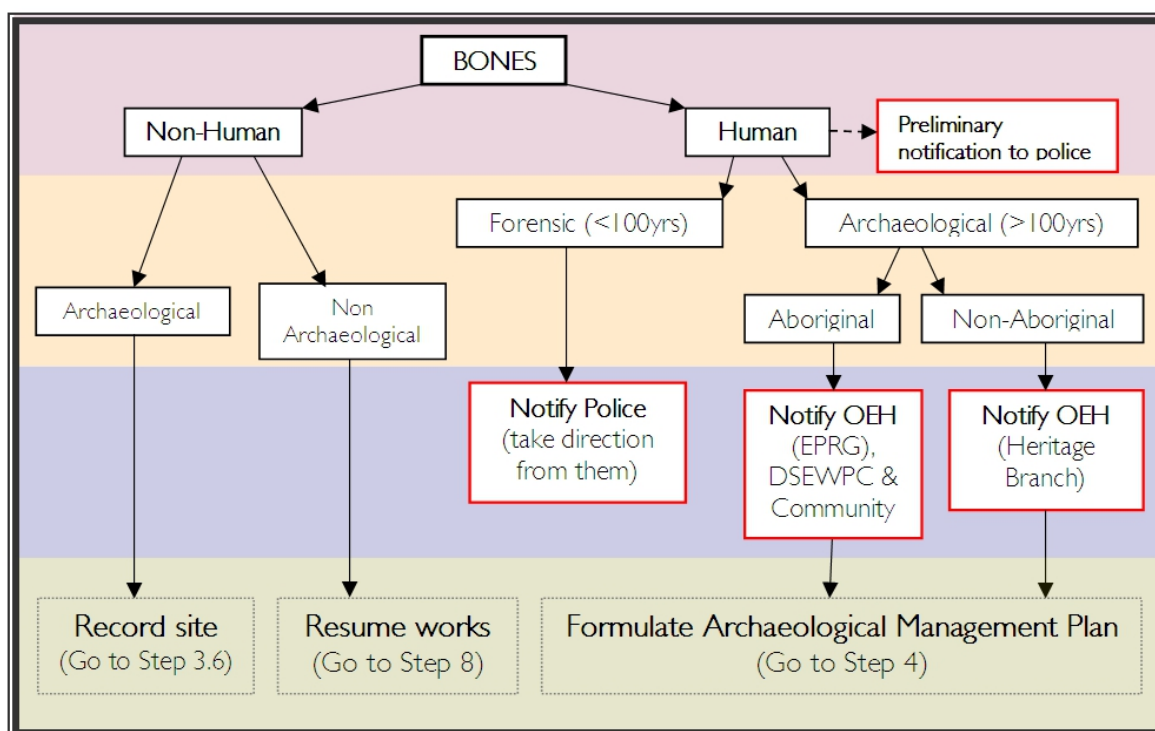
The simple diagram below summarises the notification pathways on finding bones.

After the appropriate verbal notifications (as described in B and C), the project manager must proceed through the *Unexpected Archaeological Finds Procedure* to formulate an archaeological management plan (Step 4). Note *no* archaeological management plan is required for forensic cases (A), as all future management is a police matter. Non-human skeletal remains must be treated like any other unexpected archaeological find and so must proceed to recording the find as per Step 3.6.
