# Ellerton Drive extension - Areas of more abundant Mistletoe within the study area

Geotechnical Investigation Report

28 July 2014

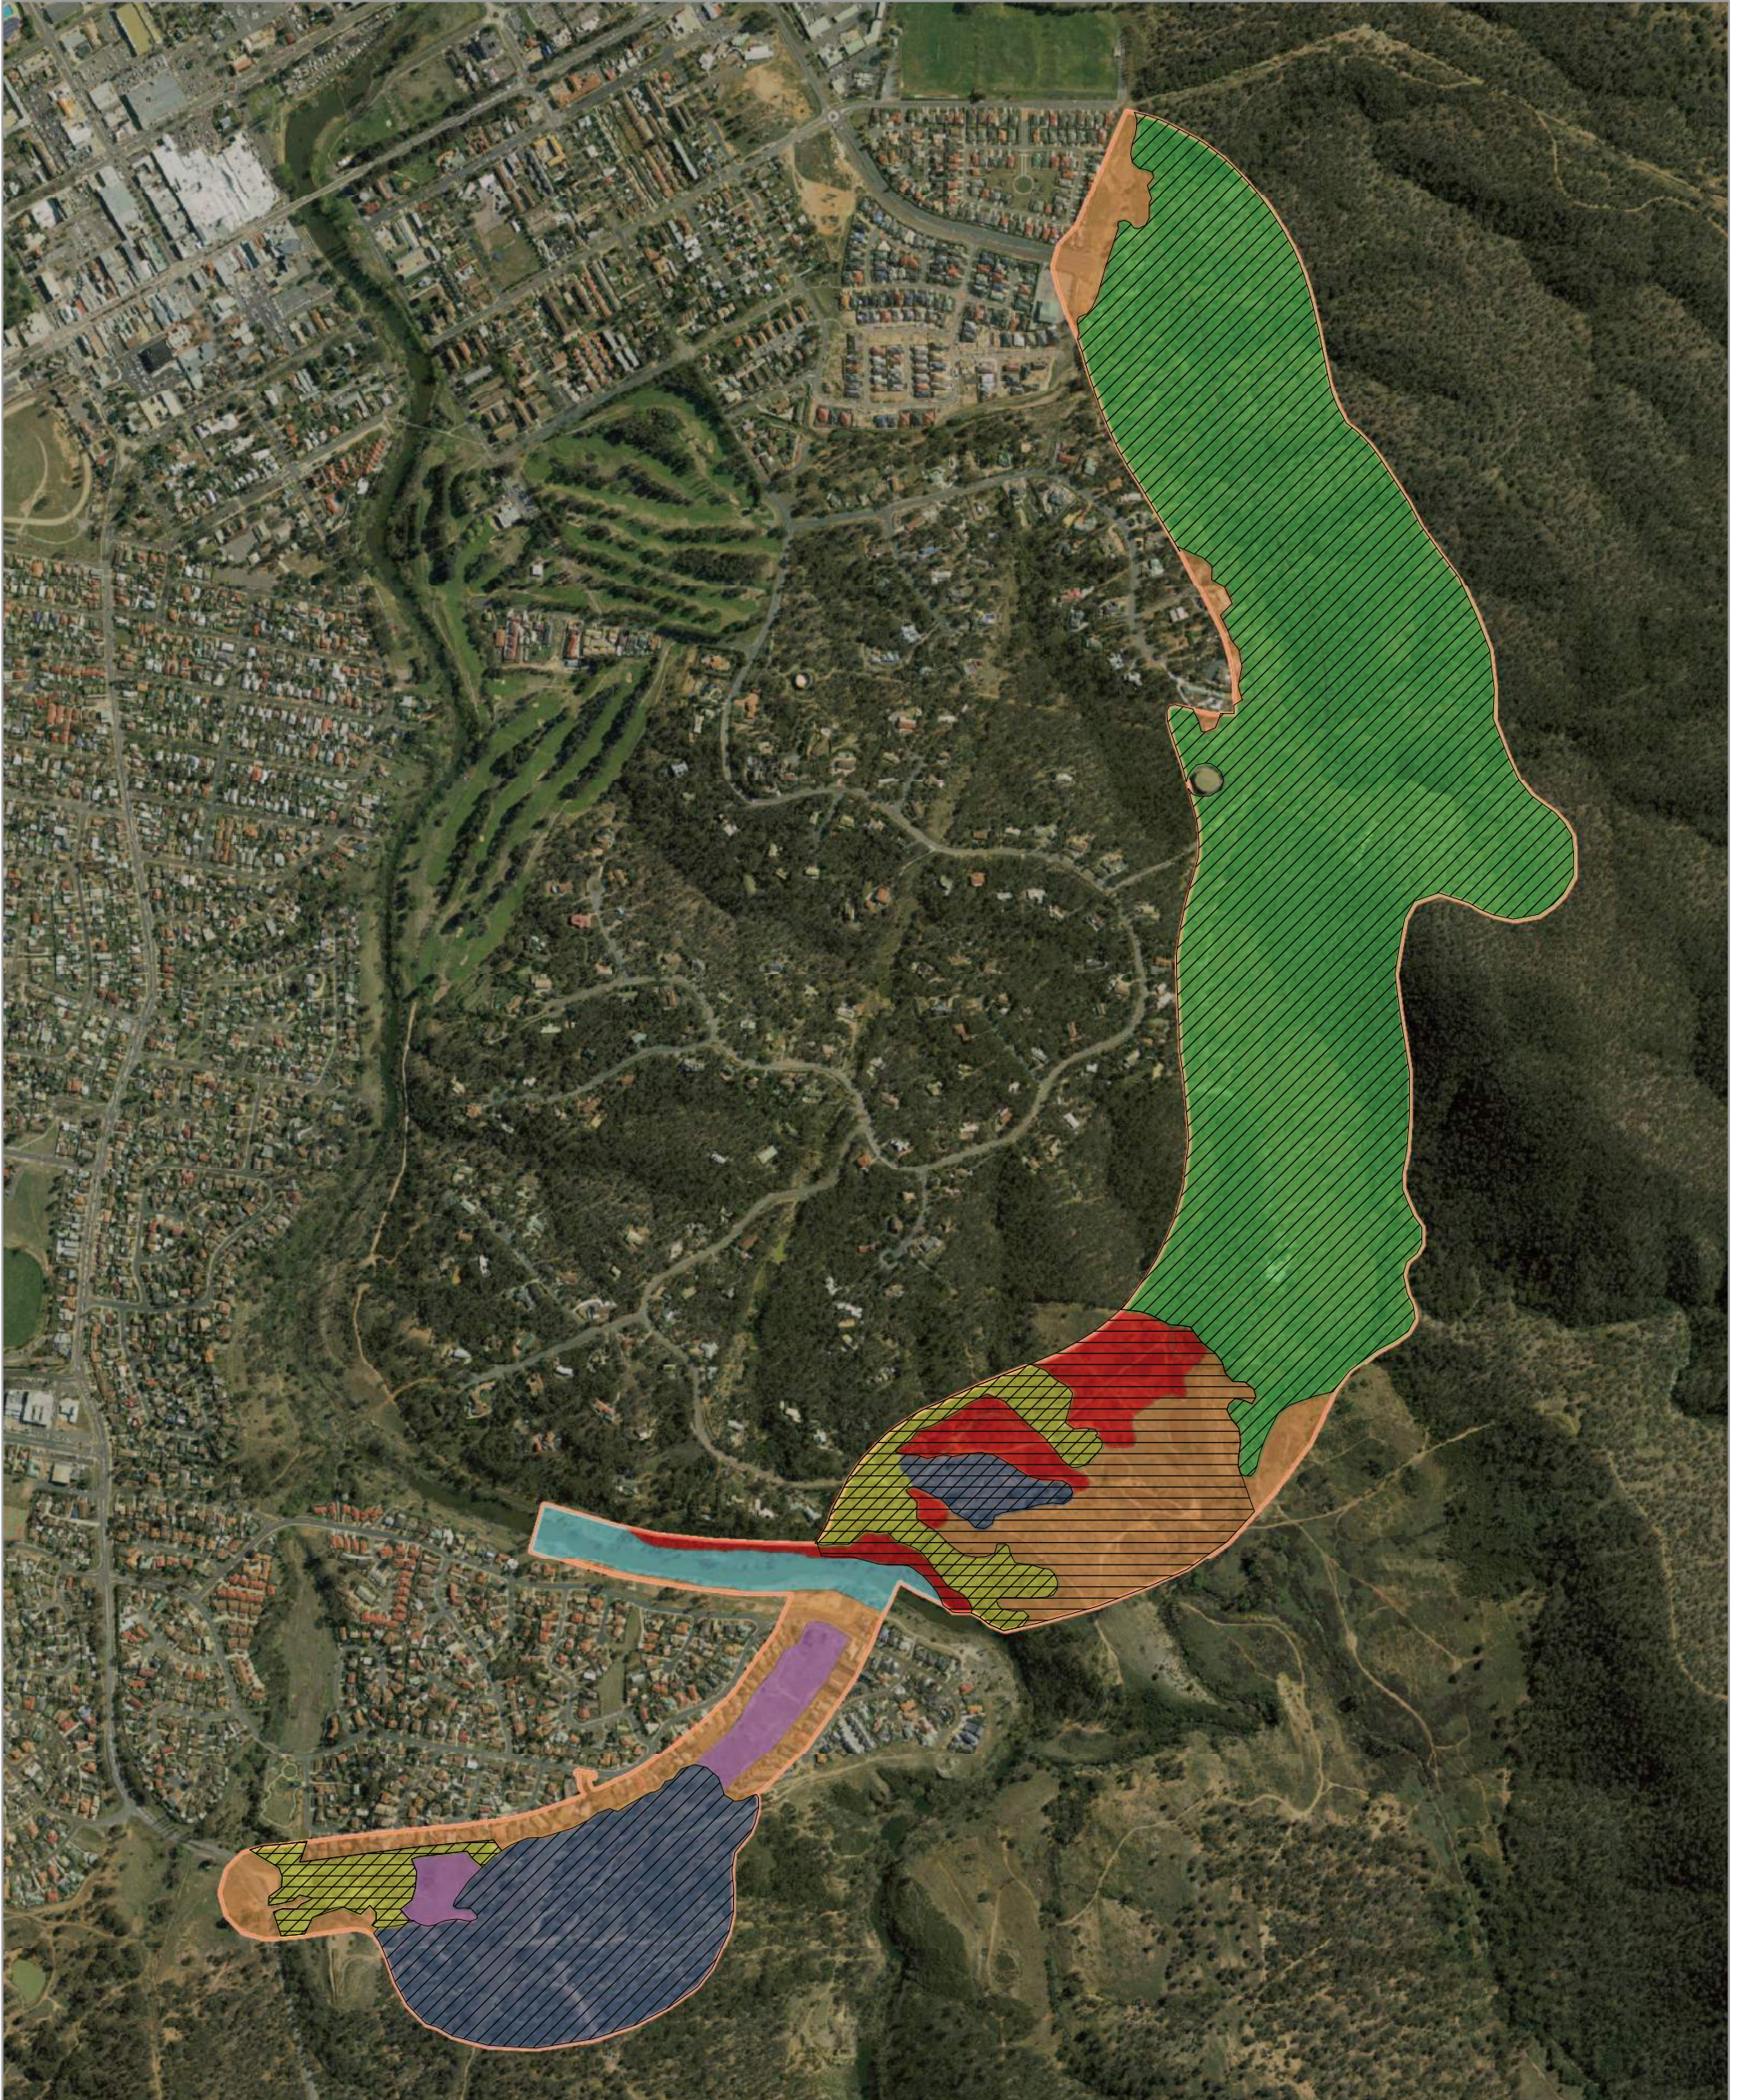
# Ellerton Drive extension - Subject species habitat - Diamond Firetail and Scarlet and Hooded Robin

| Study area | Fauna habitat type | Subject species habitat |
| | Disturbed | Diamond Firetail |
| | Dry grass forest | Scarlet and Hooded Robin |

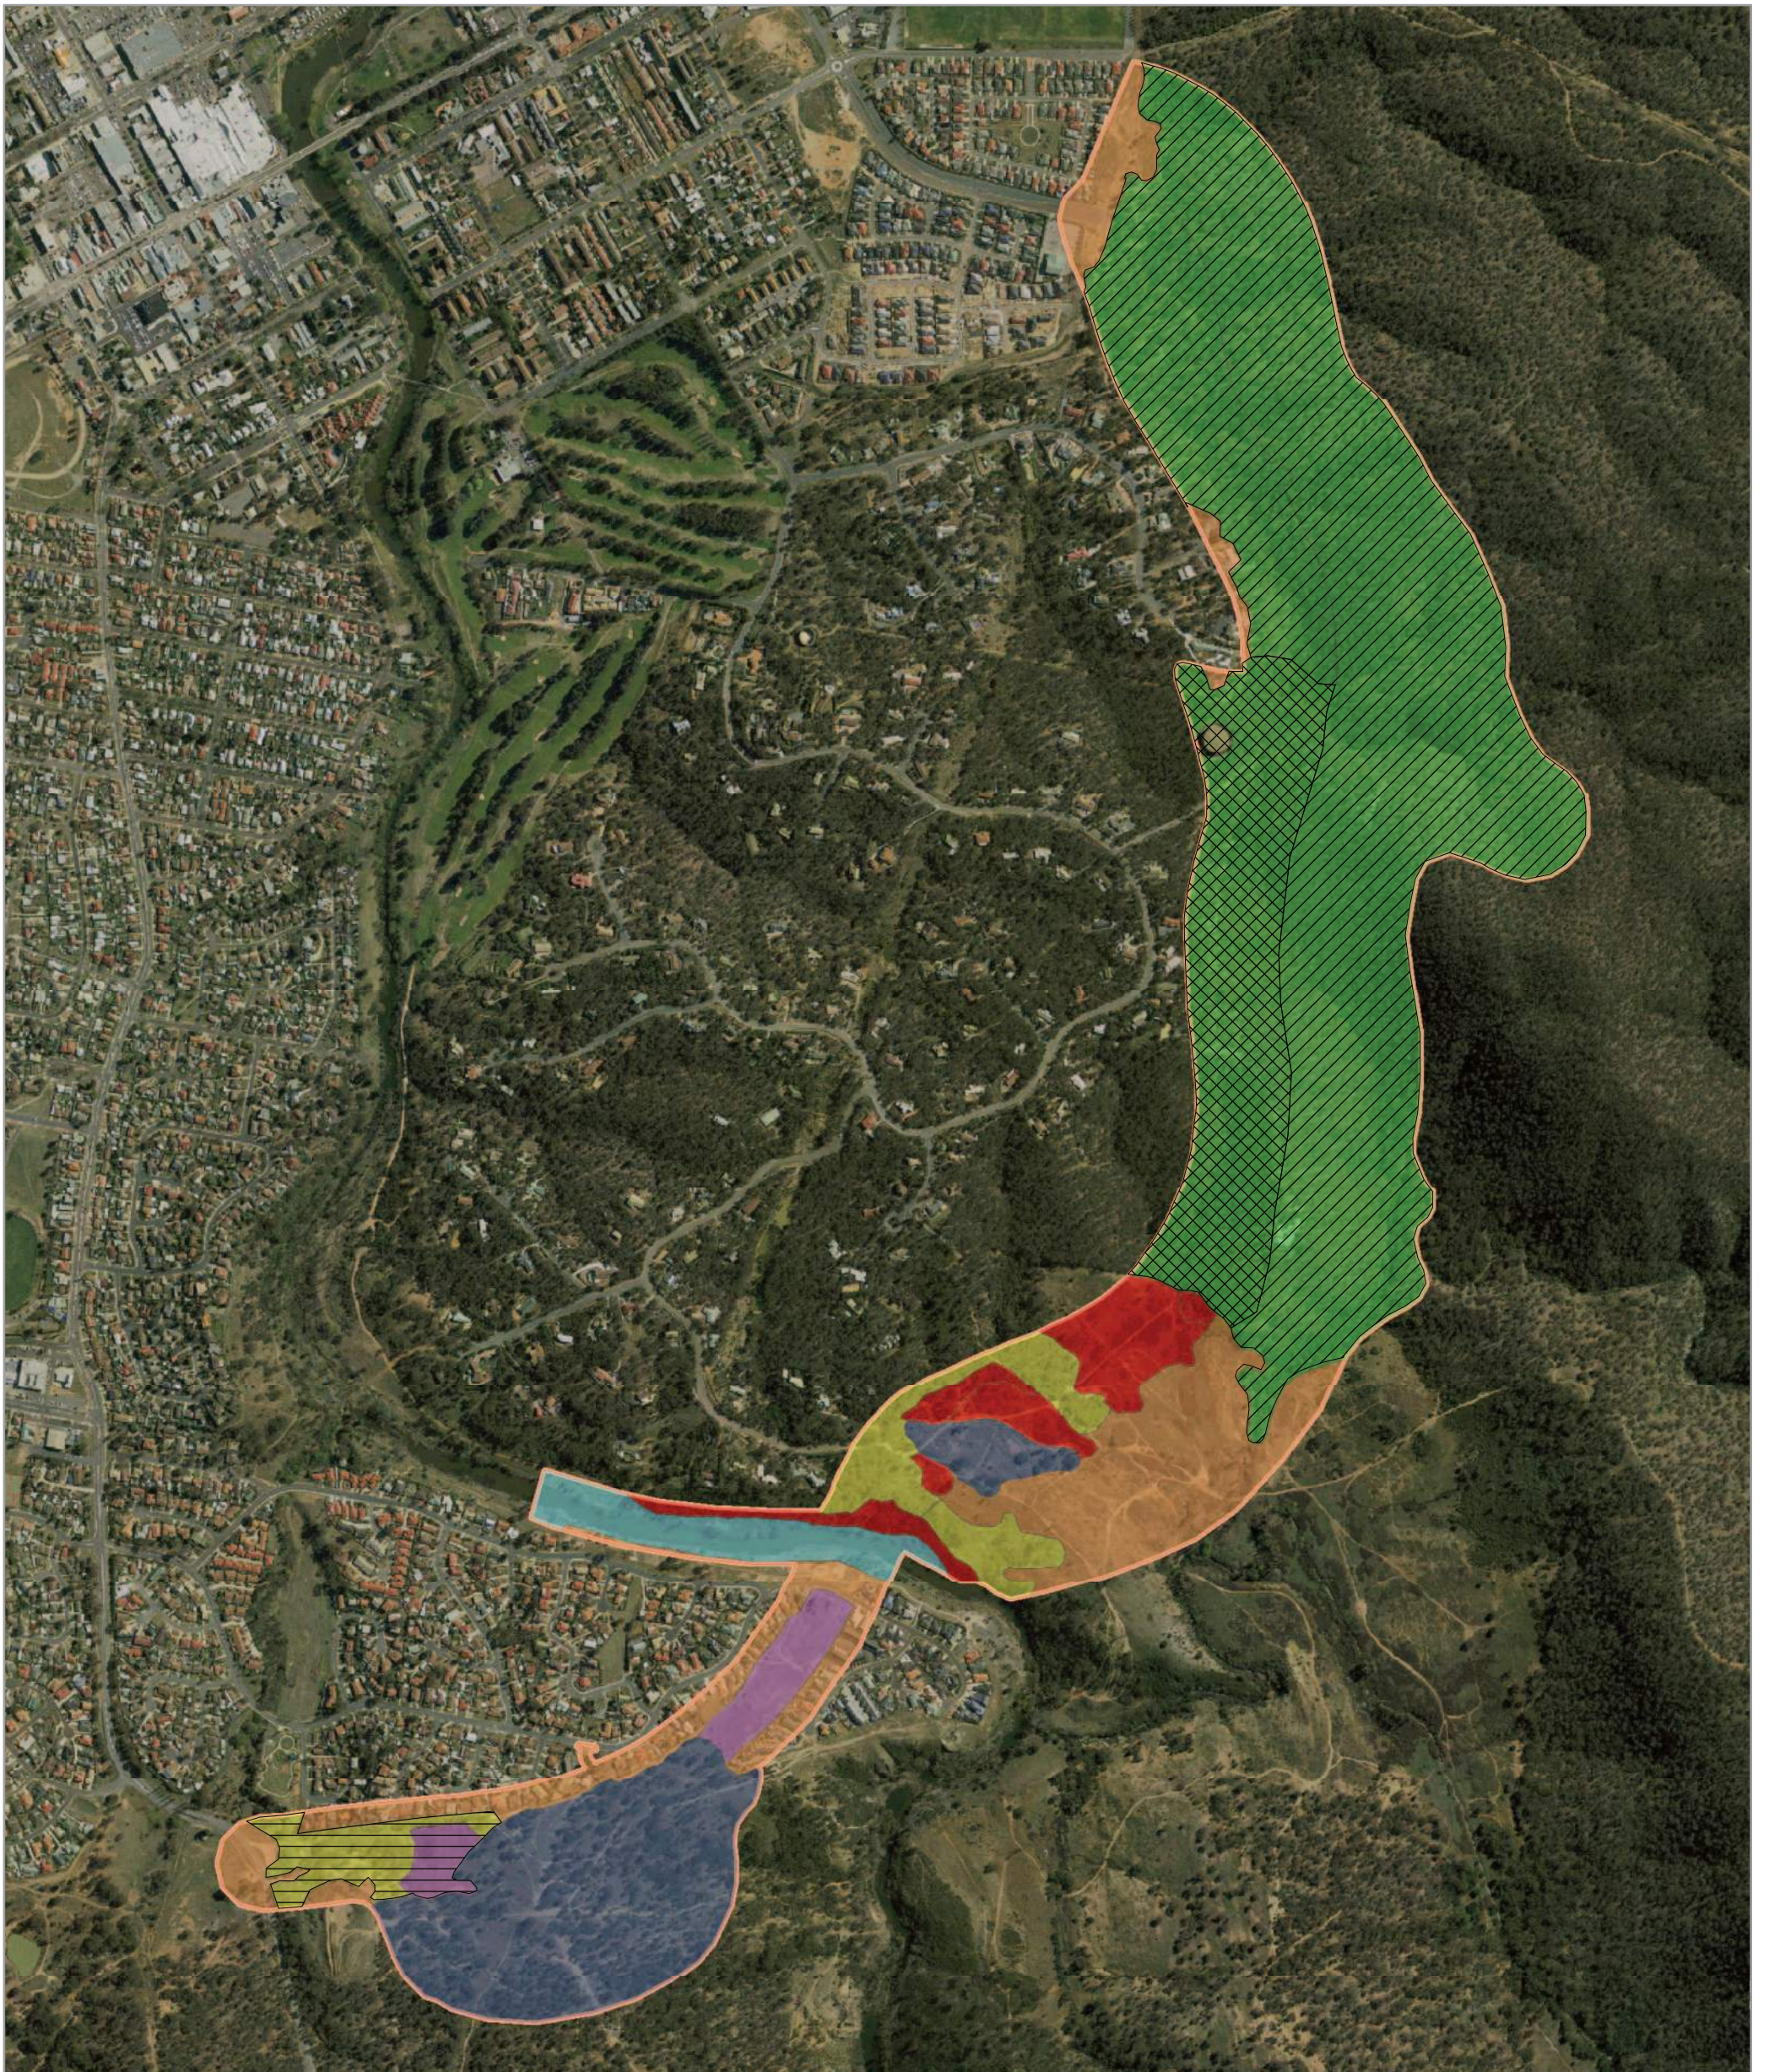
# Ellerton Drive extension - Subject species habitat - Pink-tailed Worm Lizard, Golden Sun Moth and Rosenbergs Goanna

| Study area | Fauna habitat type | Subject species habitat |
| | Disturbed | Pink-tailed Worm Lizard and Golden Sun Moth |
| | Dry grass forest | Rosenbergs Goanna |
| | Dry shrub forest | Rosenbergs Goanna (Important habitat) |

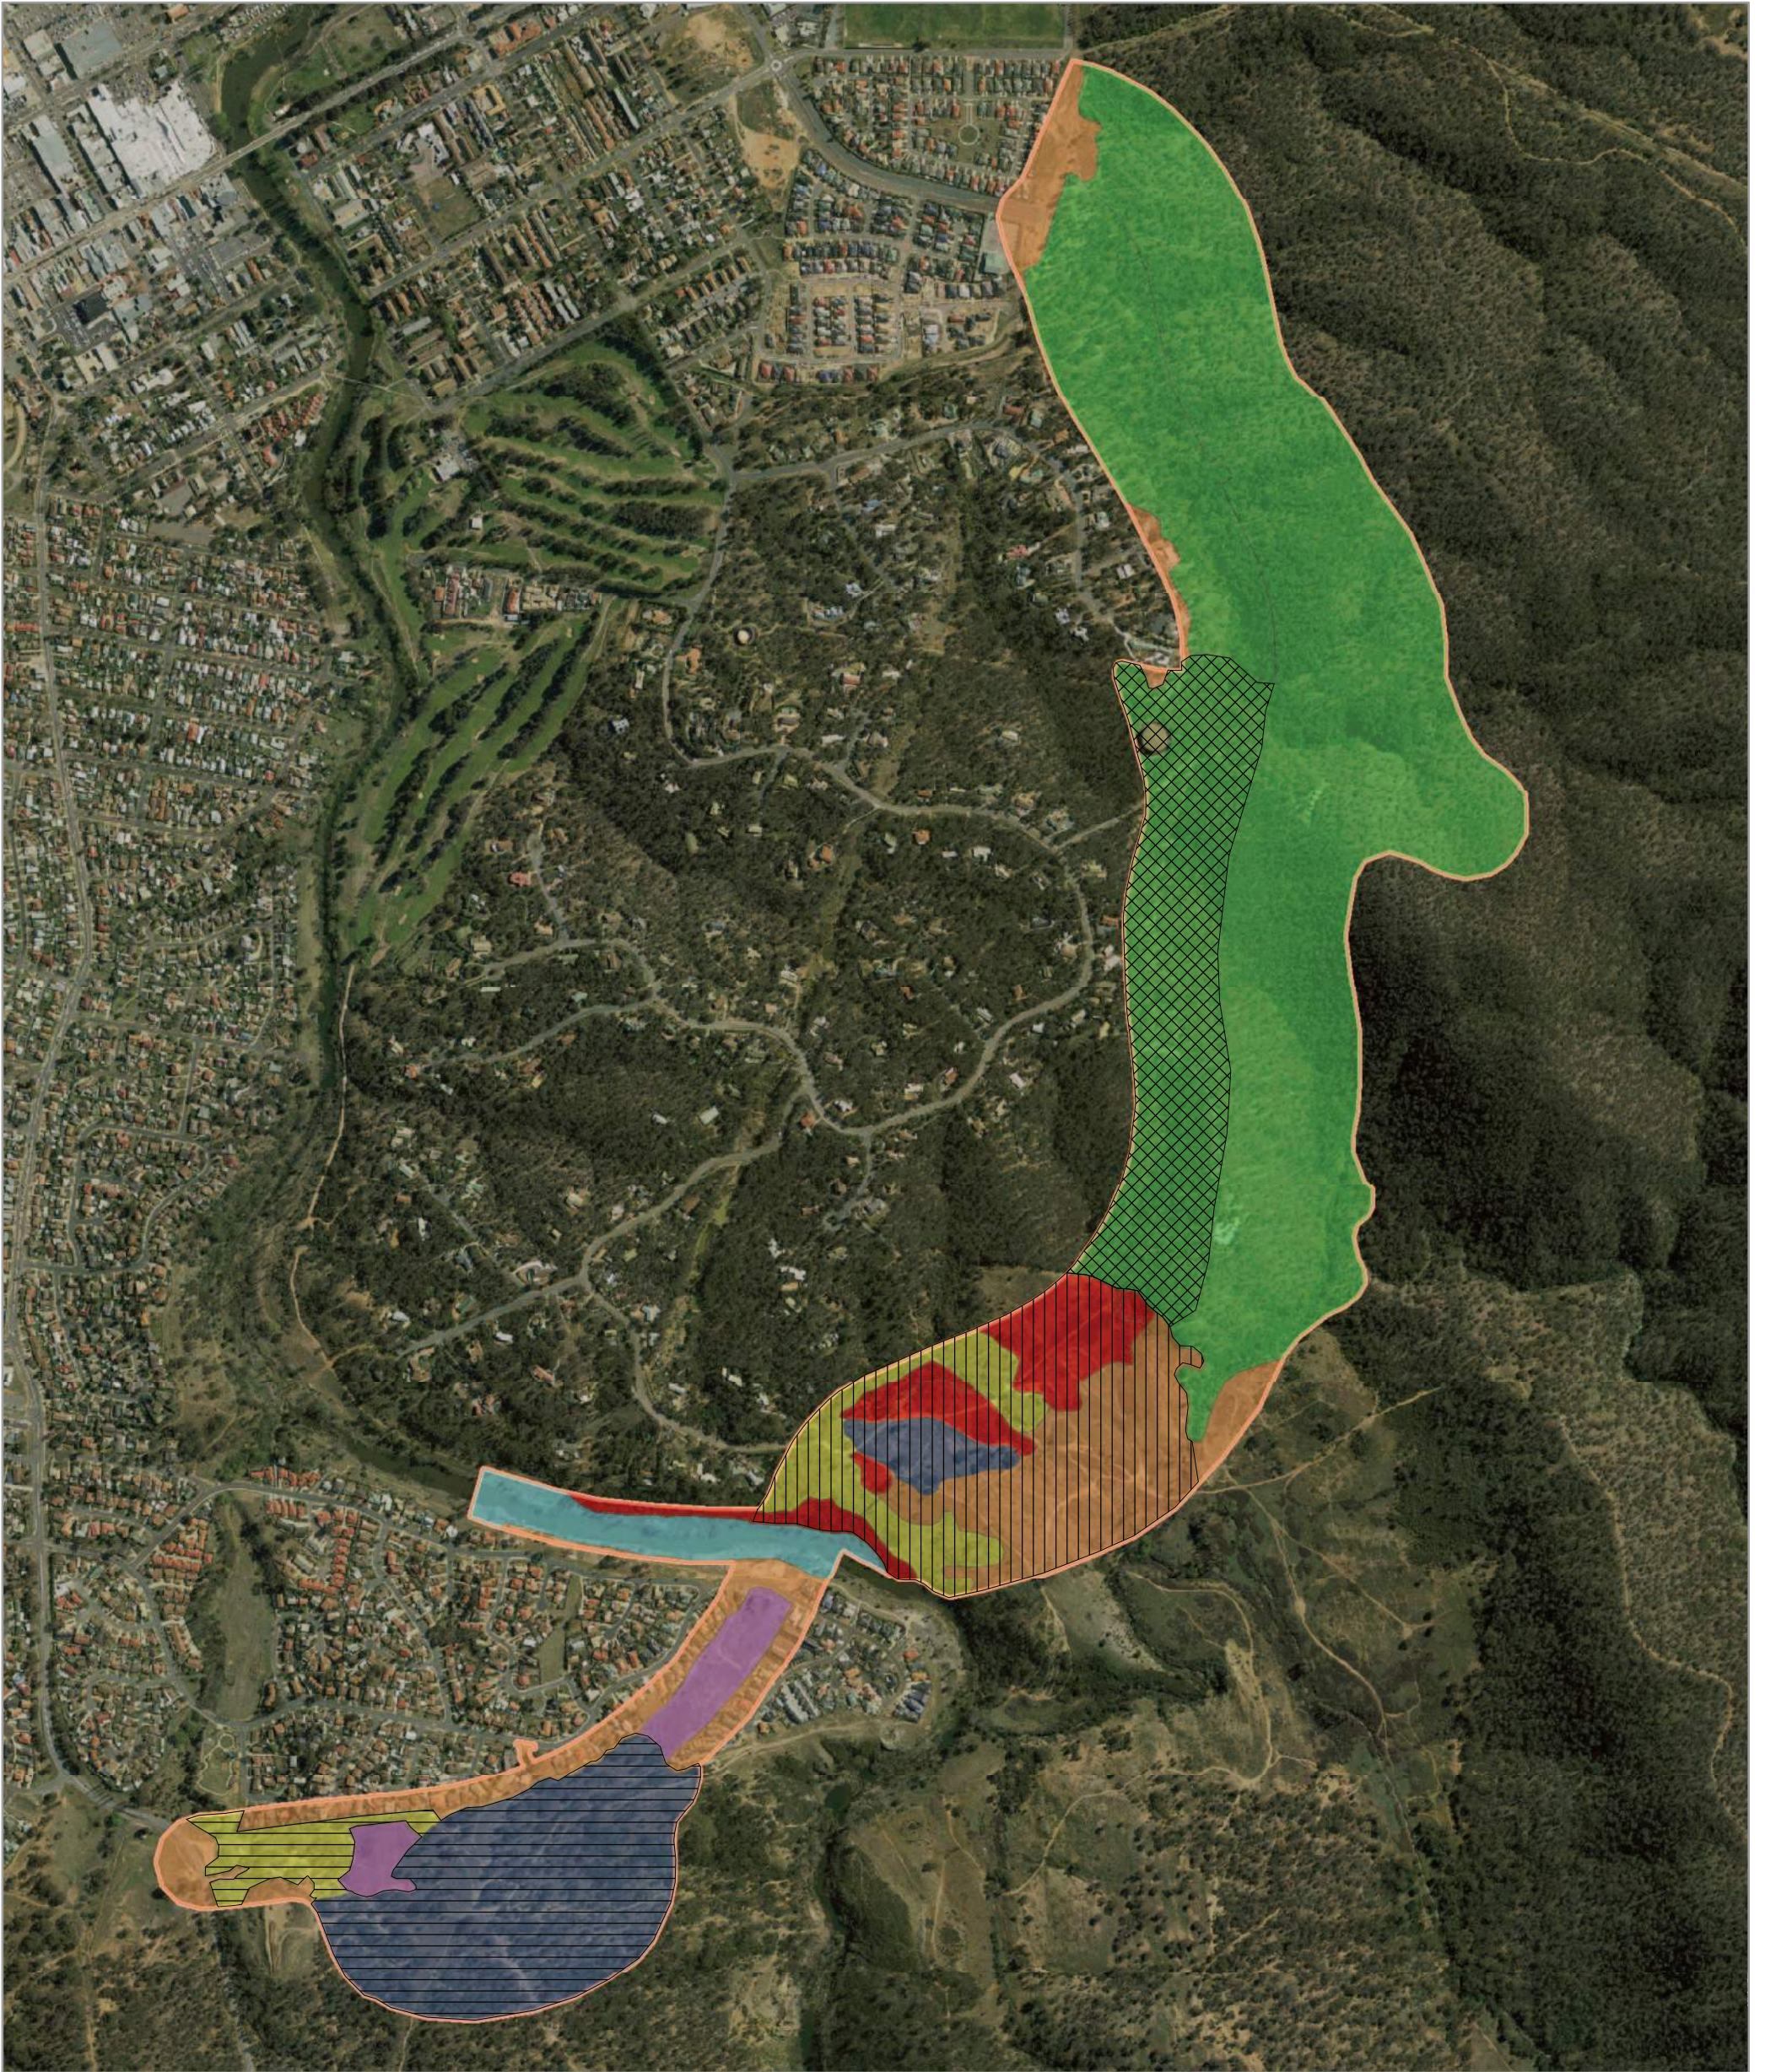
# Ellerton Drive extension - Subject species habitat - Brown Treecreeper, Gang-gang Cockatoo and Speckled Warbler

| Study area | Fauna habitat type | Subject species habitat |
| | Disturbed | Brown Treecreeper |

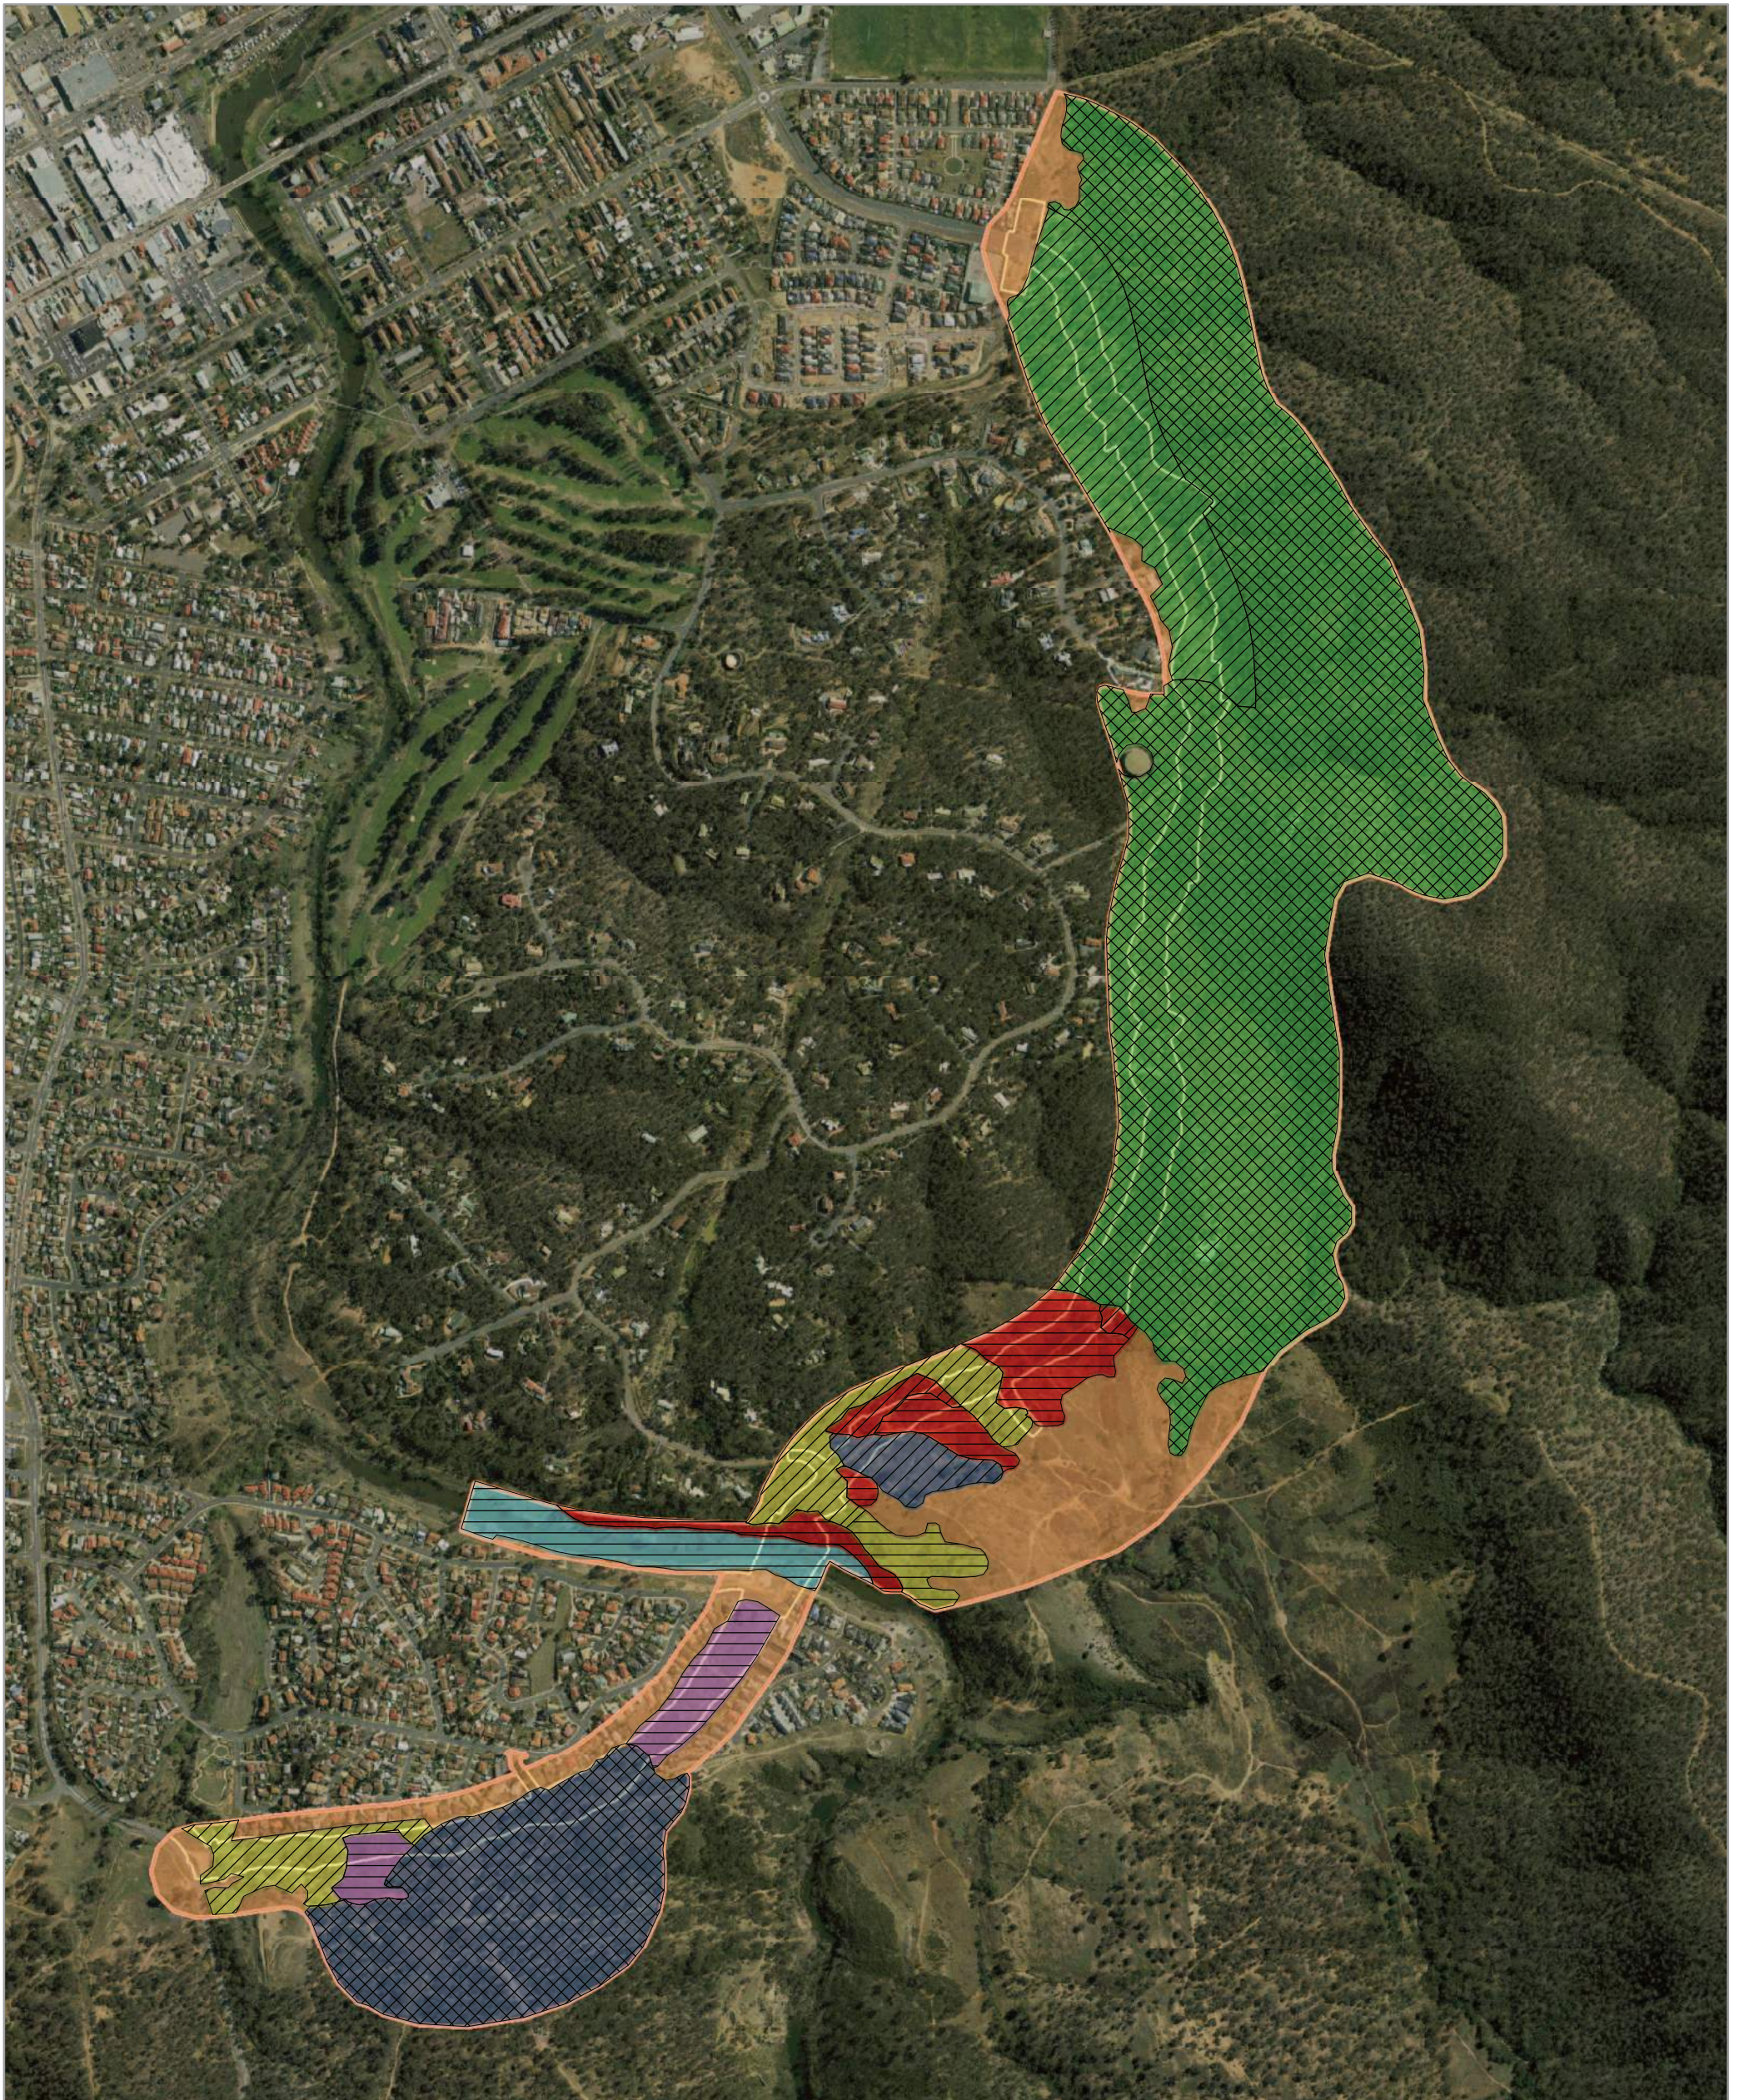
# Ellerton Drive extension - Fauna habitat types

| Study area | Fauna habitat type | Fauna habitat quality |
| | Disturbed | Good |
