| date | <b>20/06/2014</b> | | title: | <b>TEST PIT PROFILE</b> | | |

# Engineering Log - Excavation

project: **Ellerton Drive Extension**

project no. **GEOTFYSH9703AA**

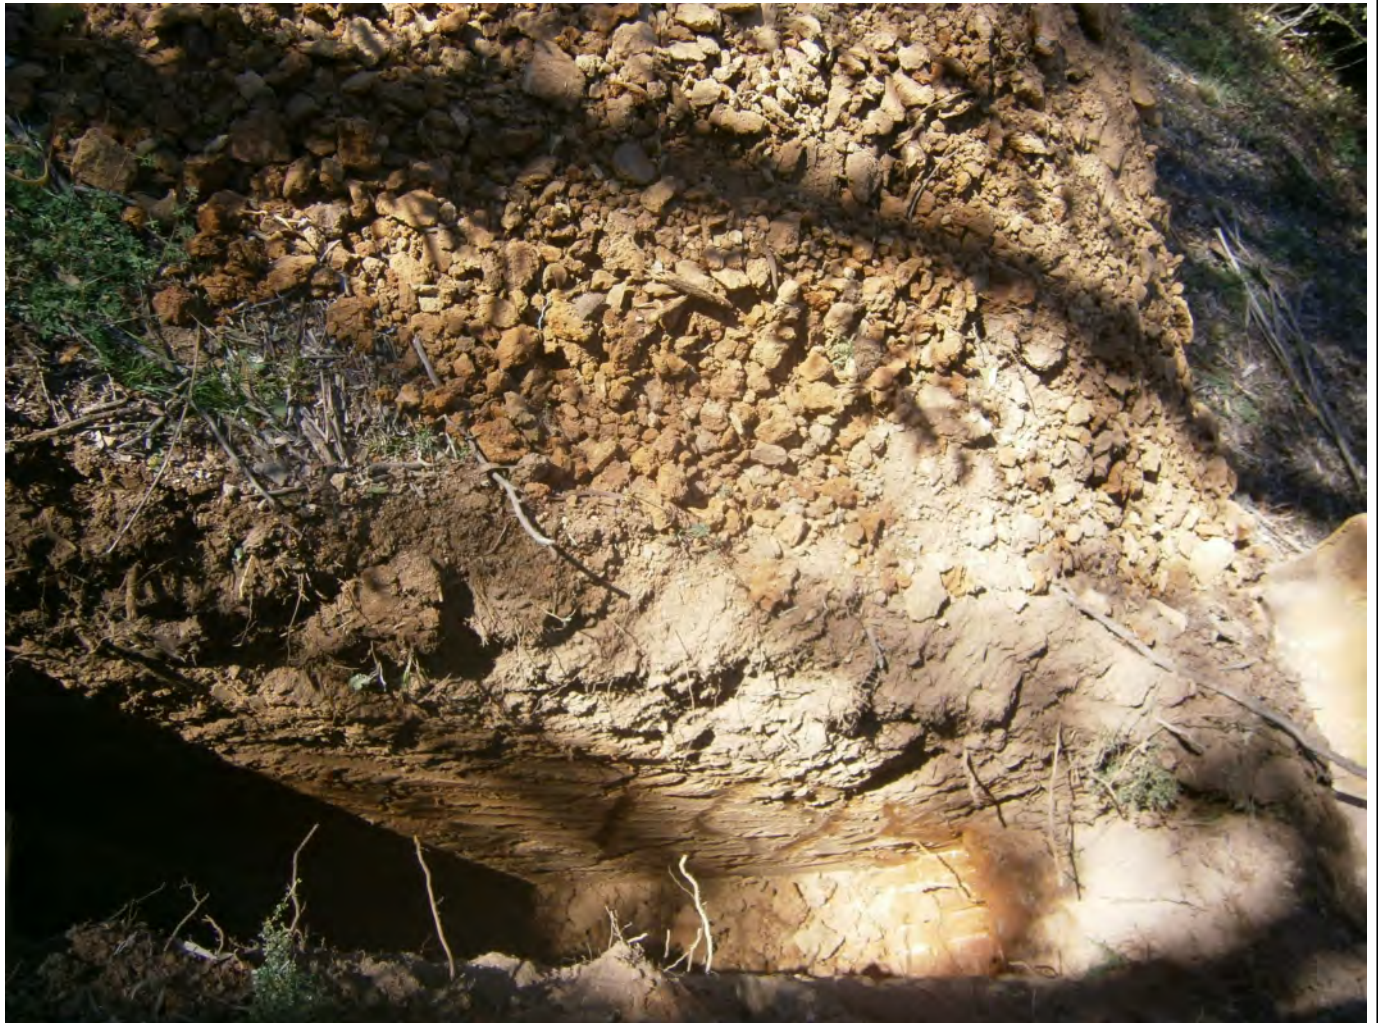
TP08

| excavation information | | | | | | | | material substance | | | | | | | | | | |
|---|---|---|---|---|---|---|---|---|---|---|---|---|---|---|---|---|--|--|
| E | N | 1 | 2 | 3 | None Observed | BX2 | -617.5 | | | CL | Sandy CLAY: low plasticity, pale brown, fine grained sand. | <Wp | F | | | COLLUVIUM | | |

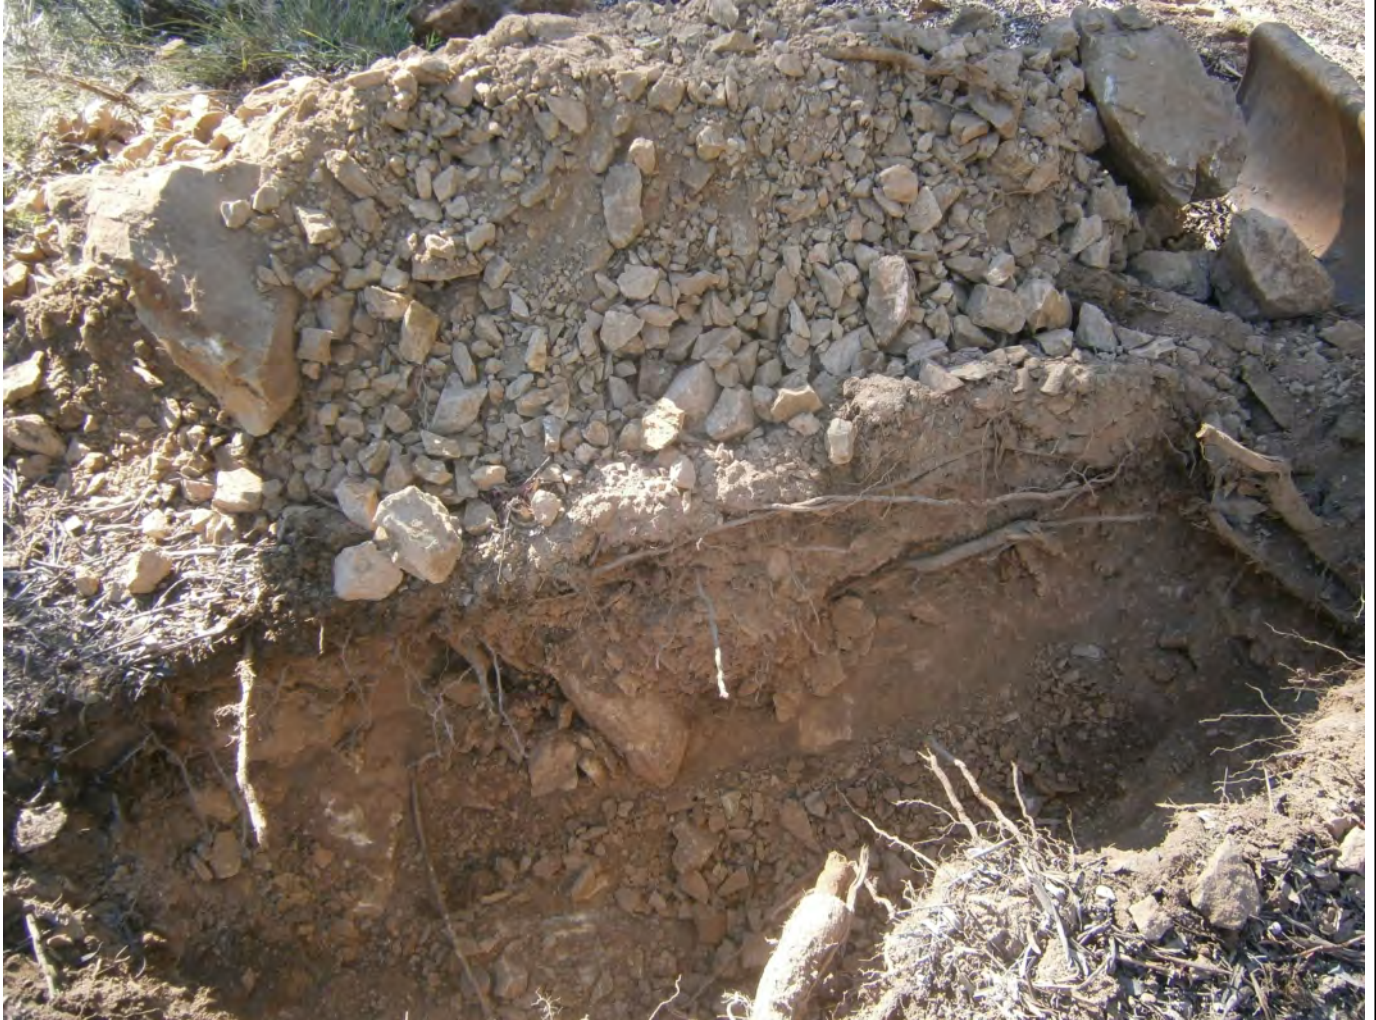
TP09

| excavation information | | | | | | | material substance | | | | | | | | | |
|---|---|---|---|---|---|---|---|---|---|---|---|---|---|---|---|---|
| ↑<br>E<br>↓ | N | 1 | 2 | 3 | None Observed | BX2 | -621.0 | 0.5 | | CL | Sandy CLAY: low plasticity, pale brown, fine grained sand, with some fine to medium grained, sub-angular gravel. | <Wp | F | 100 | 5 | COLLUVIUM |

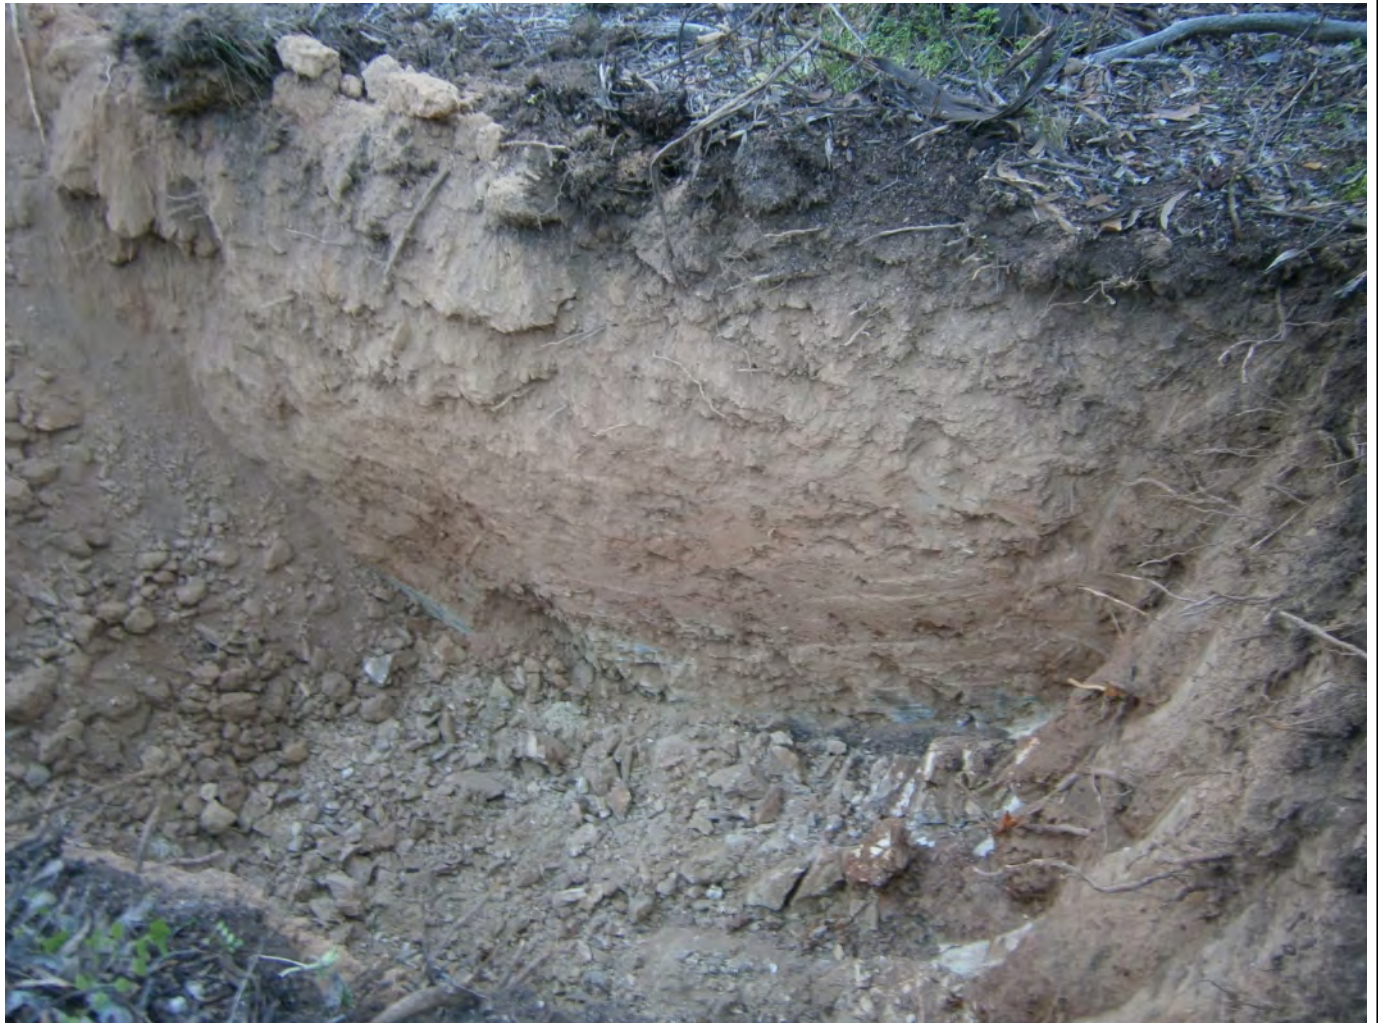
TP11

| excavation information | | | | | | material substance | | | | | | | | |
|---|---|---|---|---|---|---|---|---|---|---|---|---|---|---|
| ↑<br>N<br>↓<br>E | N | 1<br>2<br>3 | None Observed | D<br>D | -621.0 | 0.5 | | CL | Sandy CLAY: low plasticity, pale brown, fine grained sand.<br><br>Becoming orang-brown, with some fine to medium grained, angular gravel | <Wp | St to VSt<br><br>H to Fb | 100<br>200<br>300<br>400 | | COLLUVIUM |

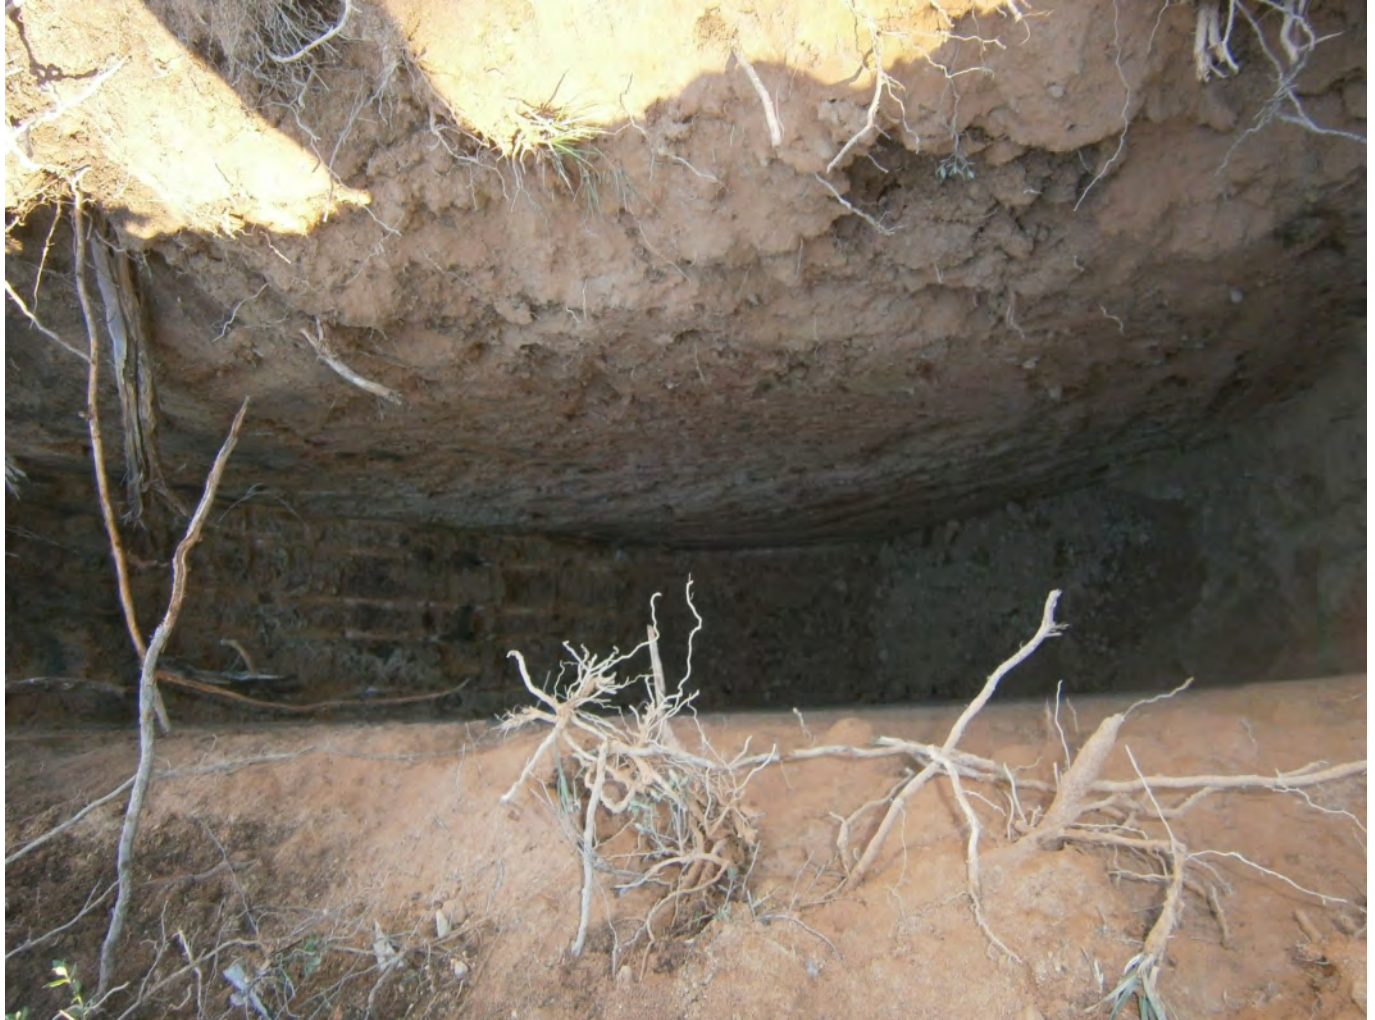
TP12

| excavation information | | | | material substance | | | | | | | | | | |
|---|---|---|---|---|---|---|---|---|---|---|---|---|---|---|
| ↑<br>N<br>↓<br>E | 1<br>2<br>3 | None Observed | | BX2 | -623.0 | 0.5 | | CL | TOPSOIL: <b>Sandy SILT</b> : low liquid limit, dark brown, fine grained sand. | <Wp | | | | TOPSOIL |

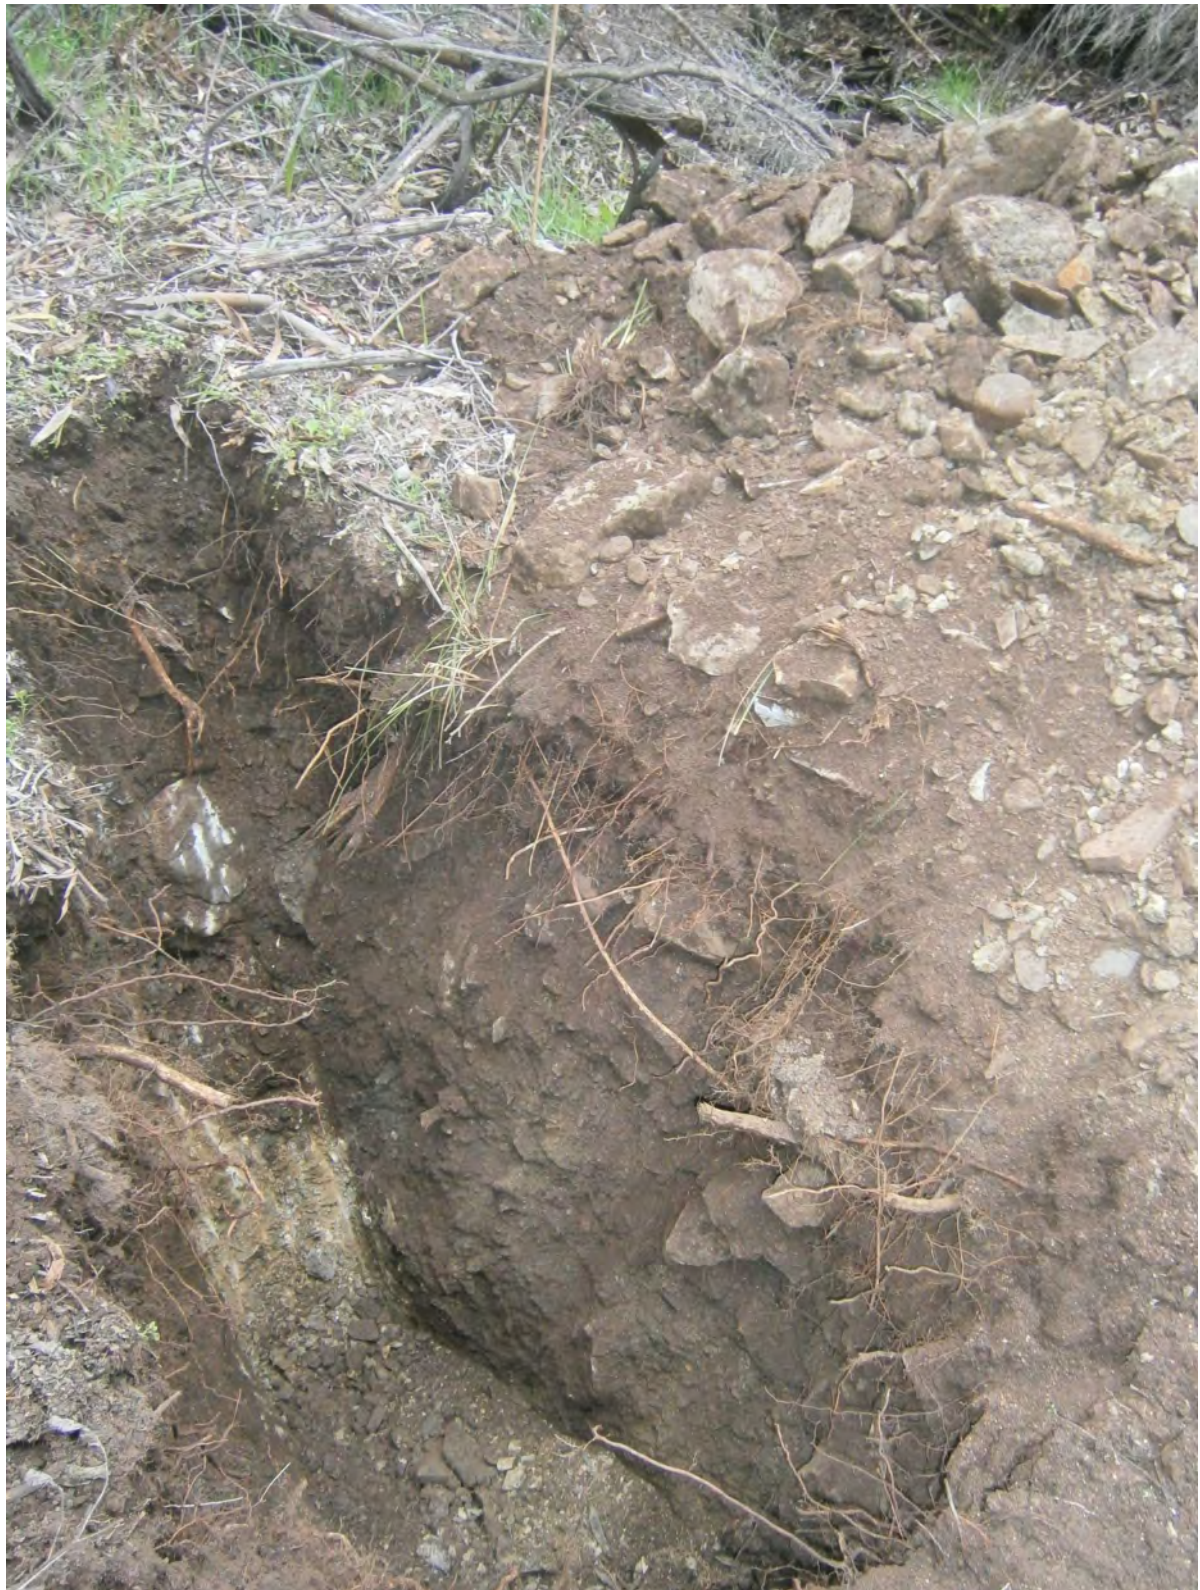
TP14

| excavation information | | | | | material substance | | | | | | | | | | | | | | | | | | | | | | | | | | | | | | | | | | | | | | | | | | | | | | | | | | | | | | | | | | | | | | | | | | | | | | | | | | | | | | | | | | | | | | | | | | | | | | | | | | | | | | | | | | | | | | | | | | | | | | | | | | | | | | | | | | | | | | | | | | | | | | | | | | | | | | | | | | | | | | | | | | | | | | | | | | | | | | | | | | | | | | | | | | | | | | | | | | | | | | | | | | | | | | | | | | | | | | | | | | | | | | | | | | | | | | | | | | | | | | | | | | | | | | | | | | | | | | | | | | | | | | | | | | | | | | | | | | | | | | | | | | | | | | | | | | | | | | | | | | | | | | | | | | | | | | | | | | | | | | | | | | | | | | | | | | | | | | | | | | | |
|---|---|---|---|---|---|---|---|---|---|---|---|---|---|---|---|---|---|---|---|---|---|---|---|---|---|---|---|---|---|---|---|---|---|---|---|---|---|---|---|---|---|---|---|---|---|---|---|---|---|---|---|---|---|---|---|---|---|---|---|---|---|---|---|---|---|---|---|---|---|---|---|---|---|---|---|---|---|---|---|---|---|---|---|---|---|---|---|---|---|---|---|---|---|---|---|---|---|---|---|---|---|---|---|---|---|---|---|---|---|---|---|---|---|---|---|---|---|---|---|---|---|---|---|---|---|---|---|---|---|---|---|---|---|---|---|---|---|---|---|---|---|---|---|---|---|---|---|---|---|---|---|---|---|---|---|---|---|---|---|---|---|---|---|---|---|---|---|---|---|---|---|---|---|---|---|---|---|---|---|---|---|---|---|---|---|---|---|---|---|---|---|---|---|---|---|---|---|---|---|---|---|---|---|---|---|---|---|---|---|---|---|---|---|---|---|---|---|---|---|---|---|---|---|---|---|---|---|---|---|---|---|---|---|---|---|---|---|---|---|---|---|---|---|---|---|---|---|---|---|---|---|---|---|---|---|---|---|---|---|---|---|---|---|---|---|---|---|---|---|---|---|---|---|---|---|---|---|---|---|---|---|---|---|---|---|---|---|---|---|---|---|---|---|---|---|---|---|---|---|---|---|---|---|---|---|---|---|---|---|---|---|---|---|---|---|---|---|---|---|---|---|---|---|---|---|---|---|---|---|---|---|---|---|---|---|---|---|---|---|---|---|---|---|---|
| N | Z | 1 | 2 | 3 | water | None Observed | BX2 | -639.0 | | CL | Gravelly CLAY: low plasticity, brown, fine to medium grained, angular gravel. | <Wp | St to VSt | 100 | 200 | 300 | 400 | 5 | 10 | 15 | 20 | 25 | 30 | 35 | 40 | 45 | 50 | 55 | 60 | 65 | 70 | 75 | 80 | 85 | 90 | 95 | 100 | 105 | 110 | 115 | 120 | 125 | 130 | 135 | 140 | 145 | 150 | 155 | 160 | 165 | 170 | 175 | 180 | 185 | 190 | 195 | 200 | 205 | 210 | 215 | 220 | 225 | 230 | 235 | 240 | 245 | 250 | 255 | 260 | 265 | 270 | 275 | 280 | 285 | 290 | 295 | 300 | 305 | 310 | 315 | 320 | 325 | 330 | 335 | 340 | 345 | 350 | 355 | 360 | 365 | 370 | 375 | 380 | 385 | 390 | 395 | 400 | 405 | 410 | 415 | 420 | 425 | 430 | 435 | 440 | 445 | 450 | 455 | 460 | 465 | 470 | 475 | 480 | 485 | 490 | 495 | 500 | 505 | 510 | 515 | 520 | 525 | 530 | 535 | 540 | 545 | 550 | 555 | 560 | 565 | 570 | 575 | 580 | 585 | 590 | 595 | 600 | 605 | 610 | 615 | 620 | 625 | 630 | 635 | 640 | 645 | 650 | 655 | 660 | 665 | 670 | 675 | 680 | 685 | 690 | 695 | 700 | 705 | 710 | 715 | 720 | 725 | 730 | 735 | 740 | 745 | 750 | 755 | 760 | 765 | 770 | 775 | 780 | 785 | 790 | 795 | 800 | 805 | 810 | 815 | 820 | 825 | 830 | 835 | 840 | 845 | 850 | 855 | 860 | 865 | 870 | 875 | 880 | 885 | 890 | 895 | 900 | 905 | 910 | 915 | 920 | 925 | 930 | 935 | 940 | 945 | 950 | 955 | 960 | 965 | 970 | 975 | 980 | 985 | 990 | 995 | 1000 | 1005 | 1010 | 1015 | 1020 | 1025 | 1030 | 1035 | 1040 | 1045 | 1050 | 1055 | 1060 | 1065 | 1070 | 1075 | 1080 | 1085 | 1090 | 1095 | 1100 | 1105 | 1110 | 1115 | 1120 | 1125 | 1130 | 1135 | 1140 | 1145 | 1150 | 1155 | 1160 | 1165 | 1170 | 1175 | 1180 | 1185 | 1190 | 1195 | 1200 | 1205 | 1210 | 1215 | 1220 | 1225 | 1230 | 1235 | 1240 | 1245 | 1250 | 1255 | 1260 | 1265 | 1270 | 1275 | 1280 | 1285 | 1290 | 1295 | 1300 | 1305 | 1310 | 1315 | 1320 | 1325 | 1330 | 1335 | 1340 | 1345 | 1350 | 1355 | 1360 | 1365 | 1370 | 1375 | 1380 | 1385 | 1390 | 1395 | 1400 | 1405 | 1410 | 1415 | 1420 | 1425 | 1430 | 1435 | 1440 | 1445 | 1450 | 1455 | 1460 | 1465 | 1470 | 1475 | 1480 | 1485 | 1490 | 1495 | 1500 | 1505 | 1510 | 1515 | 1520 | 1525 | 1530 | 1535 | 1540 | 1545 | 1550 | 1555 | 1560 | 1565 | 1570 | 1575 | 1580 | 1585 | 1590 | 1595 | 1600 | 1605 | 1610 | 1615 | 1620 | 1625 | 1630 | 1635 |

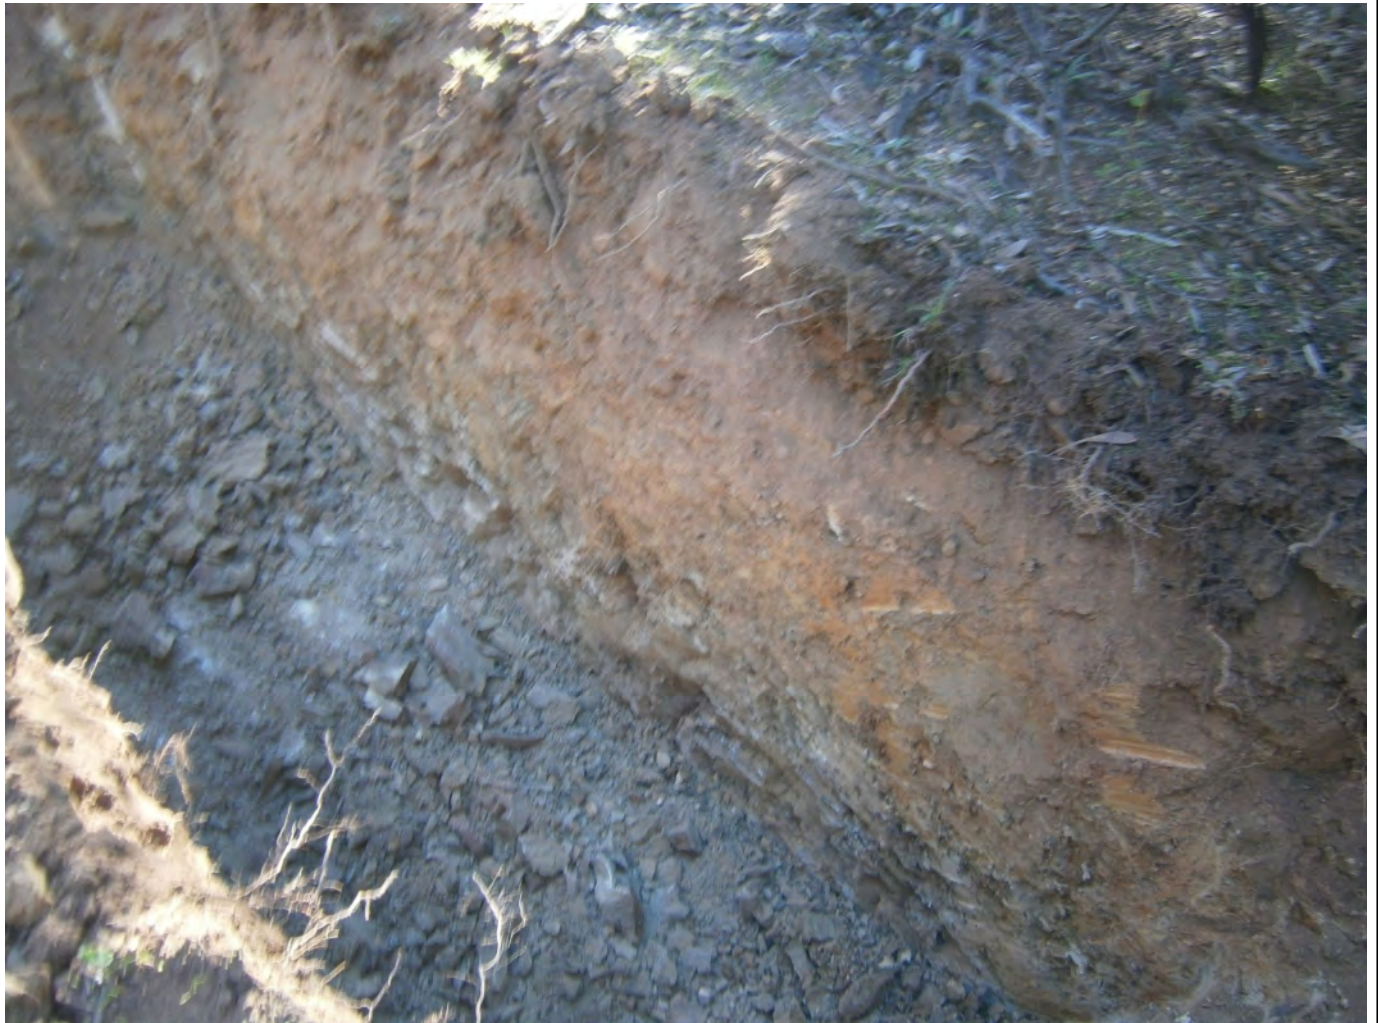
TP15

| excavation information | | | | | | material substance | | | | | | | | | |
|---|---|---|---|---|---|---|---|---|---|---|---|---|---|---|---|
| ↑<br>E<br>↓ | Z<br>↓ | 1 | 2 | None Observed | D | -639.5 | | | CL | <b>Sandy CLAY:</b> low plasticity, pale brown, fine grained sand, with rootlets. | <Wp | St to VSt | | | COLLUVIUM |

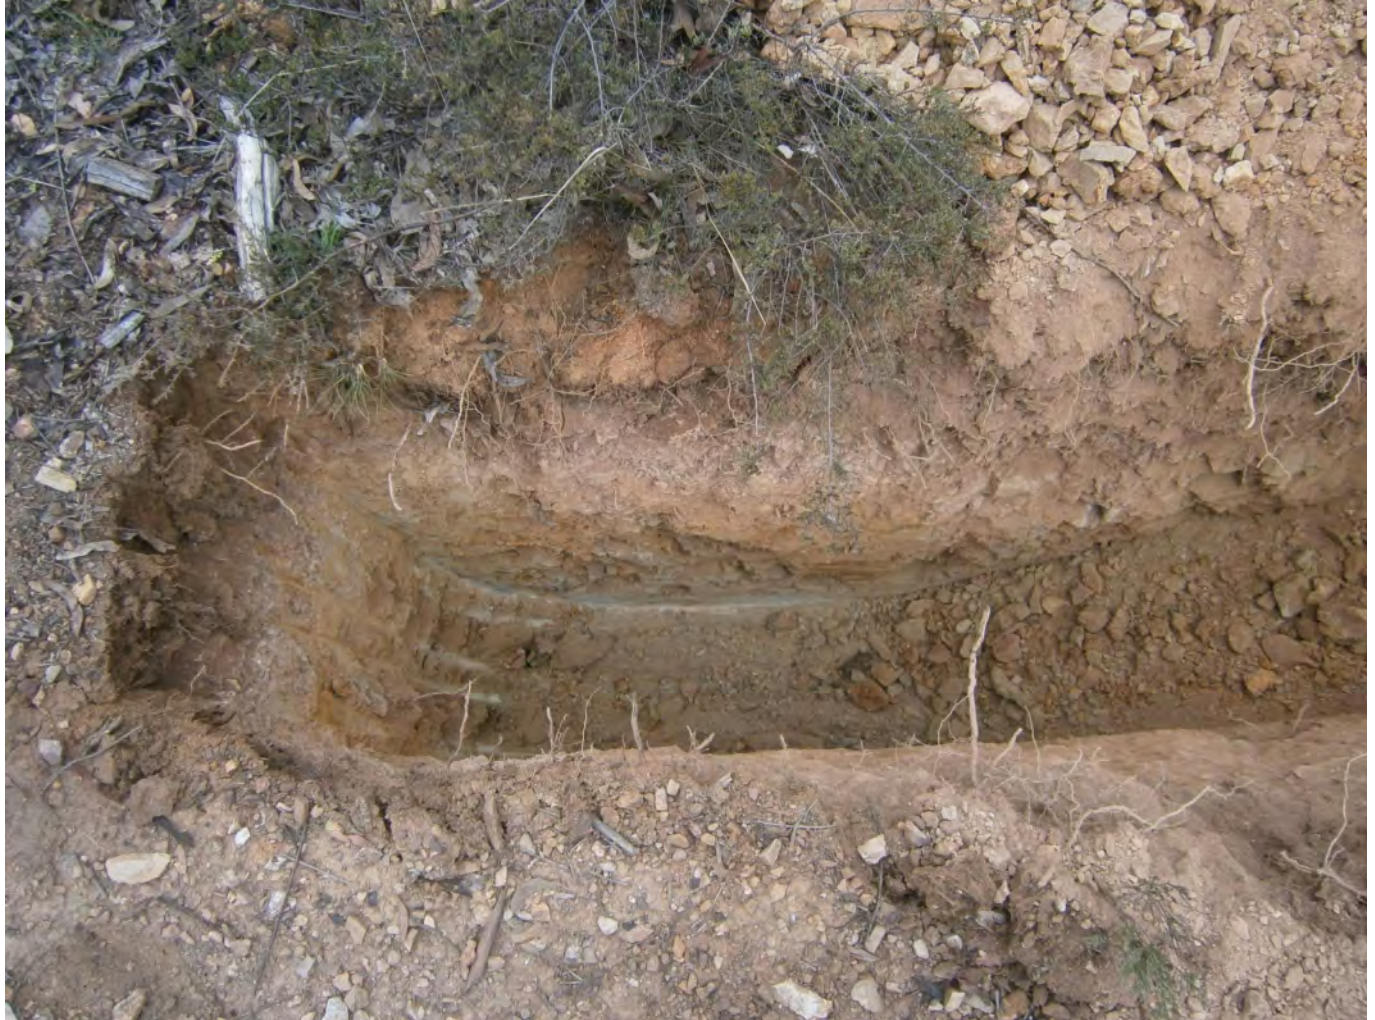
TP16

| excavation information | | | | | material substance | | | | | | | | | |
|---|---|---|---|---|---|---|---|---|---|---|---|---|---|---|
| N | | 1 | None Observed | | | | | CL | <b>Sandy CLAY:</b> low plasticity, brown, fine grained sand, with rootlets. | <Wp | St to VSt | | | <b>COLLUVIUM</b> |

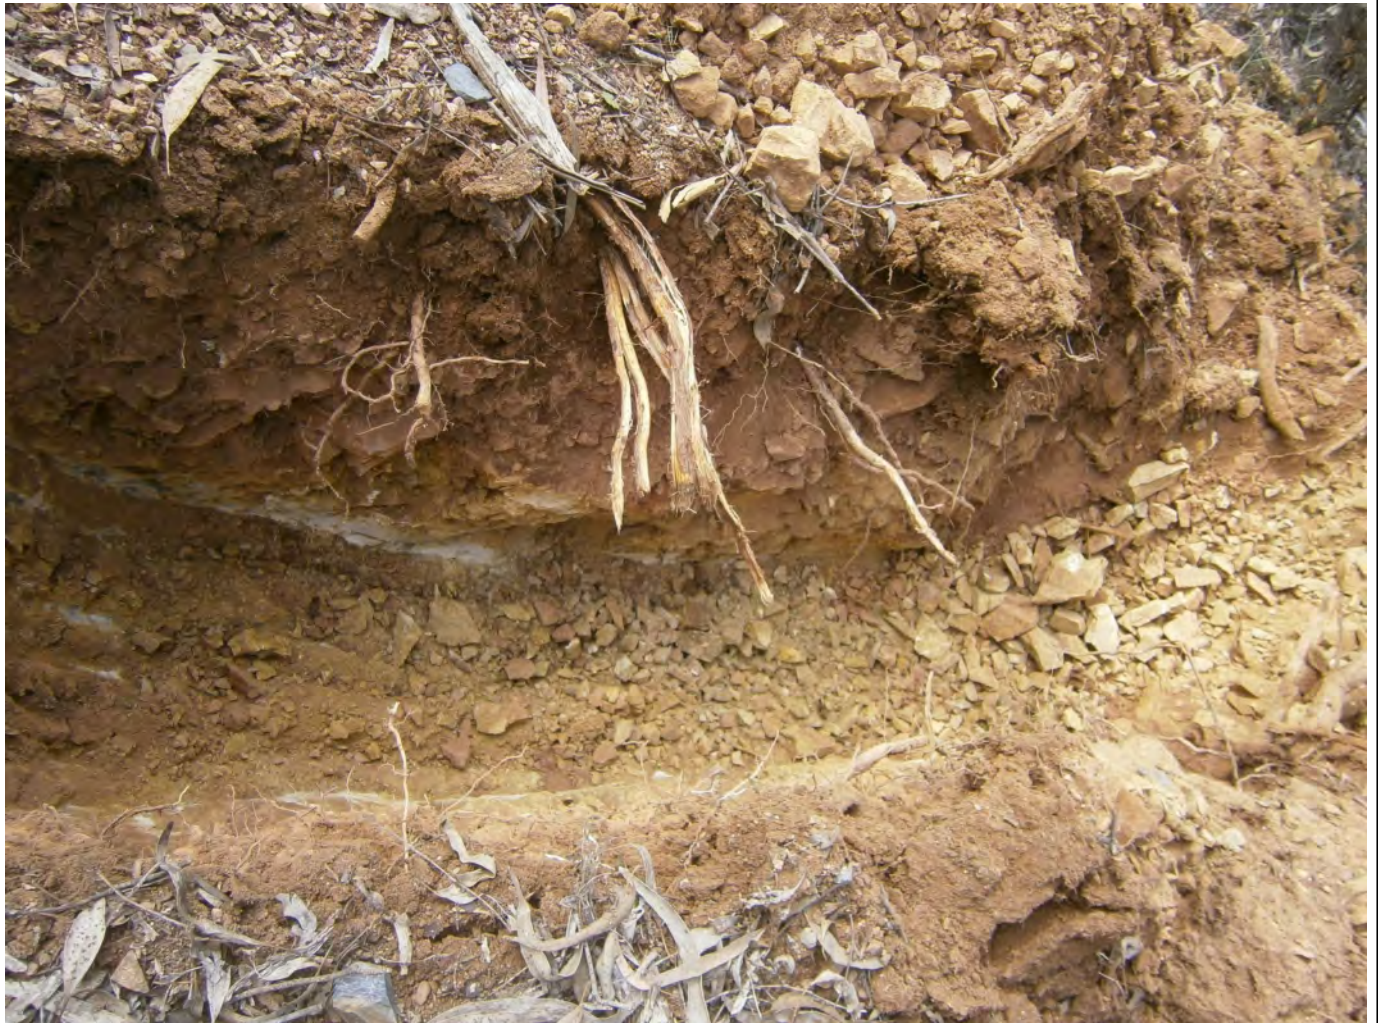
TP17

| excavation information | | | | | material substance | | | | | | | | | | | |
|---|---|---|---|---|---|---|---|---|---|---|---|---|---|---|--|--|
| ↑<br>N<br>↓ | N | 1<br>2<br>3 | None Observed | D | -651.0 | 0.5 | | CL | <b>Sandy CLAY:</b> low plasticity, brown, fine grained sand, trace fine grained, angular gravel. | <Wp | St to VSt | 100<br>200<br>300<br>400 | 5<br>10<br>15<br>20 | <b>COLLUVIUM</b> | | |

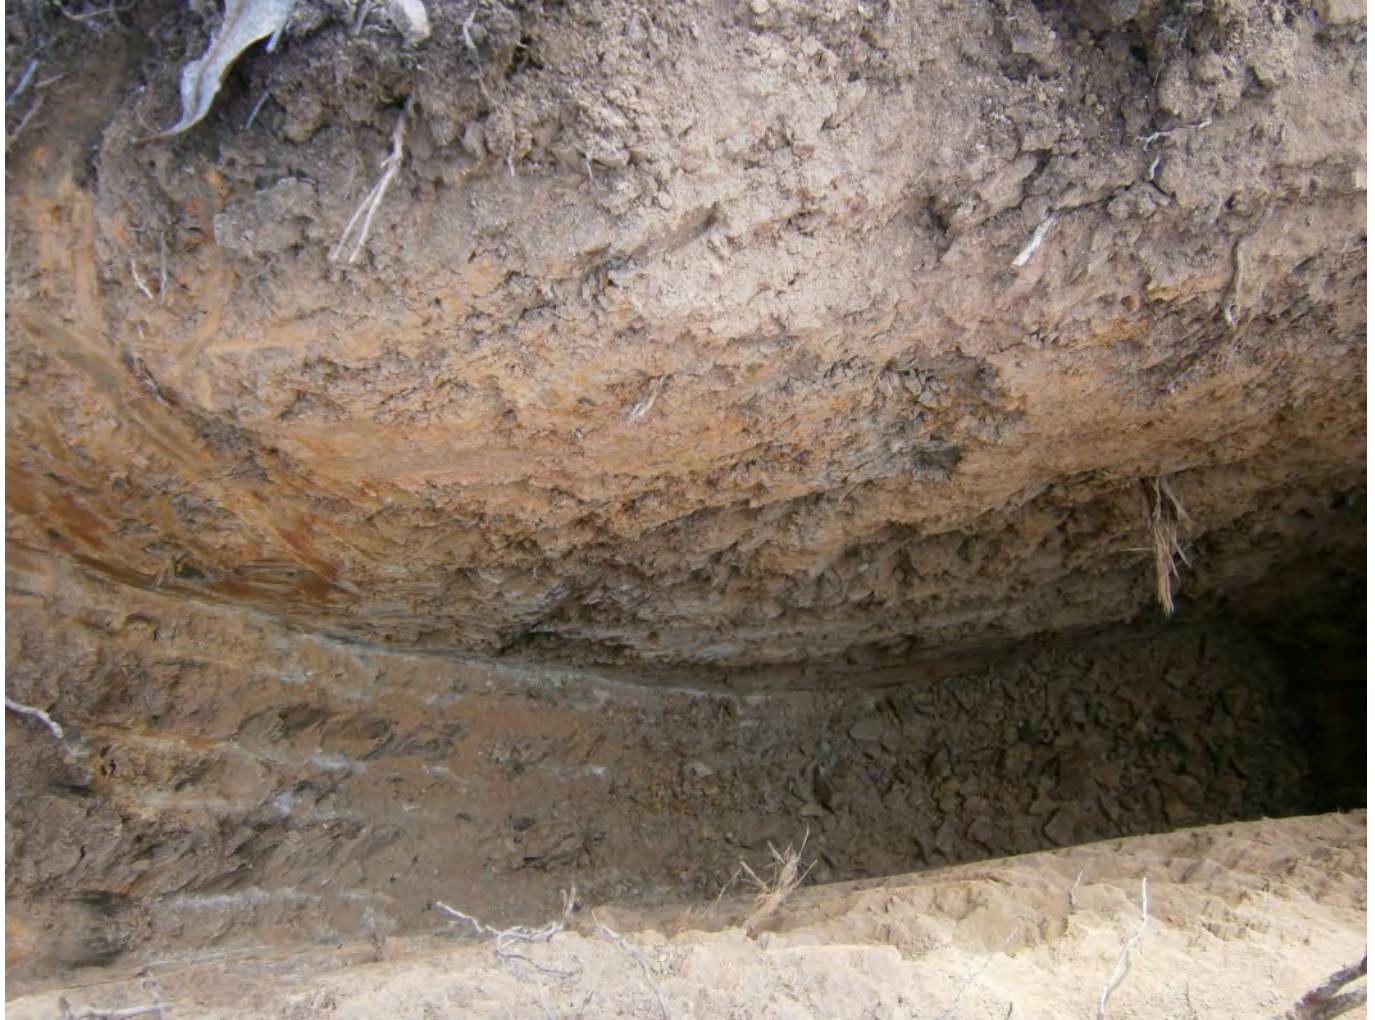
TP18

| excavation information | | | | | | material substance | | | | | | | | | | | |
|---|---|---|---|---|---|---|---|---|---|---|---|---|---|---|---|---|--|
| ↑<br>↓<br>E | N | 1 | 2 | 3 | None Observed | | 650.0 | | CL | Sandy CLAY: low plasticity, pale brown, fine grained sand, with some fine grained, sub-angular gravel. | <Wp | F | | | | COLLUVIUM | |

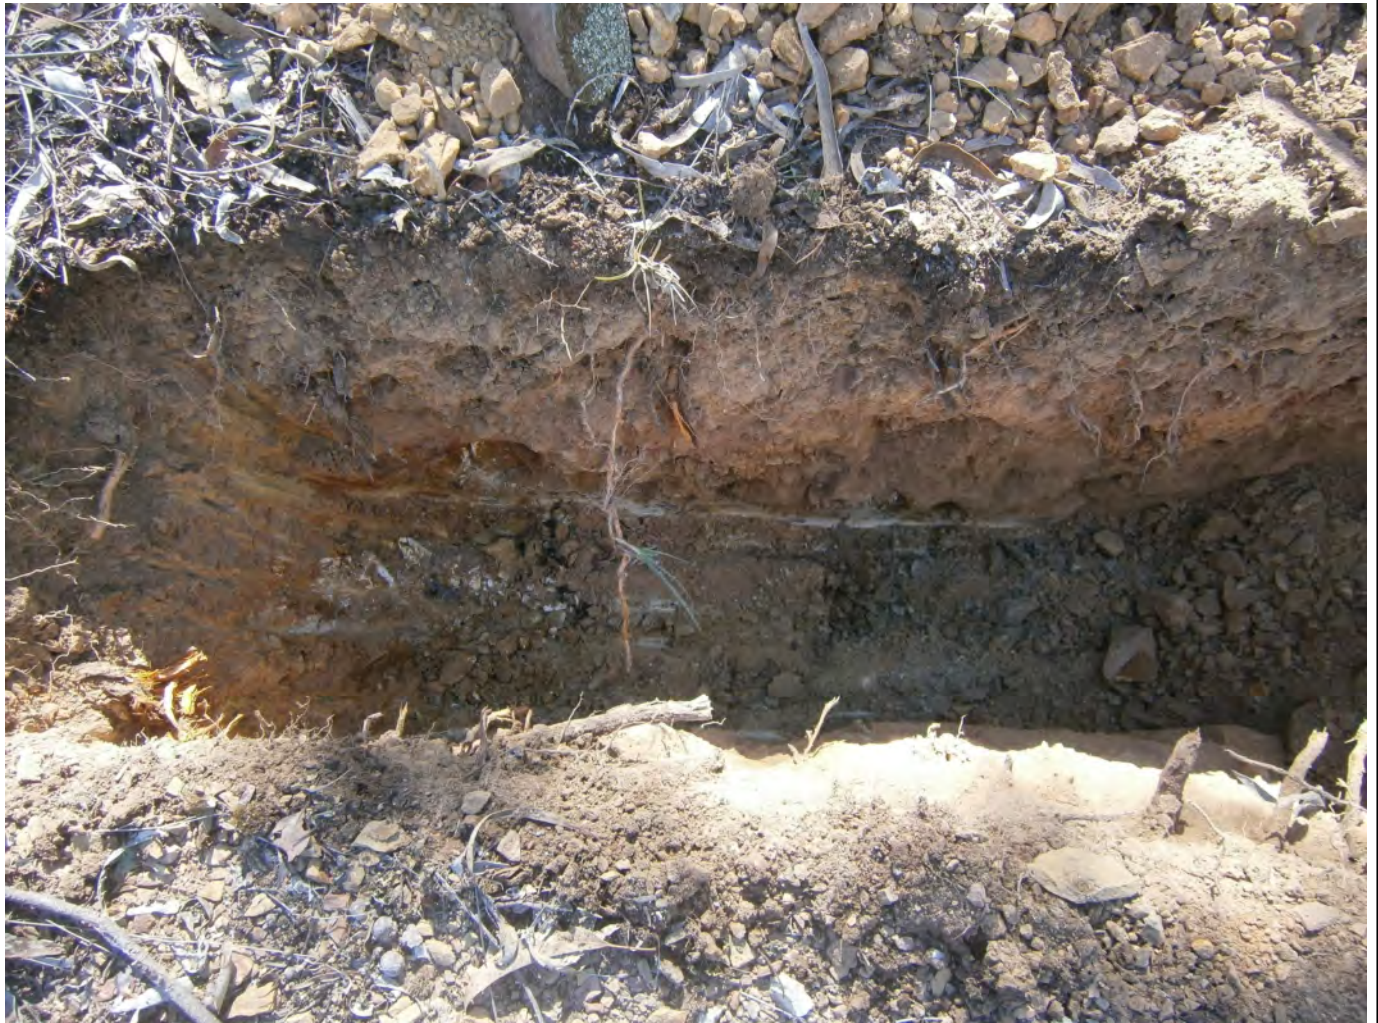
TP19

| excavation information | | | | | | material substance | | | | | | | | |
|---|---|---|---|---|---|---|---|---|---|---|---|---|---|---|
| ↑<br>E<br>↓ | N | 1 | None Observed | BX2 | | | | CL | CLAY: low plasticity, pale brown, with rootlets. | <Wp | H to Fb | 100 | 5 | COLLUVIUM |

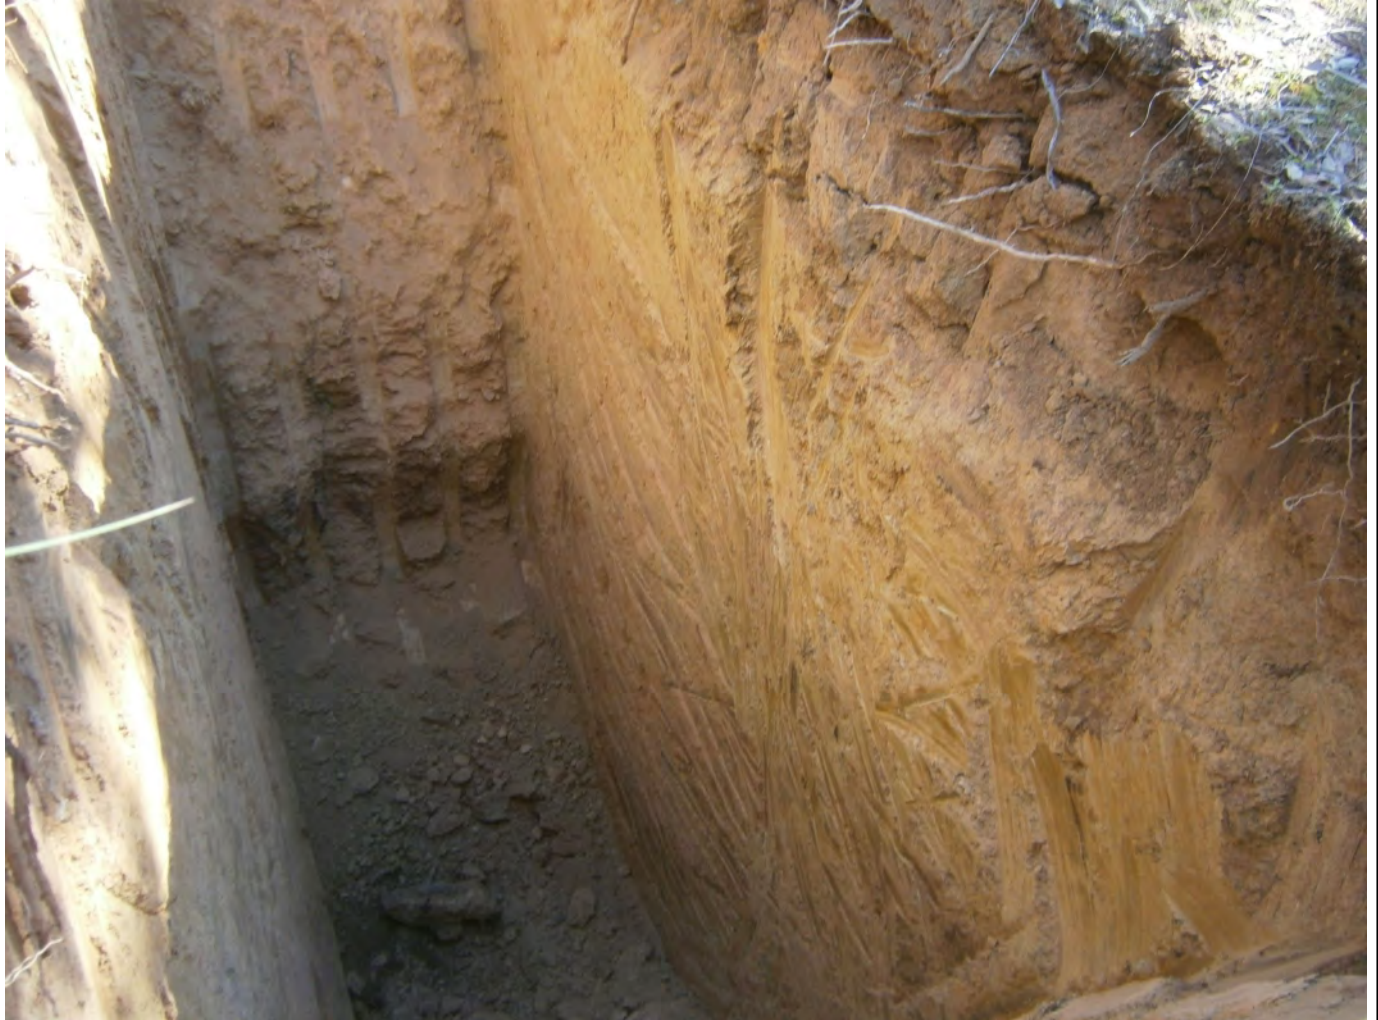
TP20

| excavation information | | | | | | material substance | | | | | | | | |
|---|---|---|---|---|---|---|---|---|---|---|---|---|---|---|
| ↑<br>N<br>↓<br>E | 1<br>2<br>3 | | None Observed | BX2 | -637.5 | | | | <b>TOPSOIL: Clayey SILT:</b> low liquid limit, dark brown. | <Wl | | 100<br>200<br>300<br>400 | 5<br>10<br>15<br>20 | <b>TOPSOIL</b> |

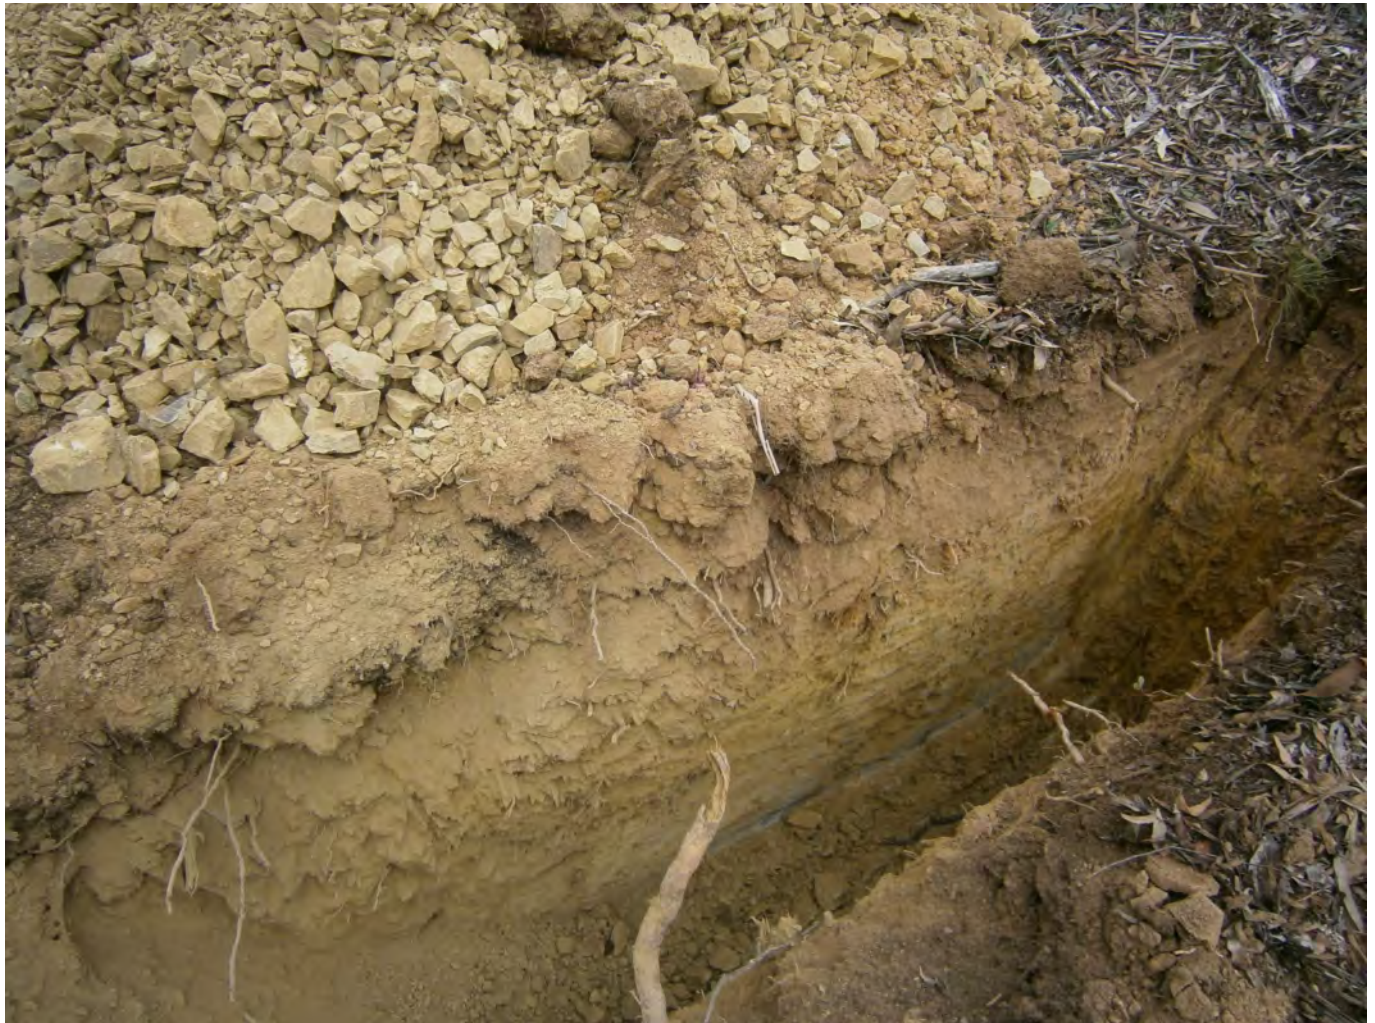
TP22

| excavation information | | | | | | material substance | | | | | | | | | |
|---|---|---|---|---|---|---|---|---|---|---|---|---|---|---|---|
| Z | 1 | 2 | 3 | None Observed | BX2 | -639.5 | | | CL | <b>Sandy CLAY:</b> low plasticity, brown, fine grained sand. | <Wp | F | | | COLLUVIUM |
| | | | | | | | | | | Test pit TP23 terminated at 2.2 m<br>Refusal on Bedrock | | | | | |

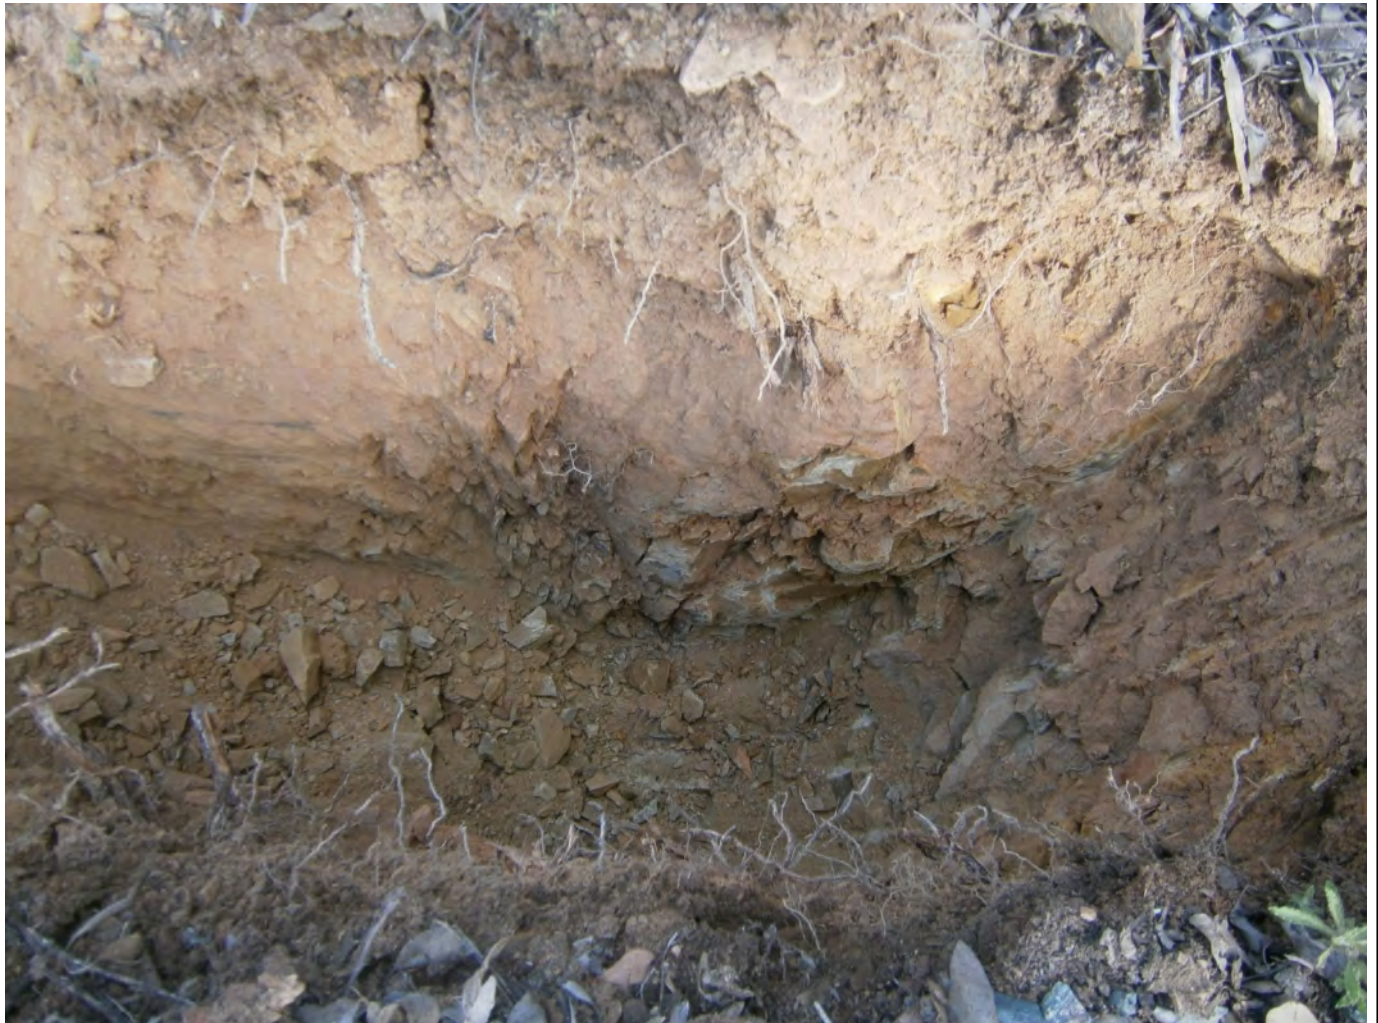
TP24

| excavation information | | | | | | material substance | | | | | | | | | |
|---|---|---|---|---|---|---|---|---|---|---|---|---|---|---|---|
| <div>E</div> <div>N</div> | | <div>1</div> <div>2</div> <div>3</div> | None Observed | D | | -639.5 | | | | SANDSTONE: fine grained, grey, highly weathered, low to medium strength. | | | | | BEDROCK |

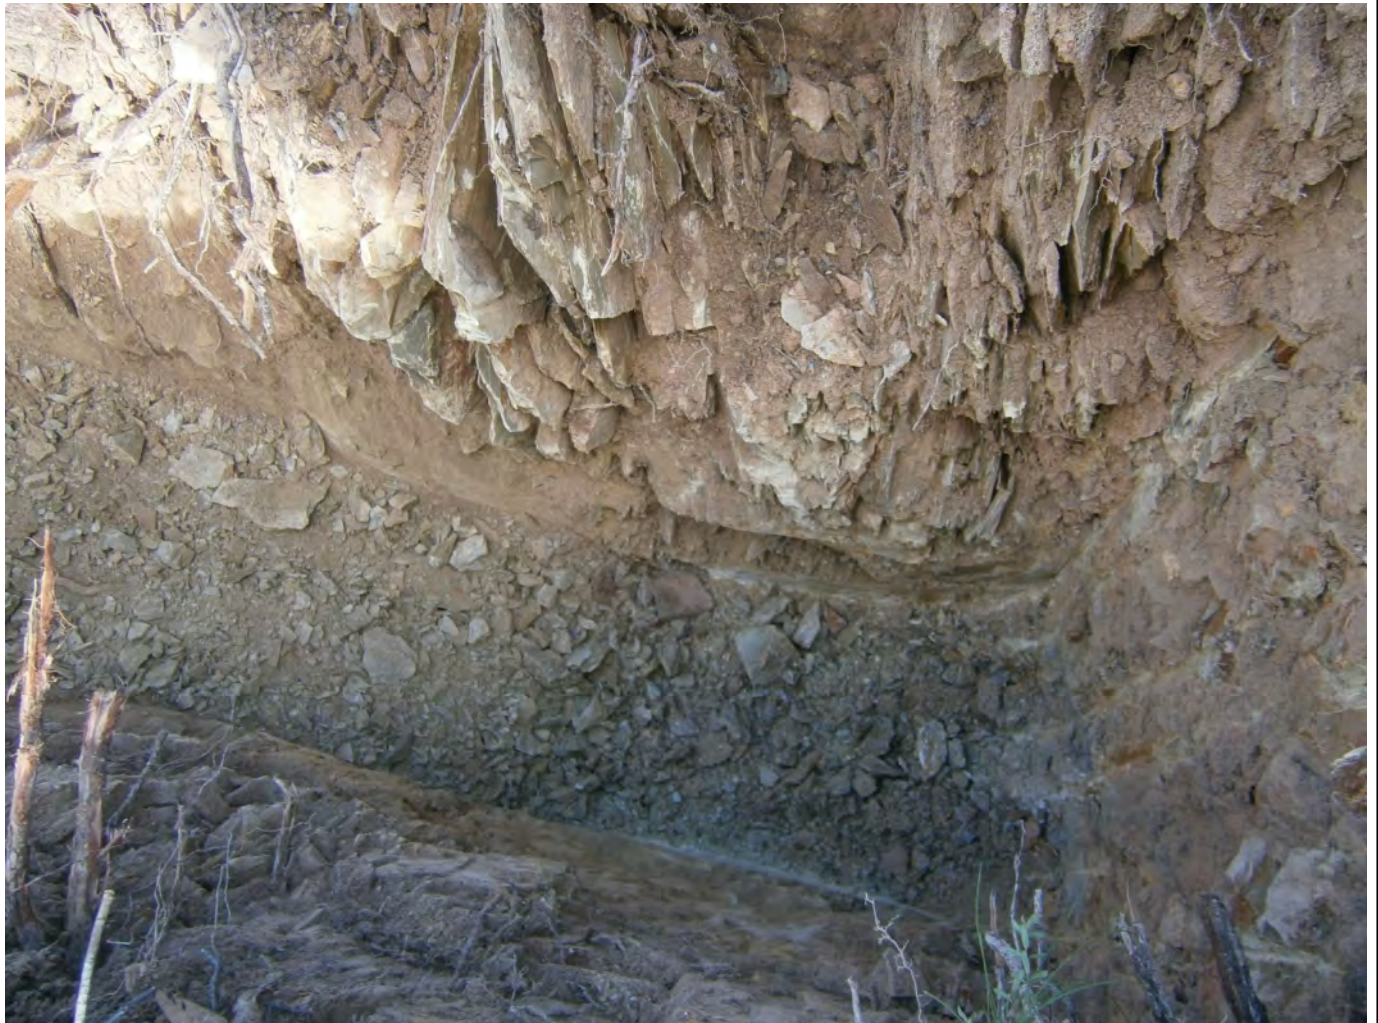
TP25

| excavation information | | | | | material substance | | | | | | | | | |
|---|---|---|---|---|---|---|---|---|---|---|---|---|---|---|
| N | | 1 | None Observed | | -647.5 | 0.5 | | | <b>SANDSTONE:</b> fine grained, brown/grey, highly weathered, low to medium strength. | | | | | |
