| date | <b>20/06/2014</b> | | title: | <b>TEST PIT PROFILE</b> | | |

# Engineering Log - Excavation

project: **Ellerton Drive Extension**

project no. **GEOTFYSH9703AA**

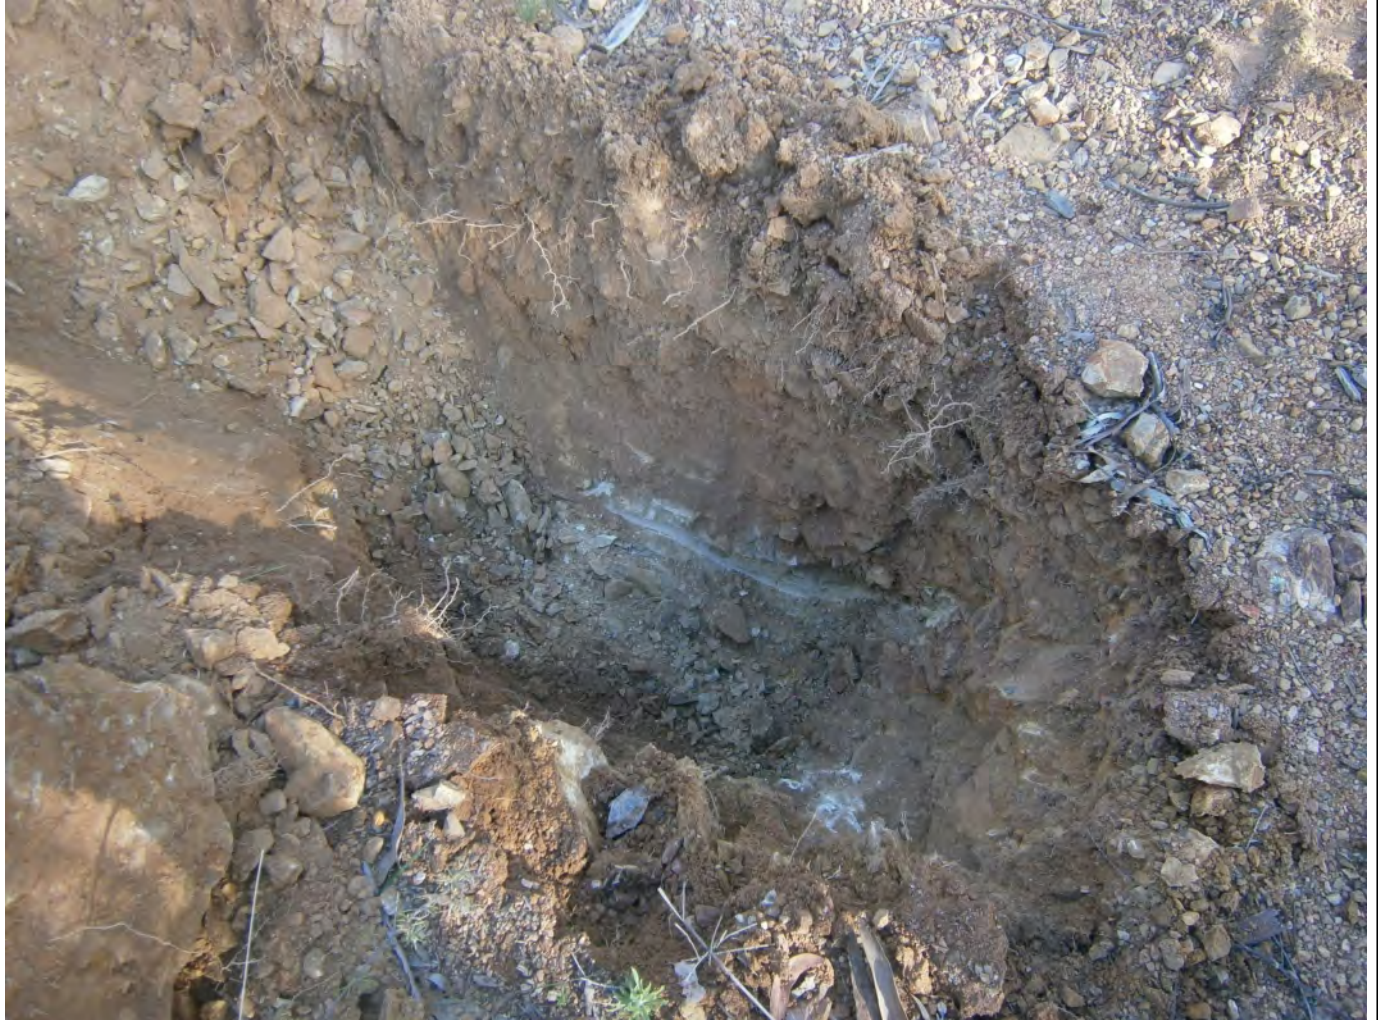
TP26

| excavation information | | | | | material substance | | | | | | | | | |
|---|---|---|---|---|---|---|---|---|---|---|---|---|---|---|
| N | | 1 | None Observed | | -640.5 | 0.5 | | GM | <b>Silty GRAVEL:</b> fine to coarse grained, angular, brown.<br><b>SANDSTONE:</b> fine grained, orange-grey, highly weathered, low to medium strength. | D | F | | | <b>COLLUVIUM</b> |

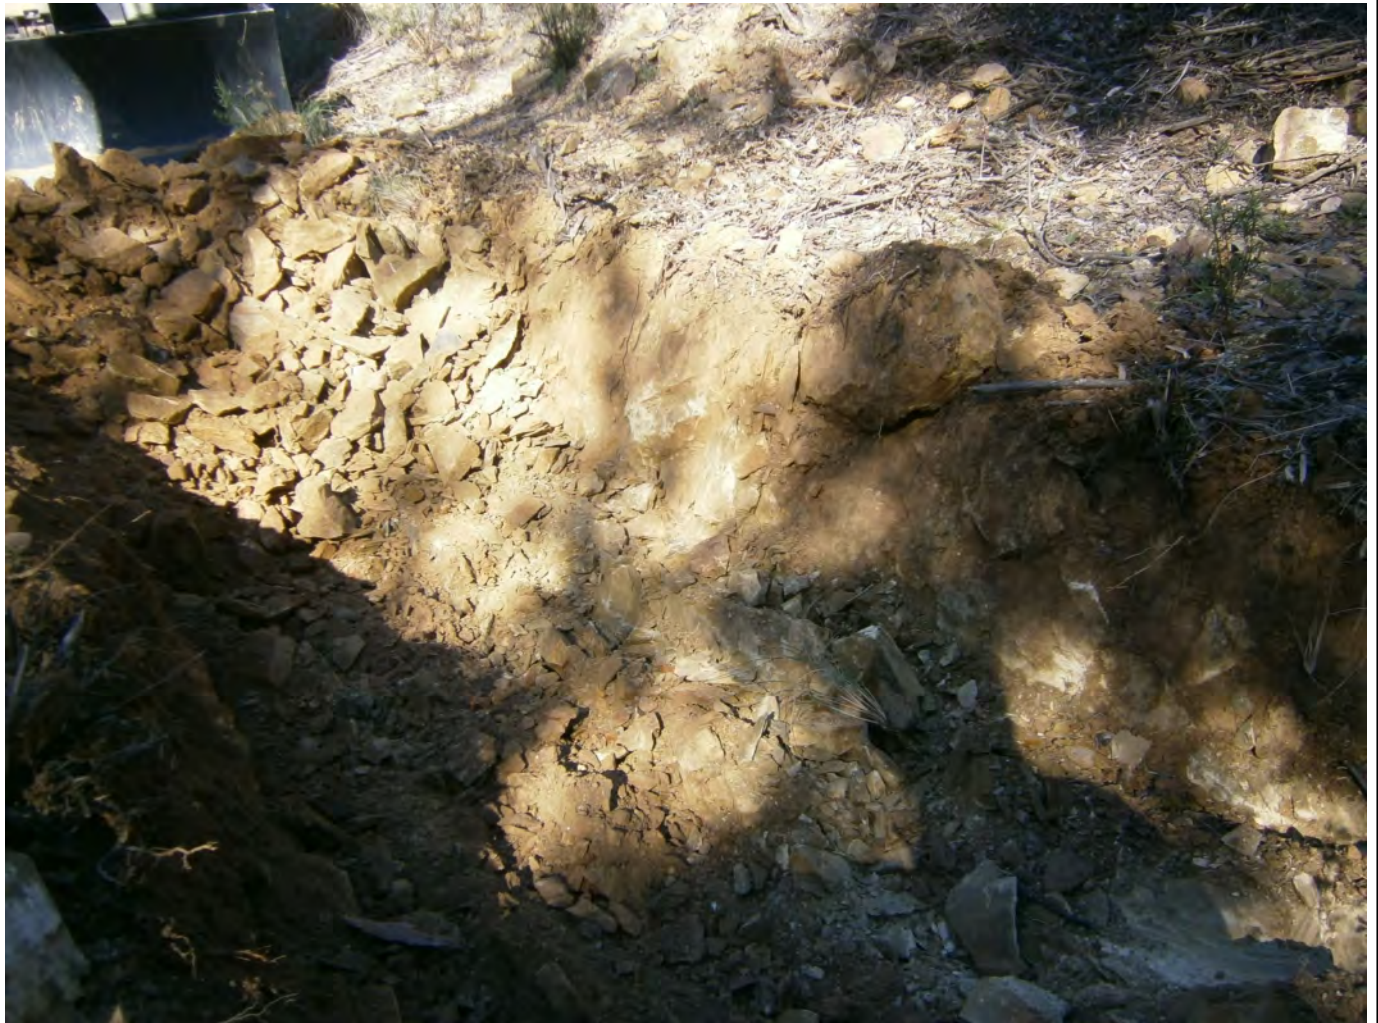
TP27

| excavation information | | | | | material substance | | | | | | | | | |
|---|---|---|---|---|---|---|---|---|---|---|---|---|---|---|
| N | | 1 | None Observed | | -635.5 | 0.5 | | | <b>SANDSTONE:</b> fine grained, orange-grey, highly weathered, low to medium strength. | | | | | <b>BEDROCK</b> |

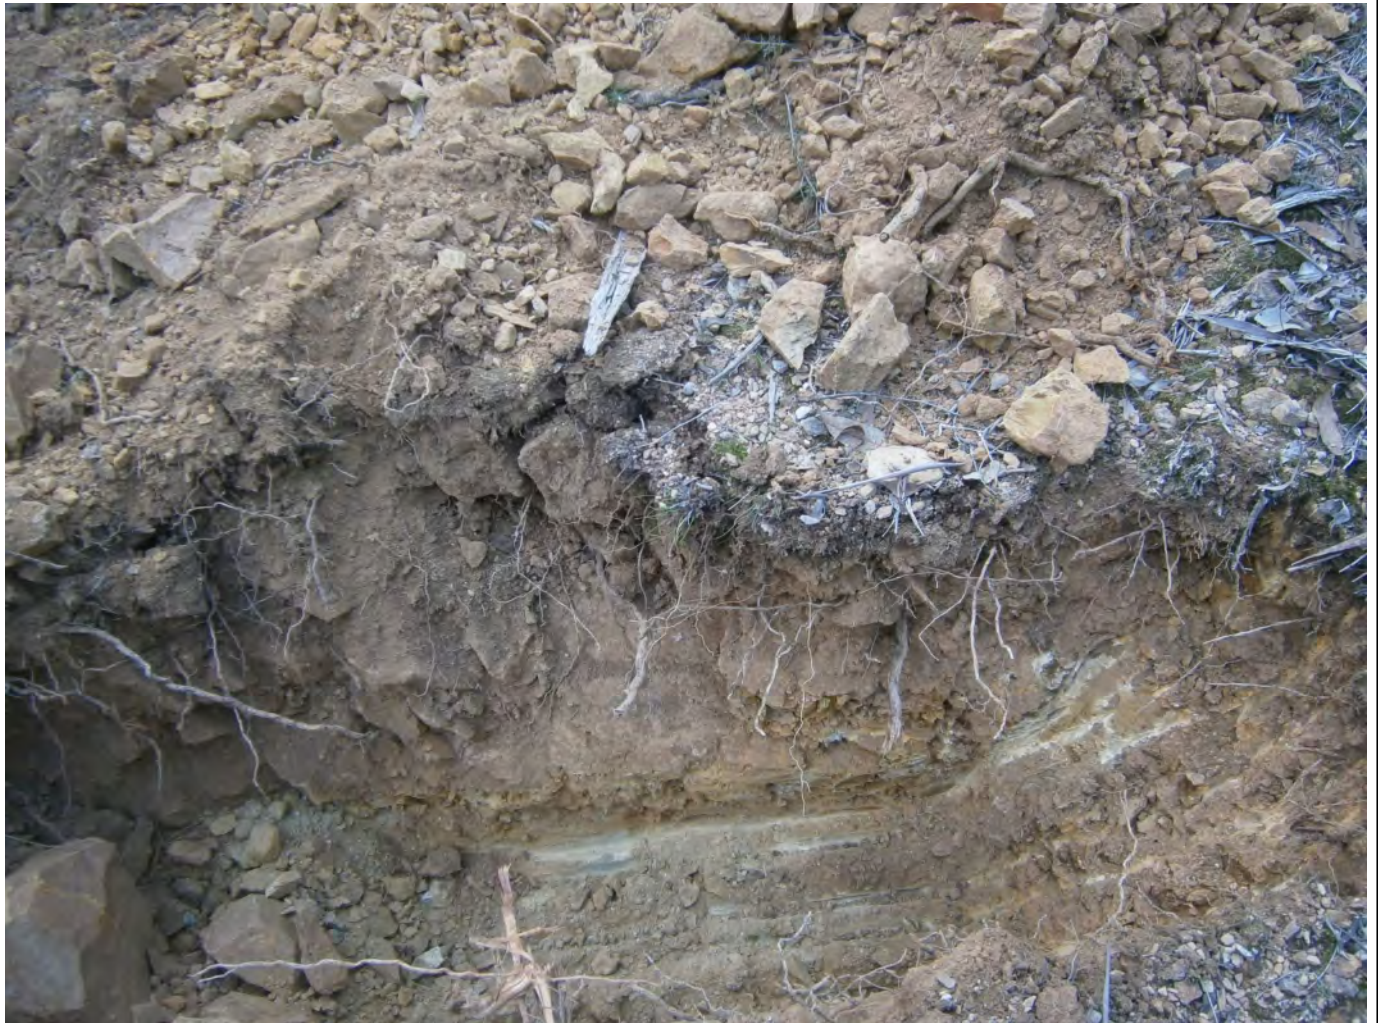
TP29

| excavation information | | | | | material substance | | | | | | | | | |
|---|---|---|---|---|---|---|---|---|---|---|---|---|---|---|
| N | | 1 | None Observed | | -623.0 | | | | <b>TOPSOIL: Sandy SILT:</b> low liquid limit, brown, fine grained sand. | <WI | | | | <b>TOPSOIL</b> |

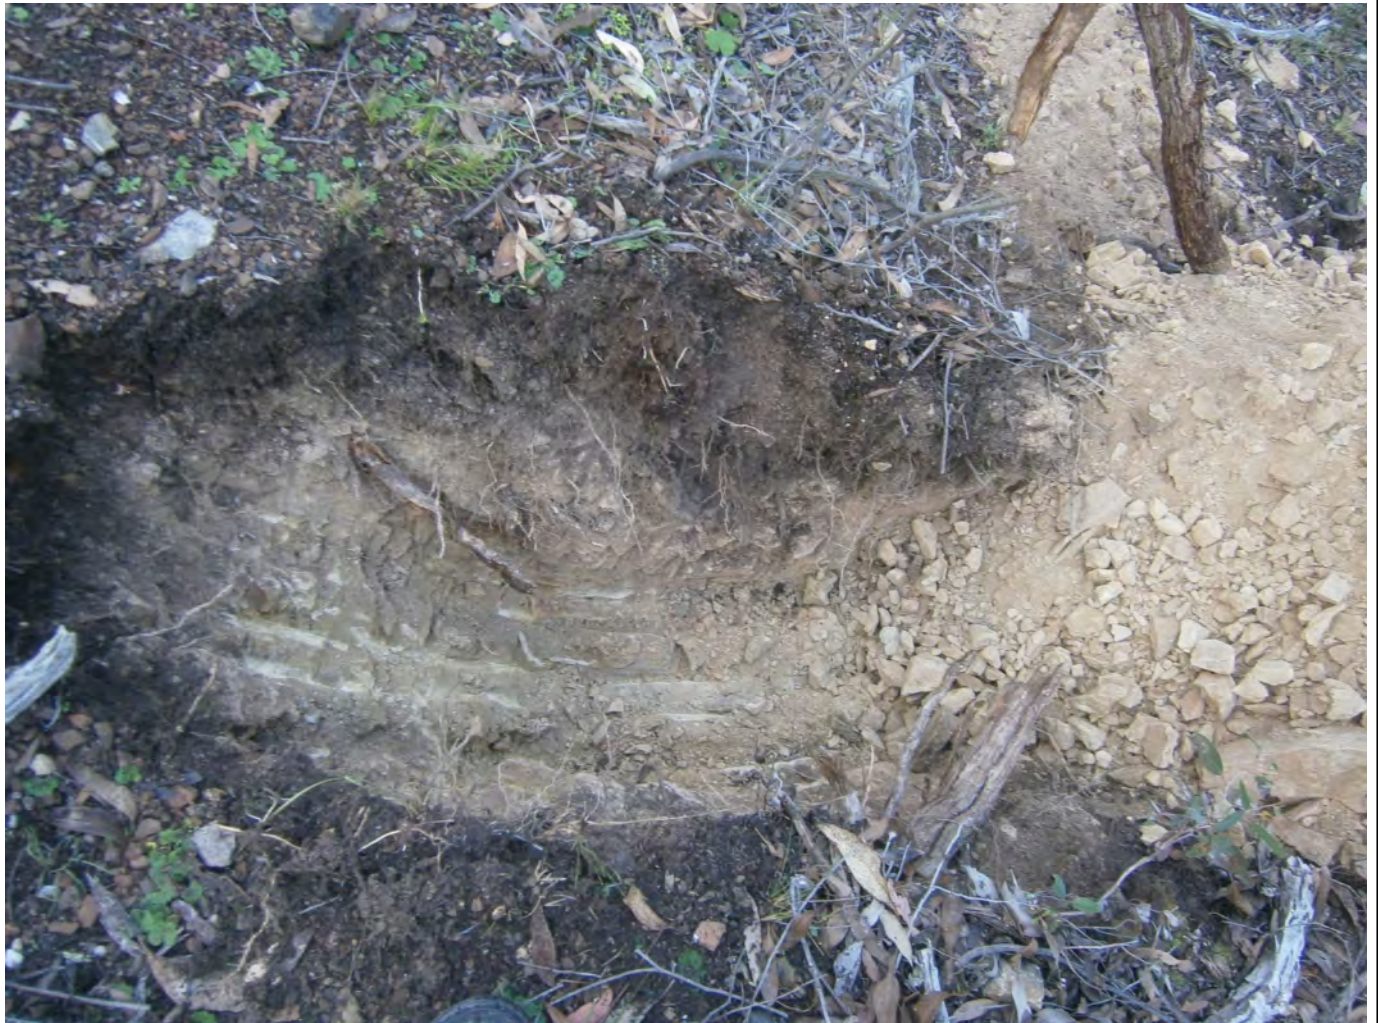
TP30

| excavation information | | | | | | material substance | | | | | | | | | | | | |
|---|---|---|---|---|---|---|---|---|---|---|---|---|---|---|---|--|--|---|
| E | N | 1 | None Observed | | | 0.5 | | | TOPSOIL: <b>Sandy SILT</b> : low liquid limit, brown, fine grained sand. | <Wl | | 100 | 5 | TOPSOIL | | | | |

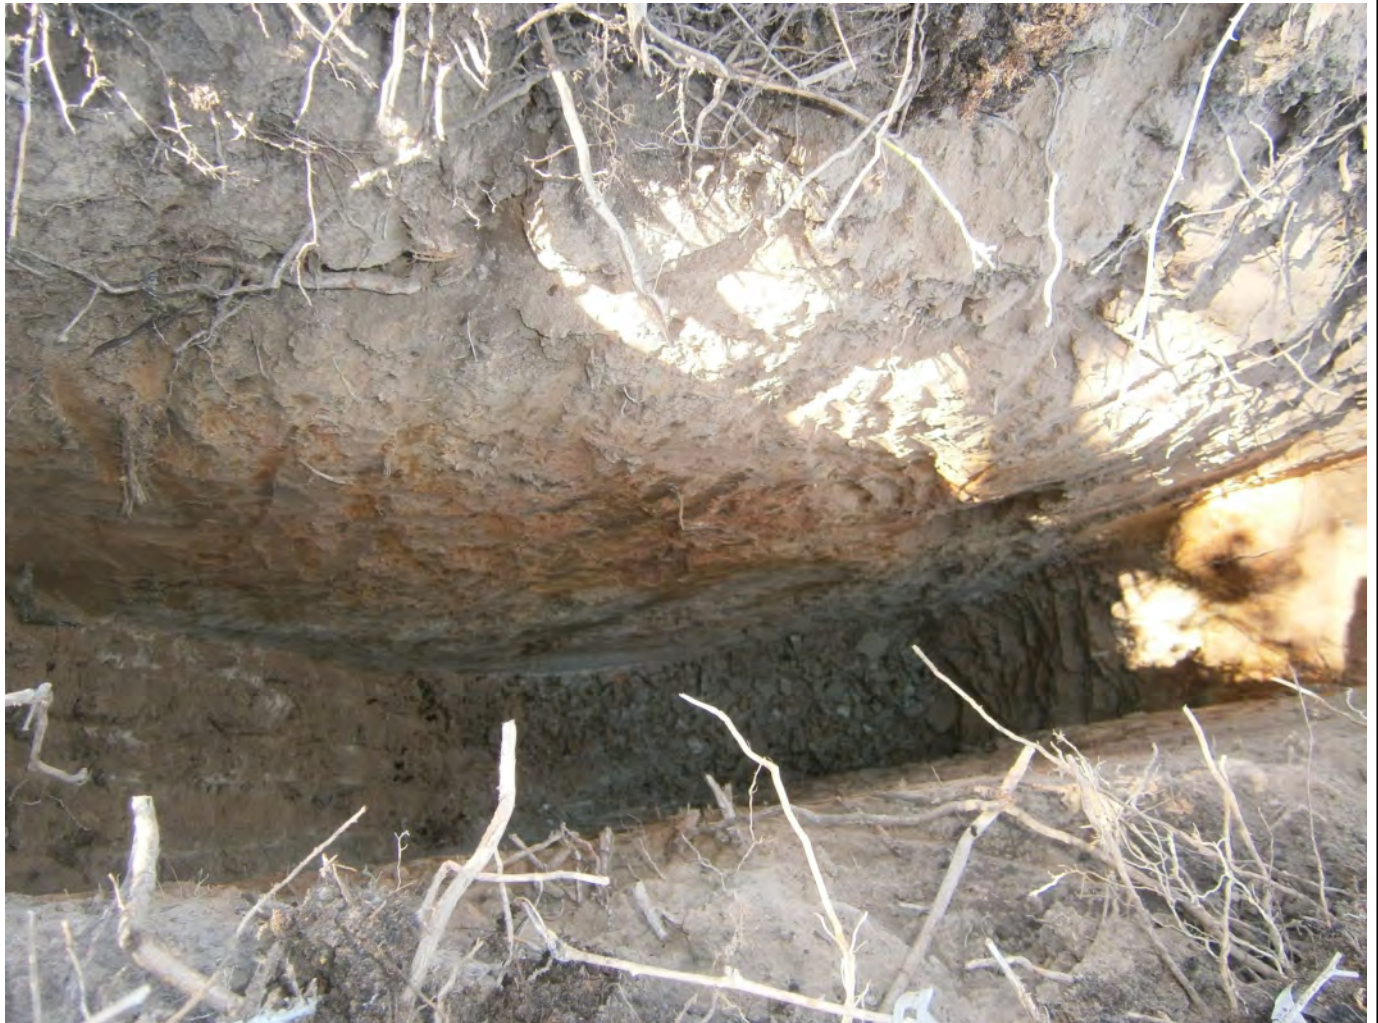
TP38

| excavation information | | | | | | material substance | | | | | | | | |
|---|---|---|---|---|---|---|---|---|---|---|---|---|---|---|
| ↑<br>N<br>↓<br>E | N | 1<br>2<br>3 | water | samples & field tests | RL (m) | depth (m) | graphic log | classification symbol | CLAY: low plasticity, pale grey-brown. | <Wp | H to Fb | 100<br>200<br>300<br>400 | 5<br>10<br>15<br>20 | COLLUVIUM |
