client: Opus International Consultants Pty Ltd		
approved	<b>BC</b>		project: Ellerton Drive Extension		
date	<b>20/06/2014</b>		title: <b>TEST PIT PROFILE</b>		
scale	<b>N.T.S.</b>		project no: GEOTFYSH9703AA	fig no: <b>43</b>	rev:
original size	<b>A4</b>

client: **Opus International Consultants Pty Ltd**  
 principal: **Queanbeyan City Council**  
 project: **Ellerton Drive Extension**  
 location: **Queanbeyan NSW**

Excavation ID: **TP44**  
 sheet: 1 of 1  
 project no: **GEOTFYSH9703AA**  
 date excavated: **14 May 2014**  
 date completed: **14 May 2014**  
 logged by: **BC**  
 checked by: **DB**

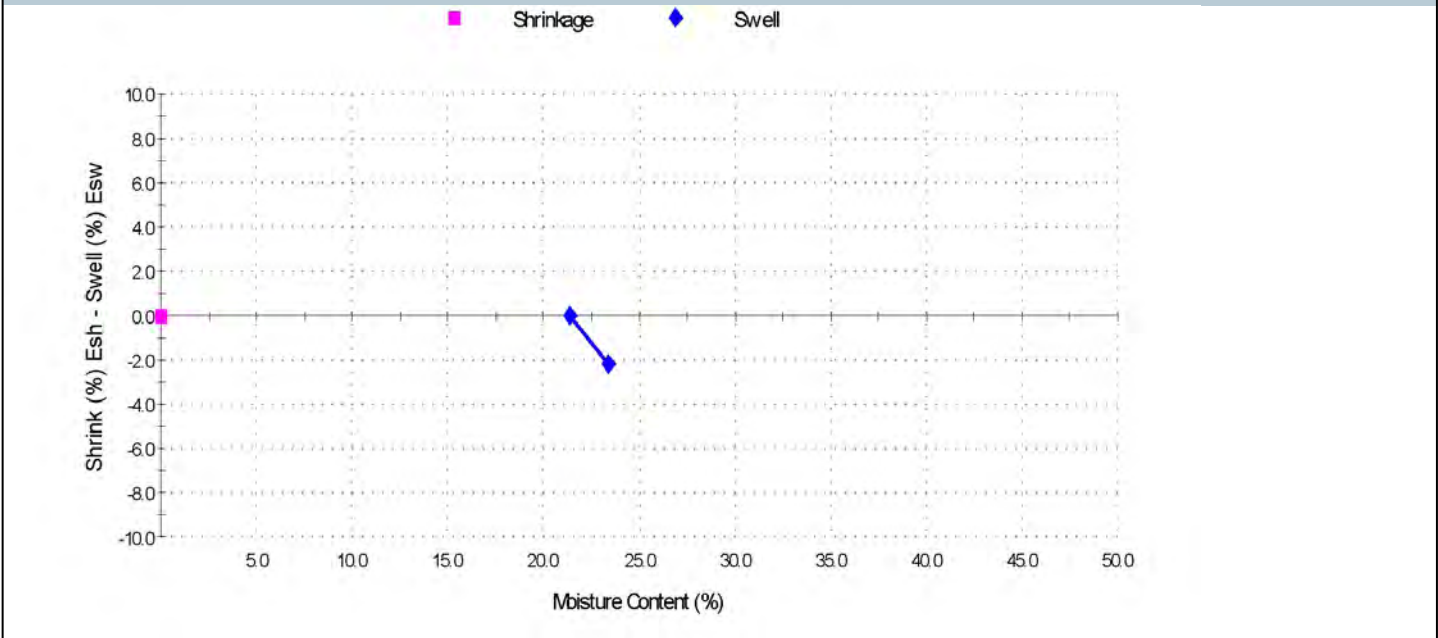
## Shrink Swell

Swell Test		AS 1289.7.1.1	Shrink Test		AS 1289.7.1.1
Swell on Saturation (%):	-2.1		Shrink on drying (%):		
Moisture Content before (%):	21.4		Shrinkage Moisture Content (%):		
Moisture Content after (%):	23.3		Est. inert material (%):		
Est. Unc. Comp. Strength before (kPa):			Crumbling during shrinkage:		
Est. Unc. Comp. Strength after (kPa):			Cracking during shrinkage:

Shrink Swell Index - Iss (%):
