Turallo Creek Bungendore – Management Plan

Final

Queanbeyan-Palerang Regional Council

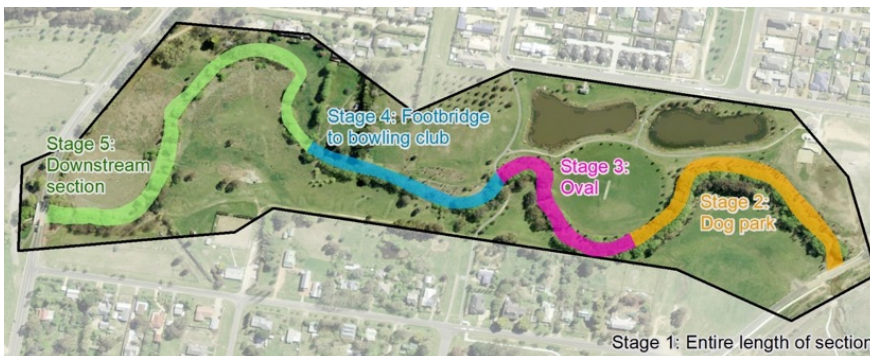
Figure E1: Staged approach to Turallo Creek rehabilitation

recommended. Stage 1 focusses on clearing willows and woody weeds from the watercourse along the entire length of the creek. Stages two to five focus on removing vegetation from the riparian zone and revegetating the area as per figure E1. Details are outlined in accompanying Project Plan.

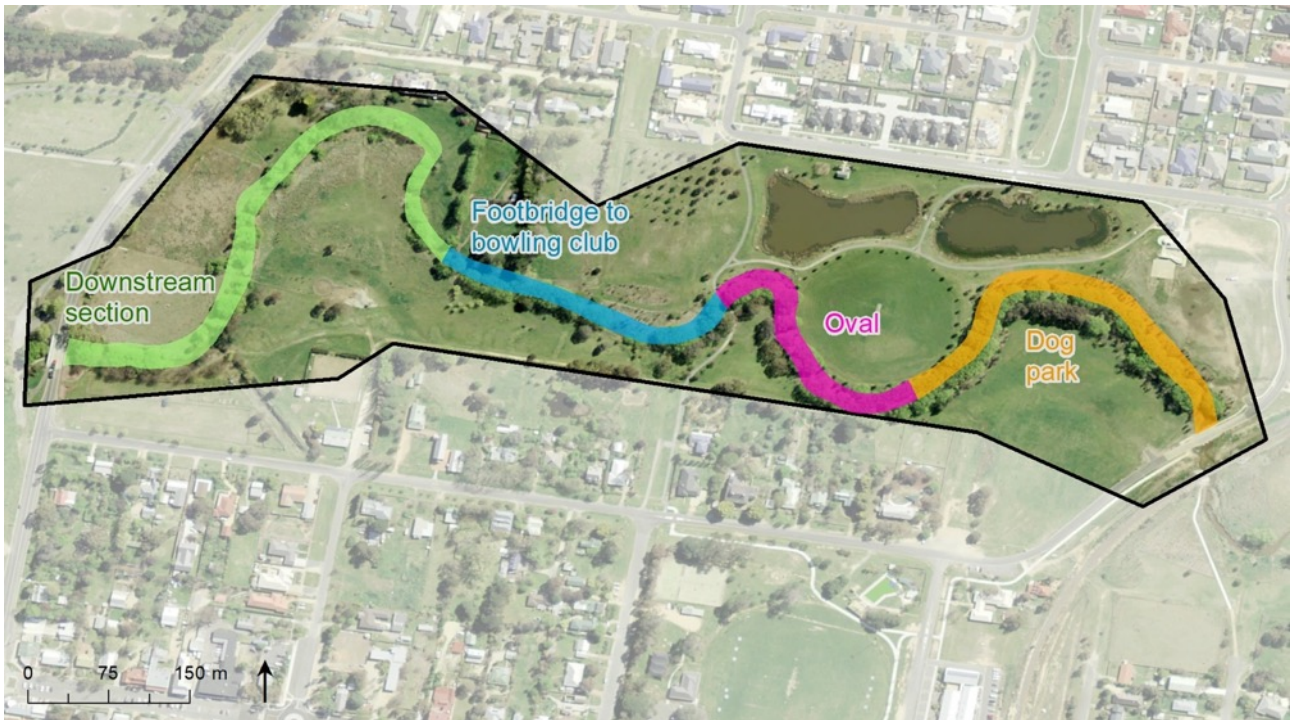
Figure 2-1: Map signposting sections along the Turallo Creek

1. Dog Park
2. Oval
3. Footbridge to Bowling Club
4. Downstream section.

The extent of the creek is shown in Figure 2-1 and a description of the geography and management issues along each section of the creek follows.

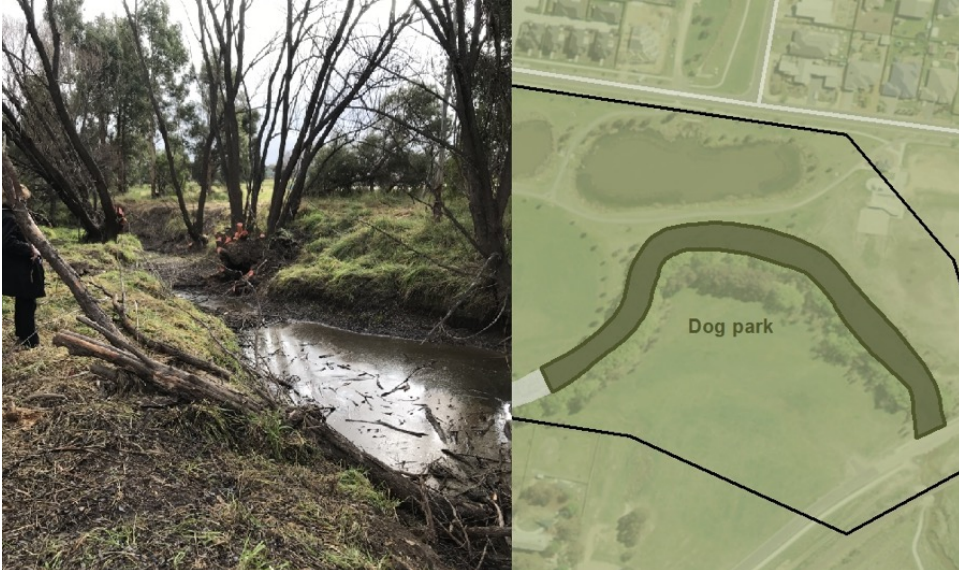
Figure 2-2: Turallo Creek - Dog park section

Infested with multi stemmed willow trees and segments of native plantings on the outer edges of the riparian zones. The section of Turallo Creek adjacent to the dog park is approximately 250m long. The creek is shallow in parts with some deeper pools (1-2m approximately). Parts of this section are incised but overall banks are stable due to the significant root system of the present willows. There are 10 year old native tree plantings on the southern and northern side of the creek. Access is difficult due to the established native plantings and during wetter periods the ground is soft on the north side making it difficult for vehicles and machinery to operate without causing significant soil disturbance (Figure 2-2).

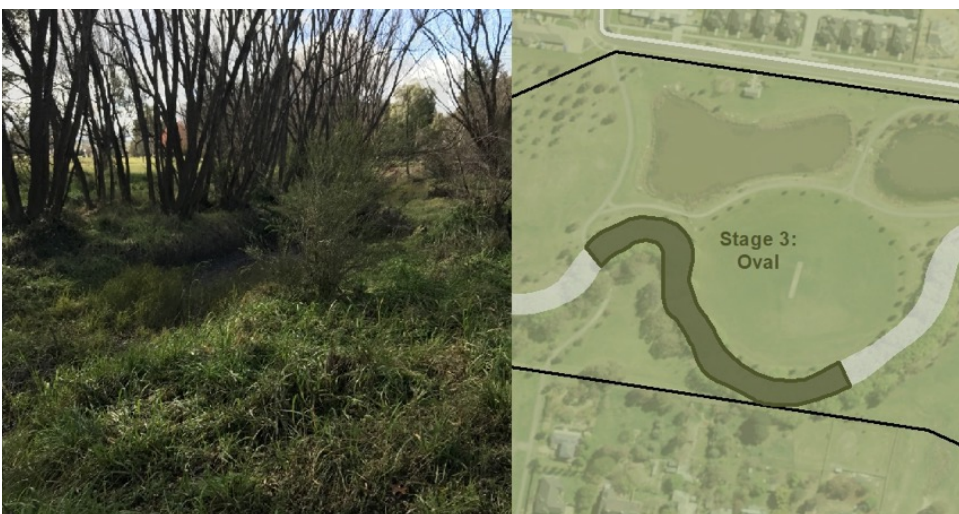
Figure 2-3: Turallo Creek - Warren Little Oval section

The section of Turallo Creek adjacent to Warren Little Oval is approximately 400 m long. Sections of this creek are close to private property borders near the preschool (south side) and the edge of Warren Little Oval (north side). Warren Little Oval was planted with Manchurian Pears on the outer rim to improve landscape amenity. Parts of this section are shallow and other parts have deeper pools (>2m approximately) compared to the dog park section. Willows dominate the watercourse and the riparian zone and there are a few larger honeysuckle plants (*Lonicera japonica*), privet (*Ligustrum spp.*) and blackberry (*Rubus fruticosus agg. spp.*) (Figure 2-3).

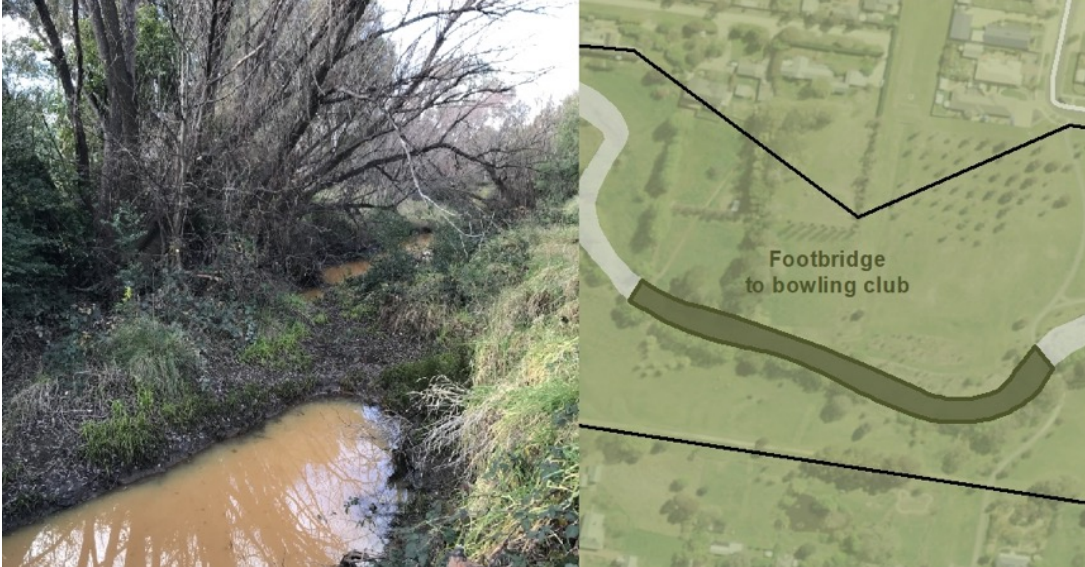
Figure 2-4: Turallo Creek – Footbridge to bowling club section

This section of Turallo Creek between the bowling club and footbridge is approximately 210m long. Parts of the riparian zone are heavily infested with blackberry and willows, which makes access to the watercourse difficult. These areas are deep (approximately >3m) and incised. Other parts are shallower and less vegetated however there are clusters of willows spread through these more open areas. On the outer edge of the riparian zone are some established native trees (Figure 2-4).

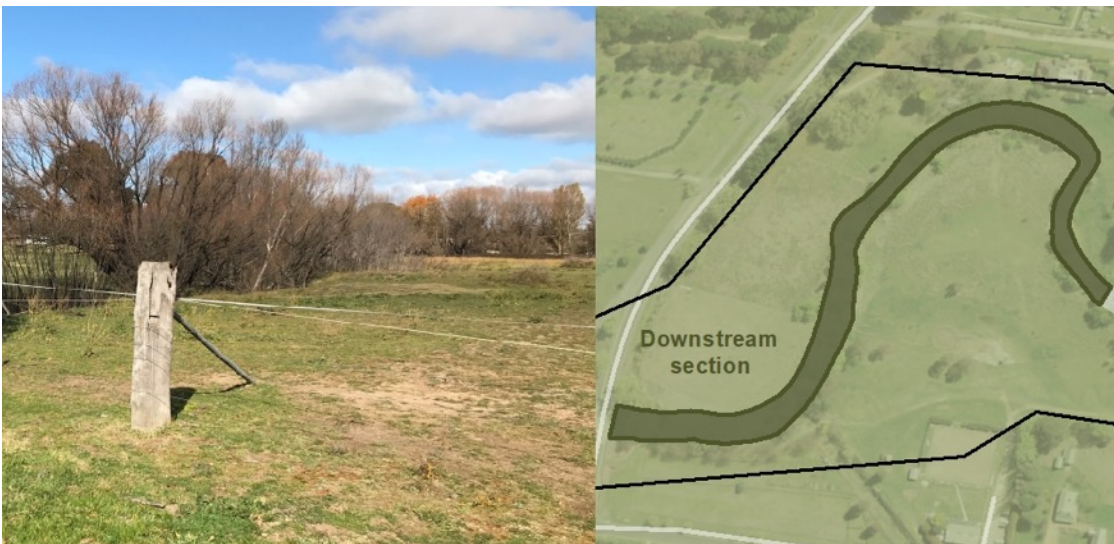
Figure 2-5: Turallo Creek – Downstream section

This section of the water course is approximately 540m long. It is bordered by private landholders on both sides so will require permission to access the waterfront for works. This stretch of creek is heavily infested with a mix of mature willow trees and suckers as well as juvenile elm trees and blackberry.
