TRAIL MANAGEMENT PLAN

JUMPING CREEK ESTATE

QUEANBEYAN NSW

30 May 2019

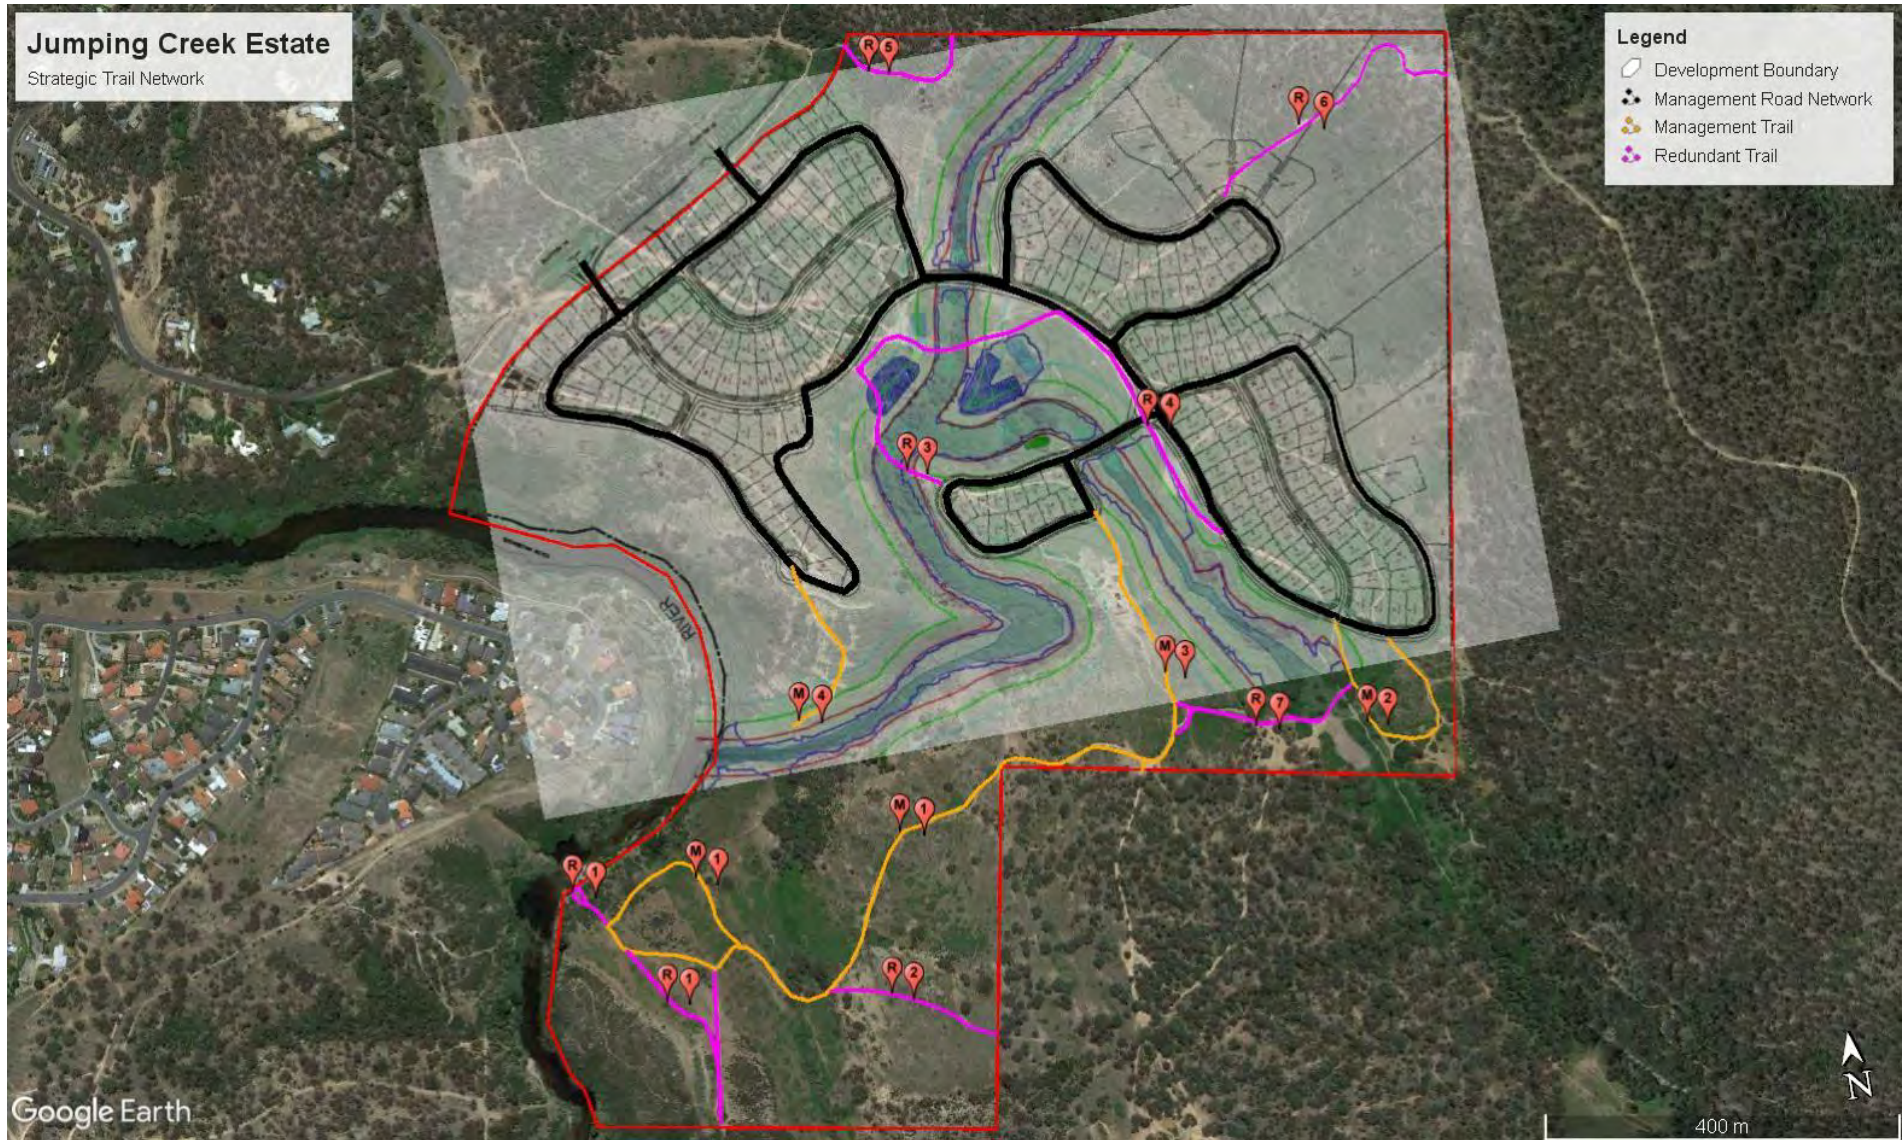
Figure 1: Strategic Trail Network

The strategic trail network proposed is shown in **Figure 1**, including the redundant trails for removal. The Management Trails identified will serve multiple purposes however the capacity of the network to effectively support a variety of land management and recreational purposes relies on all being upgraded and maintained to an appropriate standard.

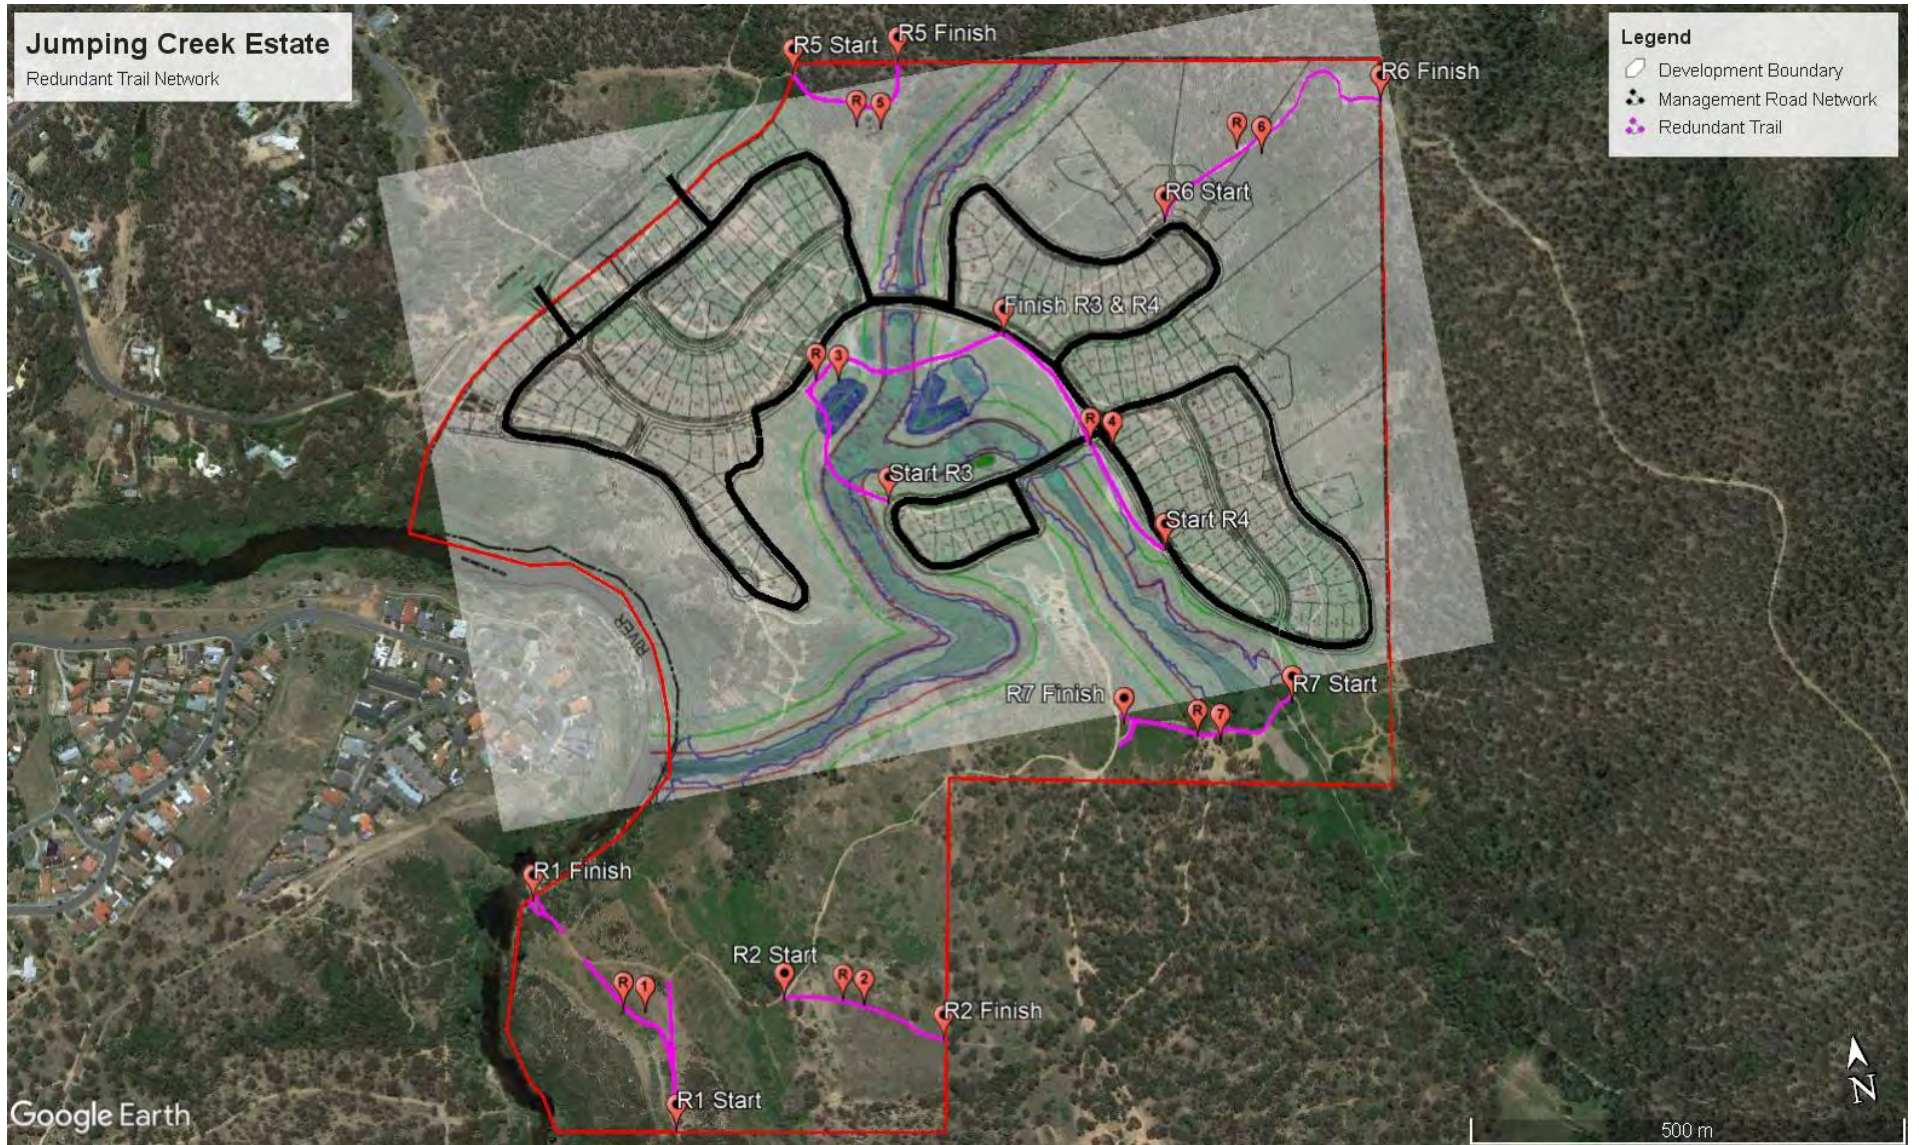
Figure 3: Redundant Trails

Trails which are redundant and a priority for removal and rehabilitation are shown in **Figure 3**.

Removal and rehabilitation effort will reinstate a stable and vegetated surface with permanent soil and water management measures implemented to ensure the ongoing erosion risk is minimised.

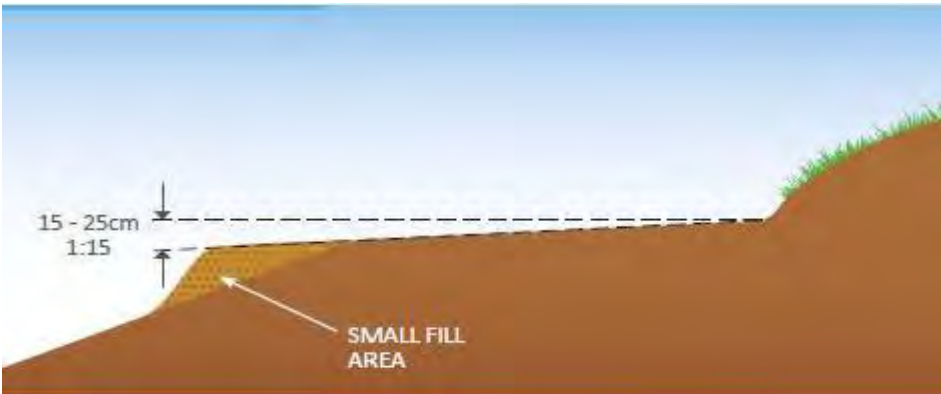
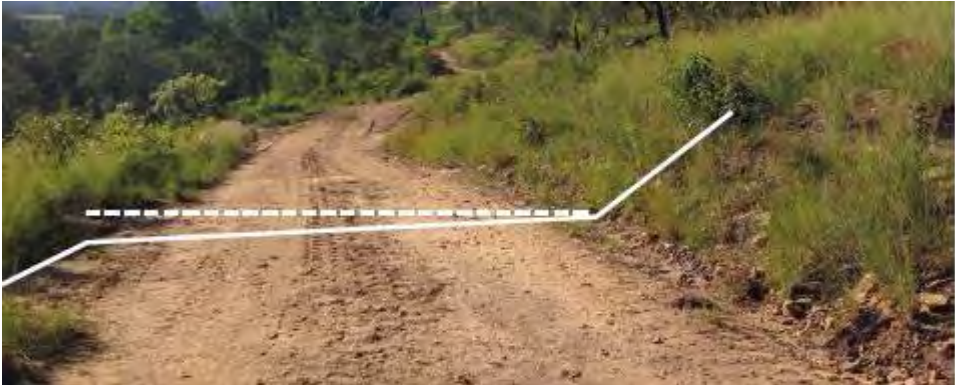
M2	REMEDIAL WORKS
<p>Road drainage crossover banks</p> <p>Start Lat 35.377436 Lon 149.259453</p> <p>End Lat 35.377256 Lon 149.260097</p>	<p>The looped section of the M2 Trail is moderately sloping and includes areas of existing wheel rut erosion and will require the installation of trail drainage works, refer Figure 5 and site coordinates. The trail surface needs to be drained regularly and drainage structures to be installed should include crossover banks. The design and spacing of these features should conform to the <i>NSW RFS Fire Trail Design, Construction and Maintenance Manual</i>.</p>
<p>All weather surface</p> <p>Start Lat 35.376108 Lon 149.259031</p> <p>End Lat 35.376675 Lon 149.259639</p>	<p>The entire length of Trail M2 should be trafficable in all-weather conditions, refer Figure 5. The trail should be topped with a suitable gravel surface. Crossfall drainage is suitable for the sections of trail constructed along the contour as the area is low slope and built on <i>in-situ</i> soil material, refer below.</p>

<p>Trail Cross-Fall Drainage (From RFS 2017)</p> <p>An all-weather surface will make the trail more useable for recreational purposes such as walking and bike riding, as well as making the trail more resilient to future erosion.</p>
