### QUEANBEYAN-PALERANG REGIONAL COUNCIL ORDINARY MEETING OF COUNCIL

ITEM 9.13 MONARO RAIL TRAIL

ATTACHMENT 1 MONARO RAIL TRAIL: TRAIL DEVELOPMENT PLAN STAGE 1A

# MONARO RAIL TRAIL TRAIL DEVELOPMENT PLANS

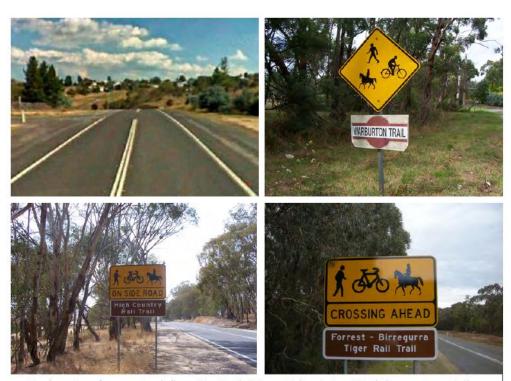
Road crossings often present a challenge. Crossing the Monaro Highway twice at Bombala presents a particular challenge (top left). The suggested solution is to include a large trail name sign at the bottom of the standard trail sign.

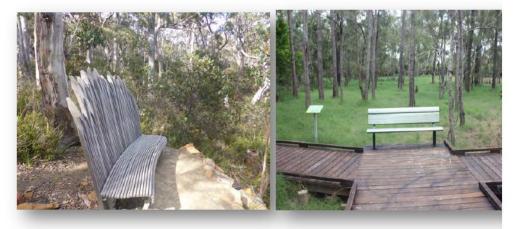
The choice of seating is important. It can really add to the trail user's experience and highlight local material and craftsmanship (above left on Cape Raoul in Tasmania). By way of contrast, the wrong seat in the wrong place facing the wrong way (above right in the John Oxley Reserve in Brisbane) can significantly detract from the user's experience.

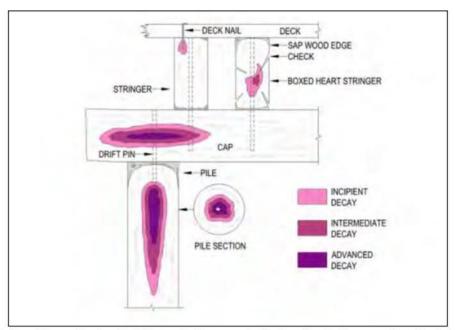
**Figure 3-2** below shows the level of decay typically found due to vertical through bolts. A similar occurrence happens to the base of the pile when they are sitting directly on concrete. The timber soaks up the water from the concrete, which accelerates decay.

Figure 3-2: Shows the level of decay that occurs in timber due to the use of vertical fasteners. Vertical fasteners increase the rate of decay in timber as they allow moisture to travel down the fastener into the heartwood of the headstock (cap), girders (stringers), corbels and piles, therefore increasing the moisture content in the middle of these elements. The heartwood of a log element is less capable of breathing and expelling moisture than the sapwood that surrounds it, so vertical connectors funnel the moisture directly into the heartwood accelerating decay. Once the moisture content exceeds 22%, timber consuming fungi are activated, and the decay process begins.

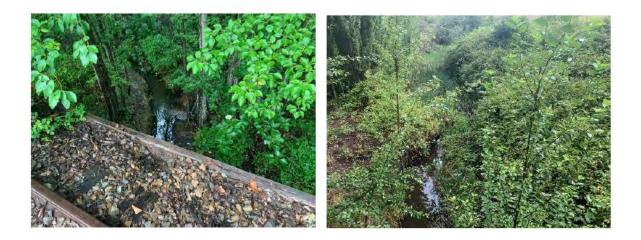
Figure 4-9: Left photo is the general downstream view from bridge deck & photo on the right is the upstream view.

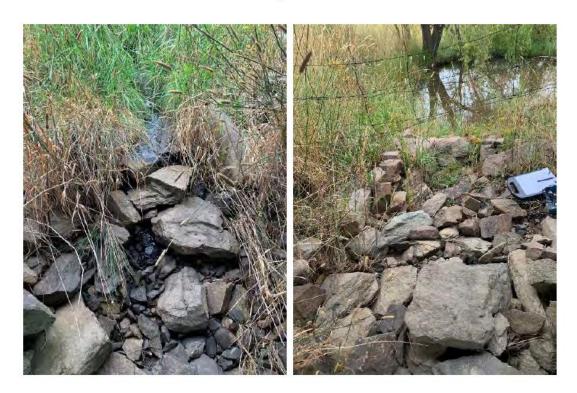
Figure 5-9: View of small inlet creek that trickles through rocks under the span 2 into a pool on the opposite side.

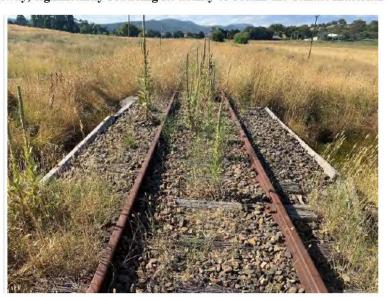
Figure 7-7: The photo above shows the general view down the rail line. Significant overgrown vegetation present through rock ballast and surrounding the substructure. Note:

Ballast is 450mm thick.

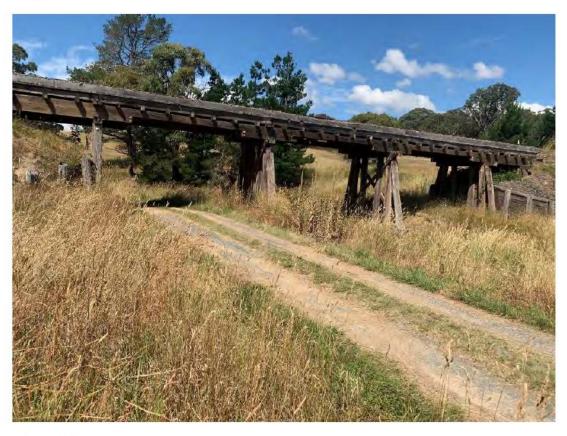
Figure 8-1: General view of Deep Creek Bridge from abutment 1 looking towards abutment 2. The timber bridge is 5 spans long and approximately 32 metres in length (Spans 1 & 5 – 4m and spans 2, 3 and 4 – 8m). Note span 2 passes over the road (4.2m Clearance) and span 3 passes over a creek 2m wide and 0.5m deep.

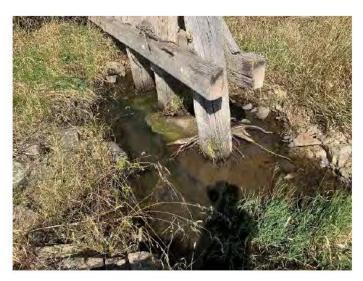
Figure 8-3: General view of pile bent 3 bearing on a concrete sill, piles were found to be in poor to very poor condition. The bottom sections of the timber piles were determined to be a 'hotspot' for decay and determined to be an ideal area to test using non-destructive methods, such as EPHOD® Stress Wave Technology. The timber piles were estimated to produce SWT data ranging between 300-1400µs. Readings above 700µs indicates that there is significant decay present and are required to be monitored. Reading of above 1000µs indicate severe decay is present resulting in the member being unable to support its own dead load.

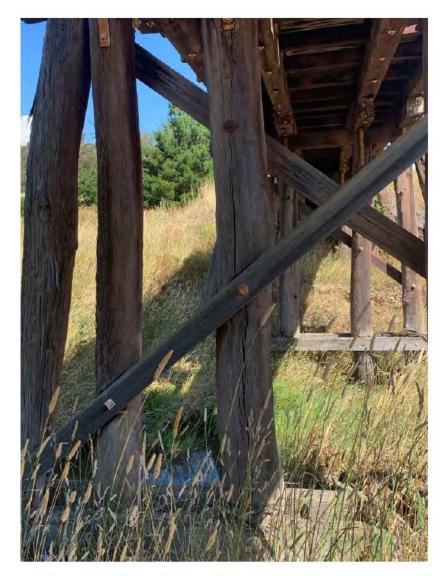
Figure 8-7: View of timber pile and cross bracing connection.

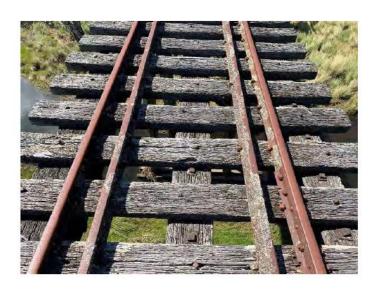
Figure 10-6: Top view of bridge open deck. Transoms and girders can be seen to be in poor to very poor condition, with significant deterioration present in all elements. This is seen to be caused by the vertical connections used in construction. If not sealed appropriately they are seen to funnel water and become moisture traps, when moisture content within timber exceeds 22%, decay causing fungi are activated and the decay process begins. Note: Large cavity around vertical connection in right side photo.

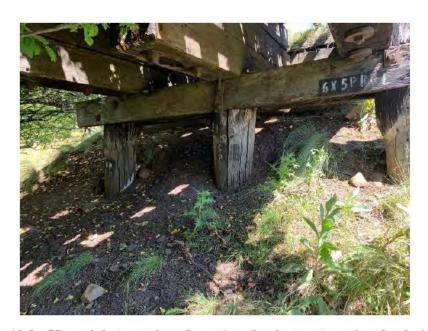
Figure 10-8: View of abutment 2 configuration, the abutment was found to be in poor condition with significant decay present. It was noted that the left two piles had large vertical splits in them, whilst the right pule had significant decay of sapwood.

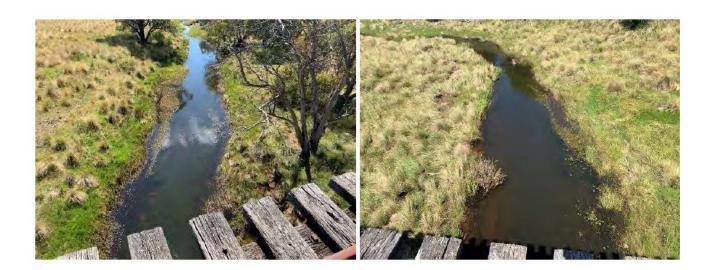
Figure 10-9: Left side image shows the view looking upstream and the right-side image shows the view downstream of the bridge of the edge of the open deck bridge.

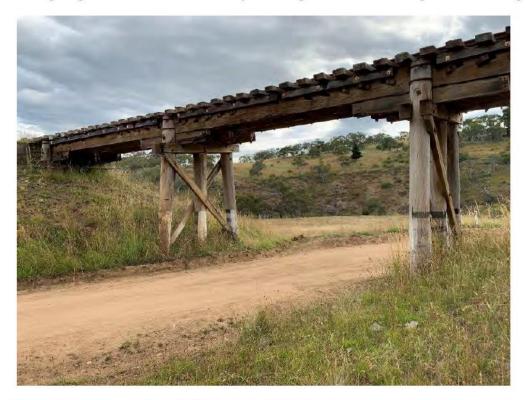
Figure 11-1: General view of Old Bombala Rd Bridge from abutment 1 looking towards abutment 2. The timber bridge is 3 spans long and approximately 22 metres in length (Sp1=7.8m, SP2=6.8m & SP3=6.6m). Note span 2 passes over the road (4.1m Clearance).

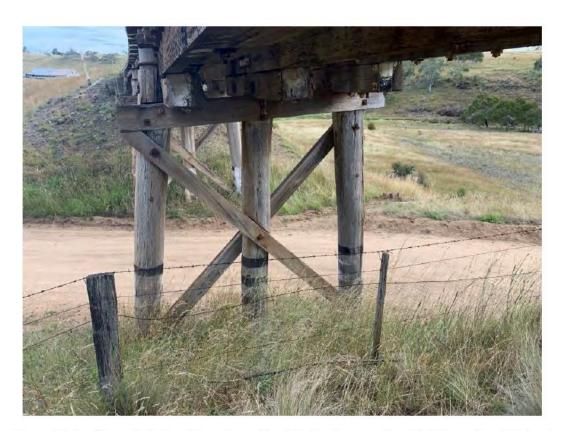
Figure 11-2: View of pile bent 1 configuration. The bents comprise of 3 driven piles. Pile bent 2 and 3 are supported by cross bracing. The two abutments do not contain the cross bracing but are supported by sheeting planks to retain backfill. It was noted that several piles and headstocks have started to undergo decay. It can be seen on pile 3 significant sapwood decay occurring.

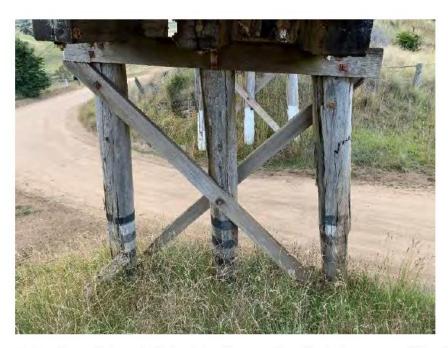
Figure 11-3: General view of pile bent 2. piles were found to be in poor condition. With significant sapwood decay present in all piles, it was noted that all piles have large vertical splits through the horizontal connections. The bottom sections of the timber piles were determined to be a 'hotspot' for decay due to increased moisture retained by the overgrown vegetation.

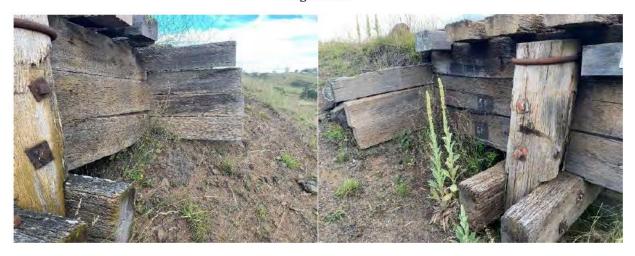
Figure 11-4: The images above show the condition of the breast wall at AB2. The abutment sheeting was found to be in fair condition with minor decay of the sapwood present. The headstock ends were in poor condition with decay and cracking present.

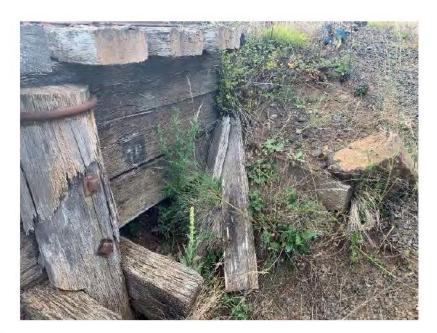
Figure 11-5: View of abutment 1, found to be in poor condition with major decay of sapwood present in piles and broken/missing elements in abutment sheeting.

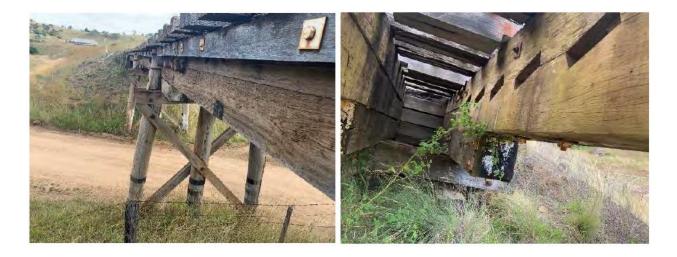
Figure 11-6: A view of girders formation and condition. Girders were found to be in fair to poor condition, the left photo shows a horizontal crack that is seen to be progressively increasing in size. The right photo shows sapwood decay of the internal girders.

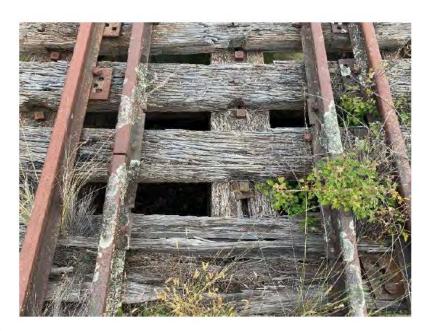
Figure 11-7: View of the bridge open deck, transom sleepers were found to be in poor to very poor condition with significant decay, cavities and severely damaged members present throughout. It was noted that the vertical connections to the top girders were seen to funnel moisture and increase the moisture content present in both elements causes significant decay. When the moisture content exceeds 22%, timber consuming fungi are activated, and the decay process begins. Top girders were found to be in poor to very poor condition.

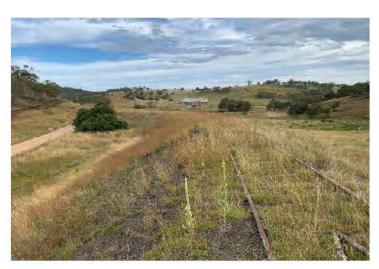
Figure 11-8: View of overgrown approach.

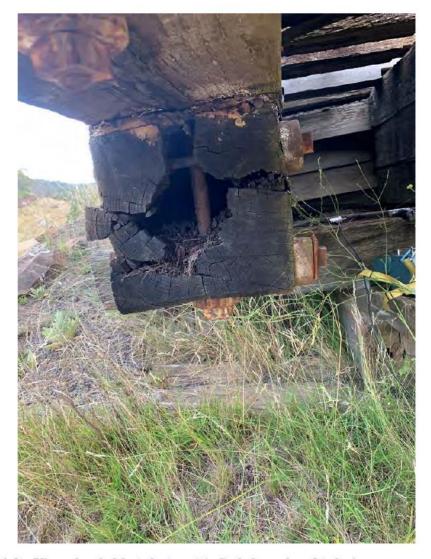
Figure 11-9: View of corbel 3 at abutment 1, Corbel was found to be in very poor condition with a large cavity present in the end. The vertical connection is visible highlighting the depth. The corbel needs replacement due to multiple failure points. Note the vertical fastener has split the corbel and the anti-splitter bolts have done the same thing. So many of these old details contributed to higher maintenance costs and reduced longevity.

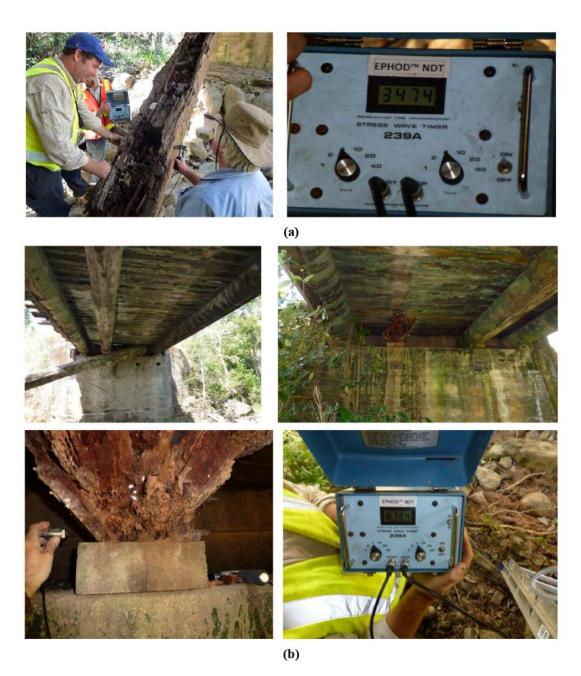
This rating was based on a small sample size of NDT field data collected and it is highly recommended to conduct a detailed inspection of the entire bridge. See **Figure 12-1** and **Appendix A** for more detail about this technology. This will gain a higher level of accuracy for the recommended repair options listed and costed in **Sections 4.3, 5.3, 6.3, 7.3, 8.3, 9.3, 10.3 & 11.3.**

Figure 12-1: Photos showing global failure of a timber log girders. Both failures were caused by advanced decay in the ends of the girders and transverse shear failures. The primary cause of this decay was due to vertical fasteners. These failures were found in elements with SWT values in the 3k  $\mu s$  (photos a. above) to 6k  $\mu s$  range (photos b. below). Typically, similar bending extreme tensile fibre failures in log girders occur in zones of decay where there are over 2k  $\mu s$  SWT values. Similarly, if vast portions of the log girder have SWT values over 3k  $\mu s$  the failures may occur.
