EROSION CONTROL PLAN

Jumping Creek QUEANBEYAN

Version 3

29 January 2019

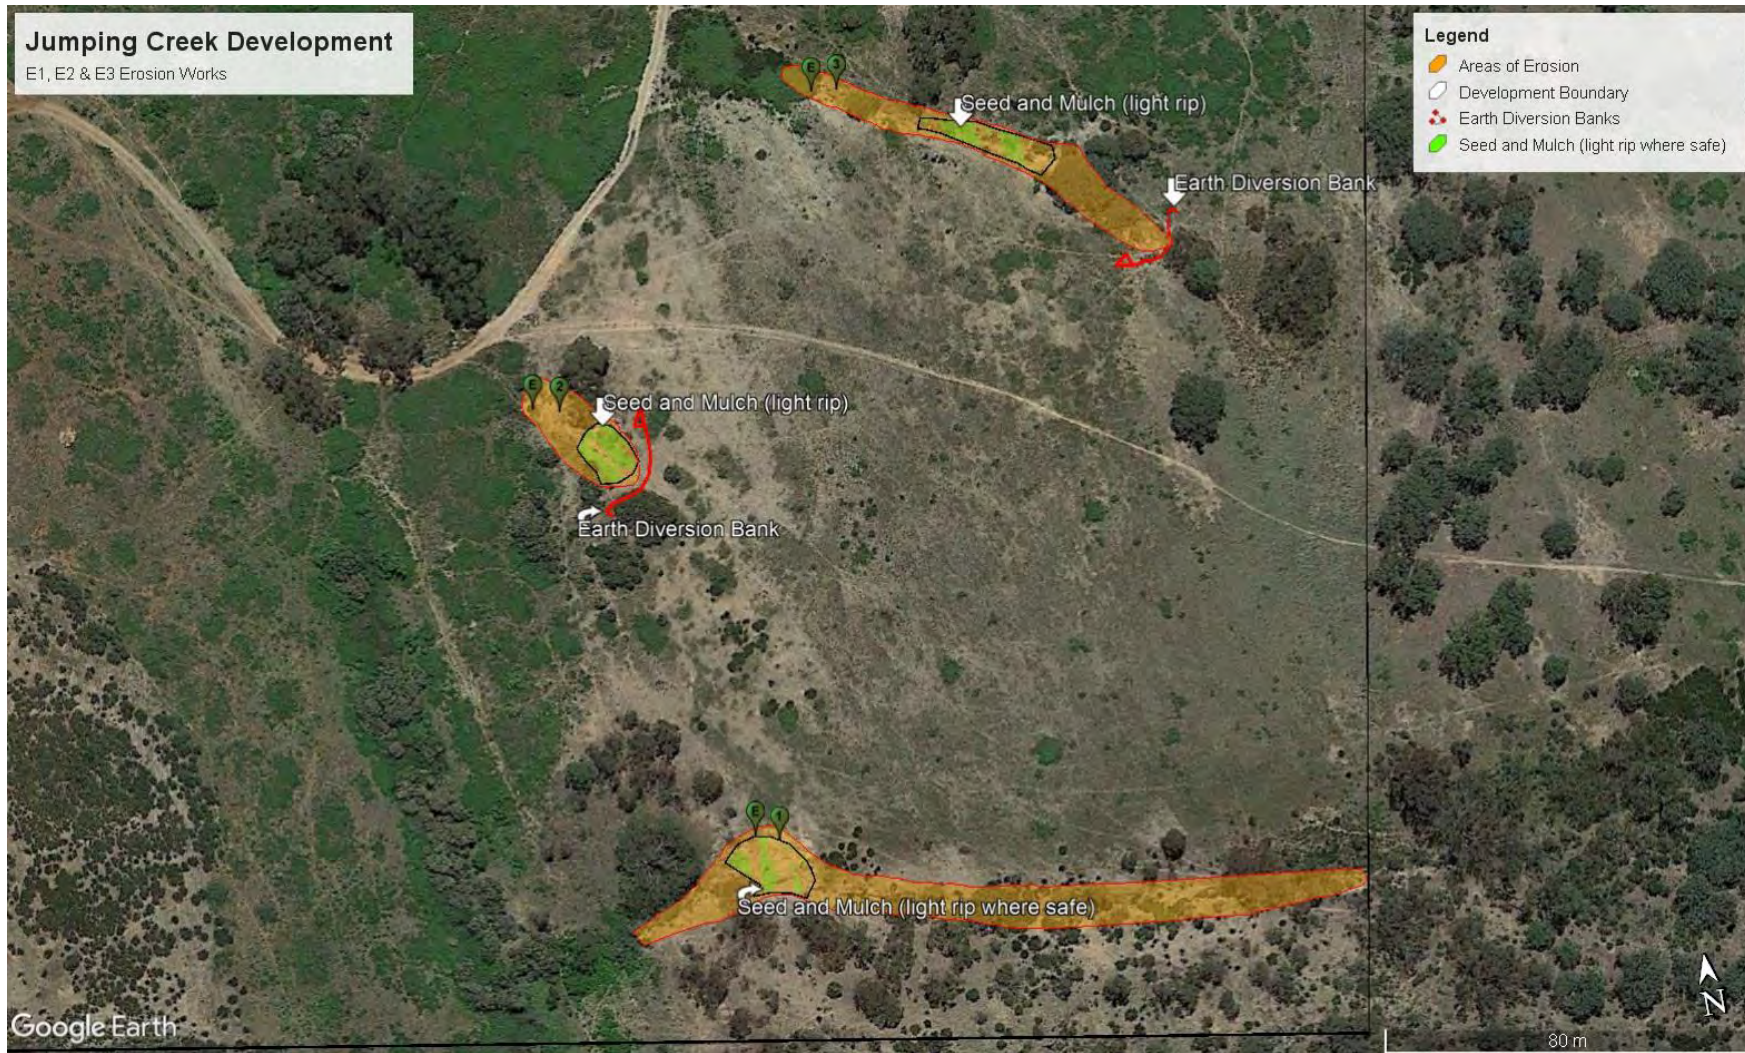
Figure 2: E1, E2 and E3 Erosion Works

E1 – Erosion Area				
SITE REF & LOCATION Lat/Long	DESCRIPTION	STATUS Active (Severe, Moderate, Minor) or Stable	REMEDIAION PRIORITY High/Medium/Low	REMEDIAION OPTION
<p>E1</p>

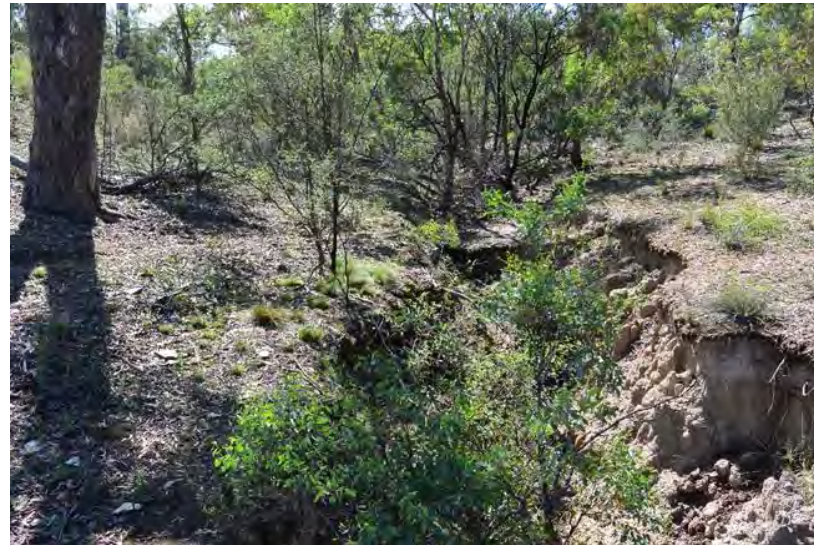
DSC 3809: Extensive native vegetation in the riparian zone

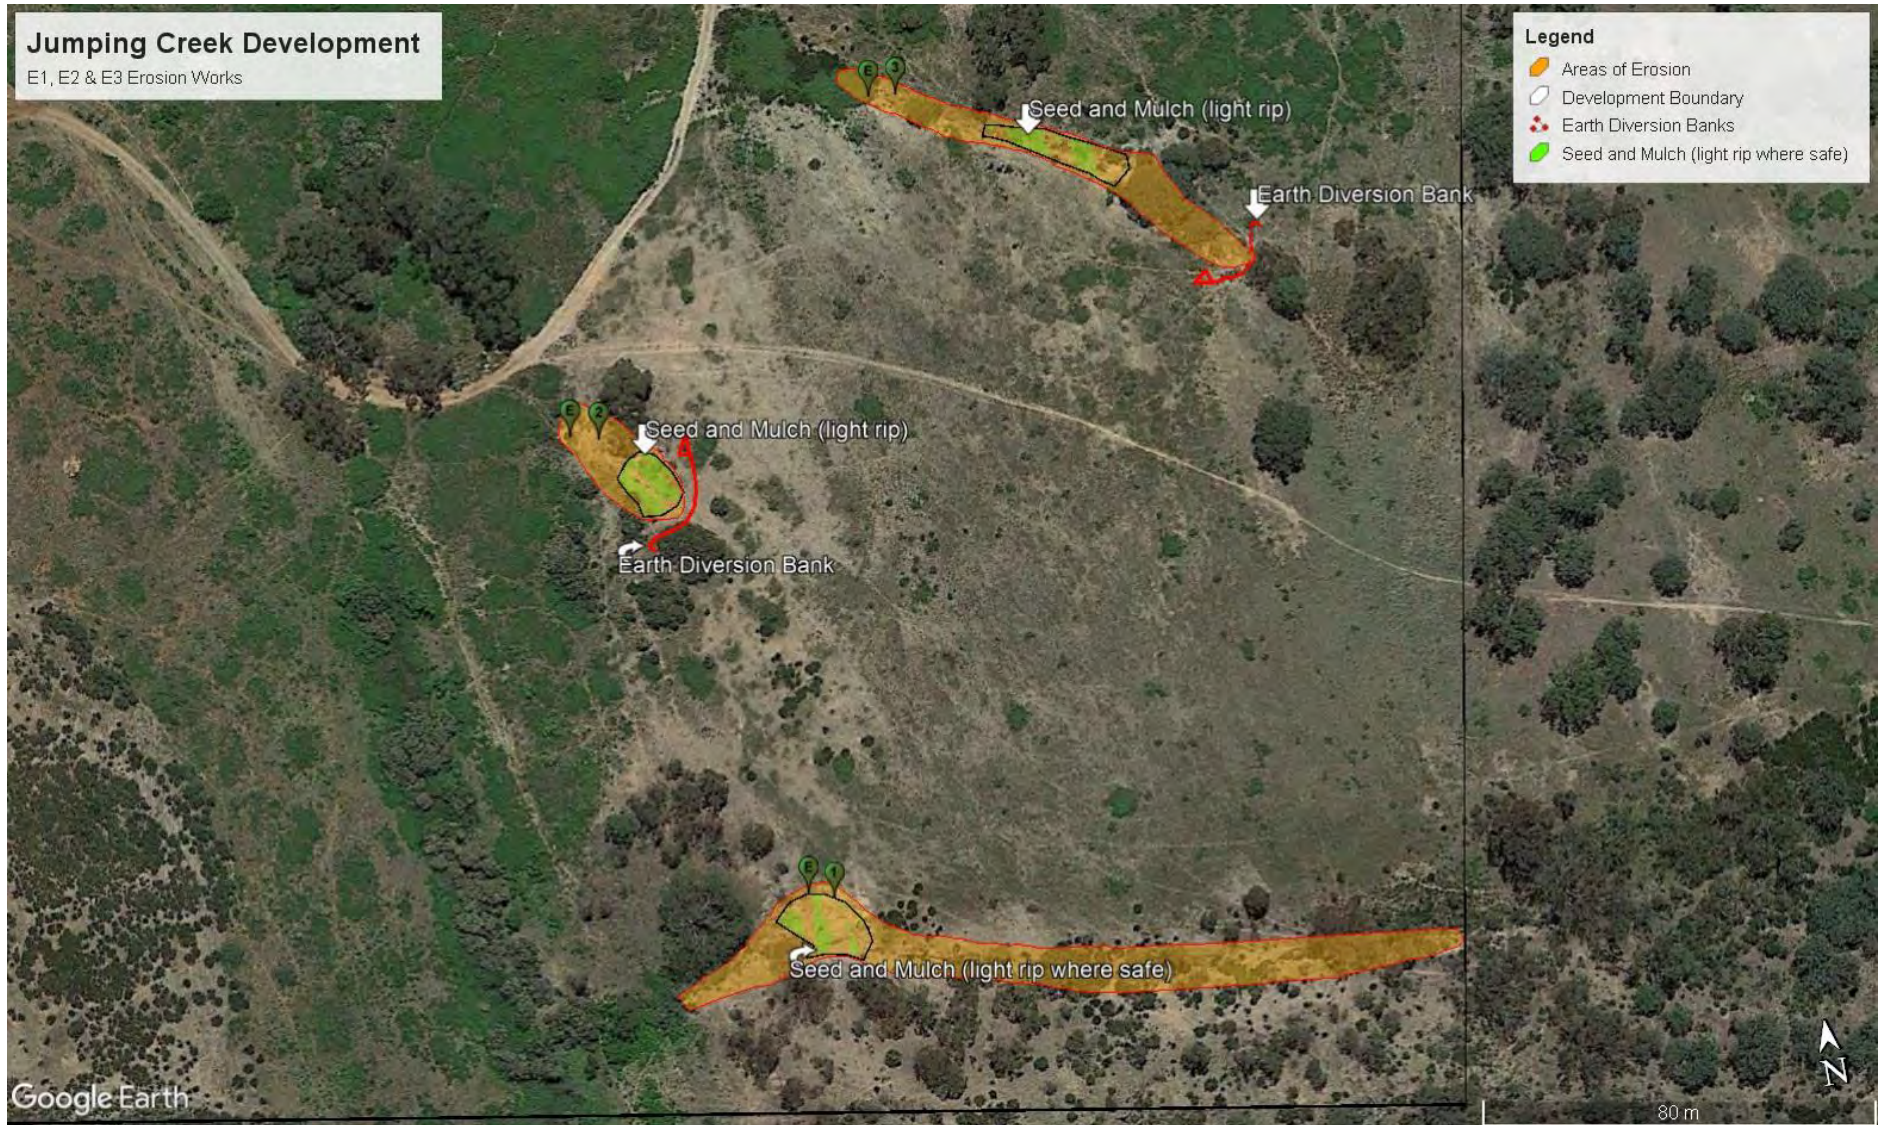
Figure 3: E1, E2 and E3 Erosion Works

E2 – Erosion Area				
SITE REF & LOCATION Lat/Long	DESCRIPTION	STATUS Active (Severe, Moderate, Minor) or Stable	REMEDIAION PRIORITY High/Medium/Low	REMEDIAION OPTION
<p>E2</p>

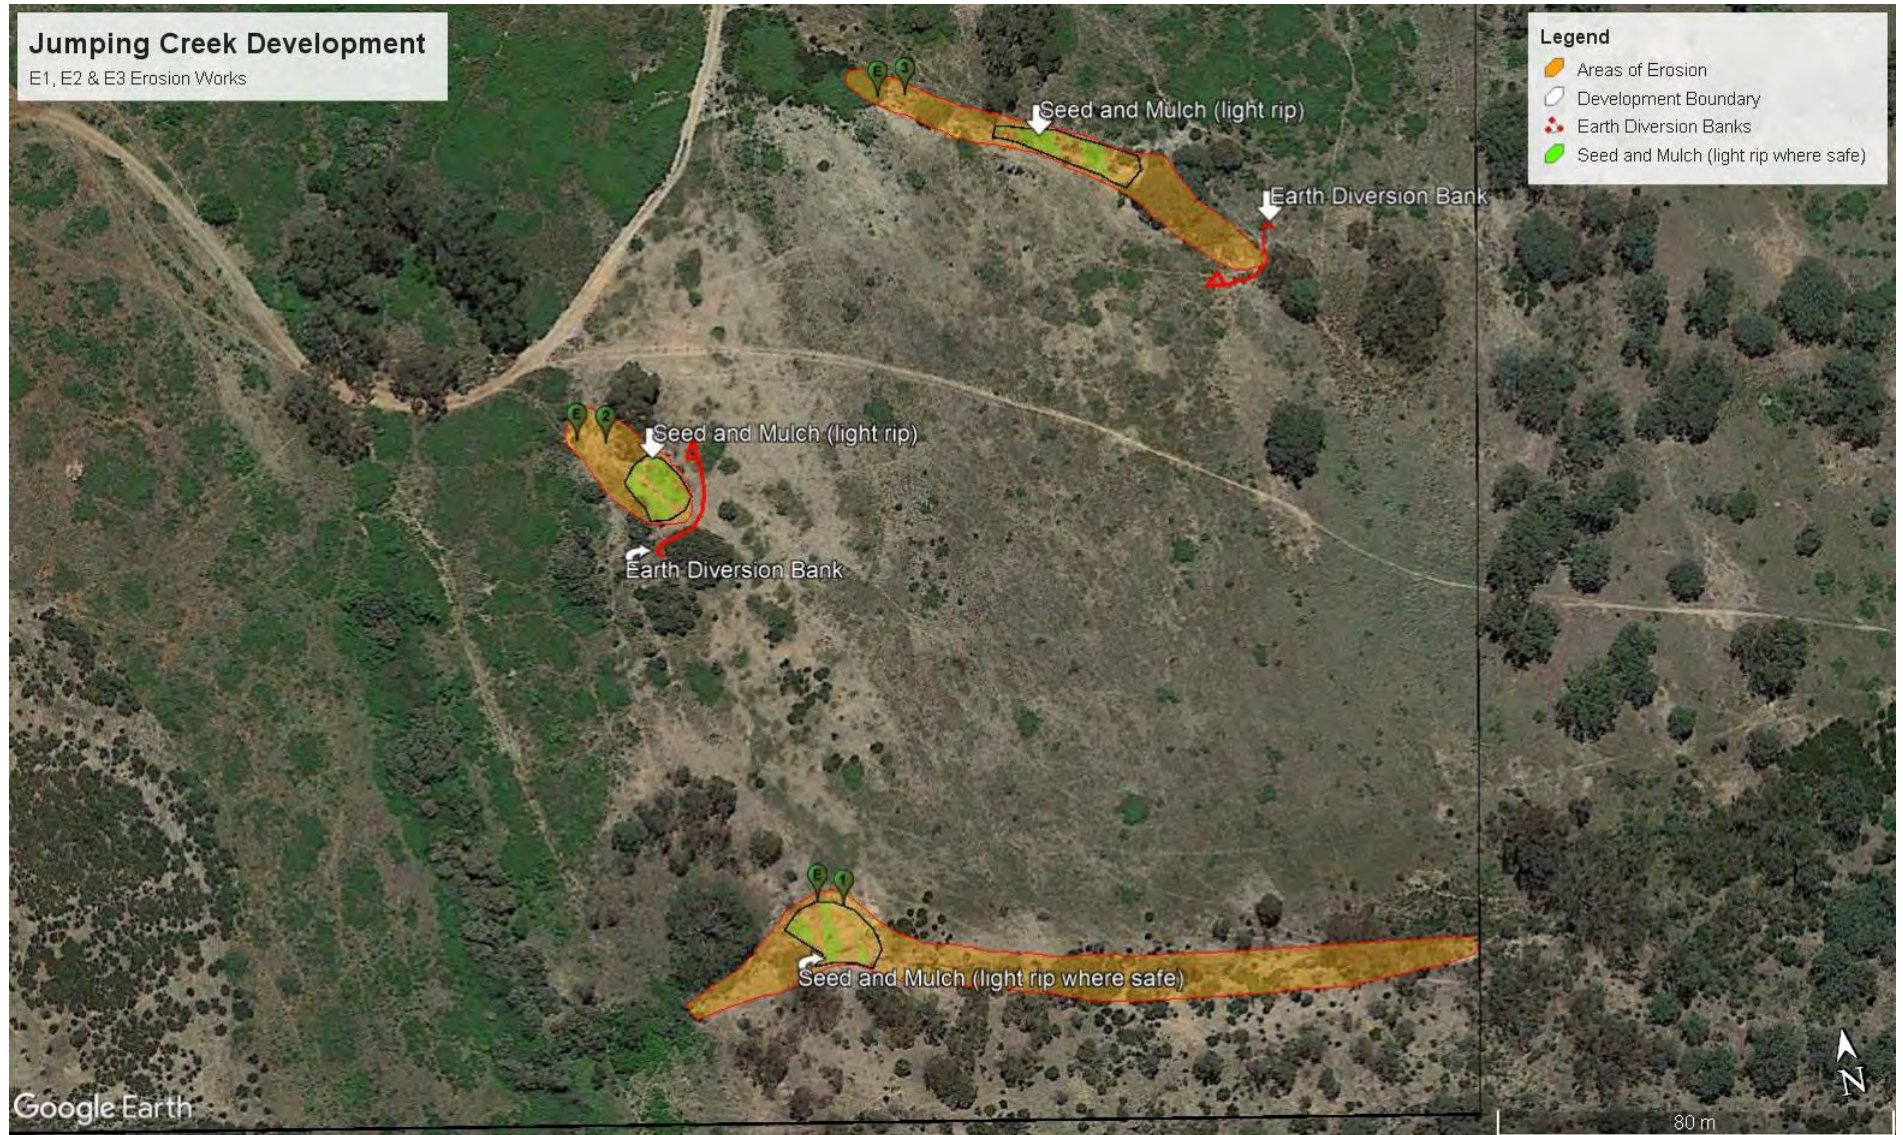
Figure 4: E1, E2 and E3 Erosion Works

E3 – Erosion Area				
SITE REF & LOCATION Lat/Long	DESCRIPTION	STATUS Active (Severe, Moderate, Minor) or Stable	REMEDIAION PRIORITY High/Medium/Low	REMEDIAION OPTION
<p>E3</p>

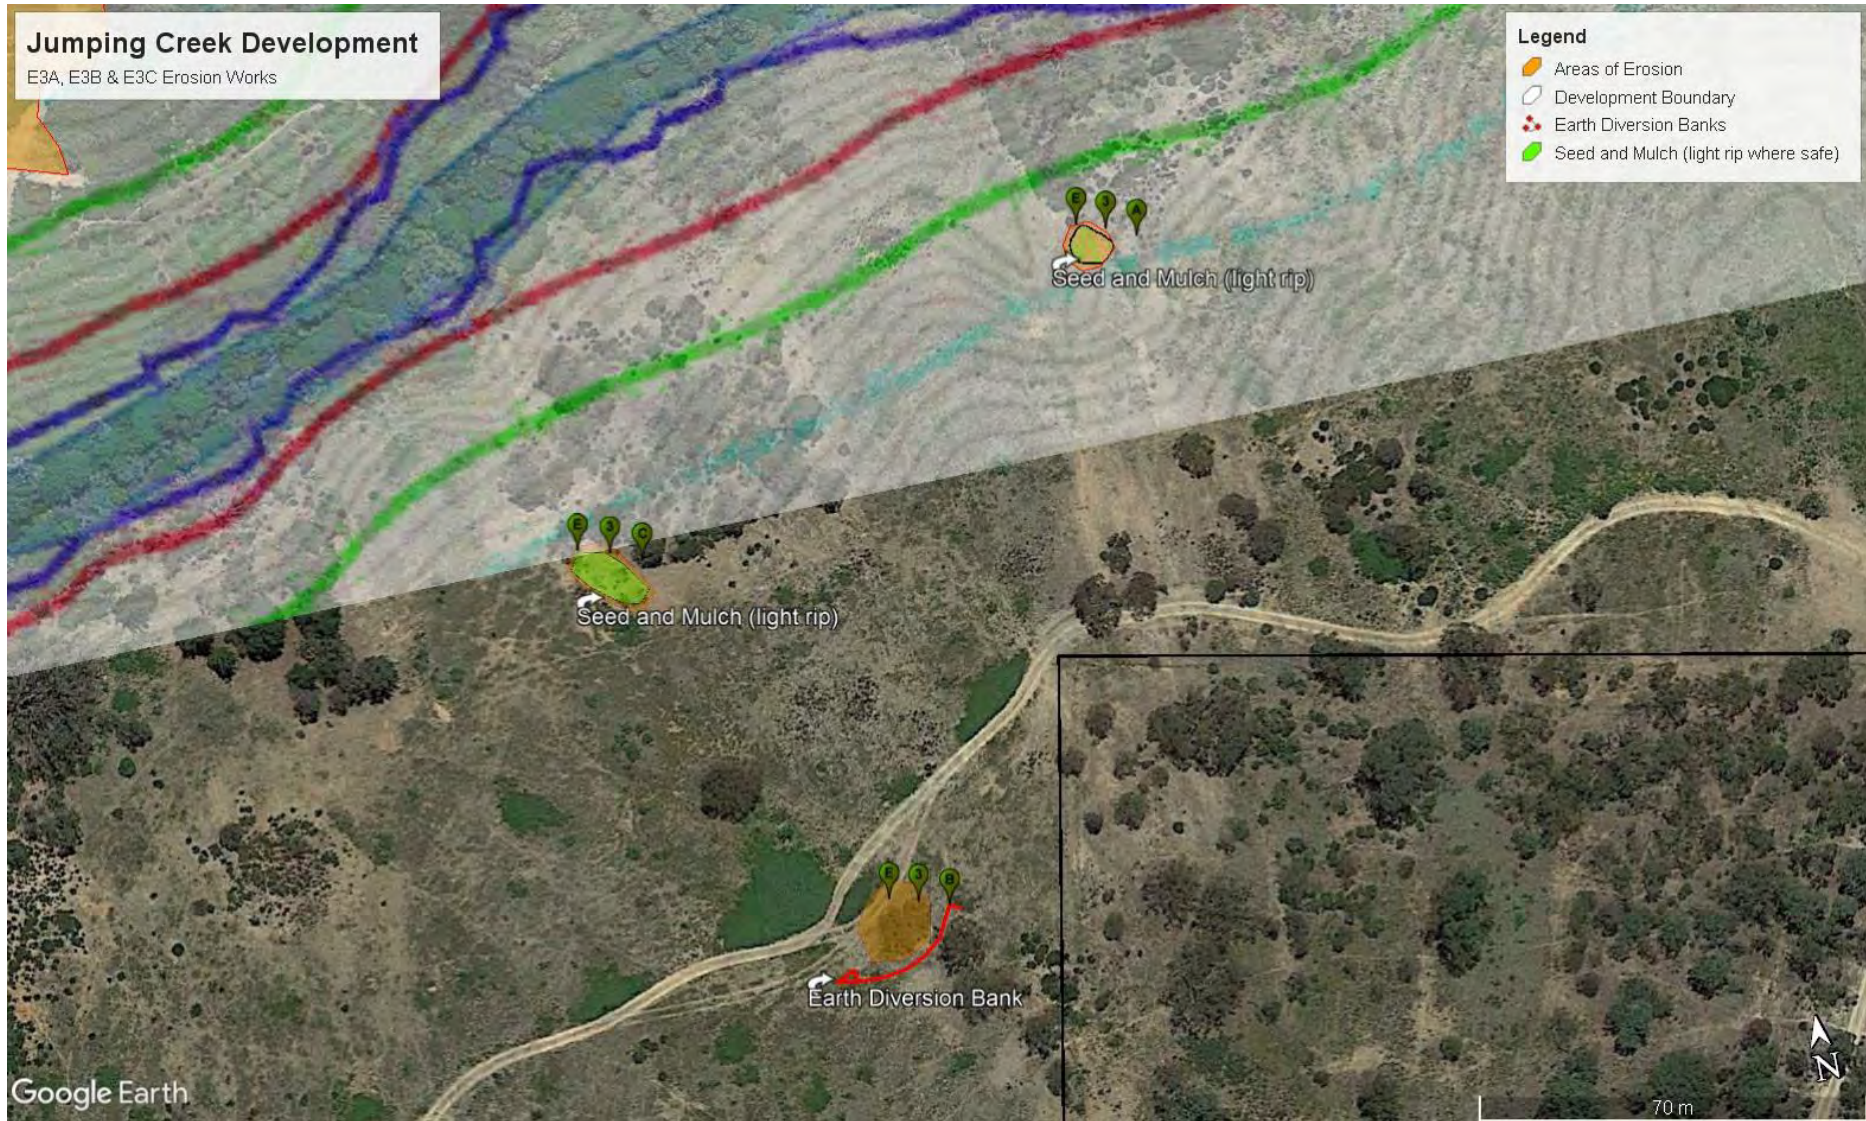
Figure 5: E3A, E3B & E3C Erosion Works

E3A, B & C – Erosion Areas				
SITE REF & LOCATION Lat/Long	DESCRIPTION	STATUS Active (Severe, Moderate, Minor) or Stable	REMEDIATION PRIORITY High/Medium/Low	REMEDIATION OPTION
<p>E3A</p> <p>Lat -35.376405 Lon 149.254887</p>	<p>Small area of gully erosion in minor drainge depression</p>

<p>E3C: Active gully head and banks</p>	<p>Minor active gully and bank erosion</p>	<p>Medium</p>	<p>Lightly scarify the area below the gully head and along the areas of bare bank, then seed and mulch areas</p>
---	---	--	---------------	--

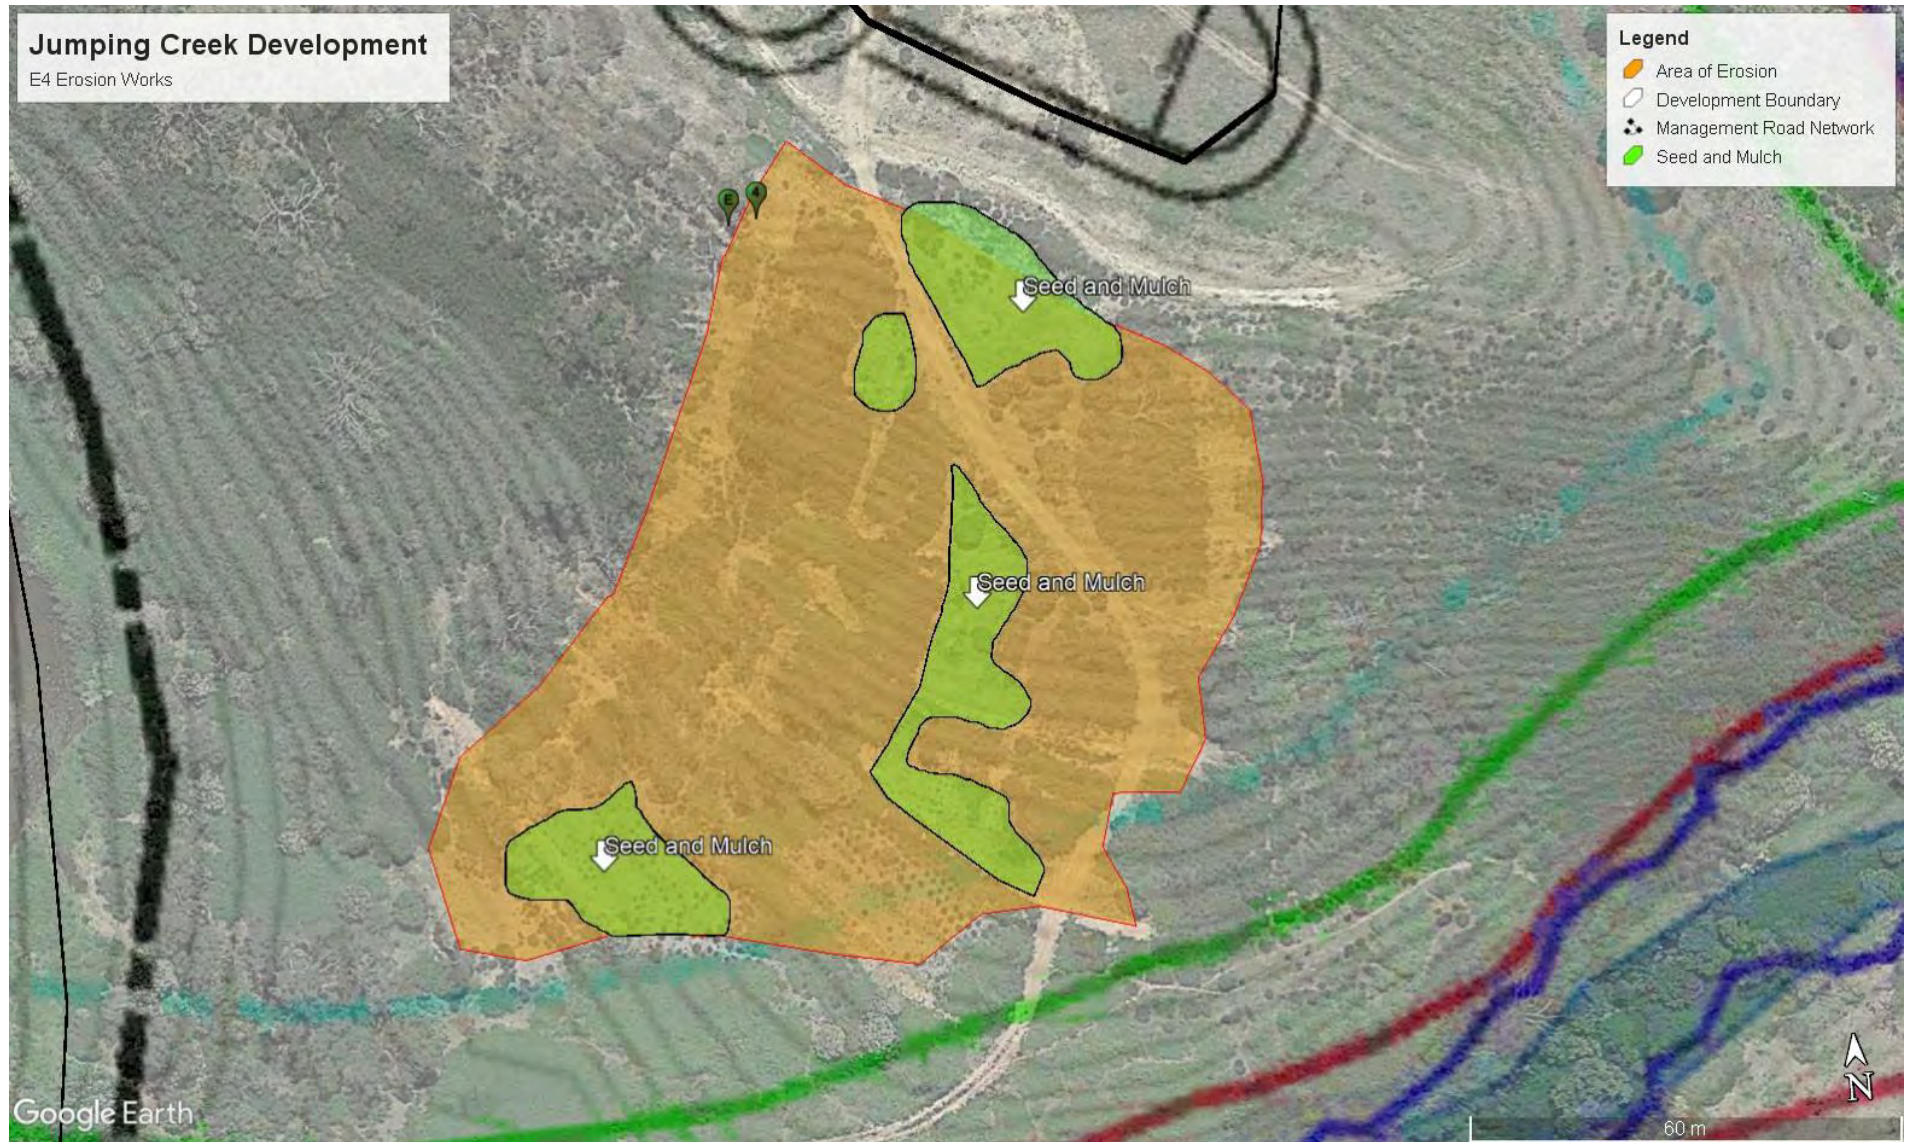
Figure 6: E4 Erosion Works

E4 – Erosion Area				
SITE REF & LOCATION Lat/Long	DESCRIPTION	STATUS Active (Severe, Moderate, Minor) or Stable	REMEDATION PRIORITY High/Medium/Low	REMEDATION OPTION
E4 Lat -°35.376043 Lon °149.251654	Extensive area of steep slope with historical erosion and soil erosion earthworks in place. Erosion created by four-wheel driving tracks up and down the steep slopes.	Small localised areas of active erosion however mostly stable.	Medium (due to high erosion risk and damage to expensive erosion control infrastructure if minor maintenance is not undertaken).	Maintain existing erosion control infrastructure by cleaning sediment out of channels and building up freeboard (height) of banks where these have been degraded. Fill areas of minor rill erosion with loose rock and topsoil. Seed and mulch bare areas to reduce sheet and rill erosion

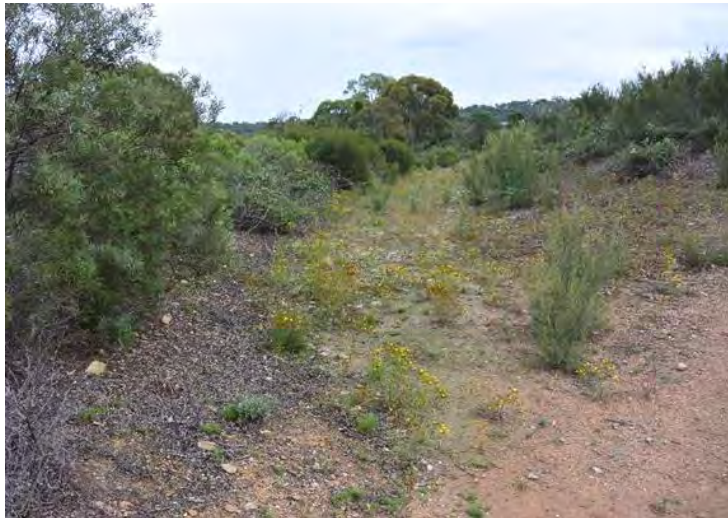
DSC 3766: Well vegetated erosion control earthworks

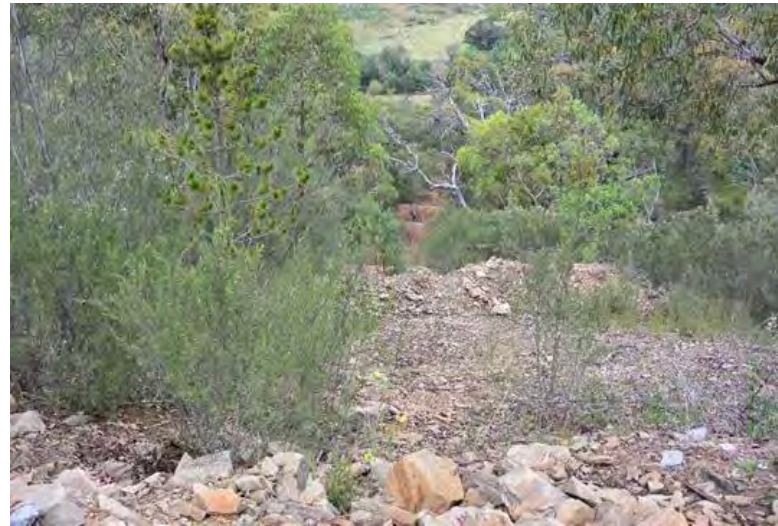
DSC 3767: Erosion control earthworks

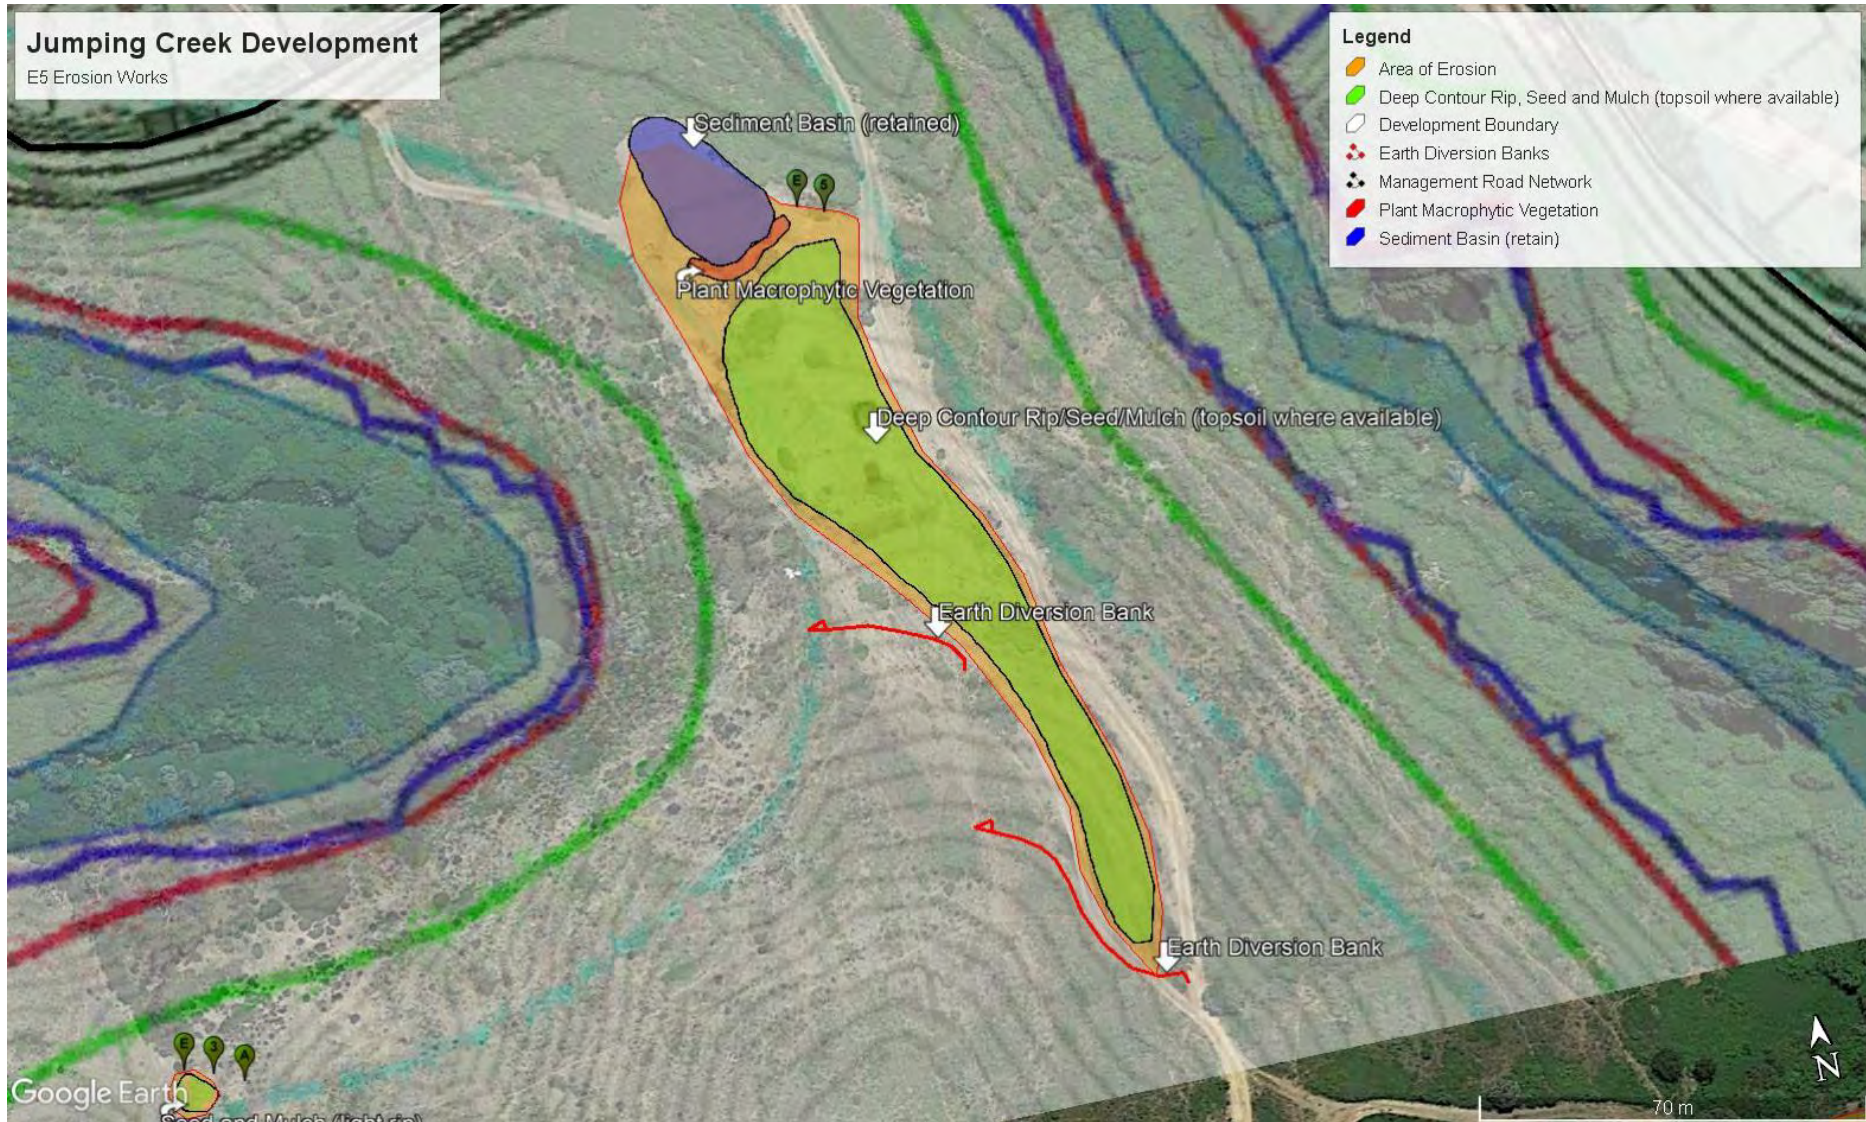
Figure 7: E5 Erosion Works

E5 – Erosion Area				
SITE REF & LOCATION Lat/Long	DESCRIPTION	STATUS Active (Severe, Moderate, Minor) or Stable	REMEDIATION PRIORITY High/Medium/Low	REMEDIATION OPTION
<p>E5</p> <p>Lat -35.375649° Lon 149.256613°</p>	<p>Gravel quarry with erosion emanating from the large area of bare subsoil and degraded bedrock material.</p>	<p>Moderately active sheet and rill erosion across most of the site</p>	<p>Medium (site drains internally to a small sediment basin reducing immediate impact on nearby watercourse)</p>	<p>Construct small earth diversion banks upslope of the gravel quarry to divert clean runoff away from the site and reduce erosion potential. Deep rip the bed of the quarry on the contour to reduce runoff and retain sediment. Where available topsoil the base of the quarry to promote revegetation. Seed and mulch the area with suitable groundcover and shrub species, refer Vegetation Management Plan. Retain the sediment detention basin and enhance the filtering capacity by planting macrophytes in the shallow backwater of the storage.</p>

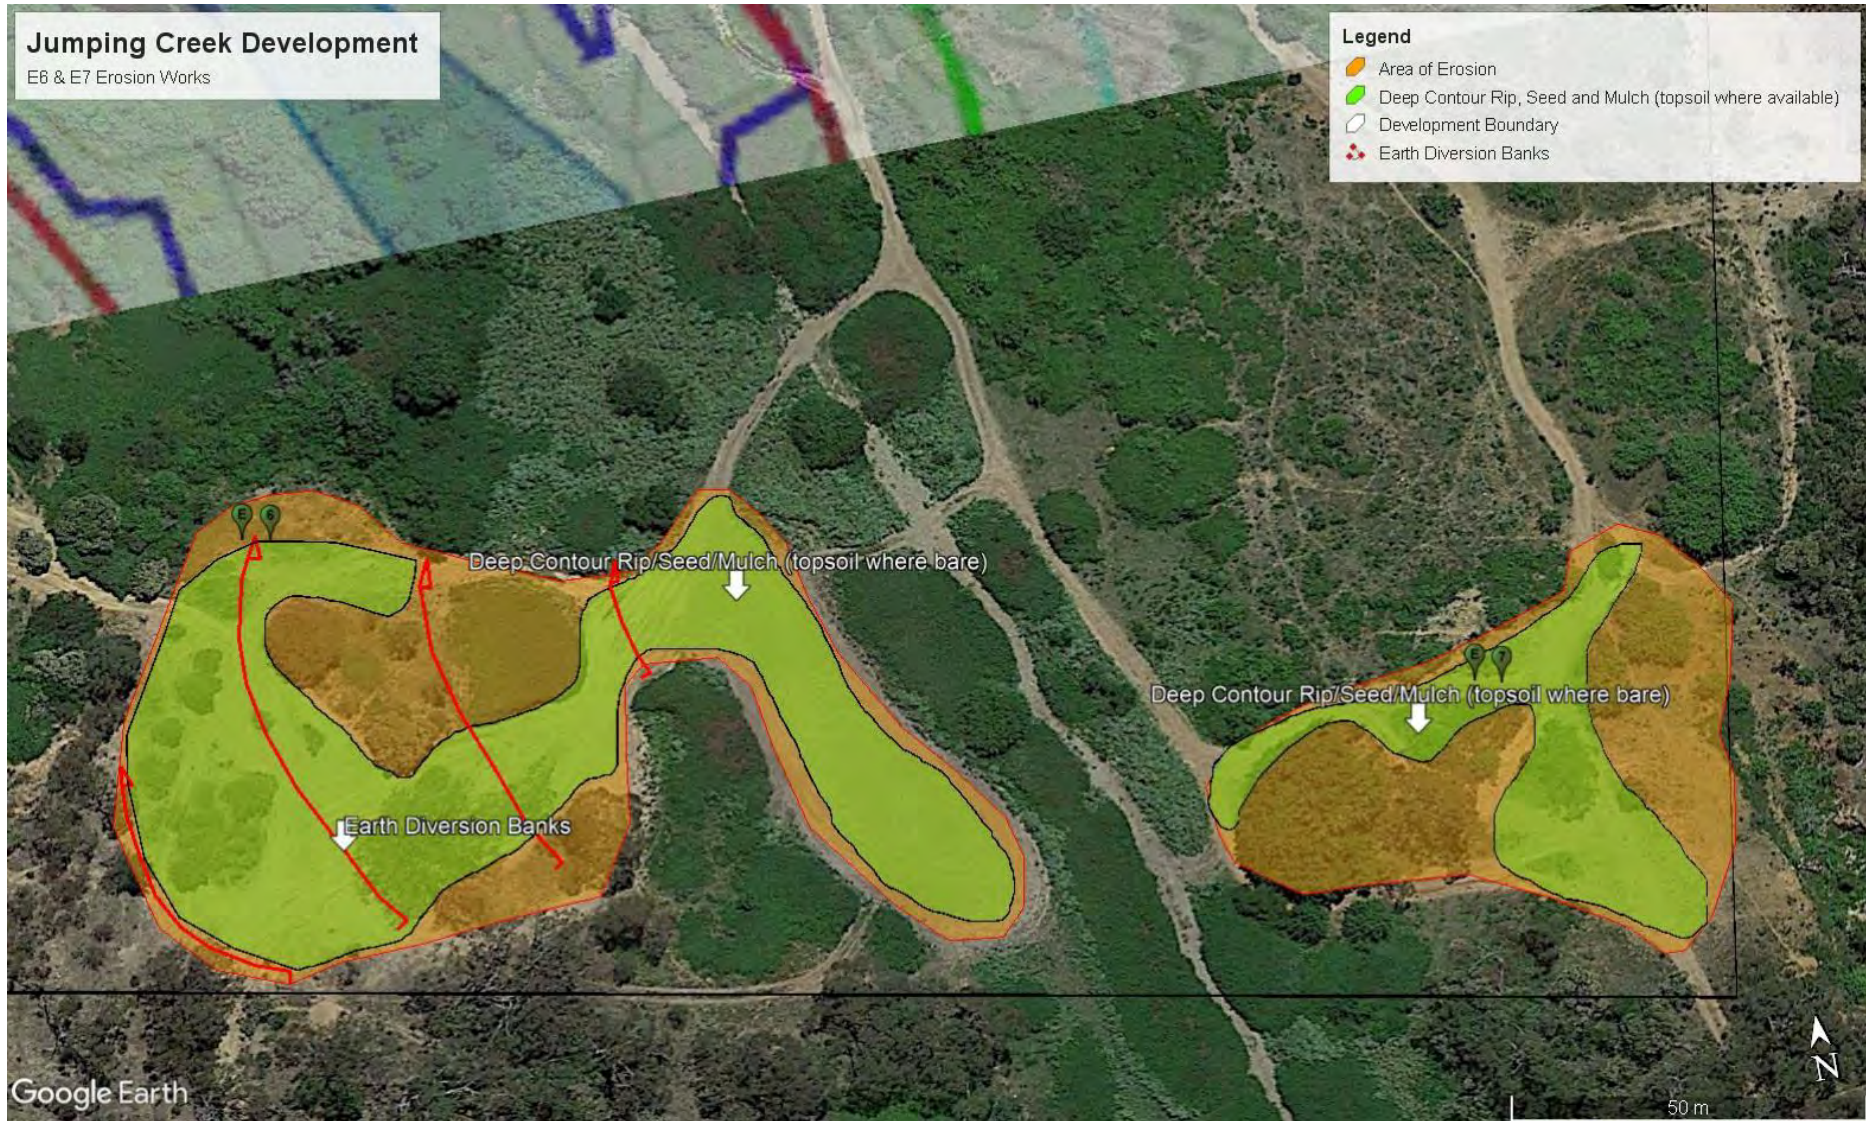
Figure 8: E6 & E7 Erosion Works

E6 – Erosion Area				
SITE REF & LOCATION Lat/Long	DESCRIPTION	STATUS Active (Severe, Moderate, Minor) or Stable	REMEDIATION PRIORITY High/Medium/Low	REMEDIATION OPTION
<p>E6</p> <p>Lat -35.376894° Lon 149.258879°</p>	<p>Extensive area of sheet and rill erosion formed by the concentration of track and trails and vehicle traffic on steep slopes. Includes an extensive area of bare creek flats below flood level</p>	<p>Active moderate to severe erosion.</p>

<p>DSC 3830: Extensive bare area with sheet and rill erosion</p>	<p>High (large extent of erosion and proximity to creek resulting in direct mobilisation of sediment to watercourse)</p>	<p>Construct an earth diversion bank to direct upslope runoff away from the site. Construct multiple graded banks across the site to control local water and convey this to a safe disposal area. Shape and deep contour rip the site below and between banks. Where possible import topsoil and spread on areas which have eroded to the subsoil level. Seed the area with suitable species, refer Vegetation Management Plan. Mulch all bare seeded areas to reduce erosion and promote germination.</p>

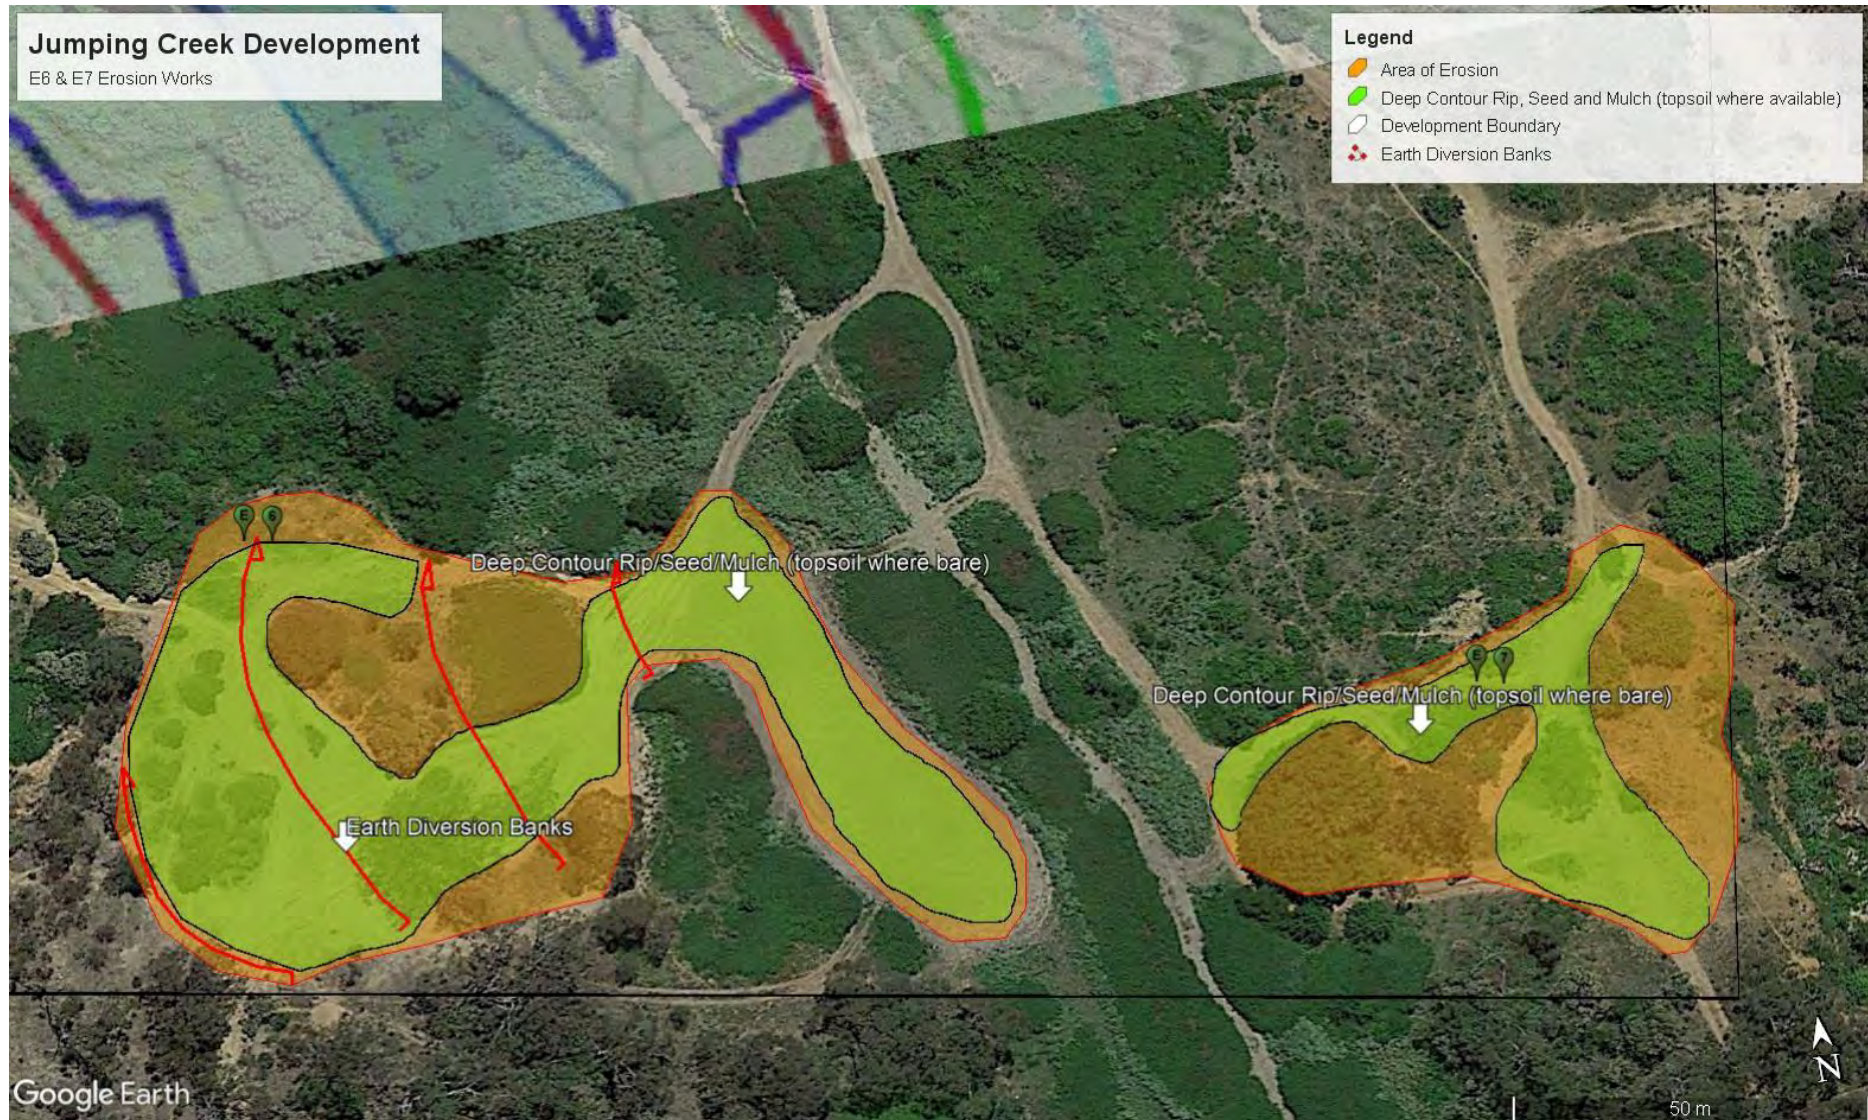
Figure 9: E6 & E7 Erosion Works

E7: Erosion Area				
SITE REF & LOCATION Lat/Long	DESCRIPTION	STATUS Active (Severe, Moderate, Minor) or Stable	REMEDIAION PRIORITY High/Medium/Low	REMEDIAION OPTION
<p>E7</p>

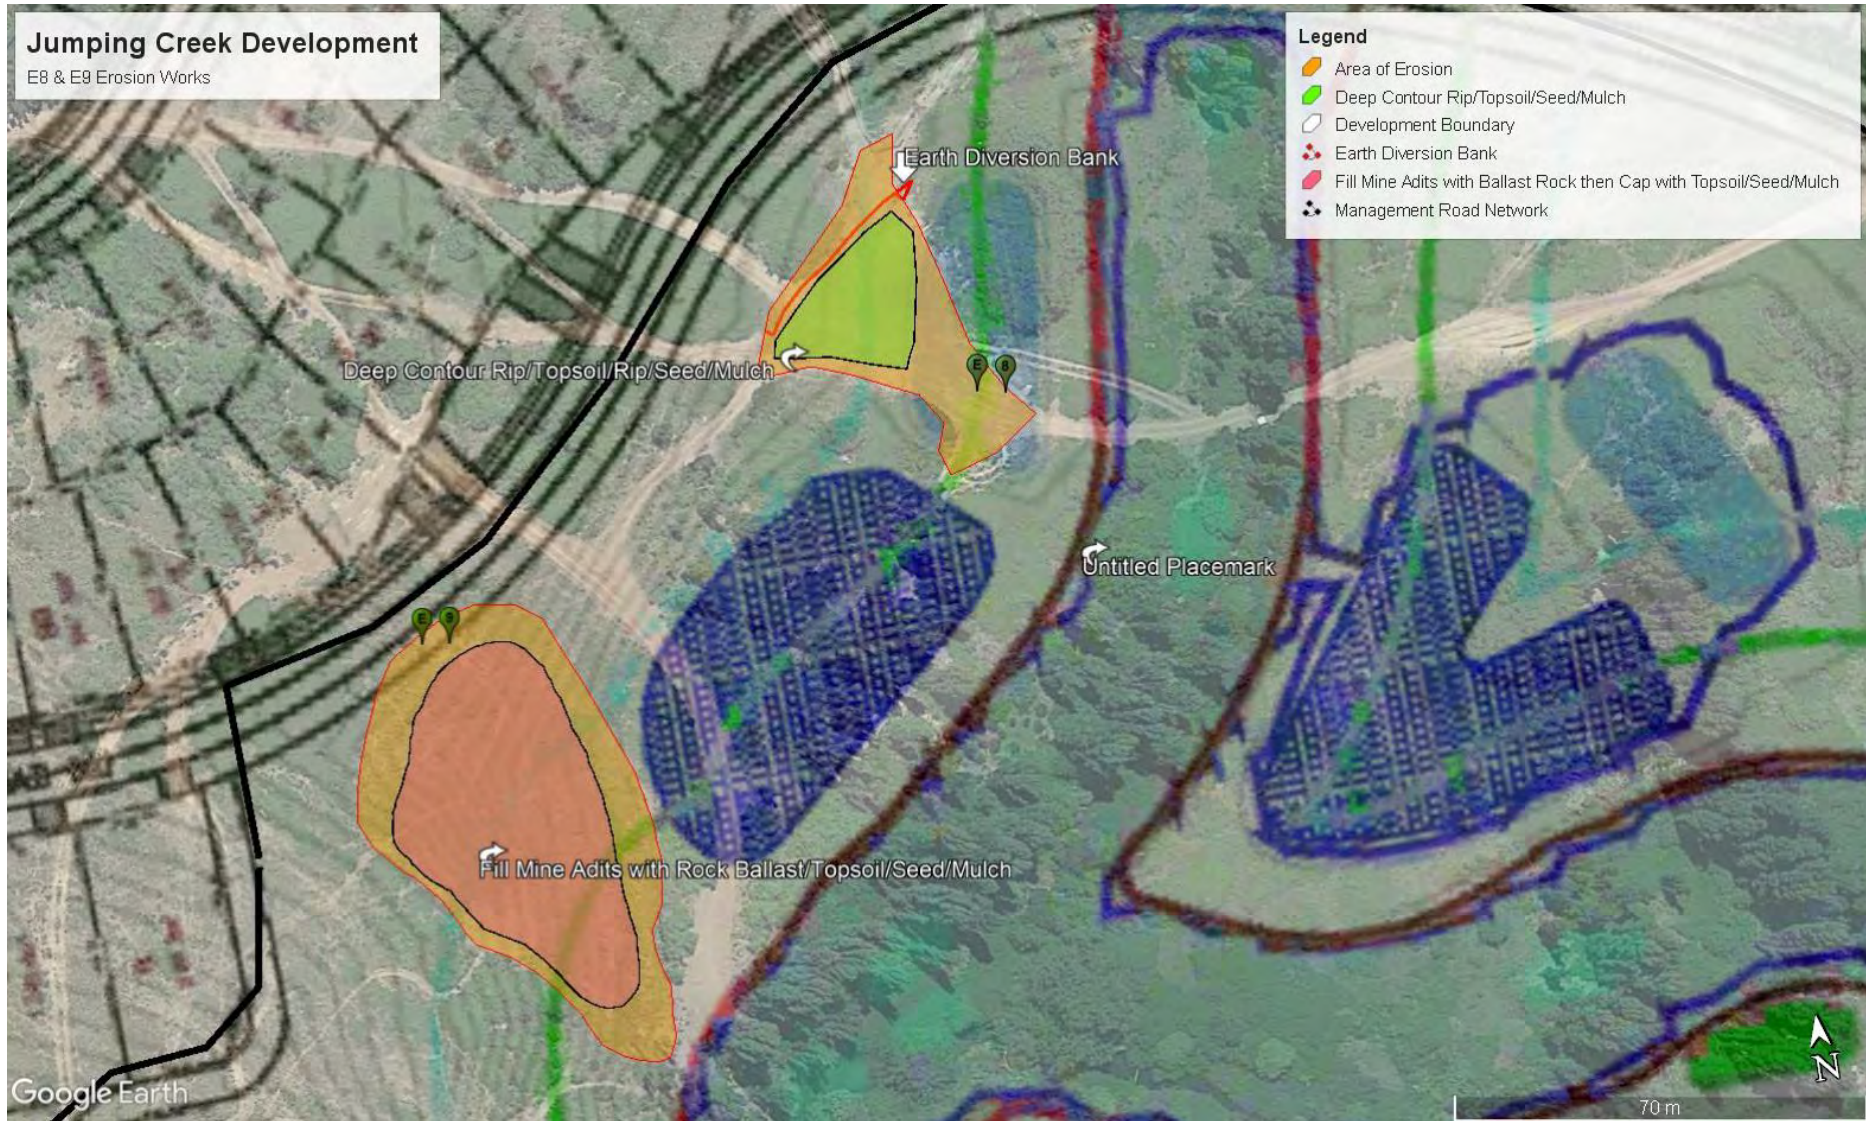
Figure 10: E8 & E9 Erosion Works

E8: Erosion Area				
SITE REF & LOCATION Lat/Long	DESCRIPTION	STATUS Active (Severe, Moderate, Minor) or Stable	REMEDATION PRIORITY High/Medium/Low	REMEDATION OPTION
<p>E8</p>

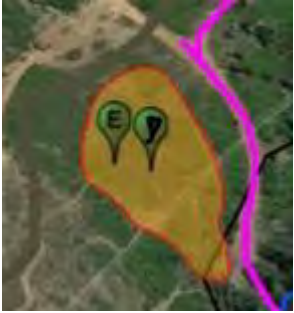
<p>Lat -35.375432° Lon 149.252395°</p>	<p>Historical mine site with small areas of bare ground and various mine adits. Largely vegetated however still presents a safety hazard</p>	<p>Stable (minor erosion risk but active safety risk)</p>
