Proposed cemetery site, Old Cooma Road, Googong: Hydrogeological Assessment

Queanbeyan-Palerang Regional Council

Project Name	Old Cooma Road, Googong Groundwater Studies – Cemetery and Crematorium
Project Number	18SYD_12109
Project Manager	Richard Cresswell
Prepared by	Richard Cresswell
Reviewed by	Johan Du Plooy
Approved by	Richard Cresswell
Status	Final
Version Number	1
Last saved on	21 May 2020

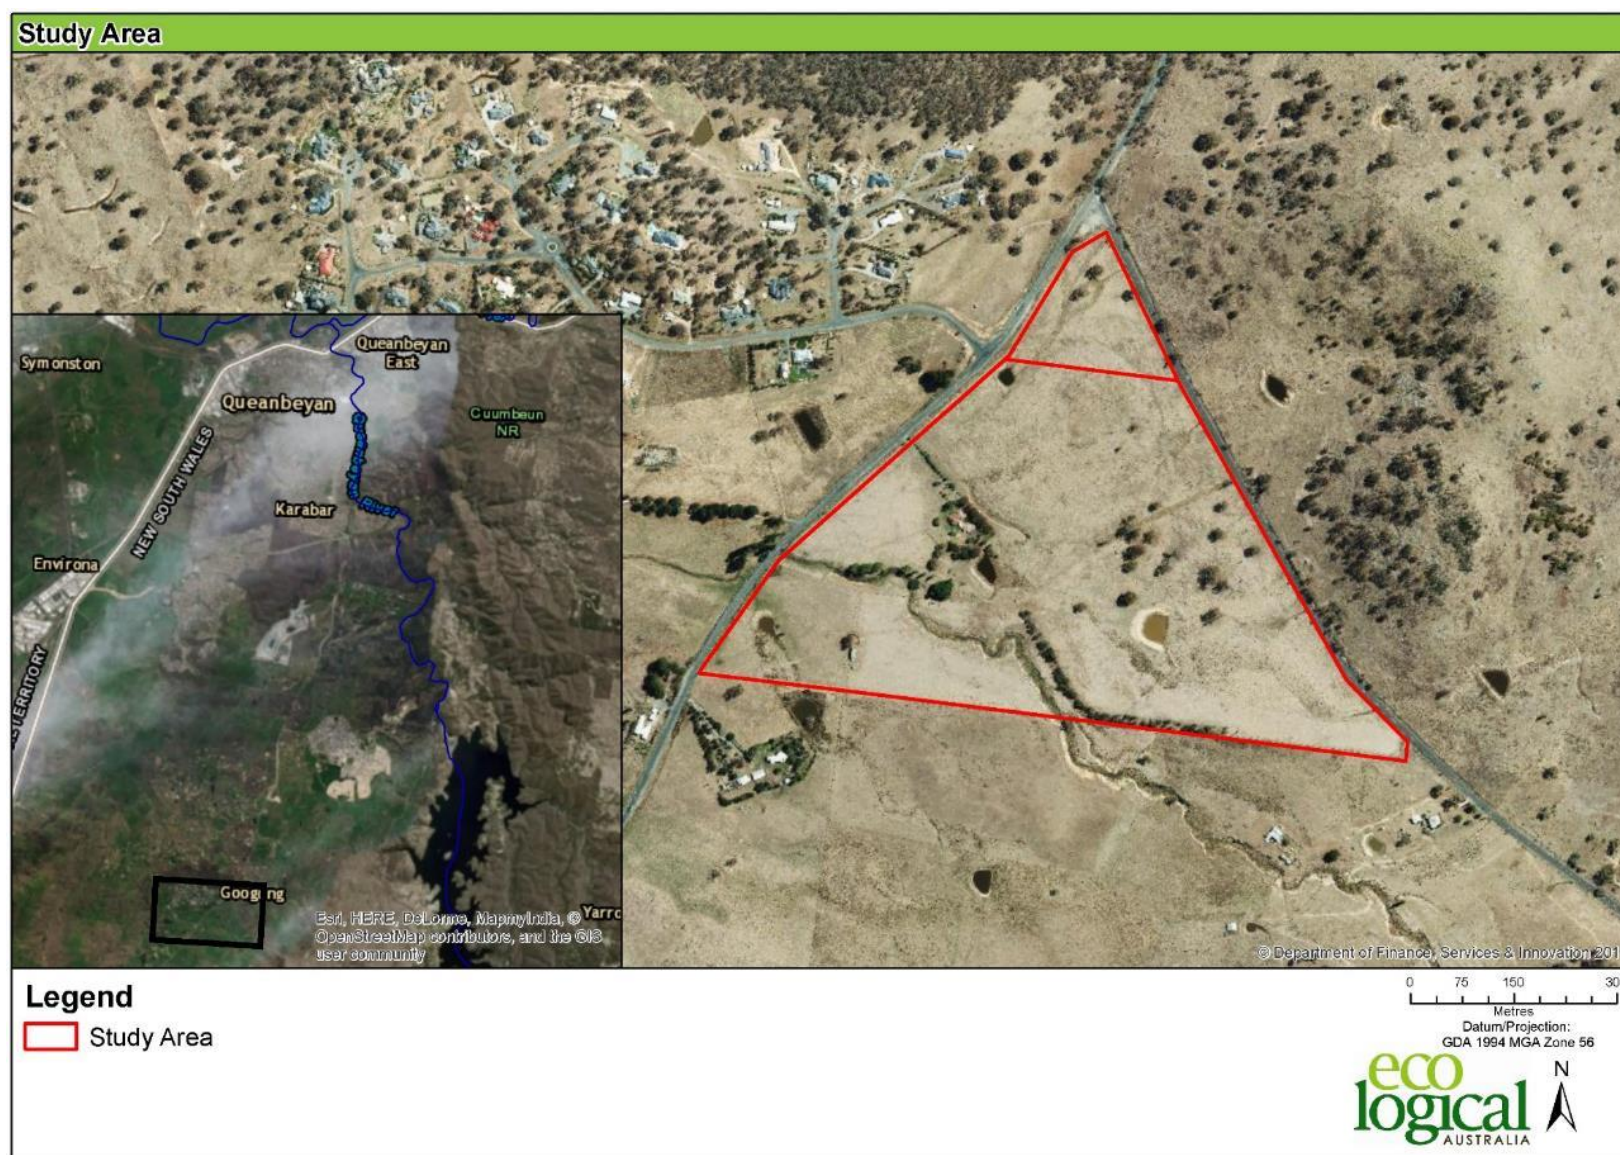
Figure 1-1: Study Area (the line across the top shows two lots associated with this site)

The study area is approximately 36.4 hectares and is located approximately 11 kilometres south-west of Queanbeyan, and approximately 5 km west of the Queanbeyan River (Figure 1-1). The Site is triangular in shape and bounded by Old Cooma Road to the west and Burra Road to the east. The Burra Road – Old Cooma Road intersection is located at the northern point of the site.

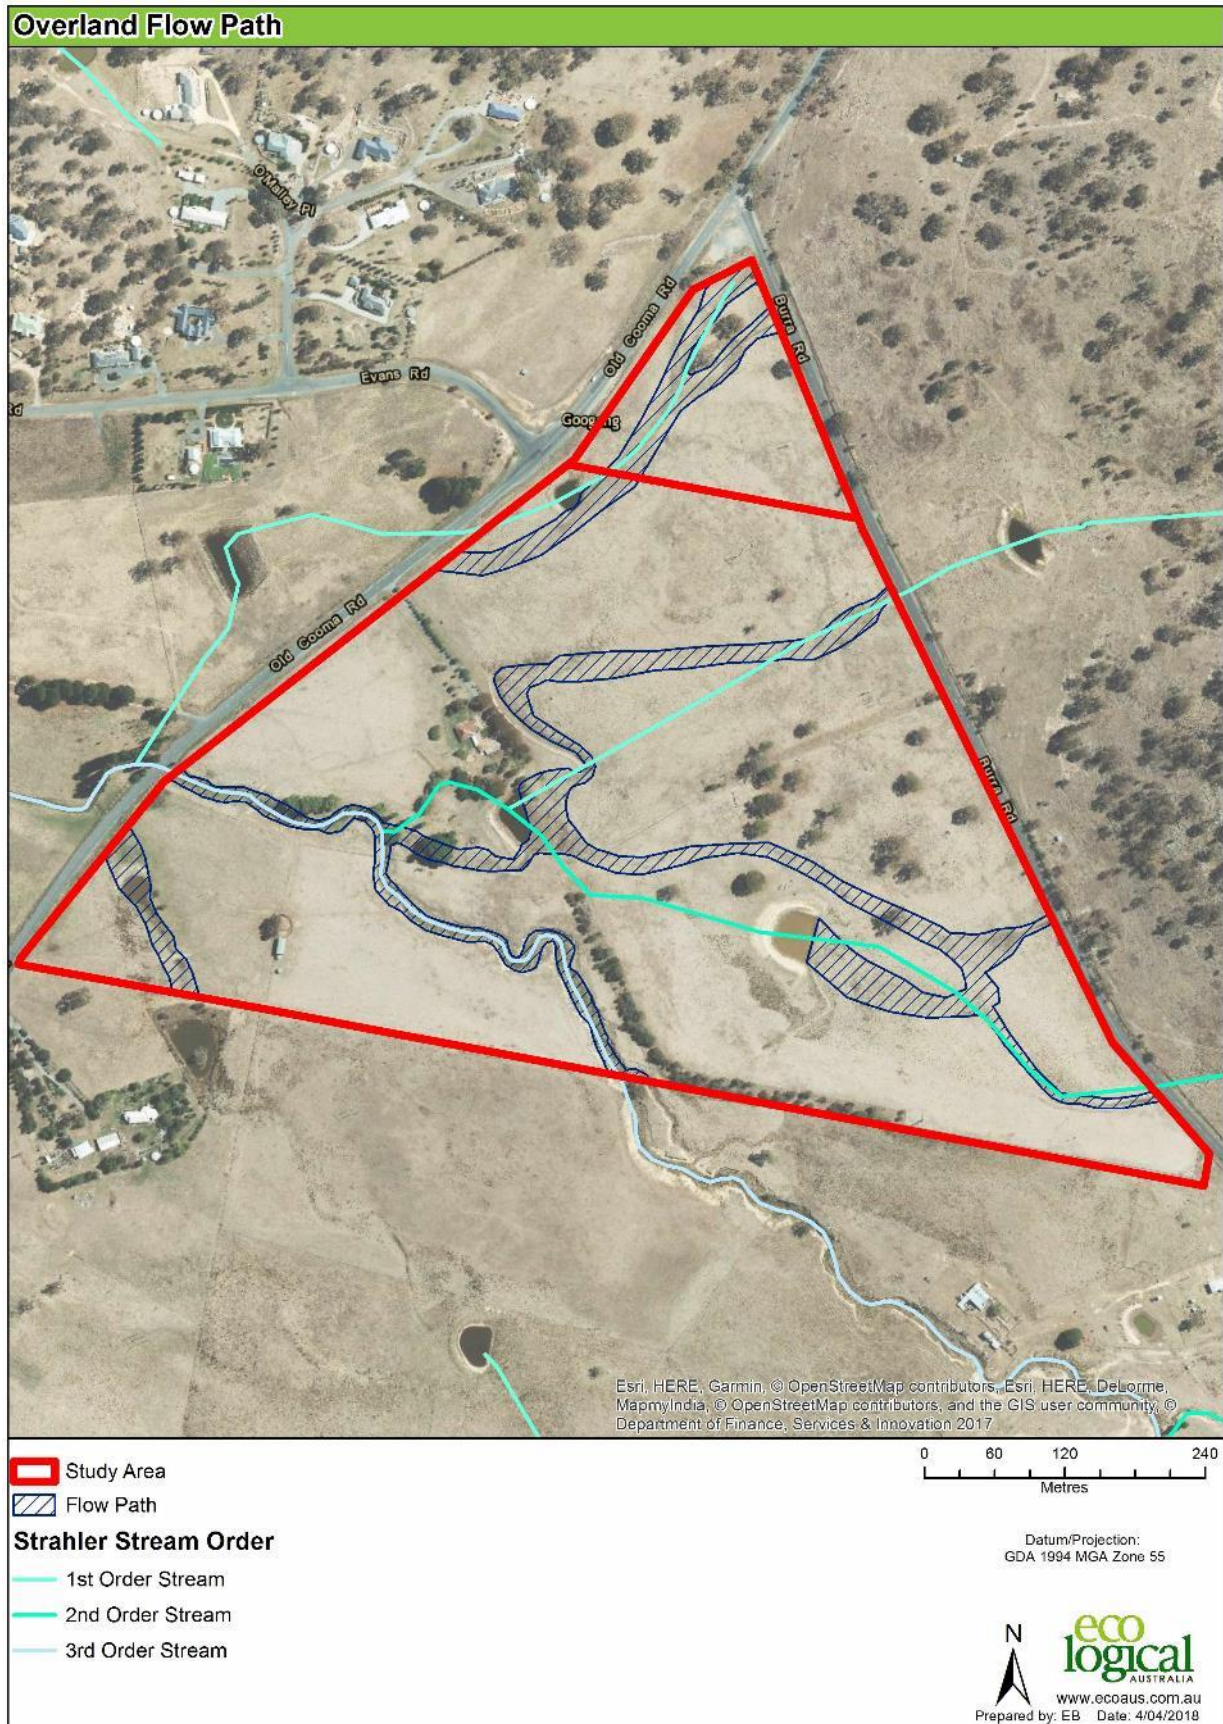
Figure 2-1: Overland flow paths across the Site. Church Creek runs from the central south boundary across to exit the Site to the west. Flow paths indicate expected flow based on the DEM. Strahler stream orders indicated for cadastral watercourses

The Site slopes gradually from north-east to south-west, developing a floodplain to the south of Church Creek, which is a third order watercourse within the Site, marked on the LEP Riparian and Watercourses Map, that crosses the site from the south to the west (Figure 2-1). The creek receives discharge from several smaller tributaries, with the regional flow direction to the north-west. There are several other smaller non-defined overland flow paths that cross the Site that were created via culverts under the roads that border the Site.

Two other unnamed first and second order water courses have also been mapped from the local contour maps as feeding into Church Creek (shown in Figure 2-1). It is unclear, however, whether these watercourses would meet the definition of a river under the Water Management Act (2000). Flood modelling undertaken previously (Eco Logical Australia, 2018) confirmed the likelihood that these water courses could flow under extreme rainfall conditions (Figure 2-2), though most flow remained concentrated in the main channel of Church Creek.

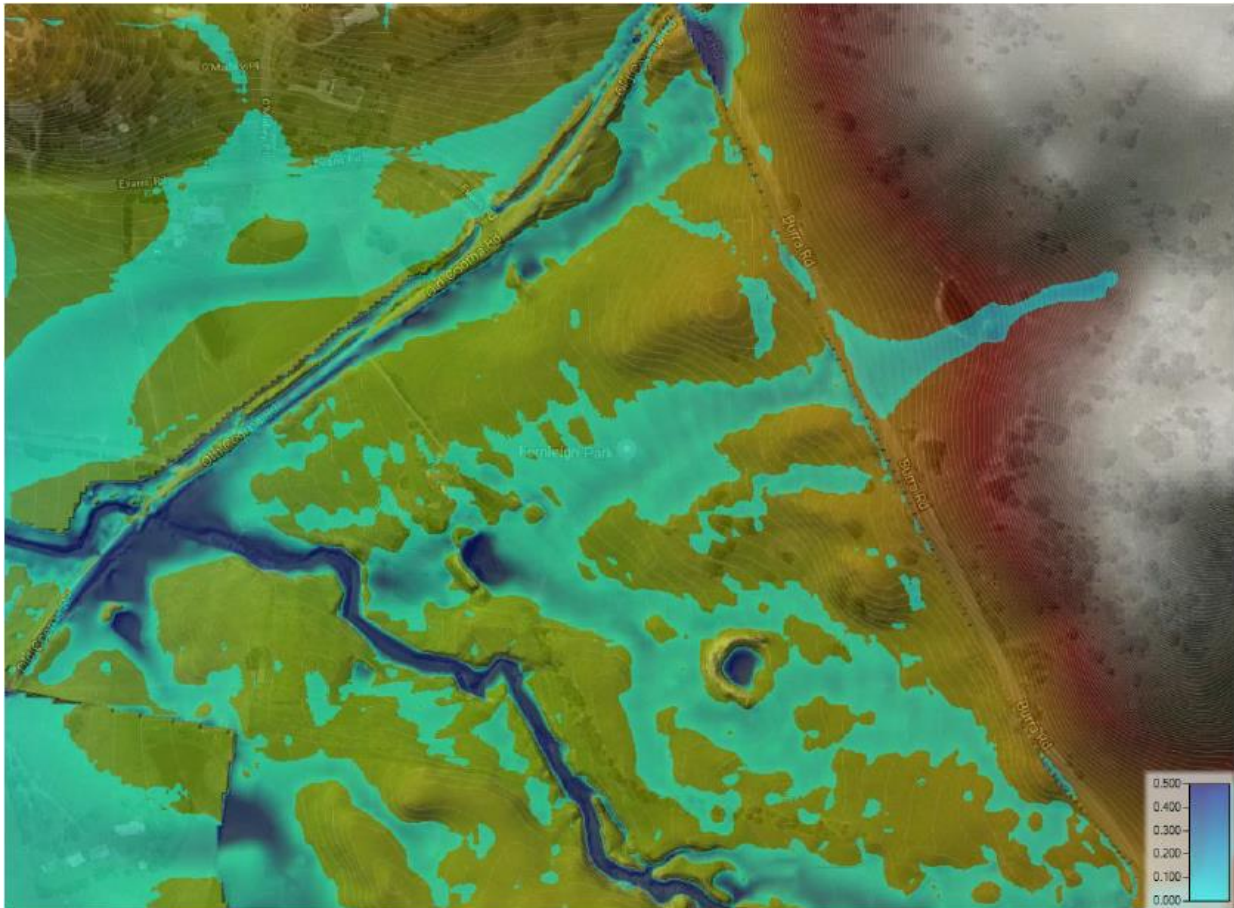
Figure 2-2: Modelled flood extents across the Site under the 1% AEP (1 in 100 year ARI conditions)(Eco Logical Australia, 2018)

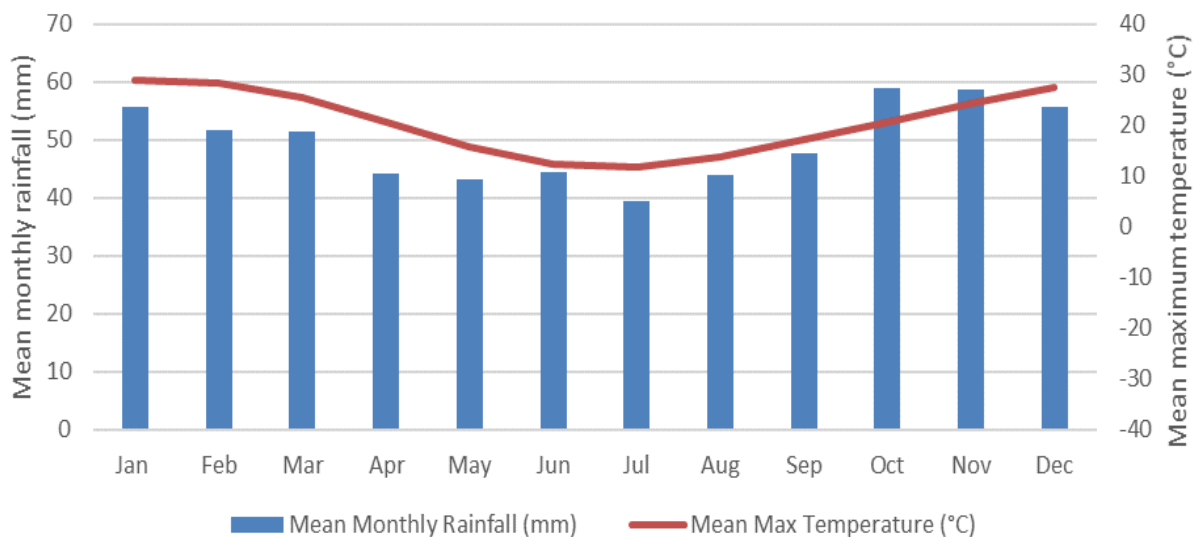
Figure 2-3: Monthly average rainfall and evaporation recorded at Tuggeranong (BoM 70339), 10.2 km west of the Site

Rainfall and temperature data was obtained from the Bureau of Meteorology (BoM) online climate database for the Tuggeranong (Isabella Plains) AWS (BoM site 070339) located approximately 10.2 km west of the study area. The regional climate is categorised as cool temperate, with year-round rainfall (average annual rainfall 631.3 mm) with a seasonal distribution showing greater rainfall in the summer months (Figure 2-3). Mean maximum temperatures range from 11.8 °C in July to 29 °C in January.

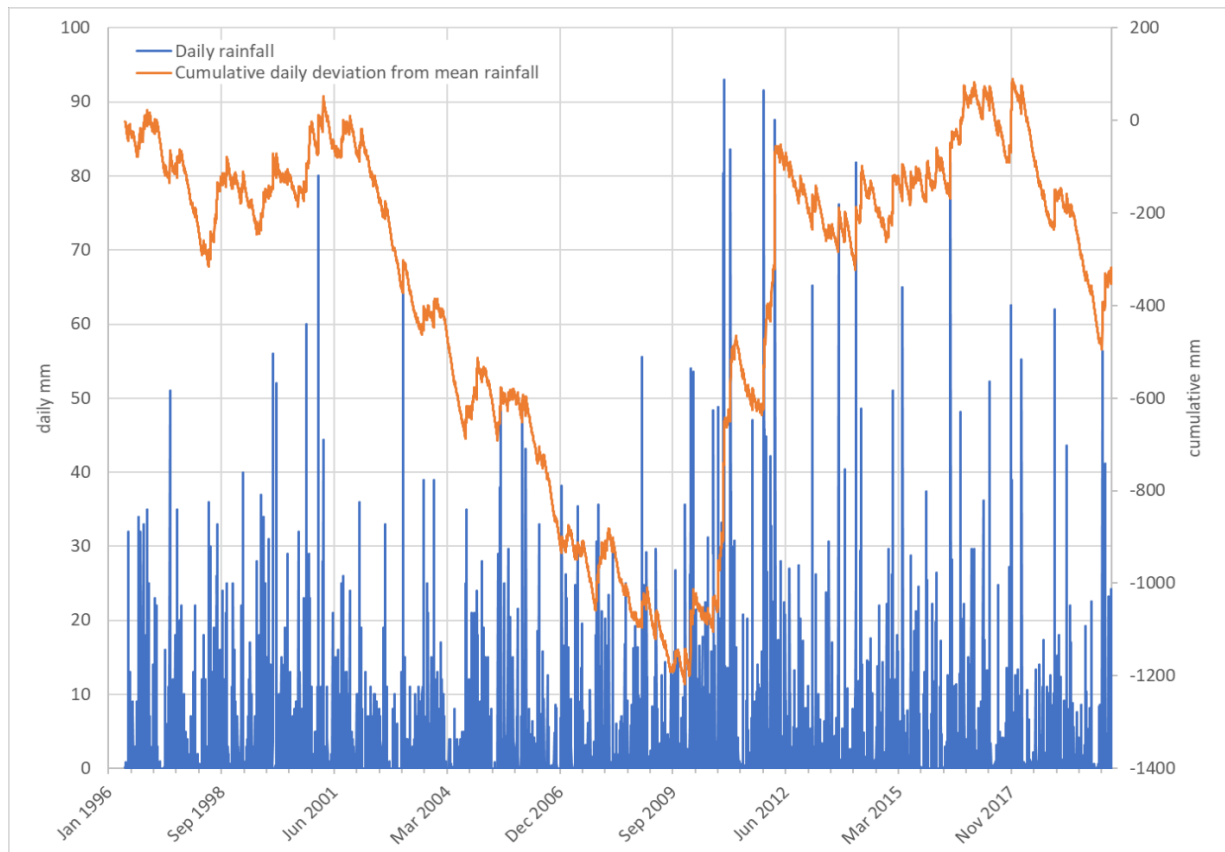
Figure 2-4: Rainfall recorded at Tuggeranong (Isabella Plains) Automated Weather Station (BoM 70339) and equivalent cumulative deviation from the mean daily rainfall

Monthly and daily rainfall data for the last 23 years was retrieved from the BoM Weather Station Directory (<http://www.bom.gov.au/climate/data/stations/>). From the daily data a cumulative deviation from the mean daily rainfall (CDMDR) provides an overview on climatic changes, highlighting wetter periods as increasing trends and dry periods as decreasing trends (Figure 2-4). This gives a good indicator as to whether the area is suffering the effects of drought or if the current precipitation level is on/above average for the region. Of note, the strong downward trend due to the Millennium Drought is clearly seen as a prolonged deficit in the CDMDR in Figure 2-4.

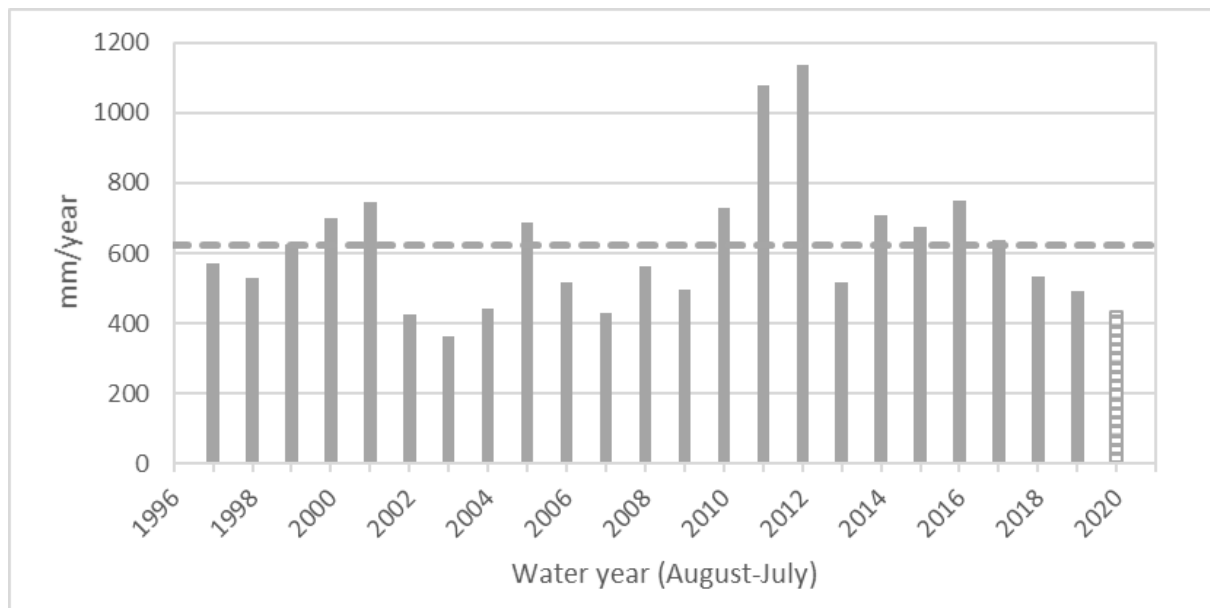
Figure 2-5: Annual rainfall for water years (August to July) at Tuggeranong (Isabella Plains) Automated Weather Station (BoM 70339). Mean rainfall for the period 1996 to 2020 of 624 mm also shown. (2020 only though to April)

Based on rainfall data from last 23 years, the region has recovered from the Millennium Drought, recovering to pre-drought conditions between 2010 and 2012, then exhibiting long-term average conditions (flat trend in the CDMDR) through to 2018. The last two years have been drier than average, though significant rainfall fell in February and March of this year (Figure 2-5).

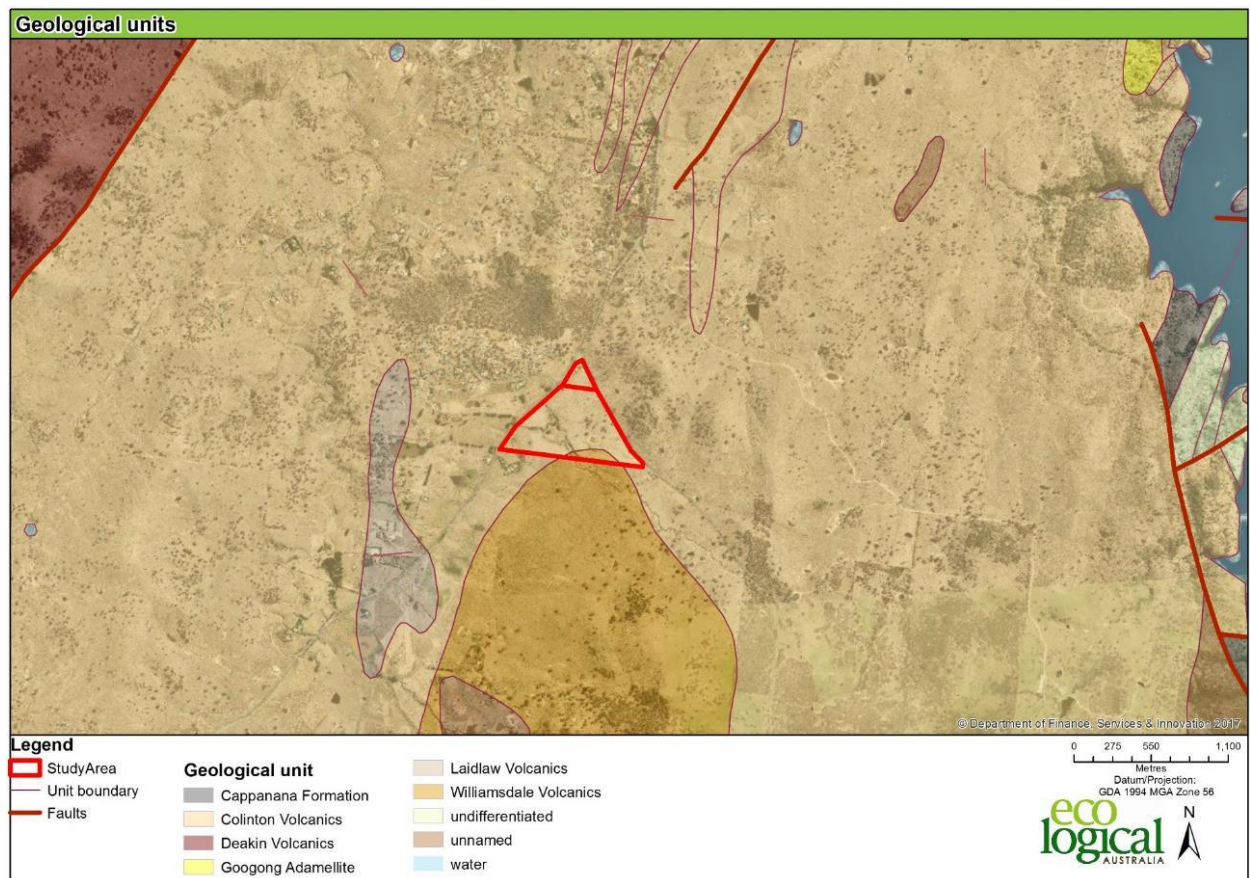
Figure 2-6: Surface Geological units across the region

The regional geological setting of the property is shown in Figure 2-6. The study area is located within a complex structural corridor within rock sequences of Silurian age, regionally described as the Canberra Graben. This structural feature is bounded to the west by the Murrumbidgee Batholith, comprised of granodioritic intrusives, and to the east by the Cullarin Horst, a complex geological province represented by deformed Ordovician-aged sediments intruded by granites (HGC, 2001).

The 1:100,000 Canberra Geology map indicates that the site is located mostly on the Colinton Volcanics bedrock, with a small part south of the study area located on the Williamsdale Volcanics. Two faults separate the Colinton Volcanics from the Deakin Volcanics approximately 3.5 km west and from Cappanana Formation approximately 4 km east of the study area.

Groundwater in the area is expected to be associated with fractures within bedrock and contained within joints, fractures, faults and fissures in the rock mass (HGC, 2001). The closest major fault mapped is approximately 1.5 km north of the study area (Figure 2-6).

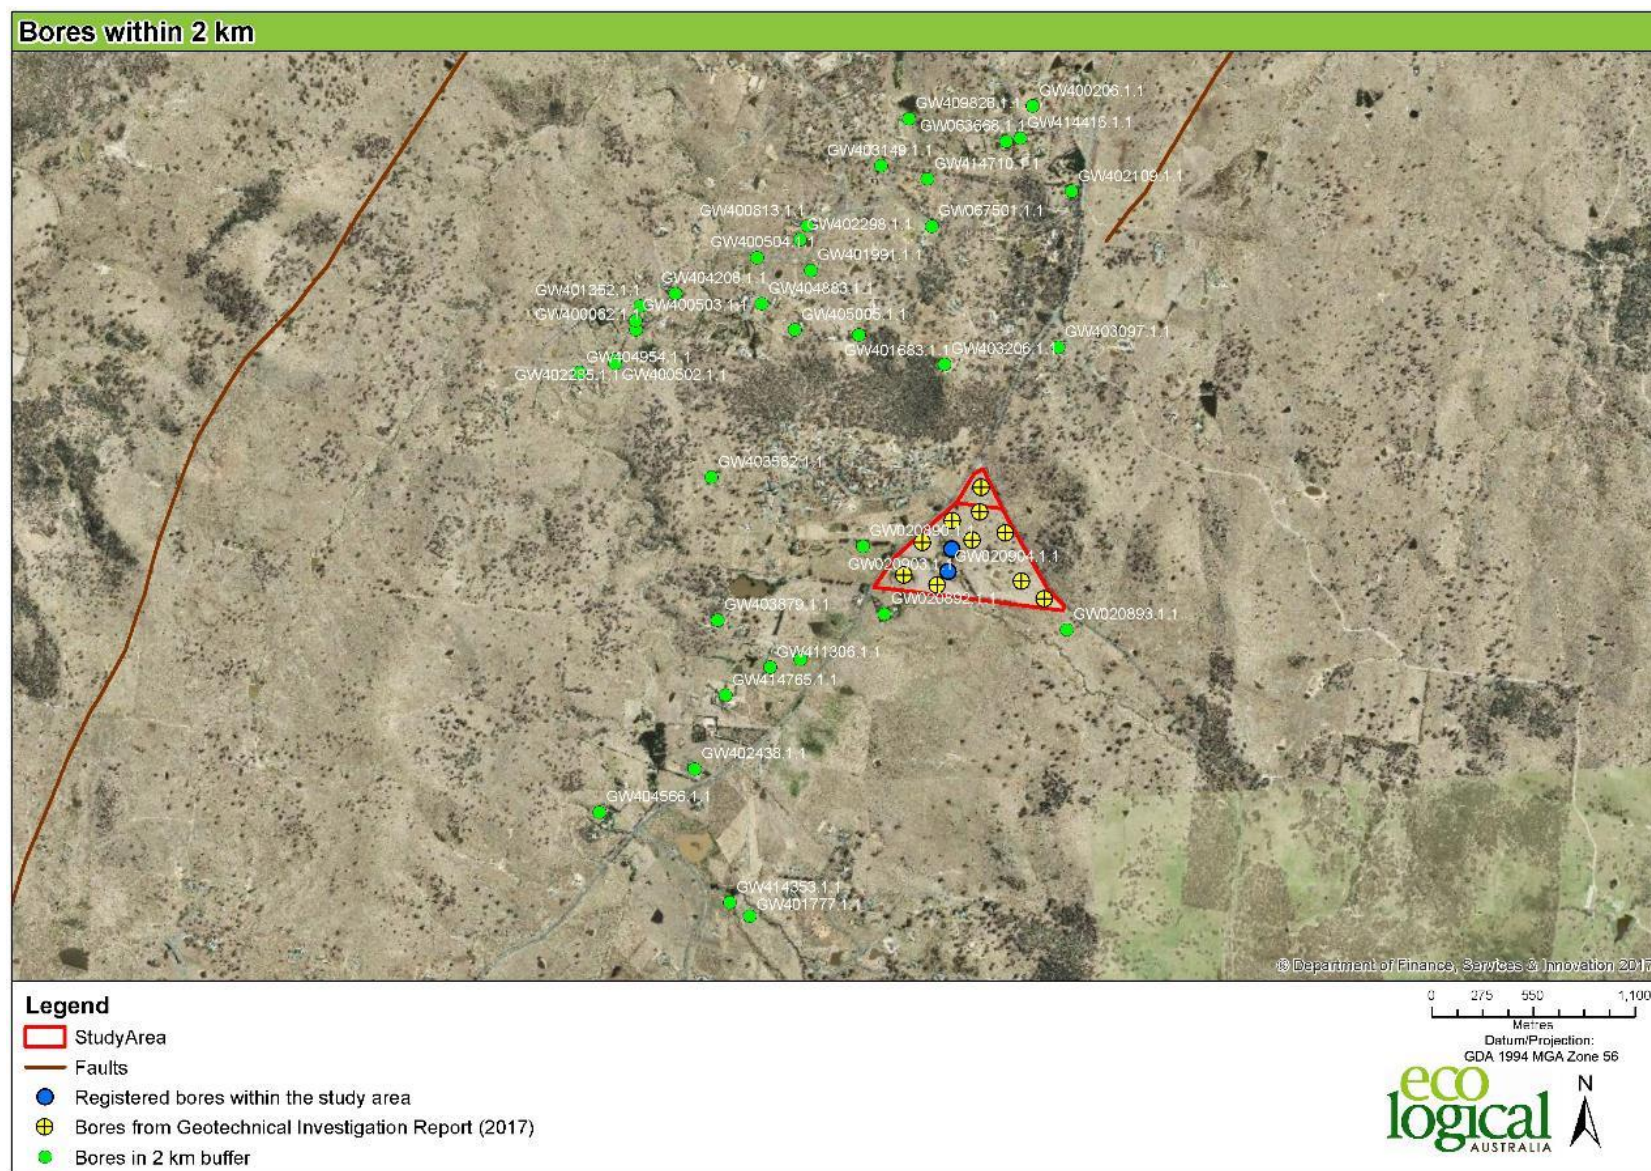
Figure 2-7: Registered and reported groundwater bores around the study area

Interrogation of the DPIE online groundwater database and the BoM Groundwater Explorer database identified 38 registered groundwater bores within approximately 2 km of the Site, with only two of the 38 bores located within or in close proximity to the Site as shown in **Figure 2-7**. No water level/quality data for these bores were available in the PINNEENA database. The five registered bores within (or

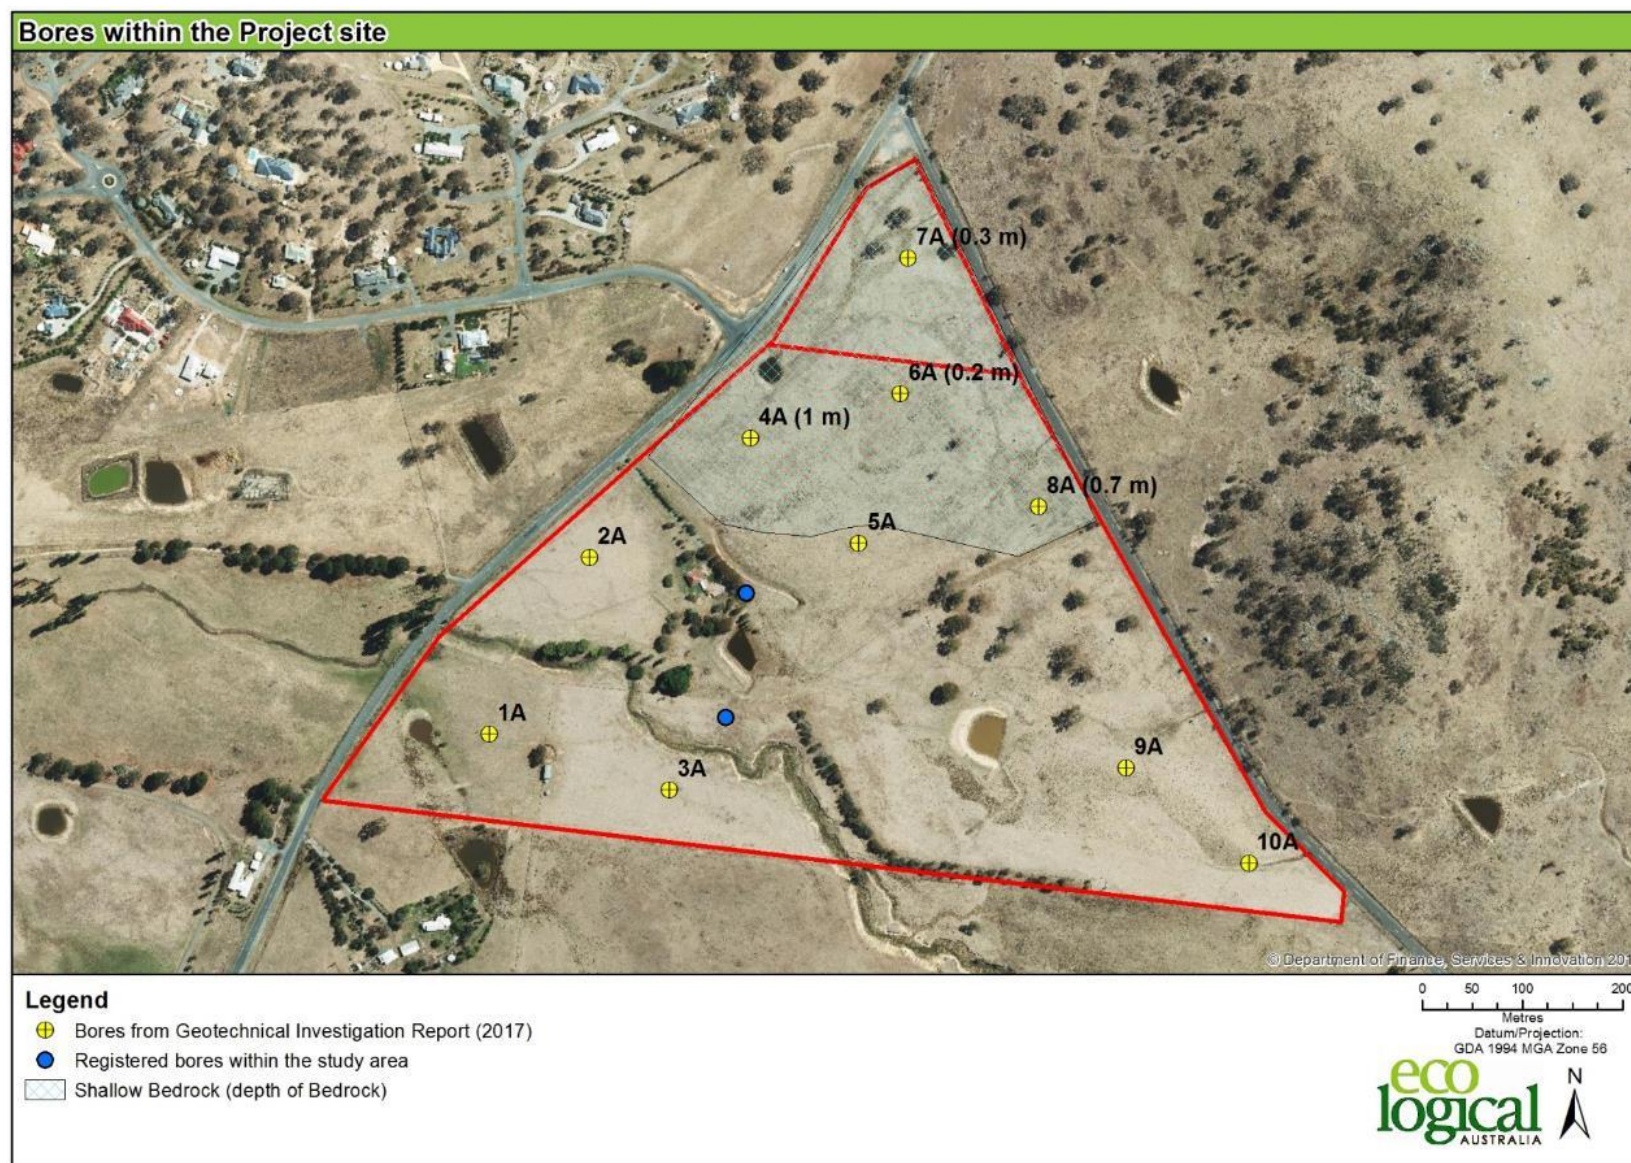
Figure 2-8: Reported bores within the project area prior to this study.

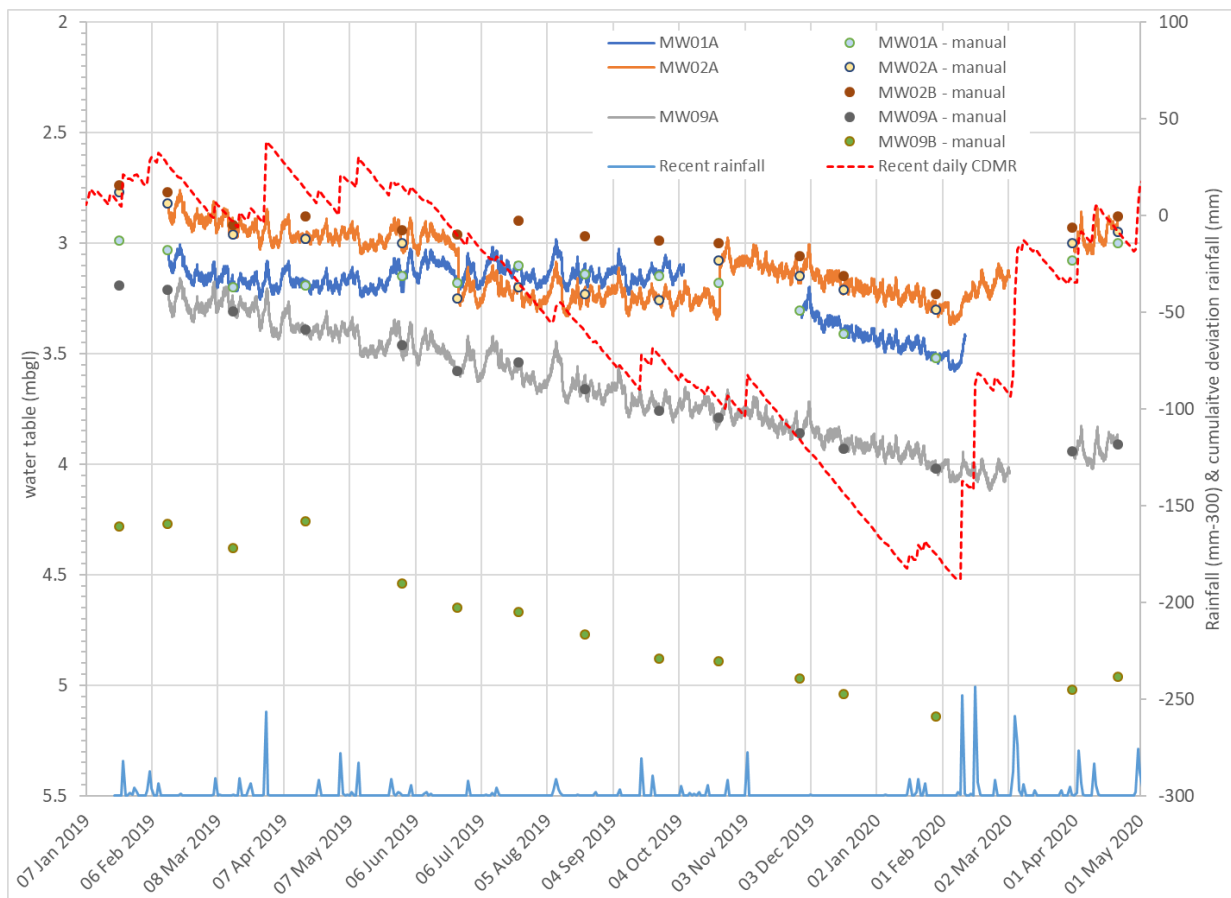
Figure 4-1: Summary chart of data retrieved from the five new monitoring bores at 1241 Cooma Road, Googong.

Time series for all collected data is presented in Figure 4-1. Water level data has now been collected over 15 months (January 2019 to April 2020) and continues with 3 data loggers in the shallow monitoring bores (in the alluvium of Bores MW01A and MW02A and the colluvium of MW09A) and on-going manual dipping on a monthly basis.

Distinct trends can be determined at each site (and each bore) providing information on groundwater recharge and movement and connectivity between shallow and deep aquifers. Comparison to the rainfall record illustrates the differing response at each location (Figure 4-1).

The time series for site 2 (Figure 4-1) shows what appears to be the effects of pumping on the shallow bore at site 2A. The congruence between the logger and manual measurements confirm that this is not an instrumentation malfunction. It is likely that this reflects the impacts from pumping at the groundwater bore at Mount Campbell Estate (Figure 2-9) during a period of very low rainfall between June and November 2019 (Figure 4-3). No impacts are seen on the deep bore (2B see Figure 4-1) suggesting the two aquifers are isolated from each other.

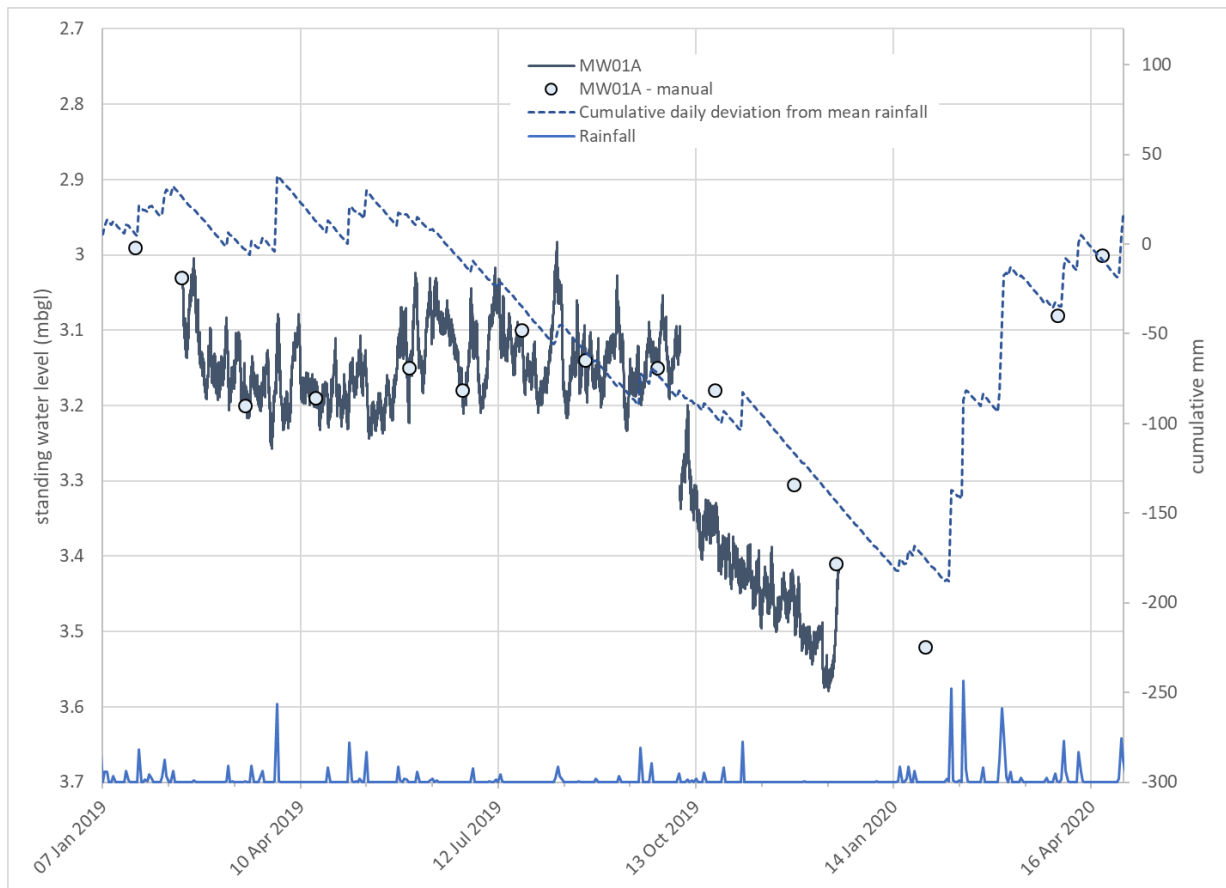
Figure 4-2: Water level at site 1A since January 2019

Throughout 2019, the shallow bore at site 1A remained steady (Figure 4-2), despite the regional rainfall deficit, until early October when the water level dropped quickly until mid-December, then began to rise, despite minimal rain in the district through November and December (less than the 10th percentiles across the recorded record). Unfortunately, the logger failed in December and the replacement logger also re-set and deleted the data. Manual measurements indicate that the water level returned to previous heights following the rains in early 2020.

The recent time series of water levels can be directly compared to the rainfall record and relative response estimated. Thus, water levels at site 1 (MW01A – Figure 4-2), show an initial response to rainfall events, but rapidly dissipate to an equilibrium level at about 3.15 m below ground level. At site 2 (MW02A – Figure 4-3) the water levels also responds immediately to all rainfall events, but only events greater than 30 mm appear to result in any significant departure from equilibrium. No rainfall results in

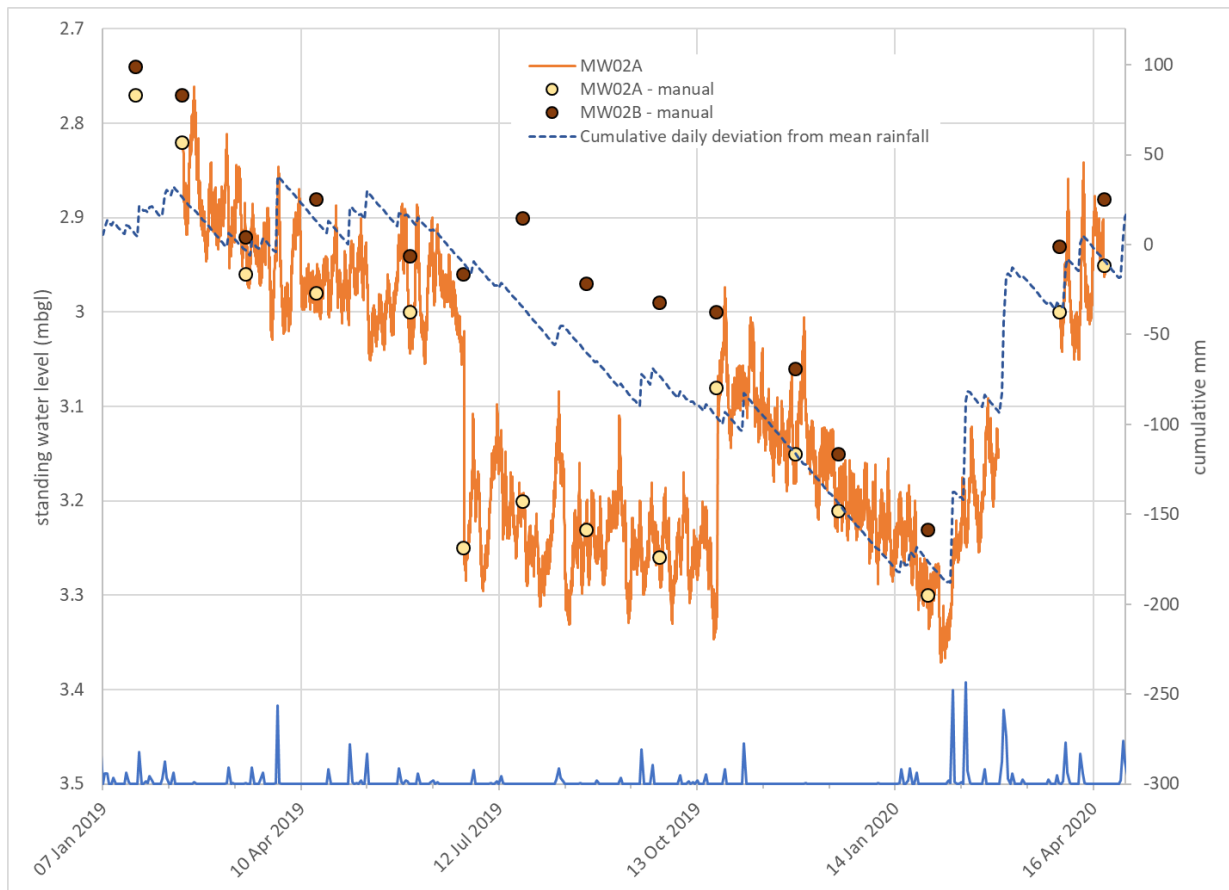
Figure 4-3: Local rainfall (Tuggeranong) compared to water levels at site 2A since January 2019

The deep bore constructed at this Site (MW02B) targeted groundwater in the underlying dacite country rock at 7.9 to 10.9 metres below ground. Water levels in this bore were consistently higher than MW02A indicating an upward pressure and separation between the two aquifers. This was emphasised when the shallow bore recorded a significant drop in June 2019, with the reduction in overlying pressure resulting in a rise in the water level in the underlying aquifer that then gradually receded over time until the shallow aquifer returned to normal levels in late October and water levels in the deep bore dropped to a comparable pressure difference to that prior to the change in level at MW02A. Both bores have tracked in parallel since that time, suggesting a common recharge source, but separation of the aquifers in the vertical sense by a confining unit.

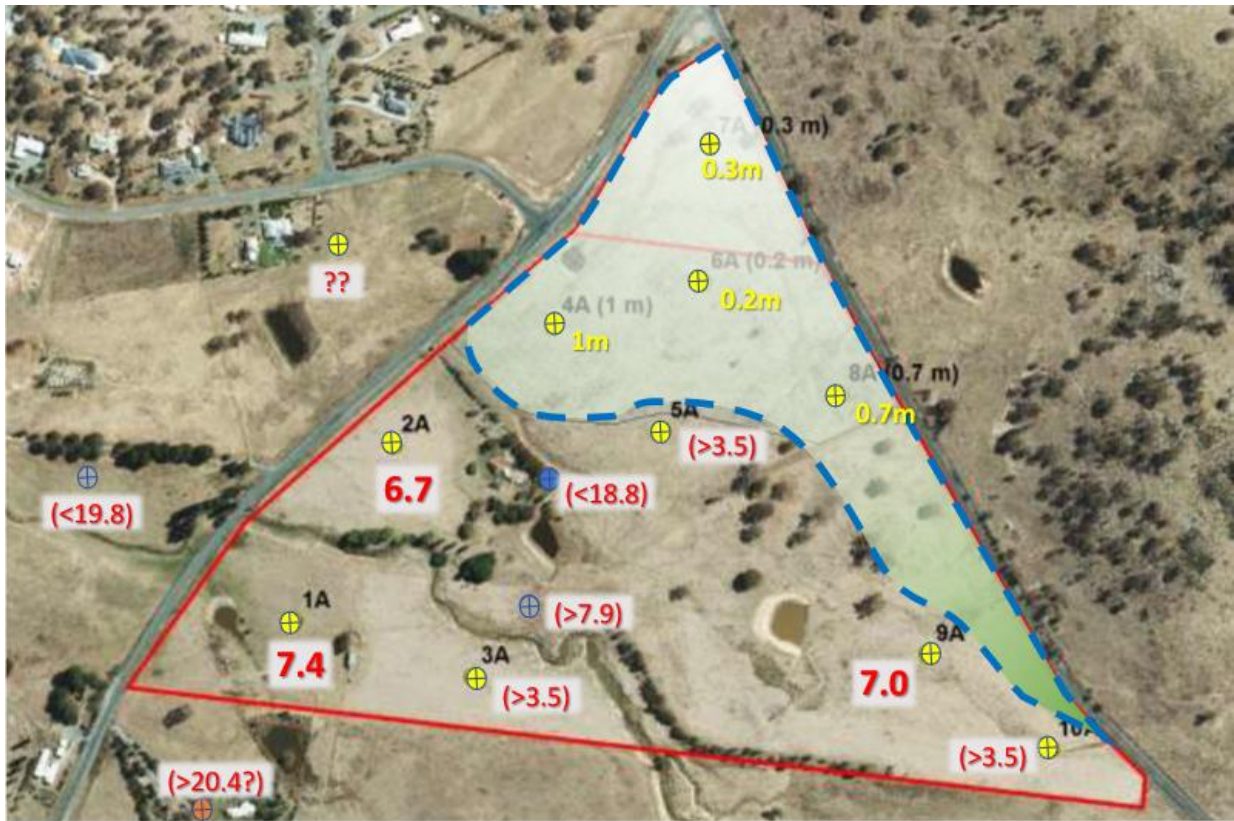
Figure 4-6: Depth to competent bedrock. Shaded area marked where bedrock is less than 3 m below ground. Numbers in brackets inferred from bore construction records.

The additional bore logs generated through installation of the new monitoring bore network provide further ground material information to assess the capability of the Site to host grave sites. Specifically, depth to competent rock can now be estimated for much of the Site and this defines a zone where depth to hard rock is less than 3 m and therefore not suitable for grave sites (Figure 4-6).

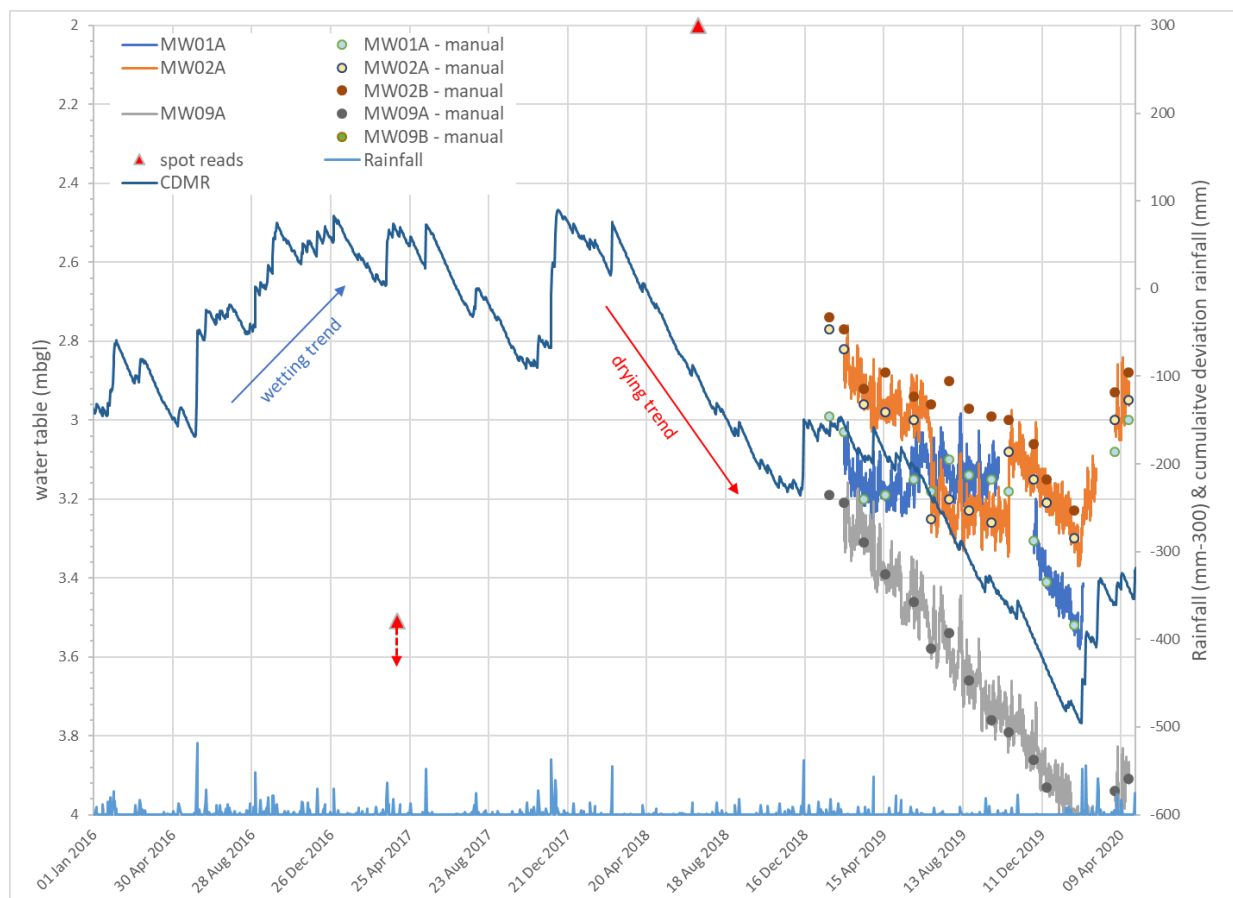
Figure 4-7: Longer term rainfall record and previous water level measurements on Site

To explain the previously measured high water levels in June 2018 the monitored data can be plotted against the long-term rainfall record (Figure 4-7). The rainfall record shows that the current phase of drying follows a significantly wetter period through 2016 and 2017. The spot read in 2018 was taken following the wetting period. Specifically, a steep rising trend in cumulative rainfall followed a sequence of high rainfall events late in 2017. That sequence is comparable, but lower, in volume (183 mm) to that recently observed in February this year (219 mm) that produced a similar cumulative increase in the rainfall record.

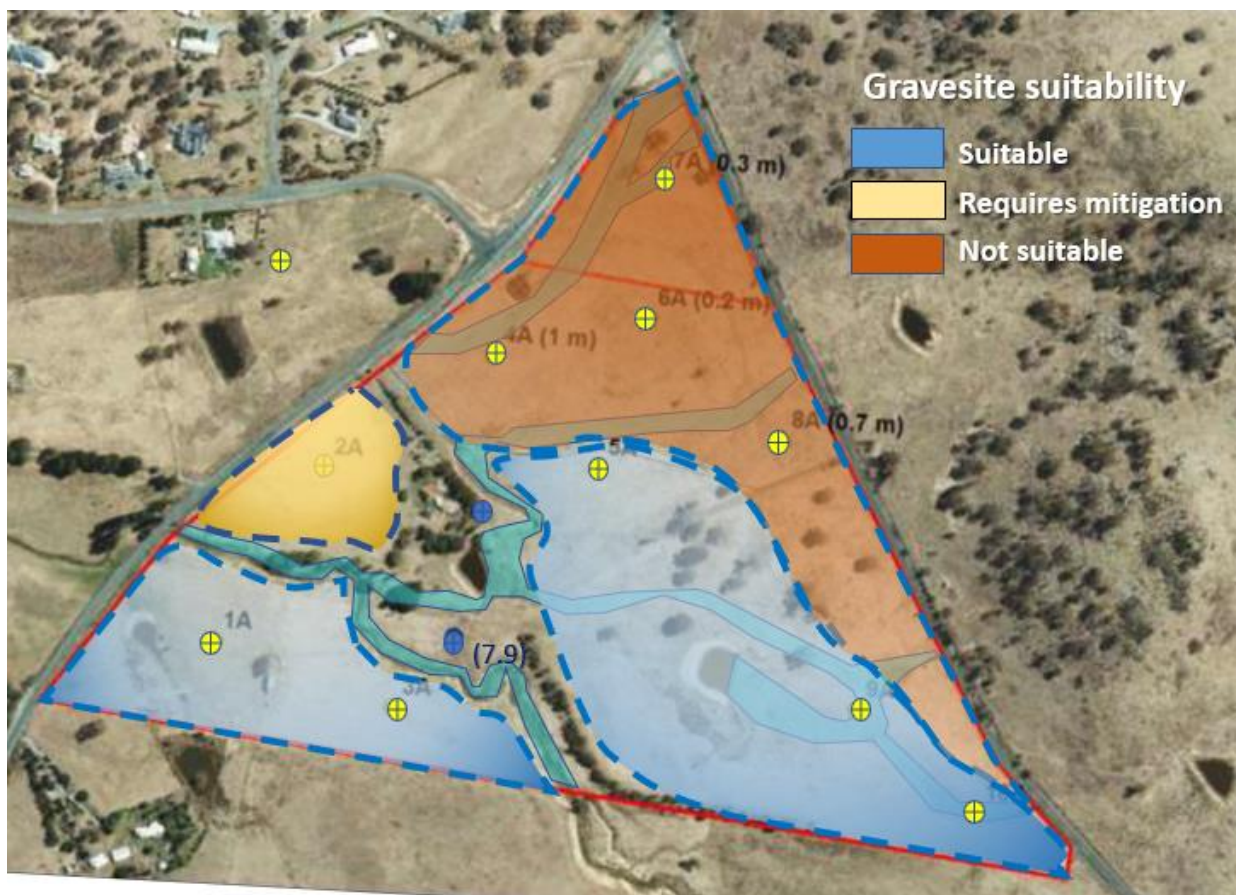
Figure 4-8: Site zonation for gravesite suitability

Consideration of water levels across the Site, combined with understanding of ground conditions and with regard to previous studies on hydrology (Eco Logical Australia, 2019), geotechnical surveys (ACT Geotechnical Engineers, 2017) and regional groundwater surveys (HGC, 2001) allows an assessment of distinct zones across the Site and their applicability for gravesite development (Figure 4-88).
