Proposed cemetery site, Old Cooma Road, Googong: Hydrogeological Assessment

Queanbeyan-Palerang Regional Council

Project Name	Old Cooma Road, Googong Groundwater Studies – Cemetery and Crematorium
Project Number	18SYD_12109
Project Manager	Richard Cresswell
Prepared by	Richard Cresswell
Reviewed by	Johan Du Plooy
Approved by	Richard Cresswell
Status	Final
Version Number	1
Last saved on	21 May 2020

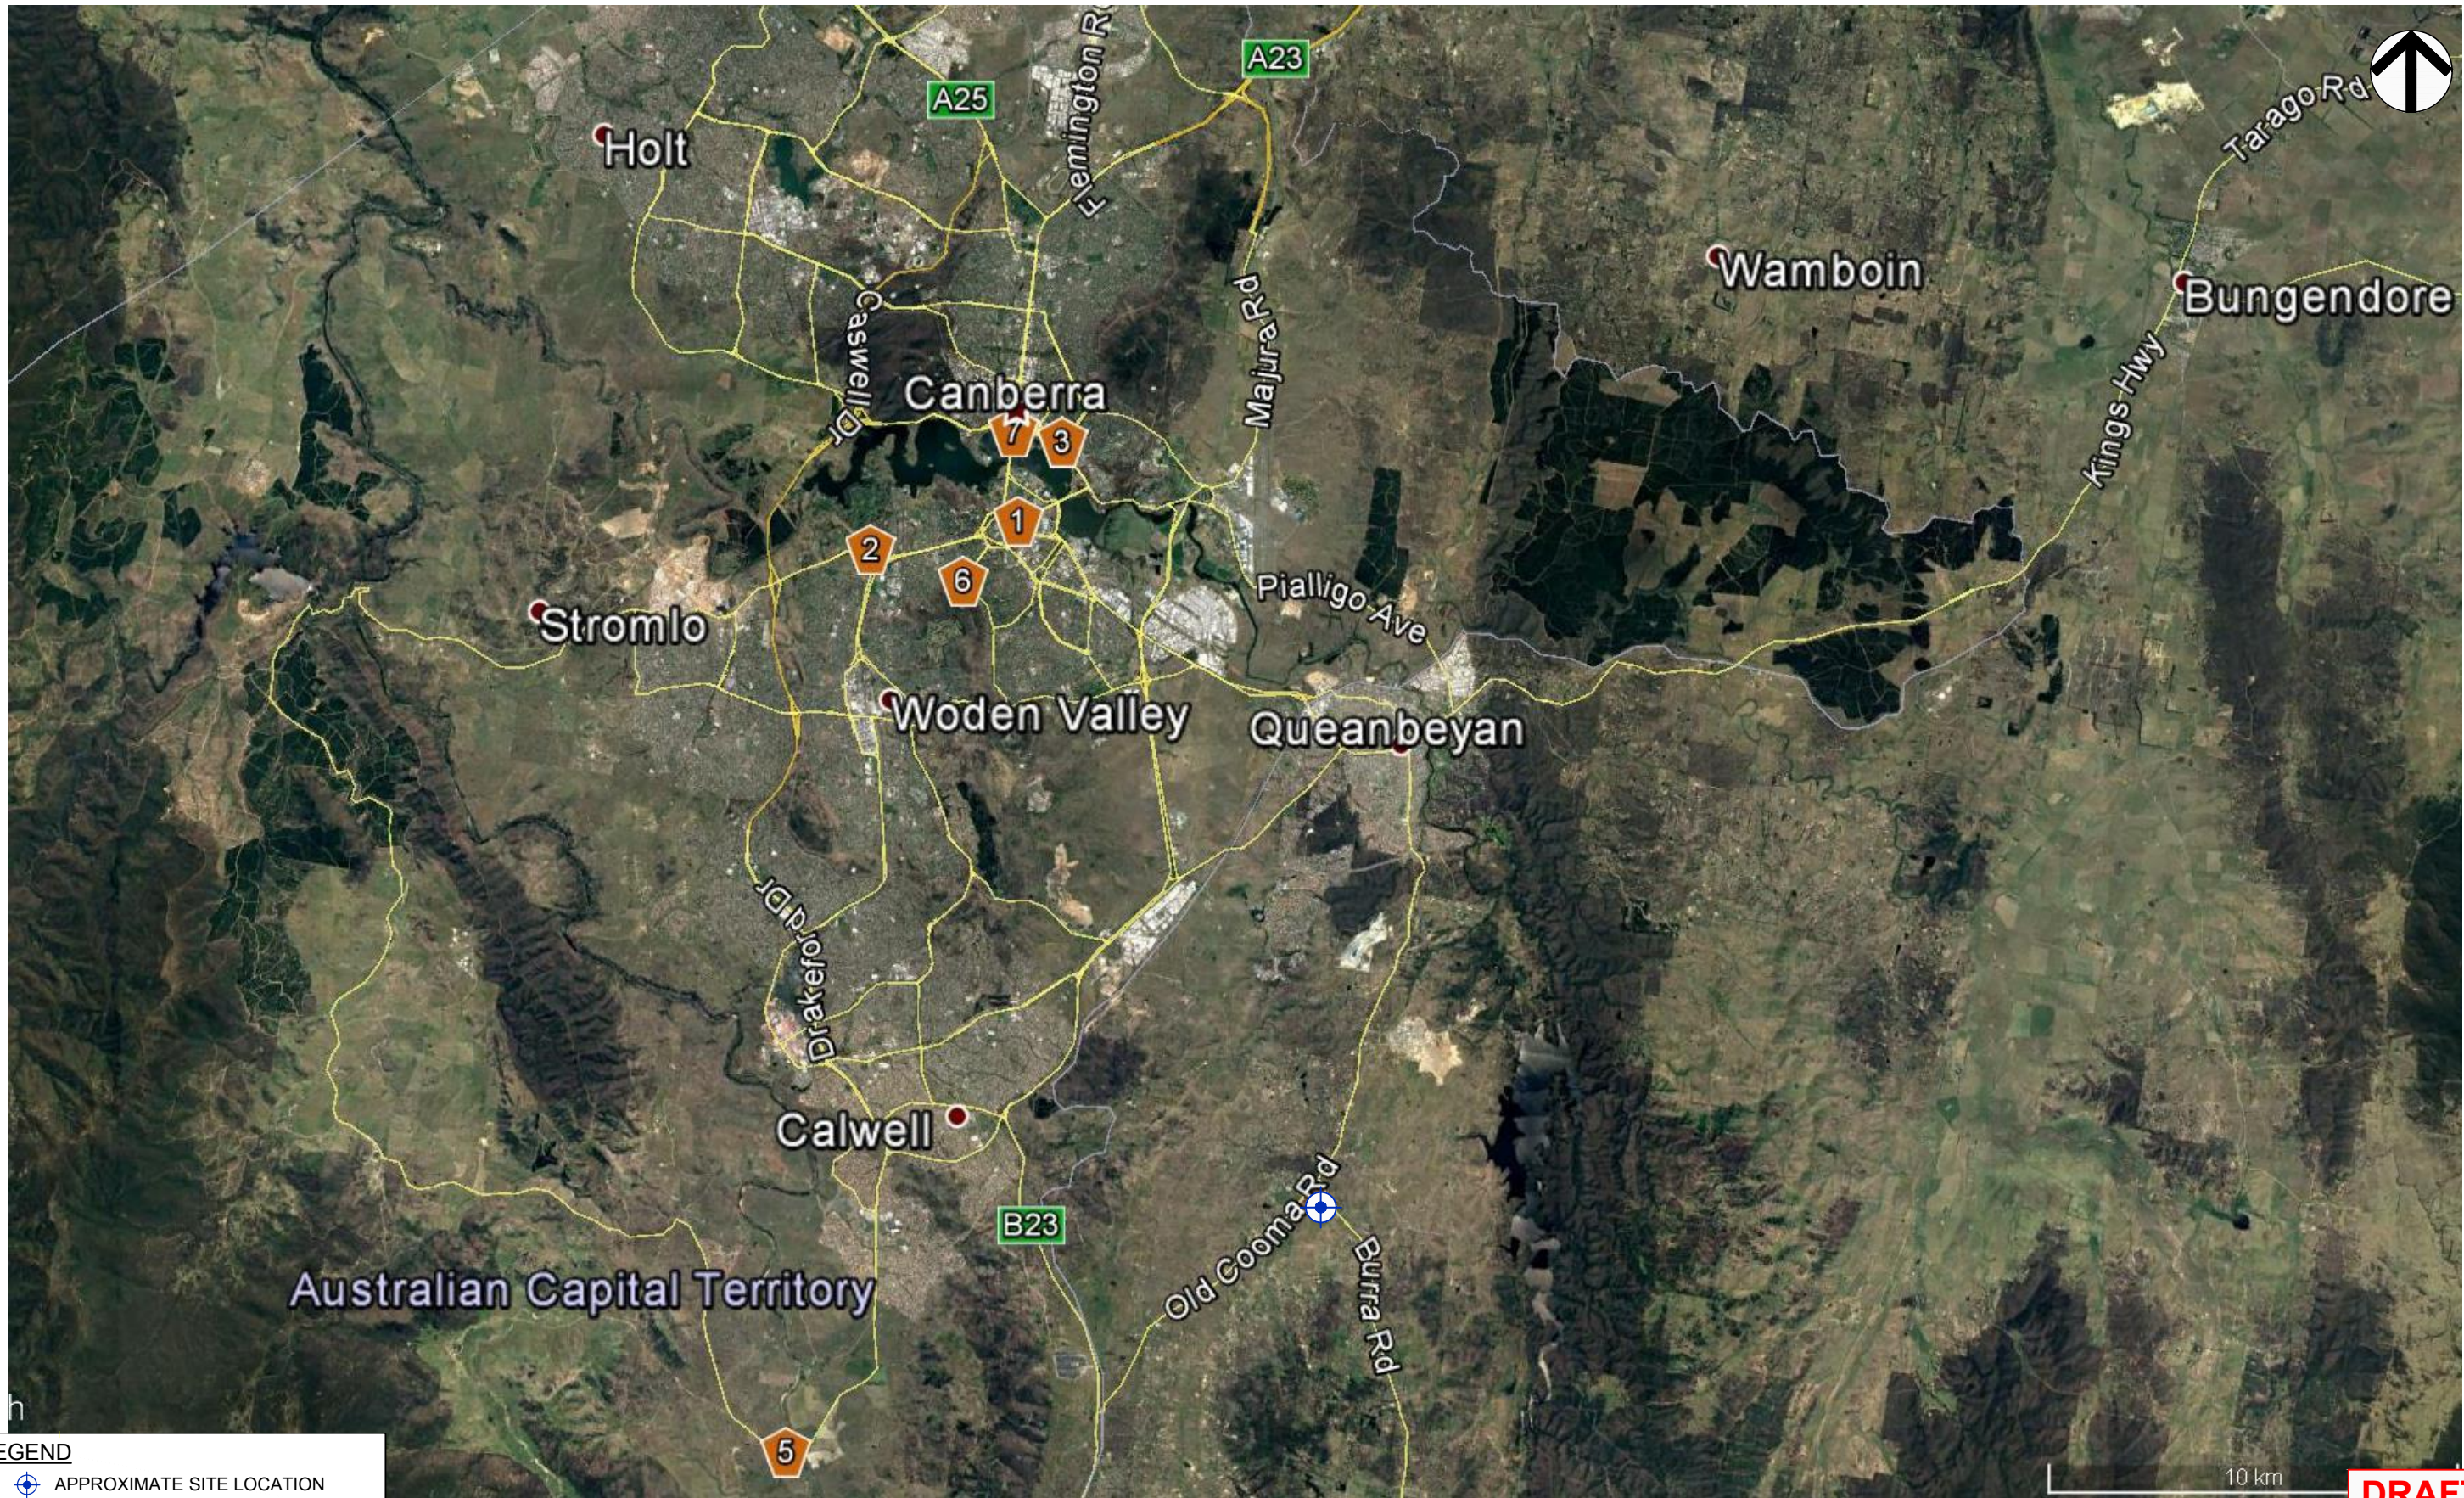
client: QUEANBEYAN-PALERANG REGIONAL COUUNCIL		
project: QPRC GROUNDWATER WELL INSTALLATION 1241 OLD COOMA RD, GOOGONG, NSW		
title: GROUNDWATER MONITORING SITE LOCATION PLAN		
project no: 754-CBREN225122-R01	figure no: FIGURE 1	rev: A

Eco Logical Australia (ELA) on behalf of Queanbeyan Palerang Regional Council (QPRC) engaged Coffey Services Australia Pty Ltd (Coffey) to install groundwater monitoring wells at three locations at a site located within Lot 2 DP112382 and Lot 126 DP754881, situated at 1241 Old Cooma Road, Googong (herein as the 'site'). Based on information provided by ELA, Coffey understands the site is being considered as a proposed development site for future use as a cemetery. The site location is shown in Figure 1, Attachment A, while a site layout plan is presented in Figure 2.

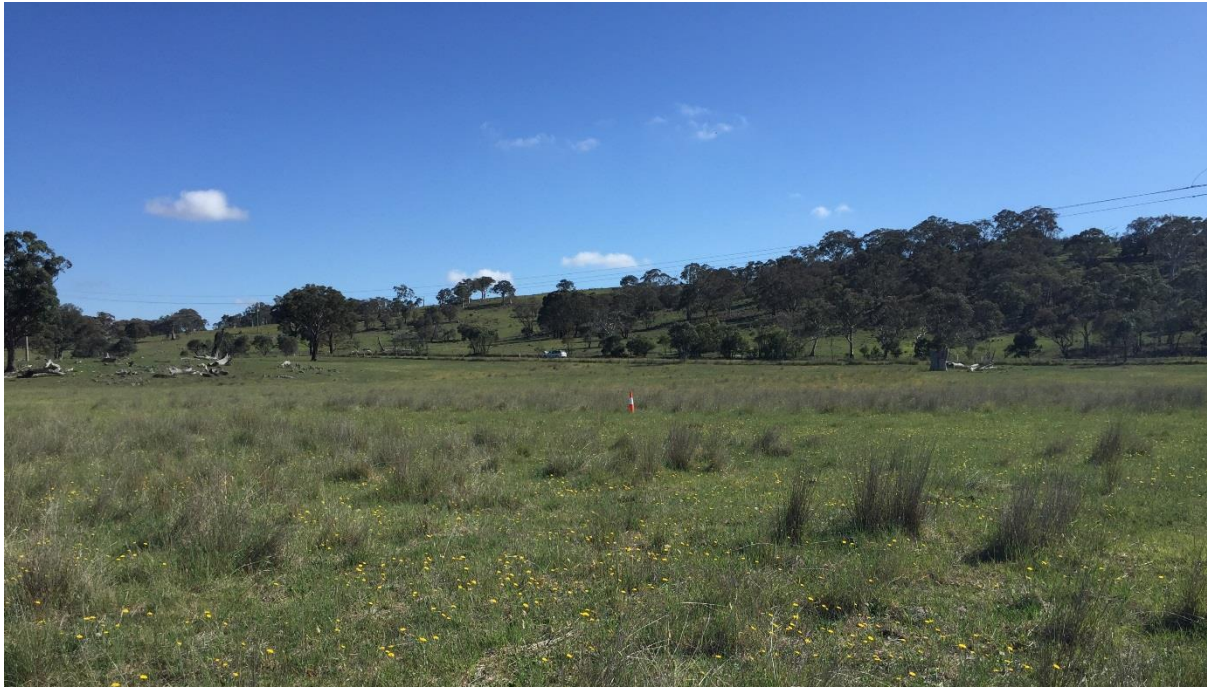
Figure 3 - Location of MW09A, in the eastern portion of the site, marked by an orange traffic cone. Borehole MW09A was excavated into alluvial soil in a slight valley.

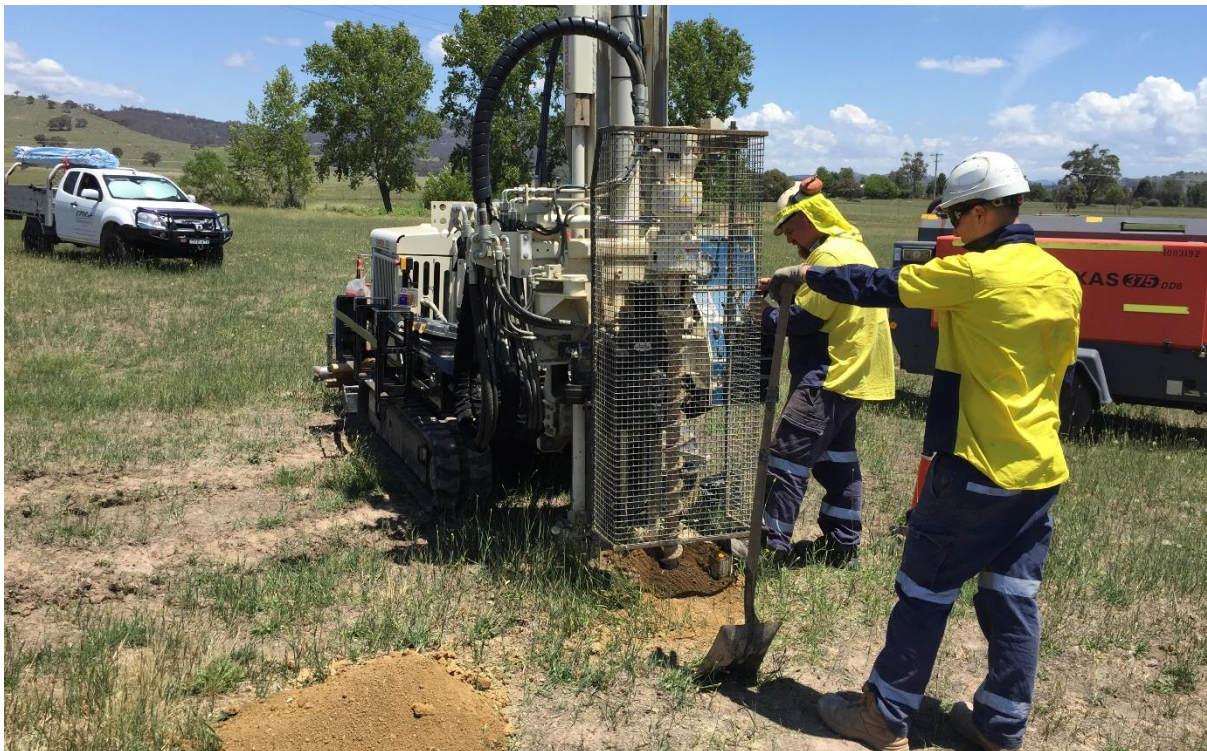
Figure 4 – Drilling borehole MW02B. Boreholes were excavated using a solid stem flight auger attachment from 0.5m bgl until auger refusal in bedrock, below which, deeper boreholes (MW02B and MW09B) were drilled into bedrock using an air hammer methods.

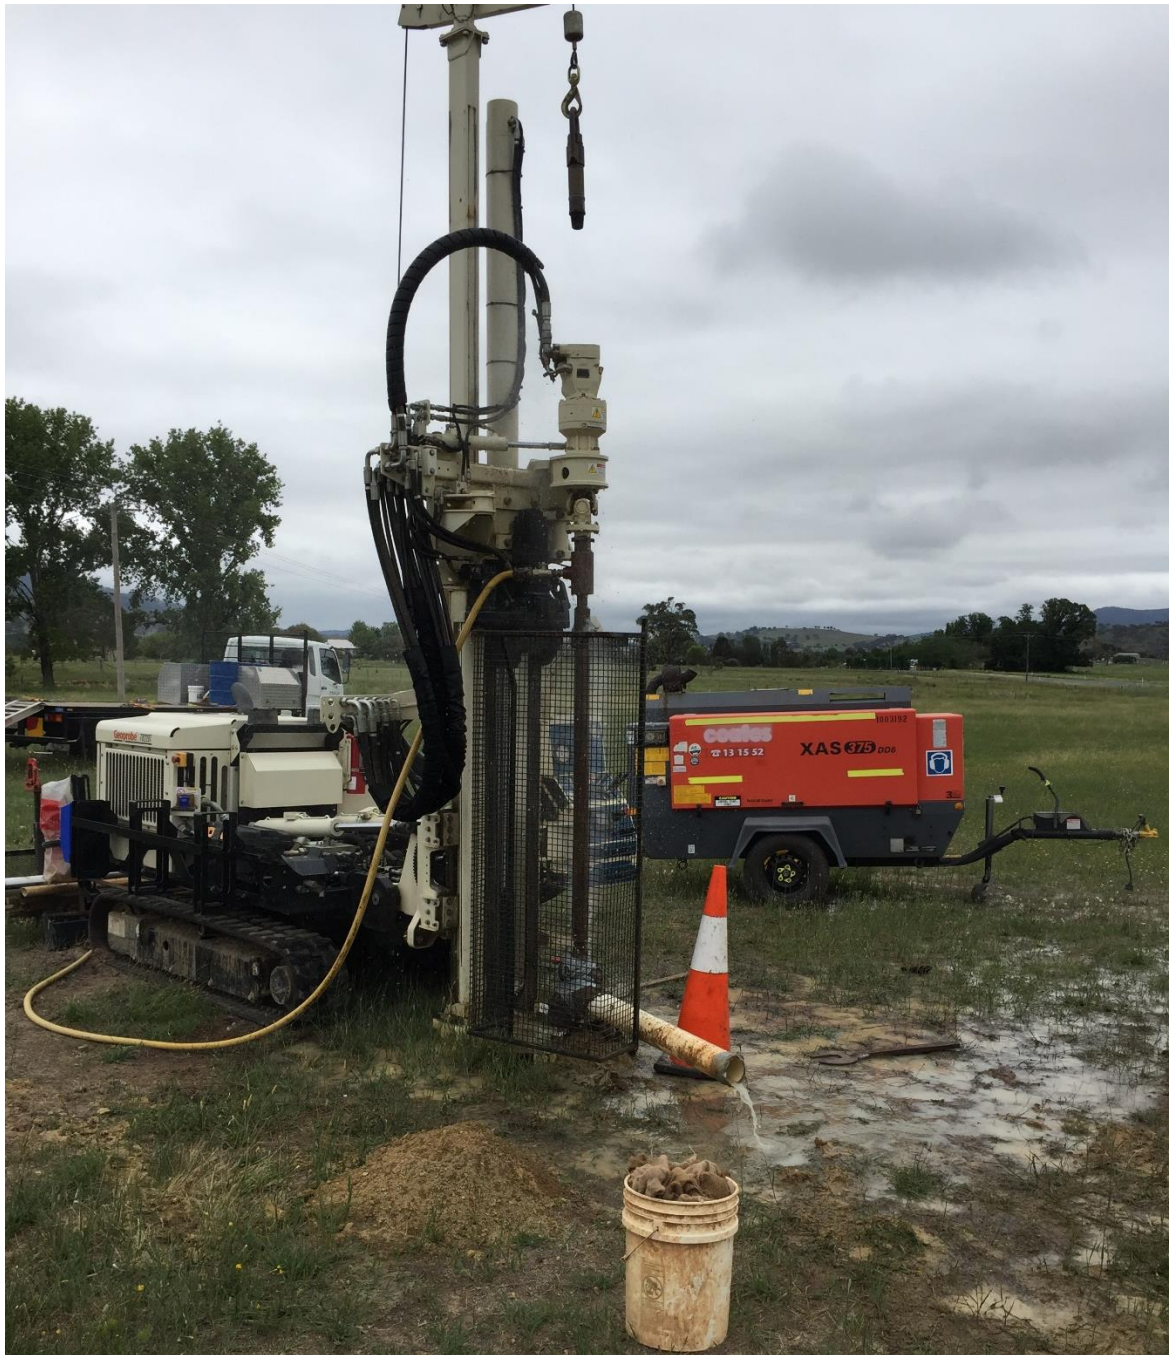
Figure 5 - Groundwater encountered during drilling for MW02B, using an air hammer attachment.
