client:	OPUS INTERNATIONAL CONSULTANTS		
project:	ELLERTON DRIVE EXTENSION ELLERTON DRIVE, QUEANBEYAN NSW		
title:	INVESTIGATION LOCATION PLAN - SHEET 4 OF 6		
project no:	GEOTFYSH09703AA	drawing no:	014
rev:	A

PROJECT: ELLERTON DRIVE EXTENSION
 PROJECT NO: GEOTFYSH 09703AA
 BOREHOLE NO: BH3 DATE: 23/5/14
 DEPTH: 1.00 - 6.00m

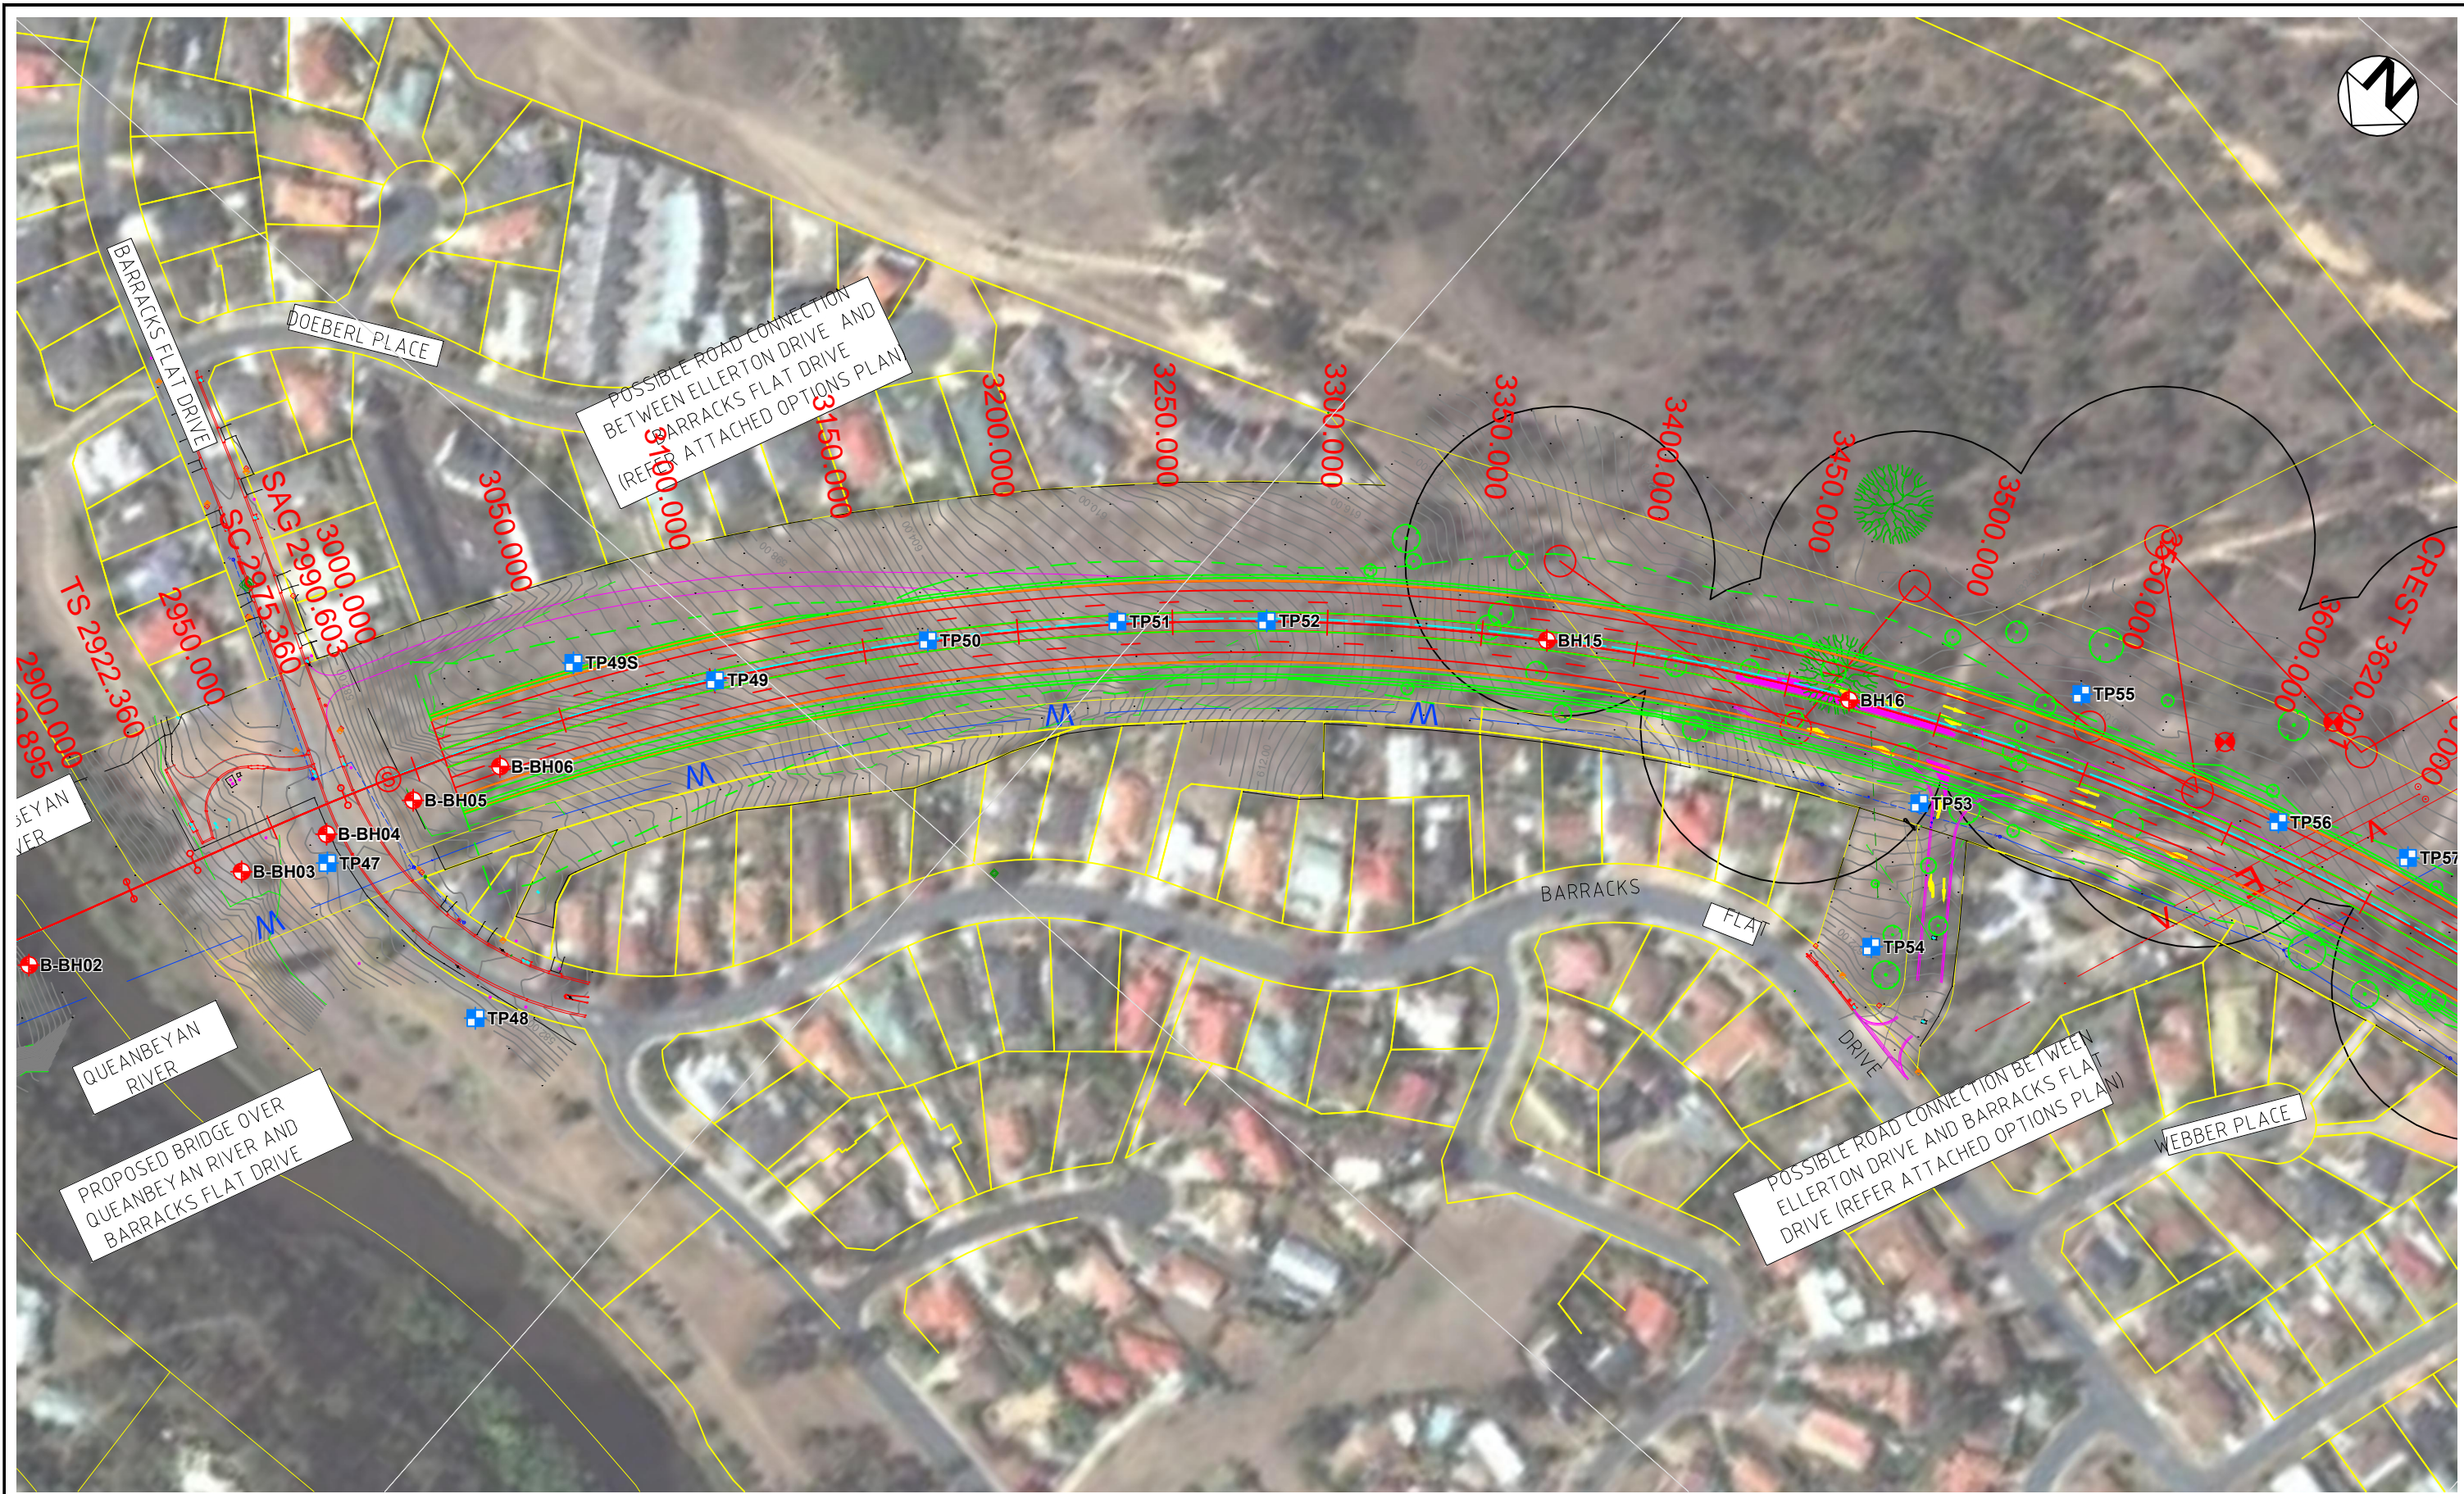
client:	OPUS INTERNATIONAL CONSULTANTS		
project:	ELLERTON DRIVE EXTENSION ELLERTON DRIVE, QUEANBEYAN NSW		
title:	INVESTIGATION LOCATION PLAN - SHEET 5 OF 6		
project no:	GEOFYSH09703AA	drawing no:	015
rev:	A

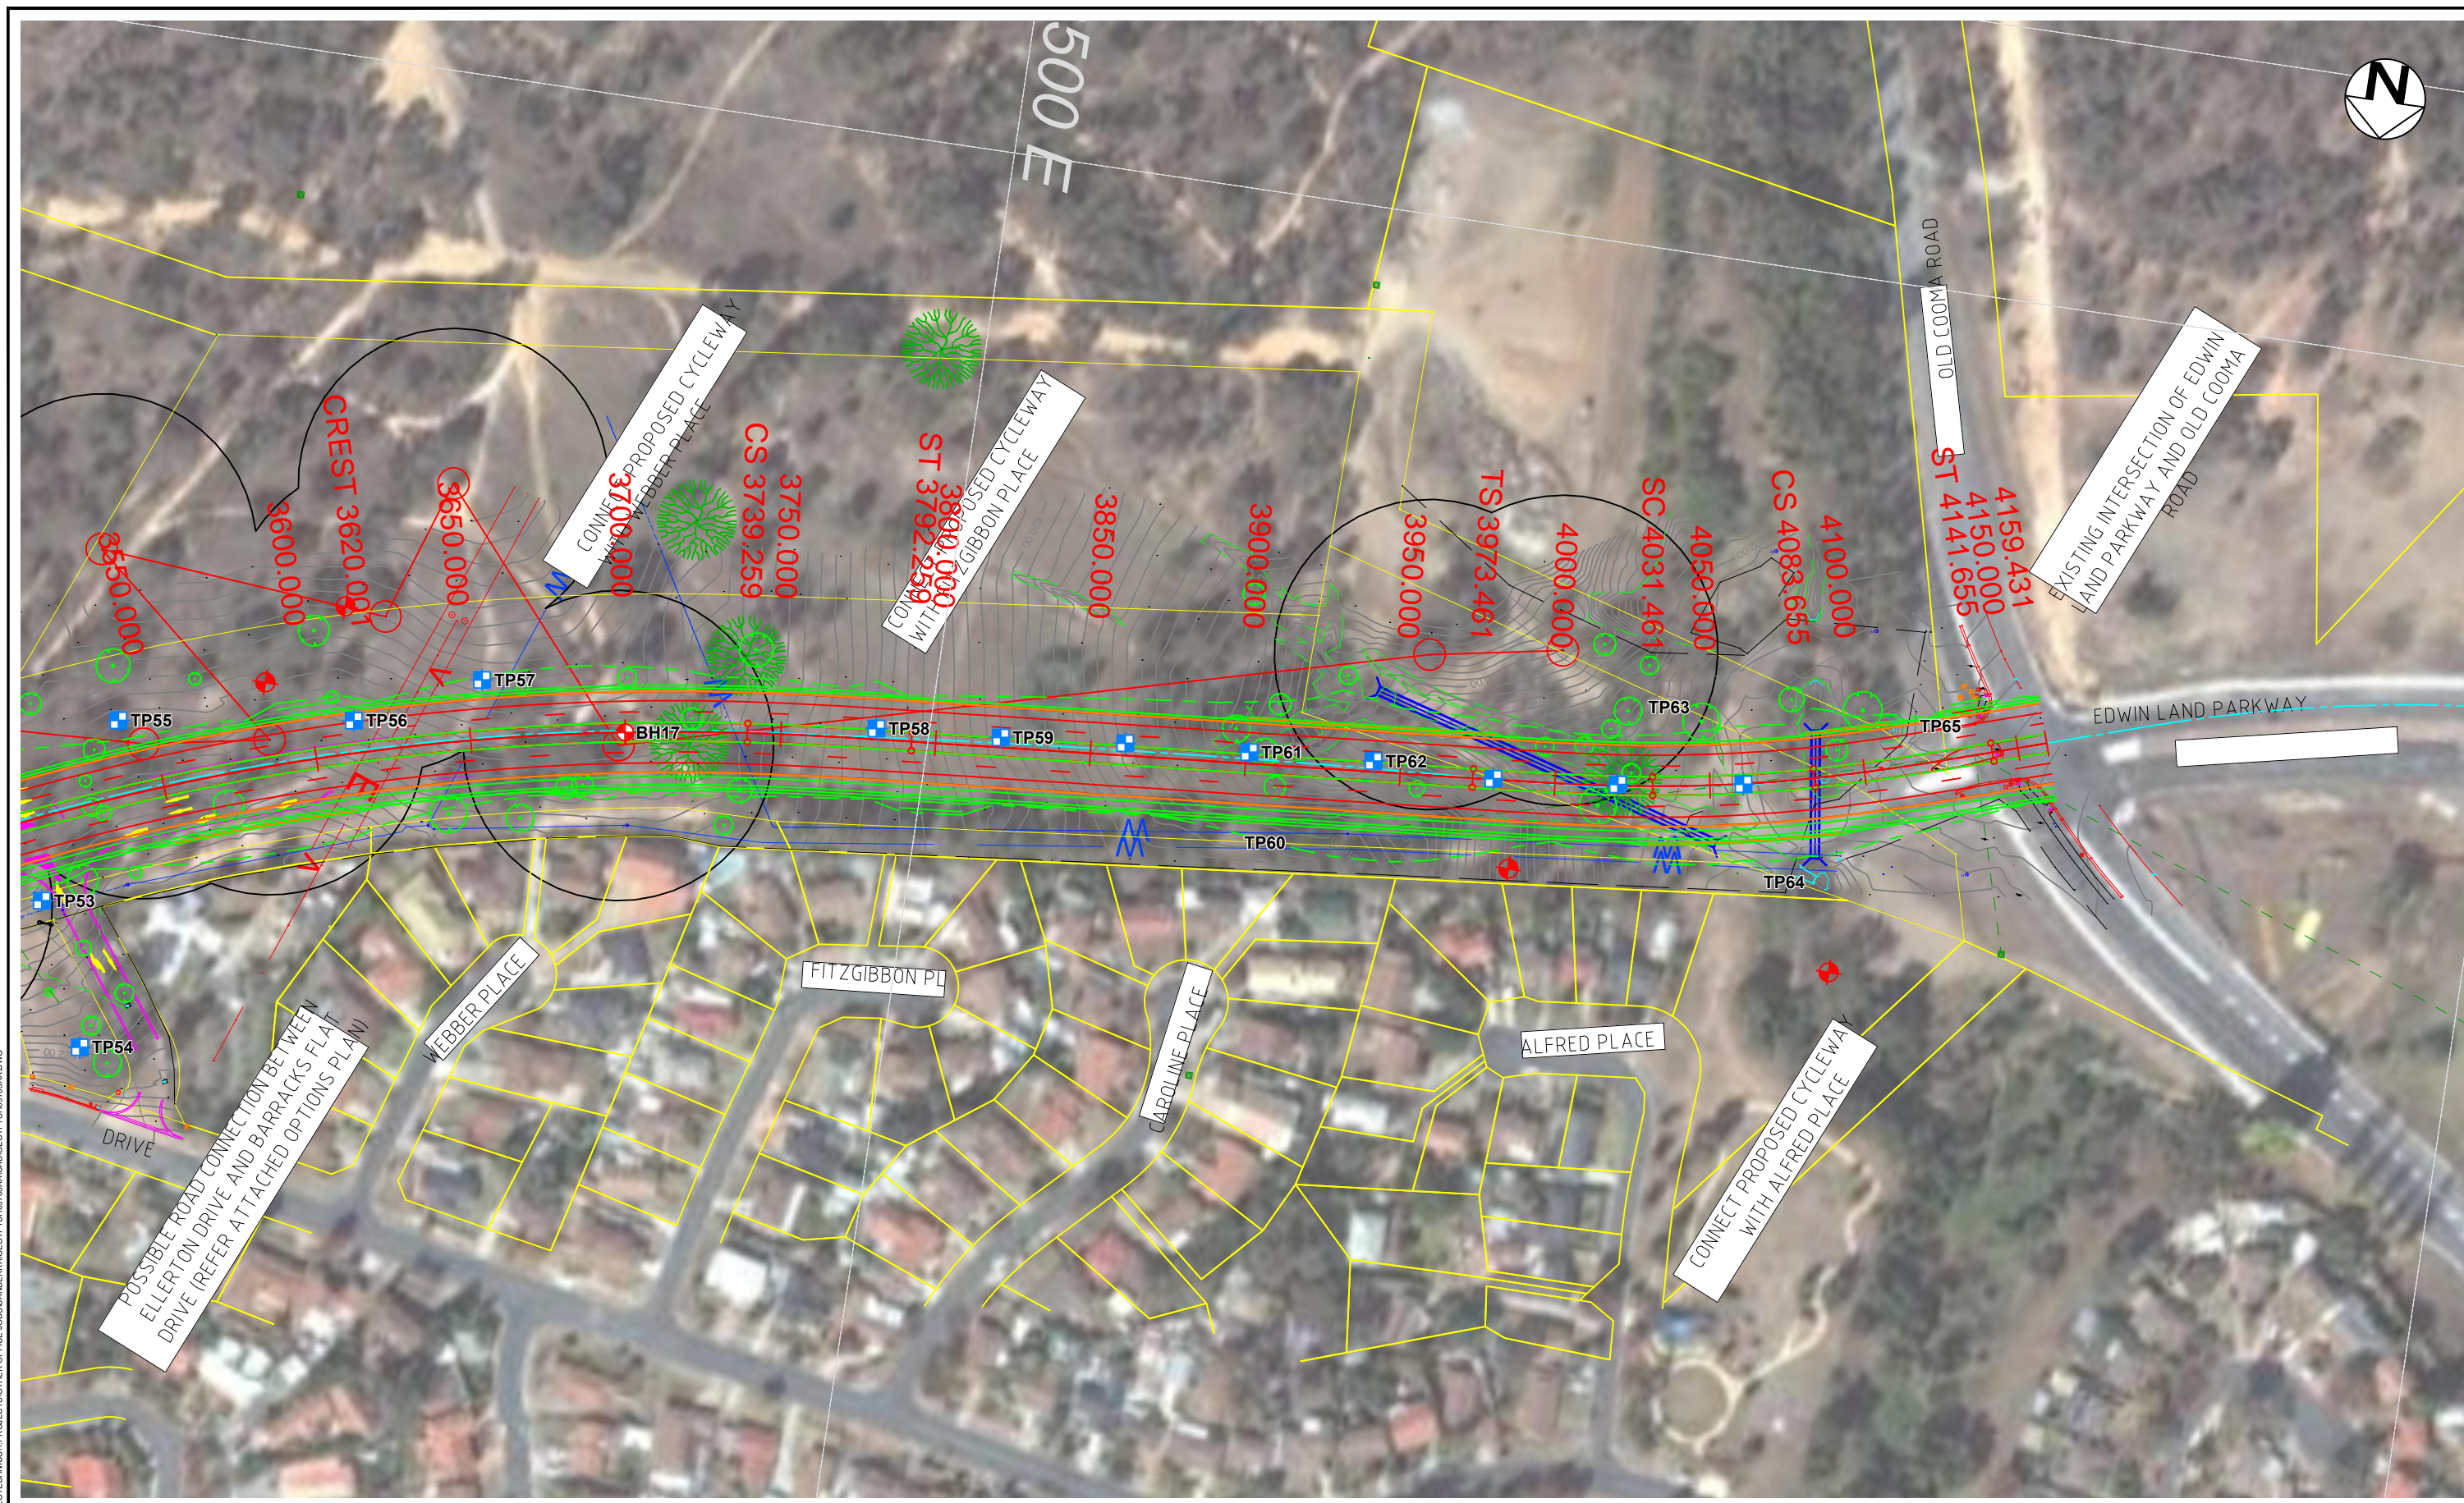
client:	OPUS INTERNATIONAL CONSULTANTS		
project:	ELLERTON DRIVE EXTENSION ELLERTON DRIVE, QUEANBEYAN NSW		
title:	INVESTIGATION LOCATION PLAN - SHEET 6 OF 6		
project no:	GEO\TYSH09703AA	drawing no:	016
rev:	A

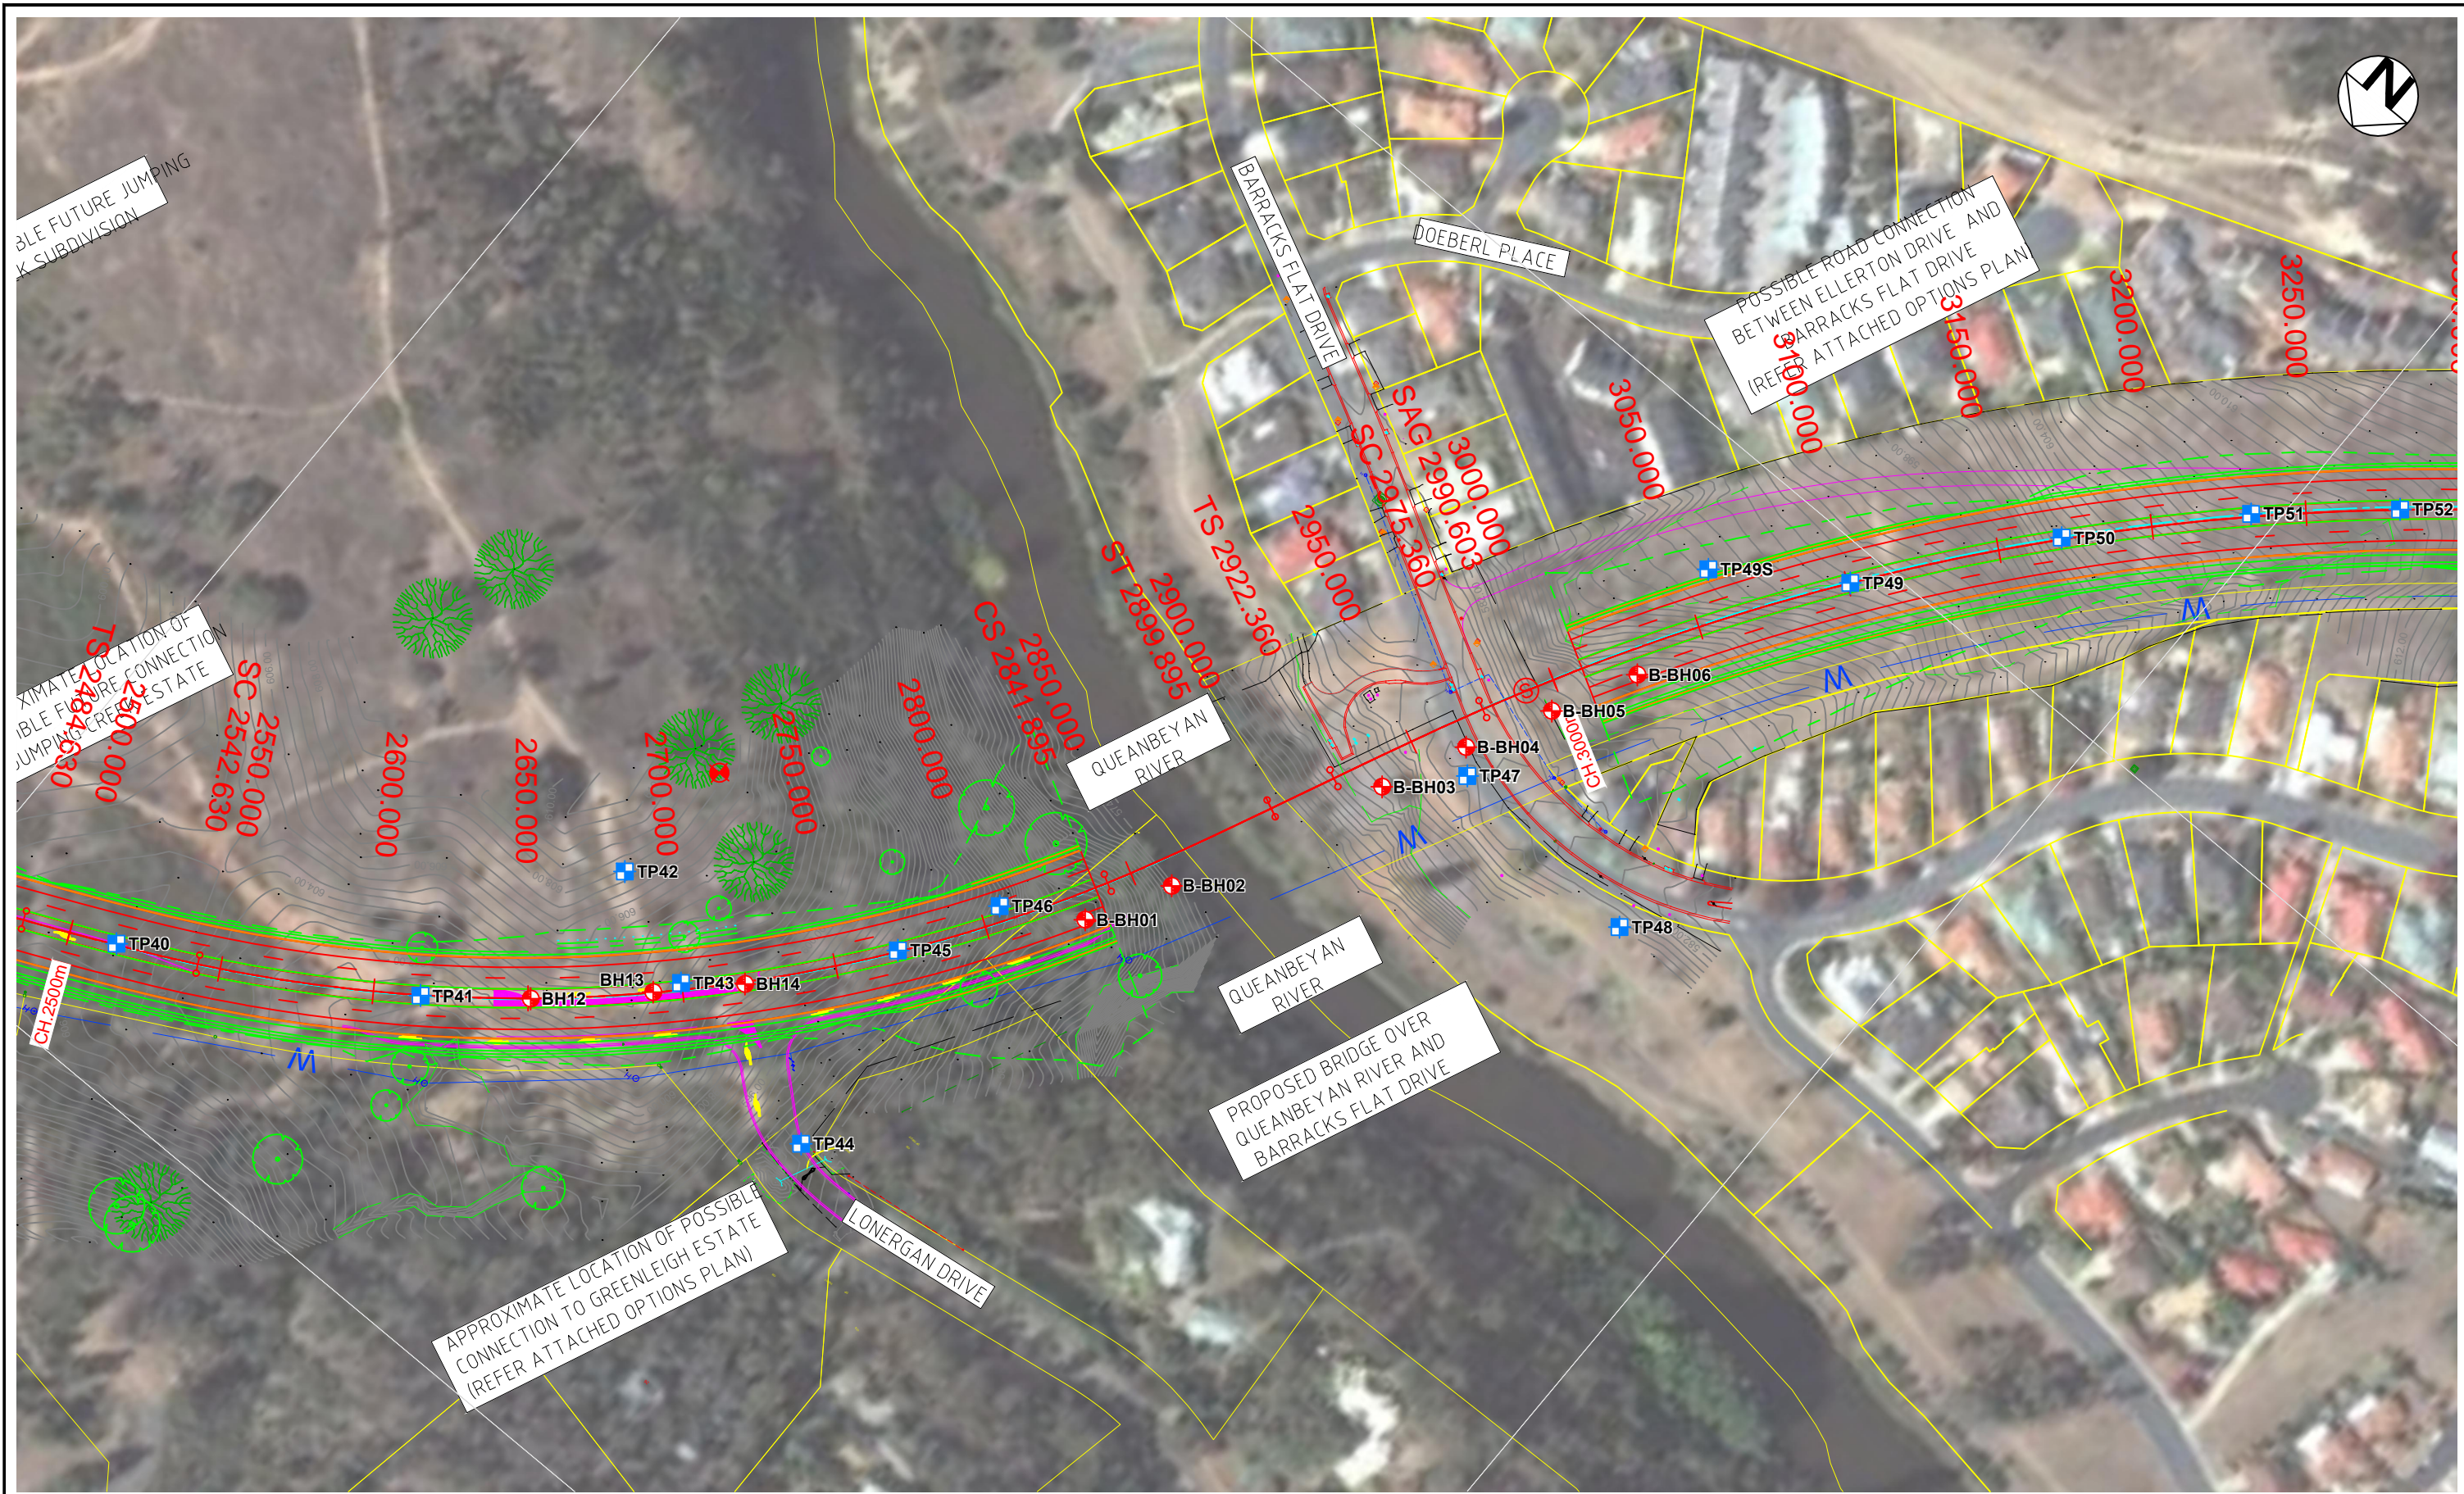
client:	OPUS INTERNATIONAL CONSULTANTS		
project:	ELLERTON DRIVE EXTENSION ELLERTON DRIVE, QUEANBEYAN NSW		
title:	INVESTIGATION LOCATION PLAN - QUEANBEYAN RIVER CROSSING		
project no:	GEOIFYSH09703AA	drawing no:	017
rev:	A

QUEANBEYAN RIVER CROSSING (REFER DRAWING 017 FOR PLAN)

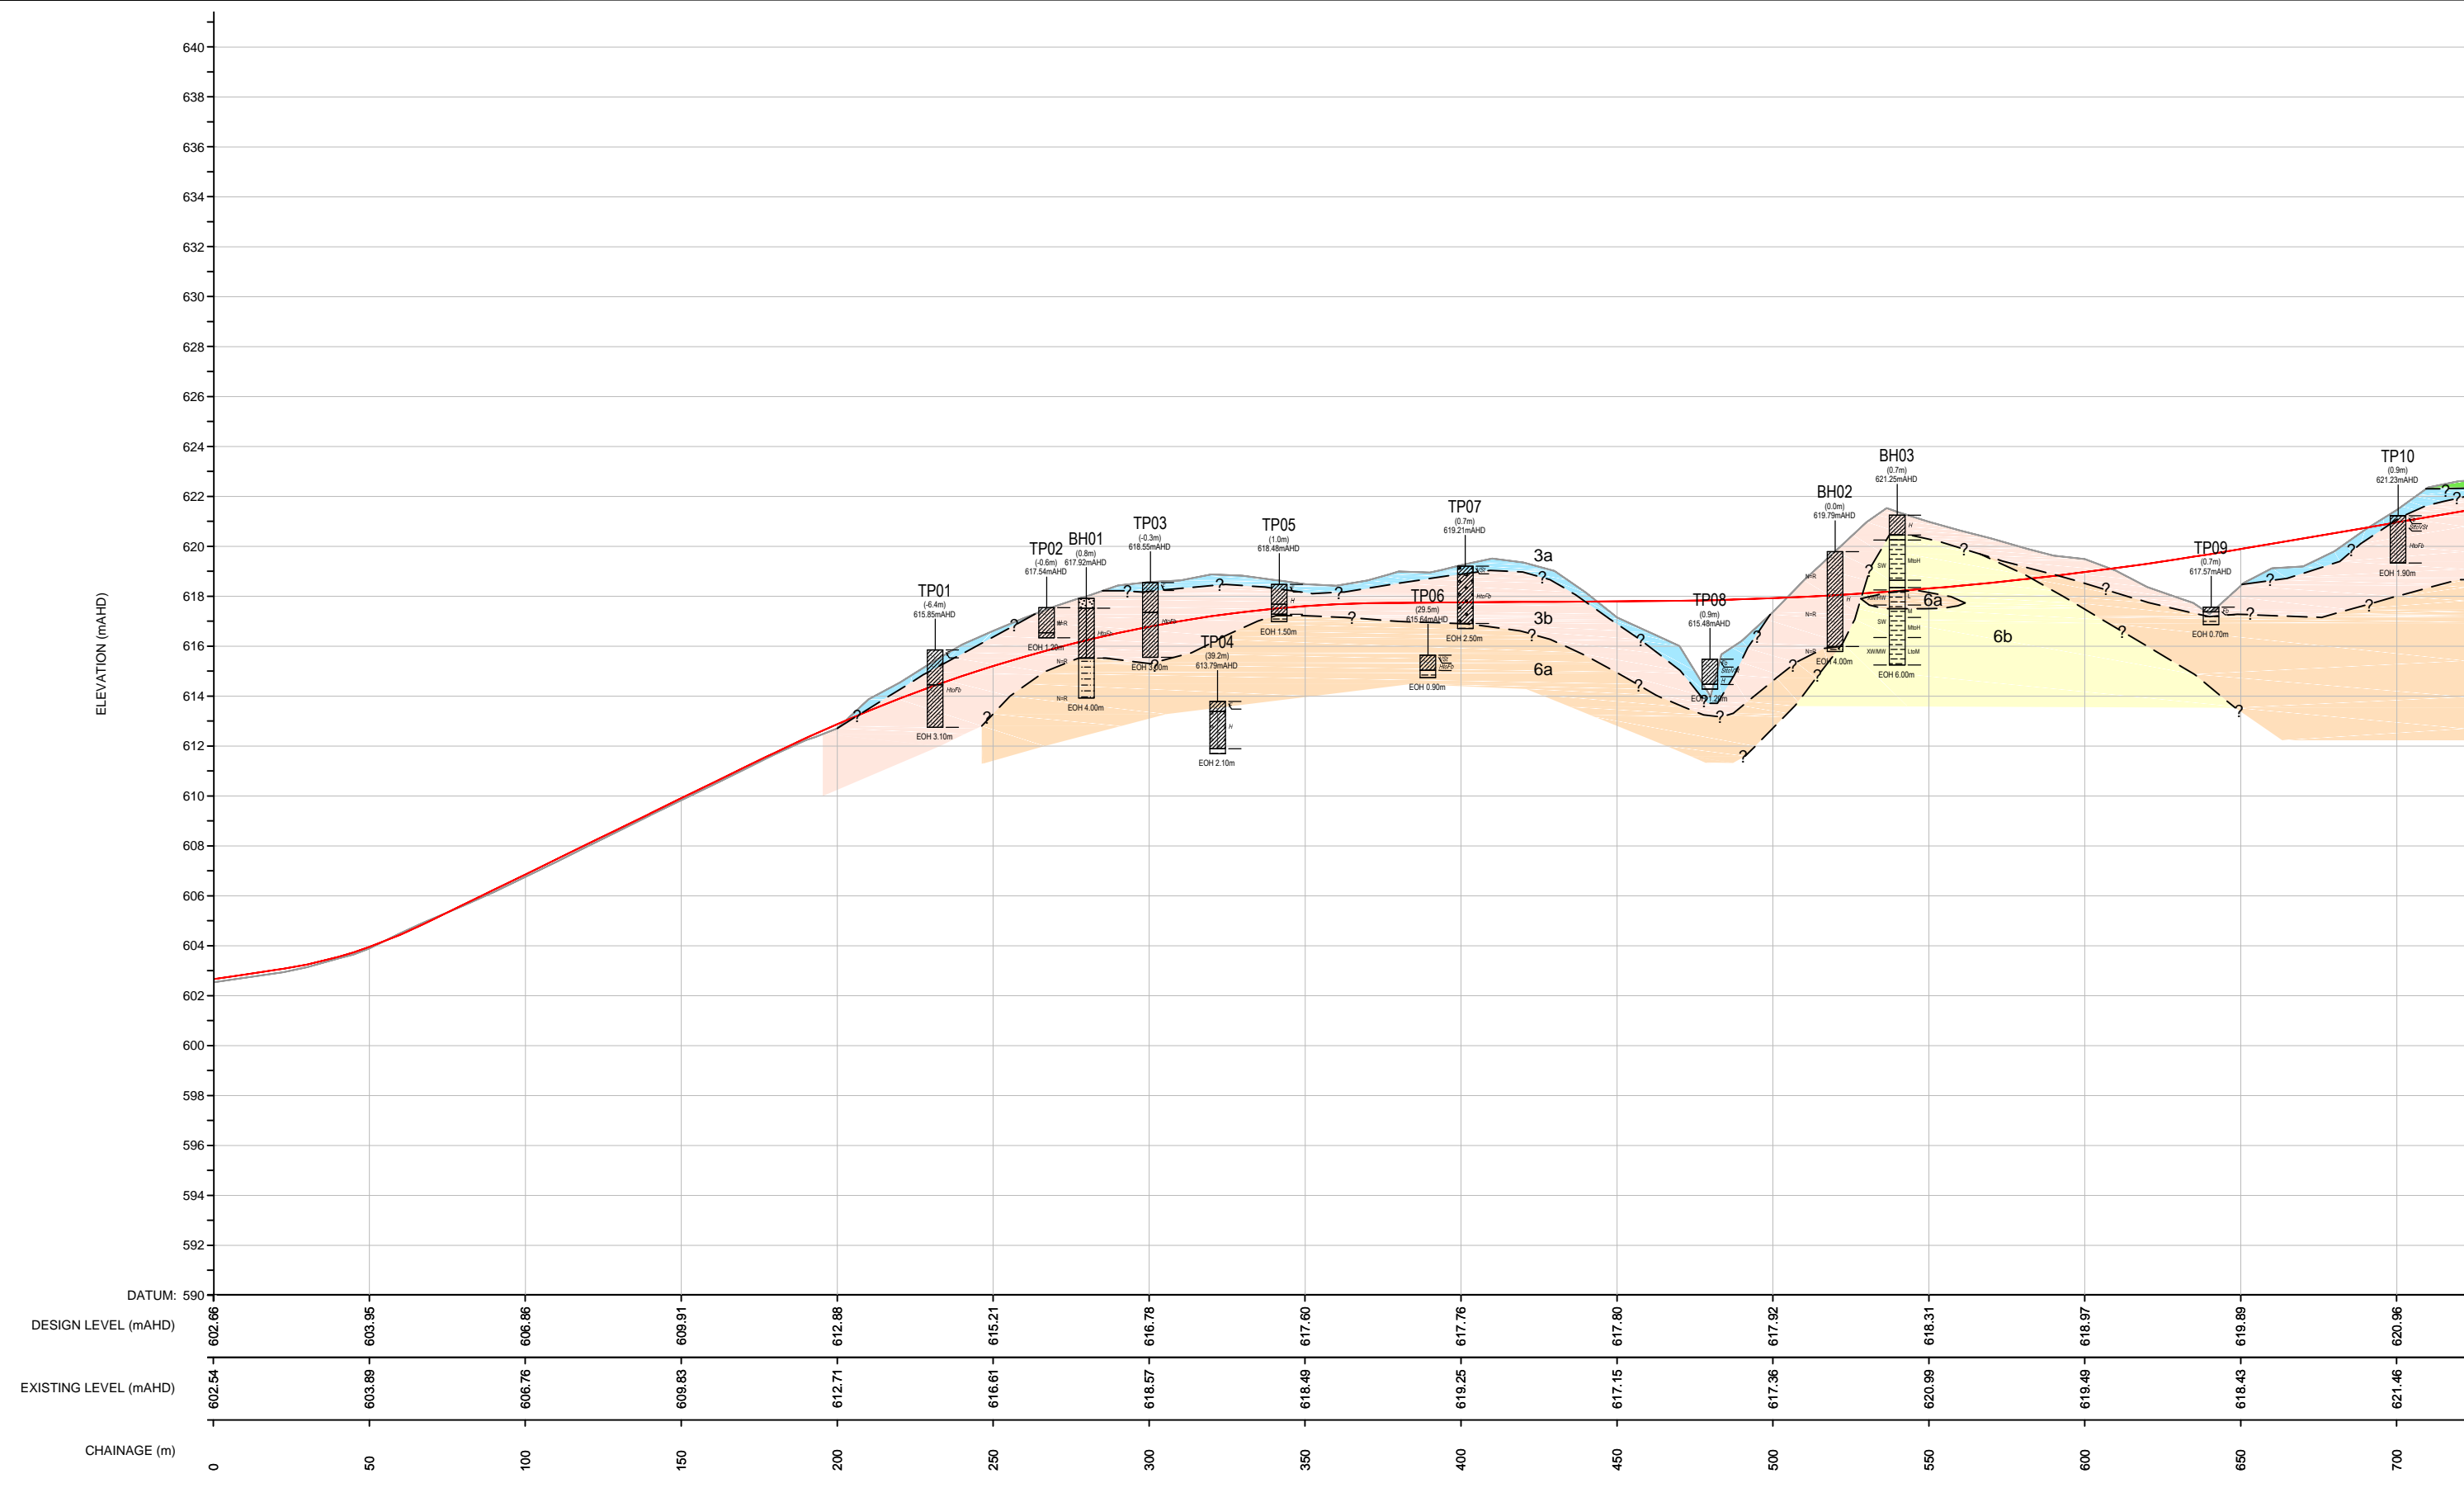
client:	OPUS INTERNATIONAL CONSULTANTS		
project:	ELLERTON DRIVE EXTENSION ELLERTON DRIVE, QUEANBEYAN NSW		
title:	GEOTECHNICAL LONG SECTION - SHEET 1 OF 7		
project no:	GEOFYSH09703AA	drawing no:	021
rev:	A

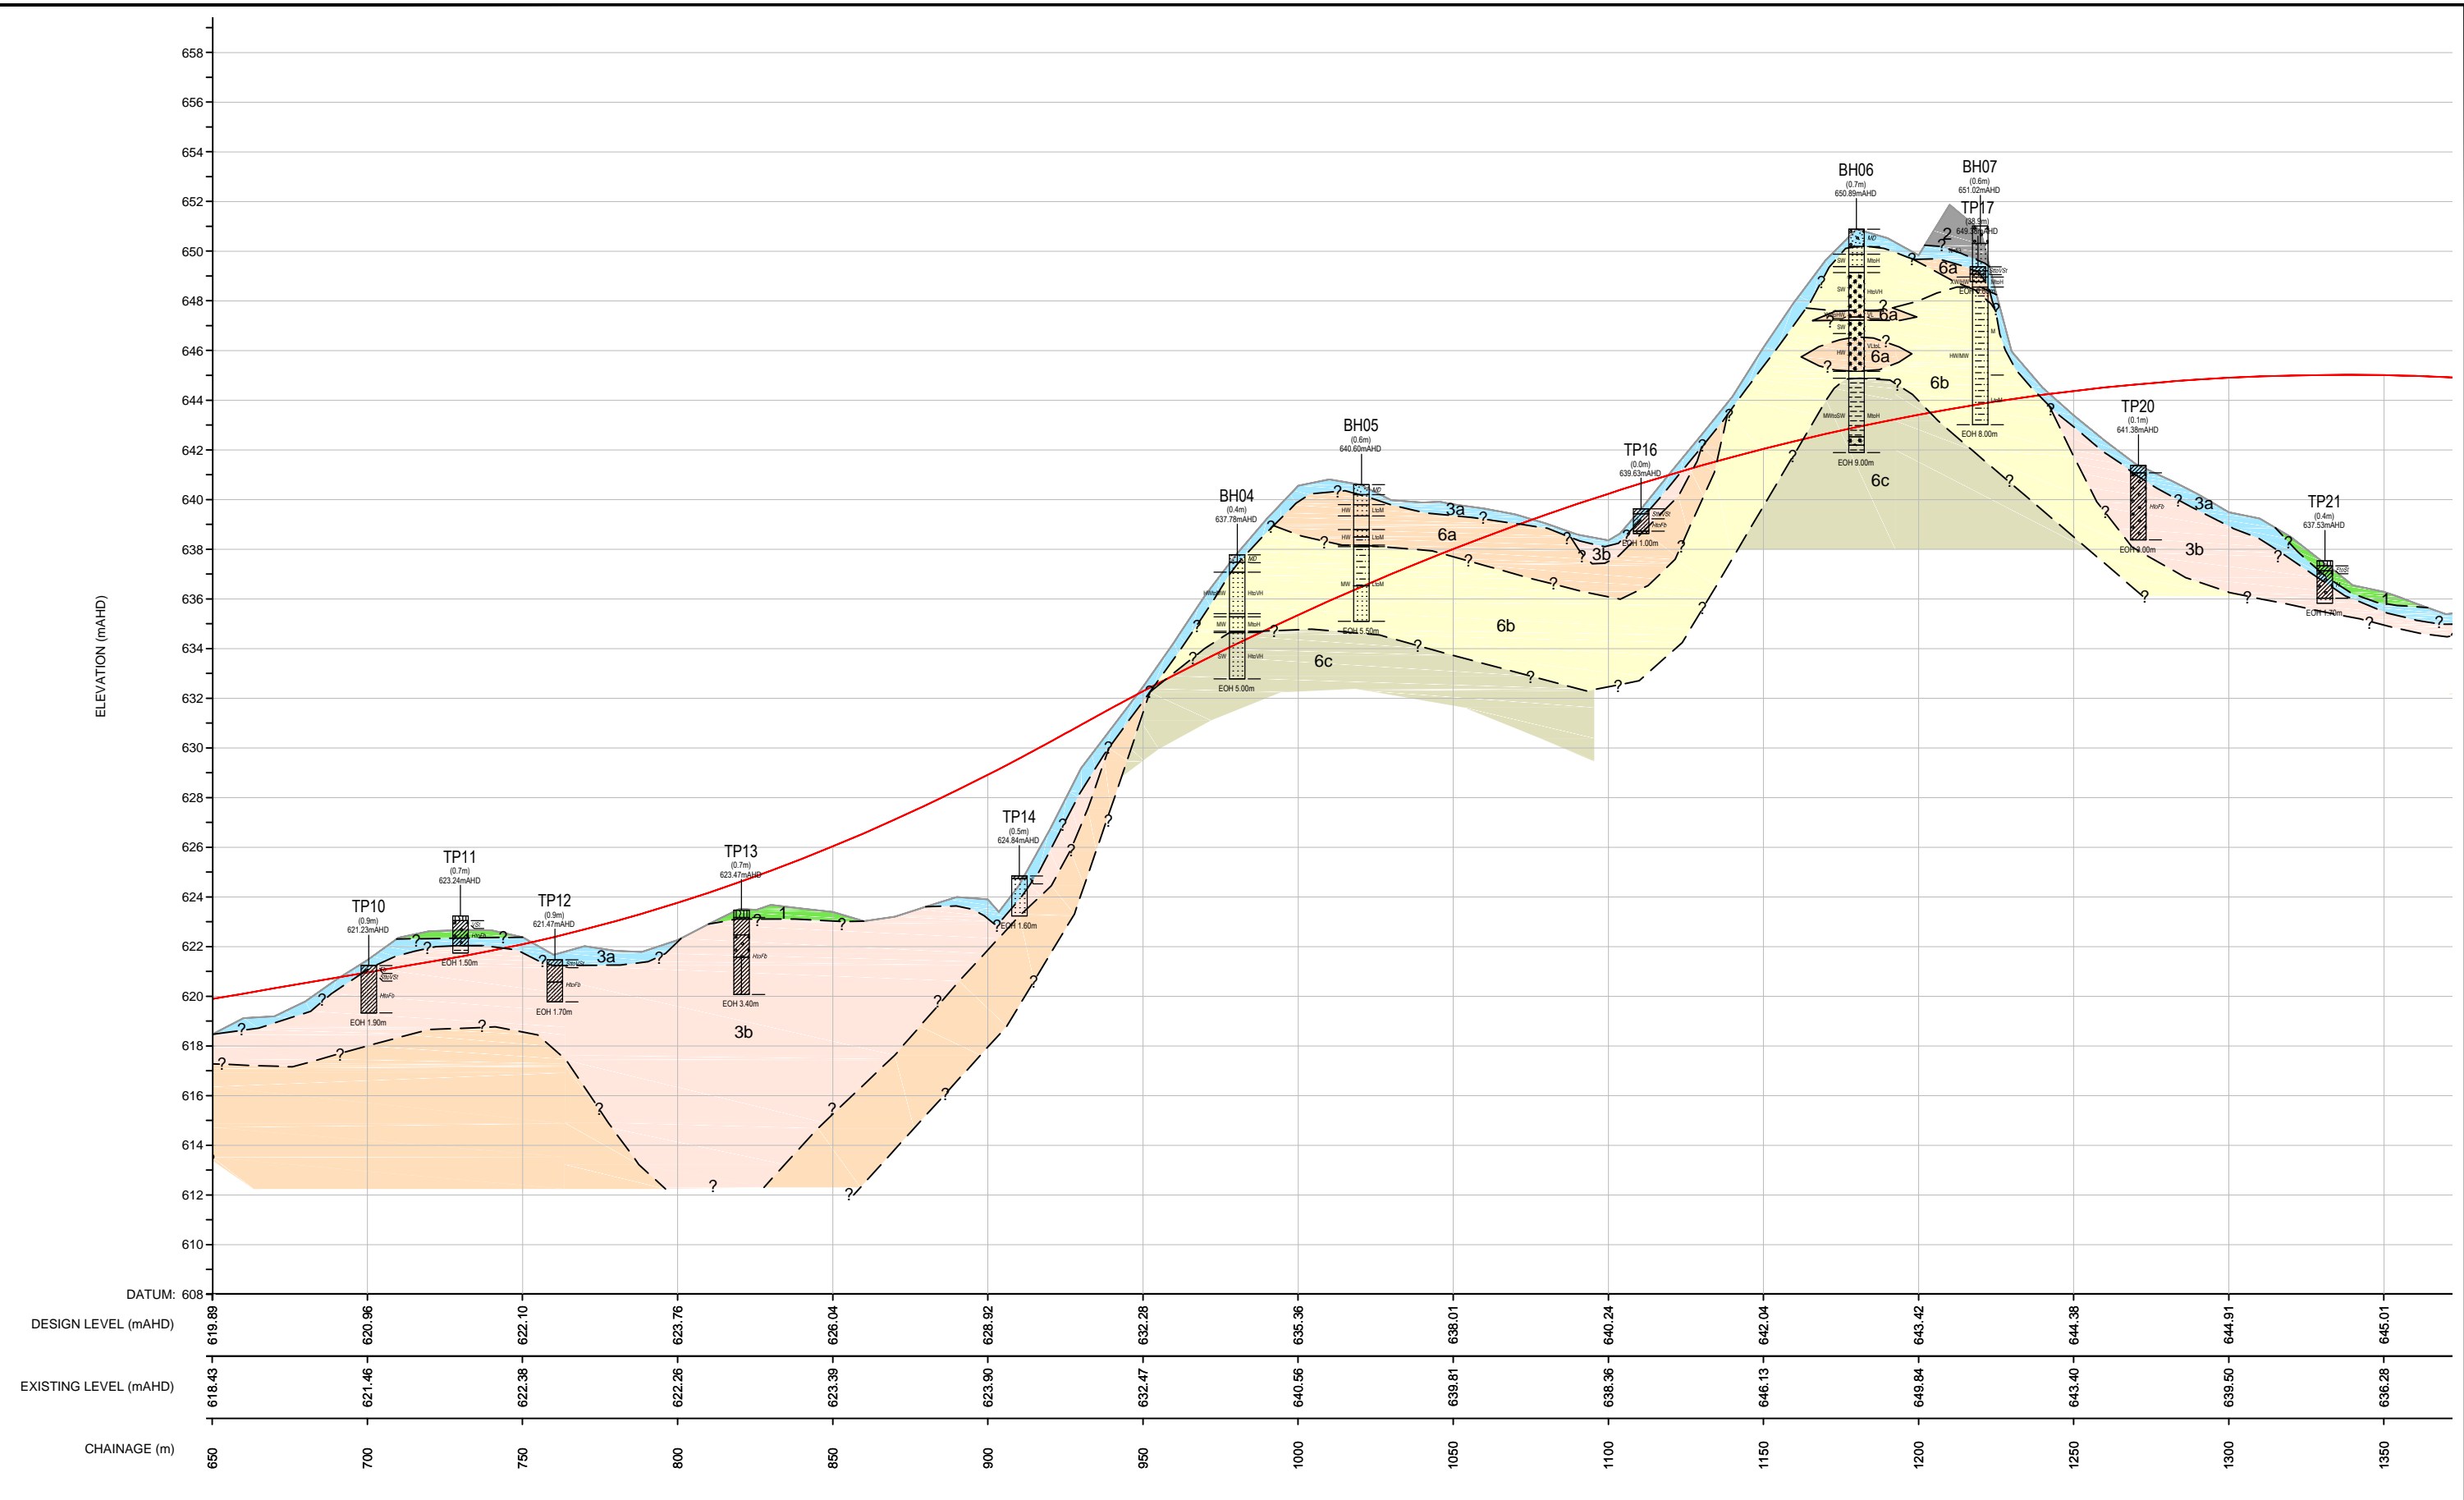
client:	OPUS INTERNATIONAL CONSULTANTS		
project:	ELLERTON DRIVE EXTENSION ELLERTON DRIVE, QUEANBEYAN NSW		
title:	GEOTECHNICAL LONG SECTION - SHEET 2 OF 7		
project no:	GEOFYSH09703AA	drawing no:	022
rev:	A

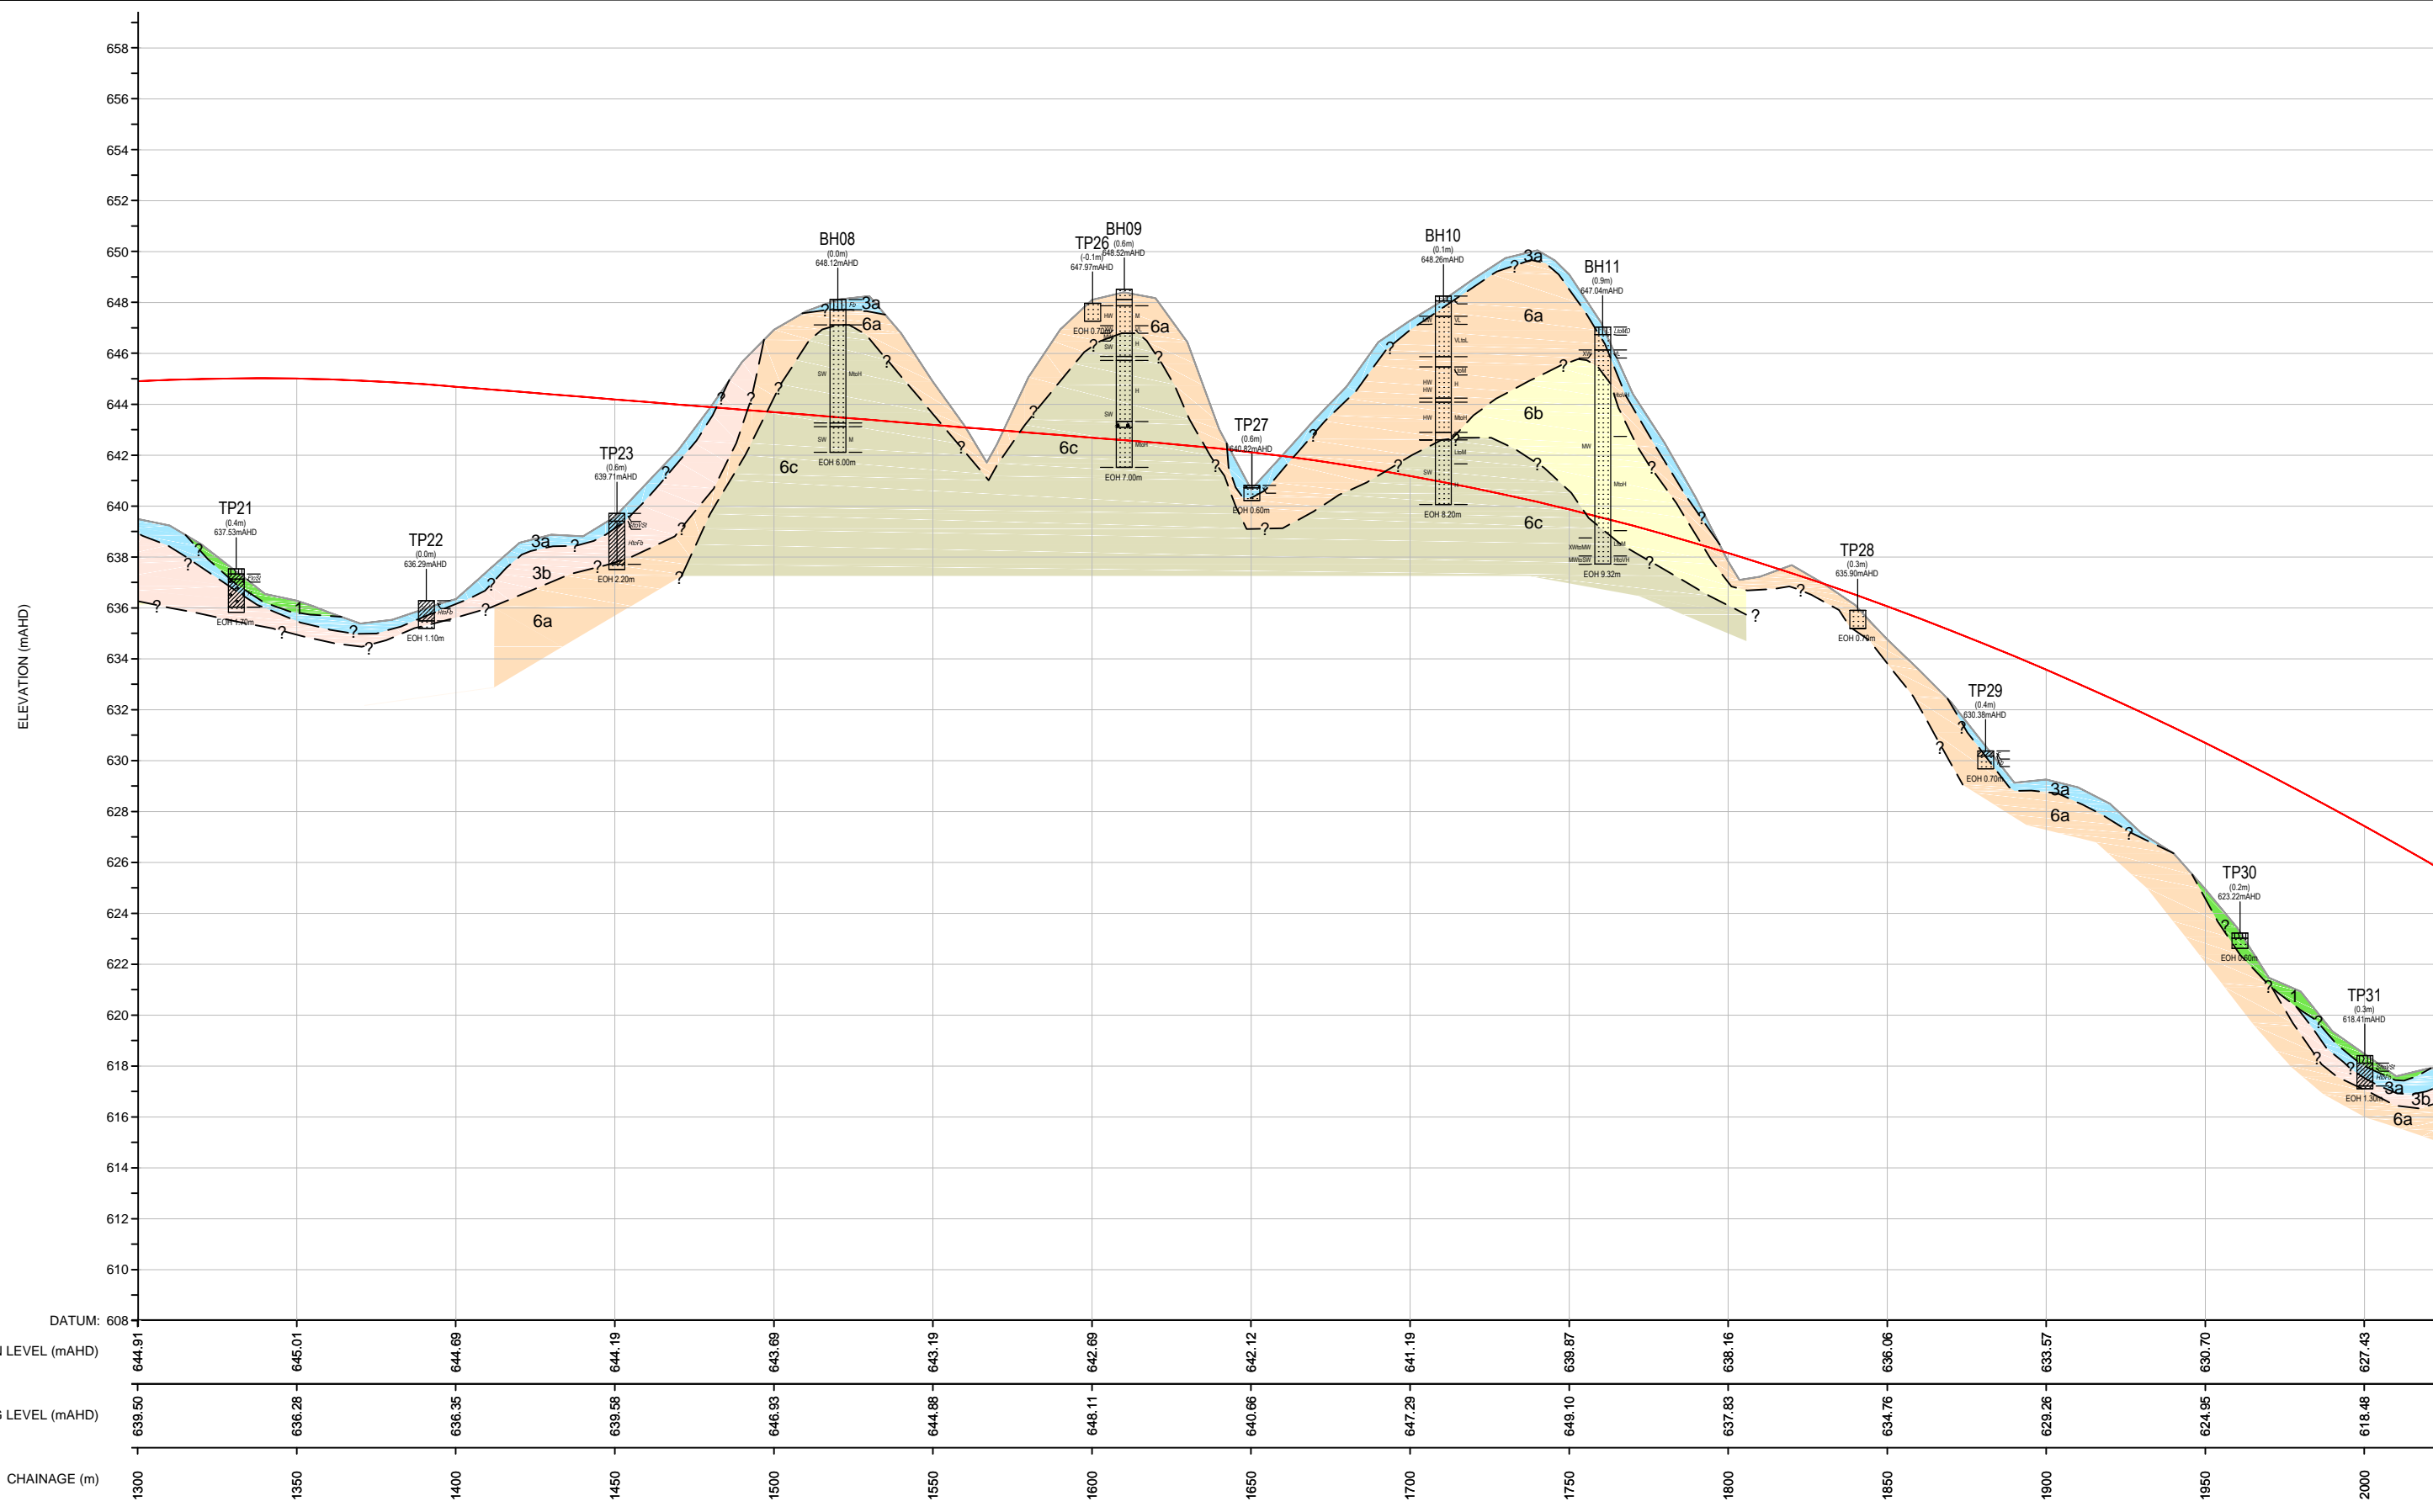
client:	OPUS INTERNATIONAL CONSULTANTS		
project:	ELLERTON DRIVE EXTENSION ELLERTON DRIVE, QUEANBEYAN NSW		
title:	GEOTECHNICAL LONG SECTION - SHEET 3 OF 7		
project no:	GEOFYSH0703AA	drawing no:	023
rev:	A
