client:	OPUS INTERNATIONAL CONSULTANTS		
project:	ELLERTON DRIVE EXTENSION ELLERTON DRIVE, QUEANBEYAN NSW		
title:	INVESTIGATION LOCATION PLAN - SHEET 4 OF 6		
project no:	GEOTFYSH09703AA	drawing no:	014
rev:	A

PROJECT: ELLERTON DRIVE EXTENSION
 PROJECT NO: GEOTFYSH 09703AA
 BOREHOLE NO: BH3 DATE: 23/5/14
 DEPTH: 1.00 - 6.00m

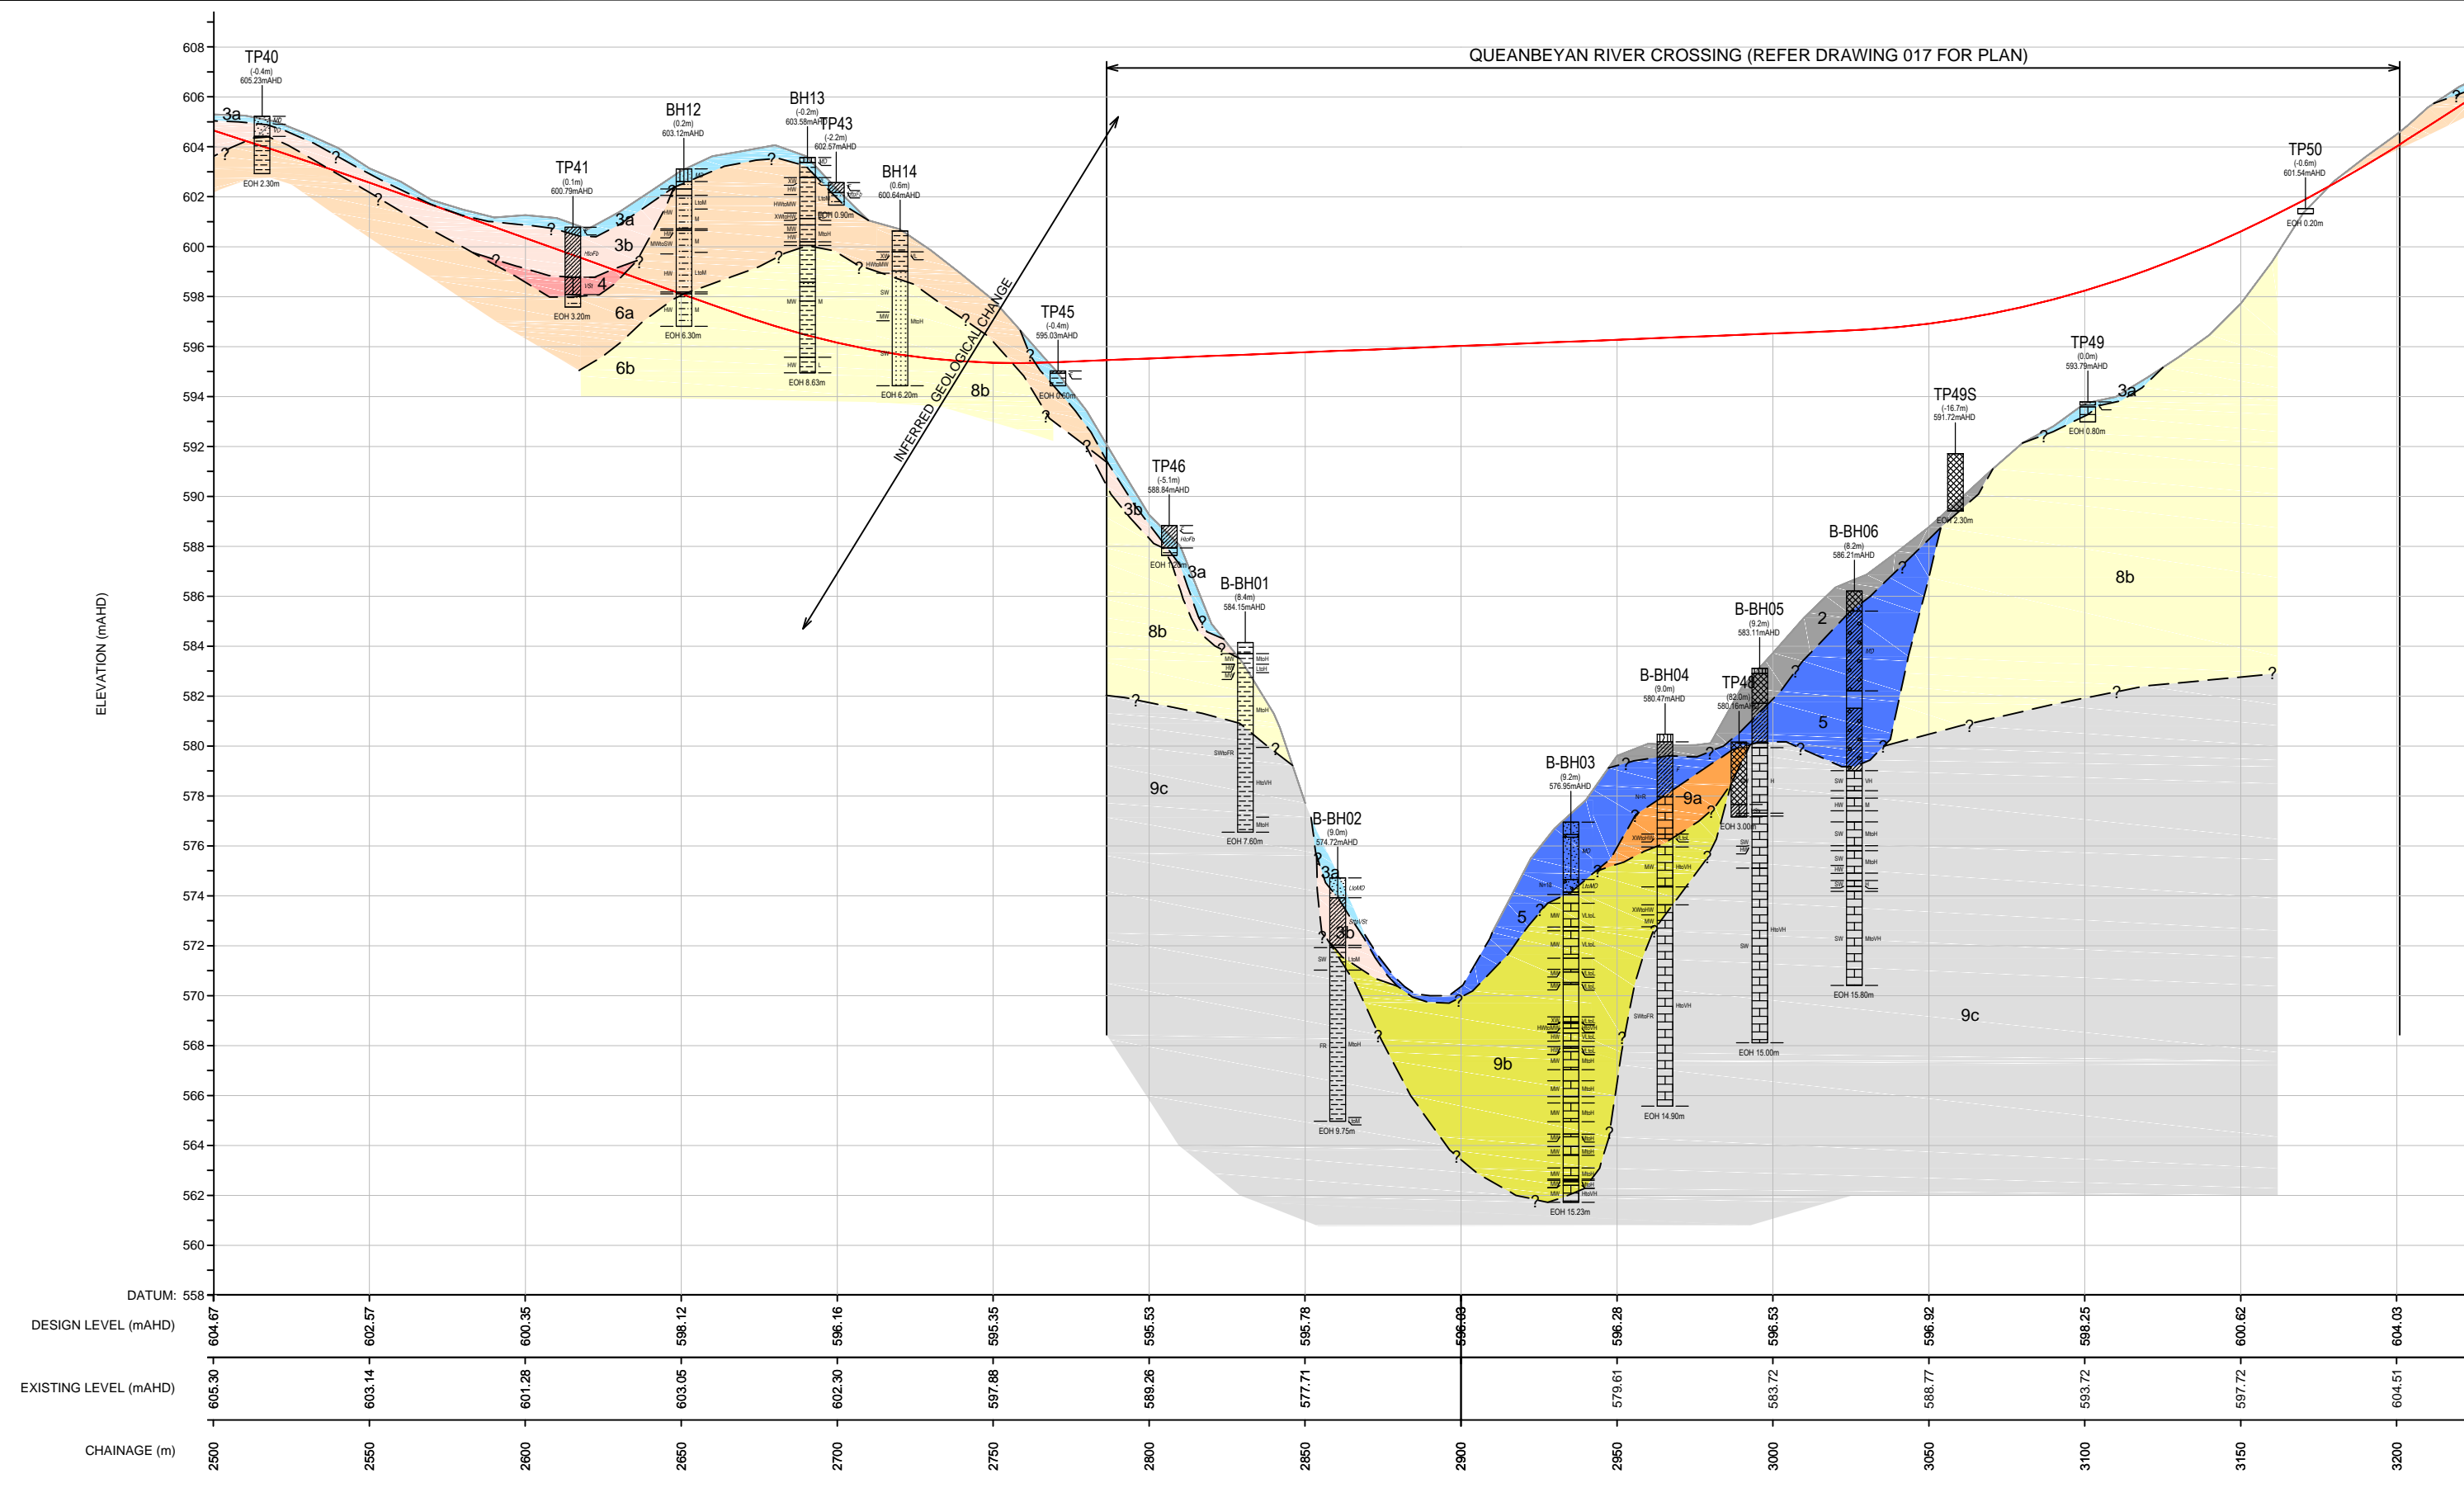
client:	OPUS INTERNATIONAL CONSULTANTS		
project:	ELLERTON DRIVE EXTENSION ELLERTON DRIVE, QUEANBEYAN NSW		
title:	GEOTECHNICAL LONG SECTION - SHEET 5 OF 7		
project no:	GEOFYSH09703AA	drawing no:	025
rev:	A

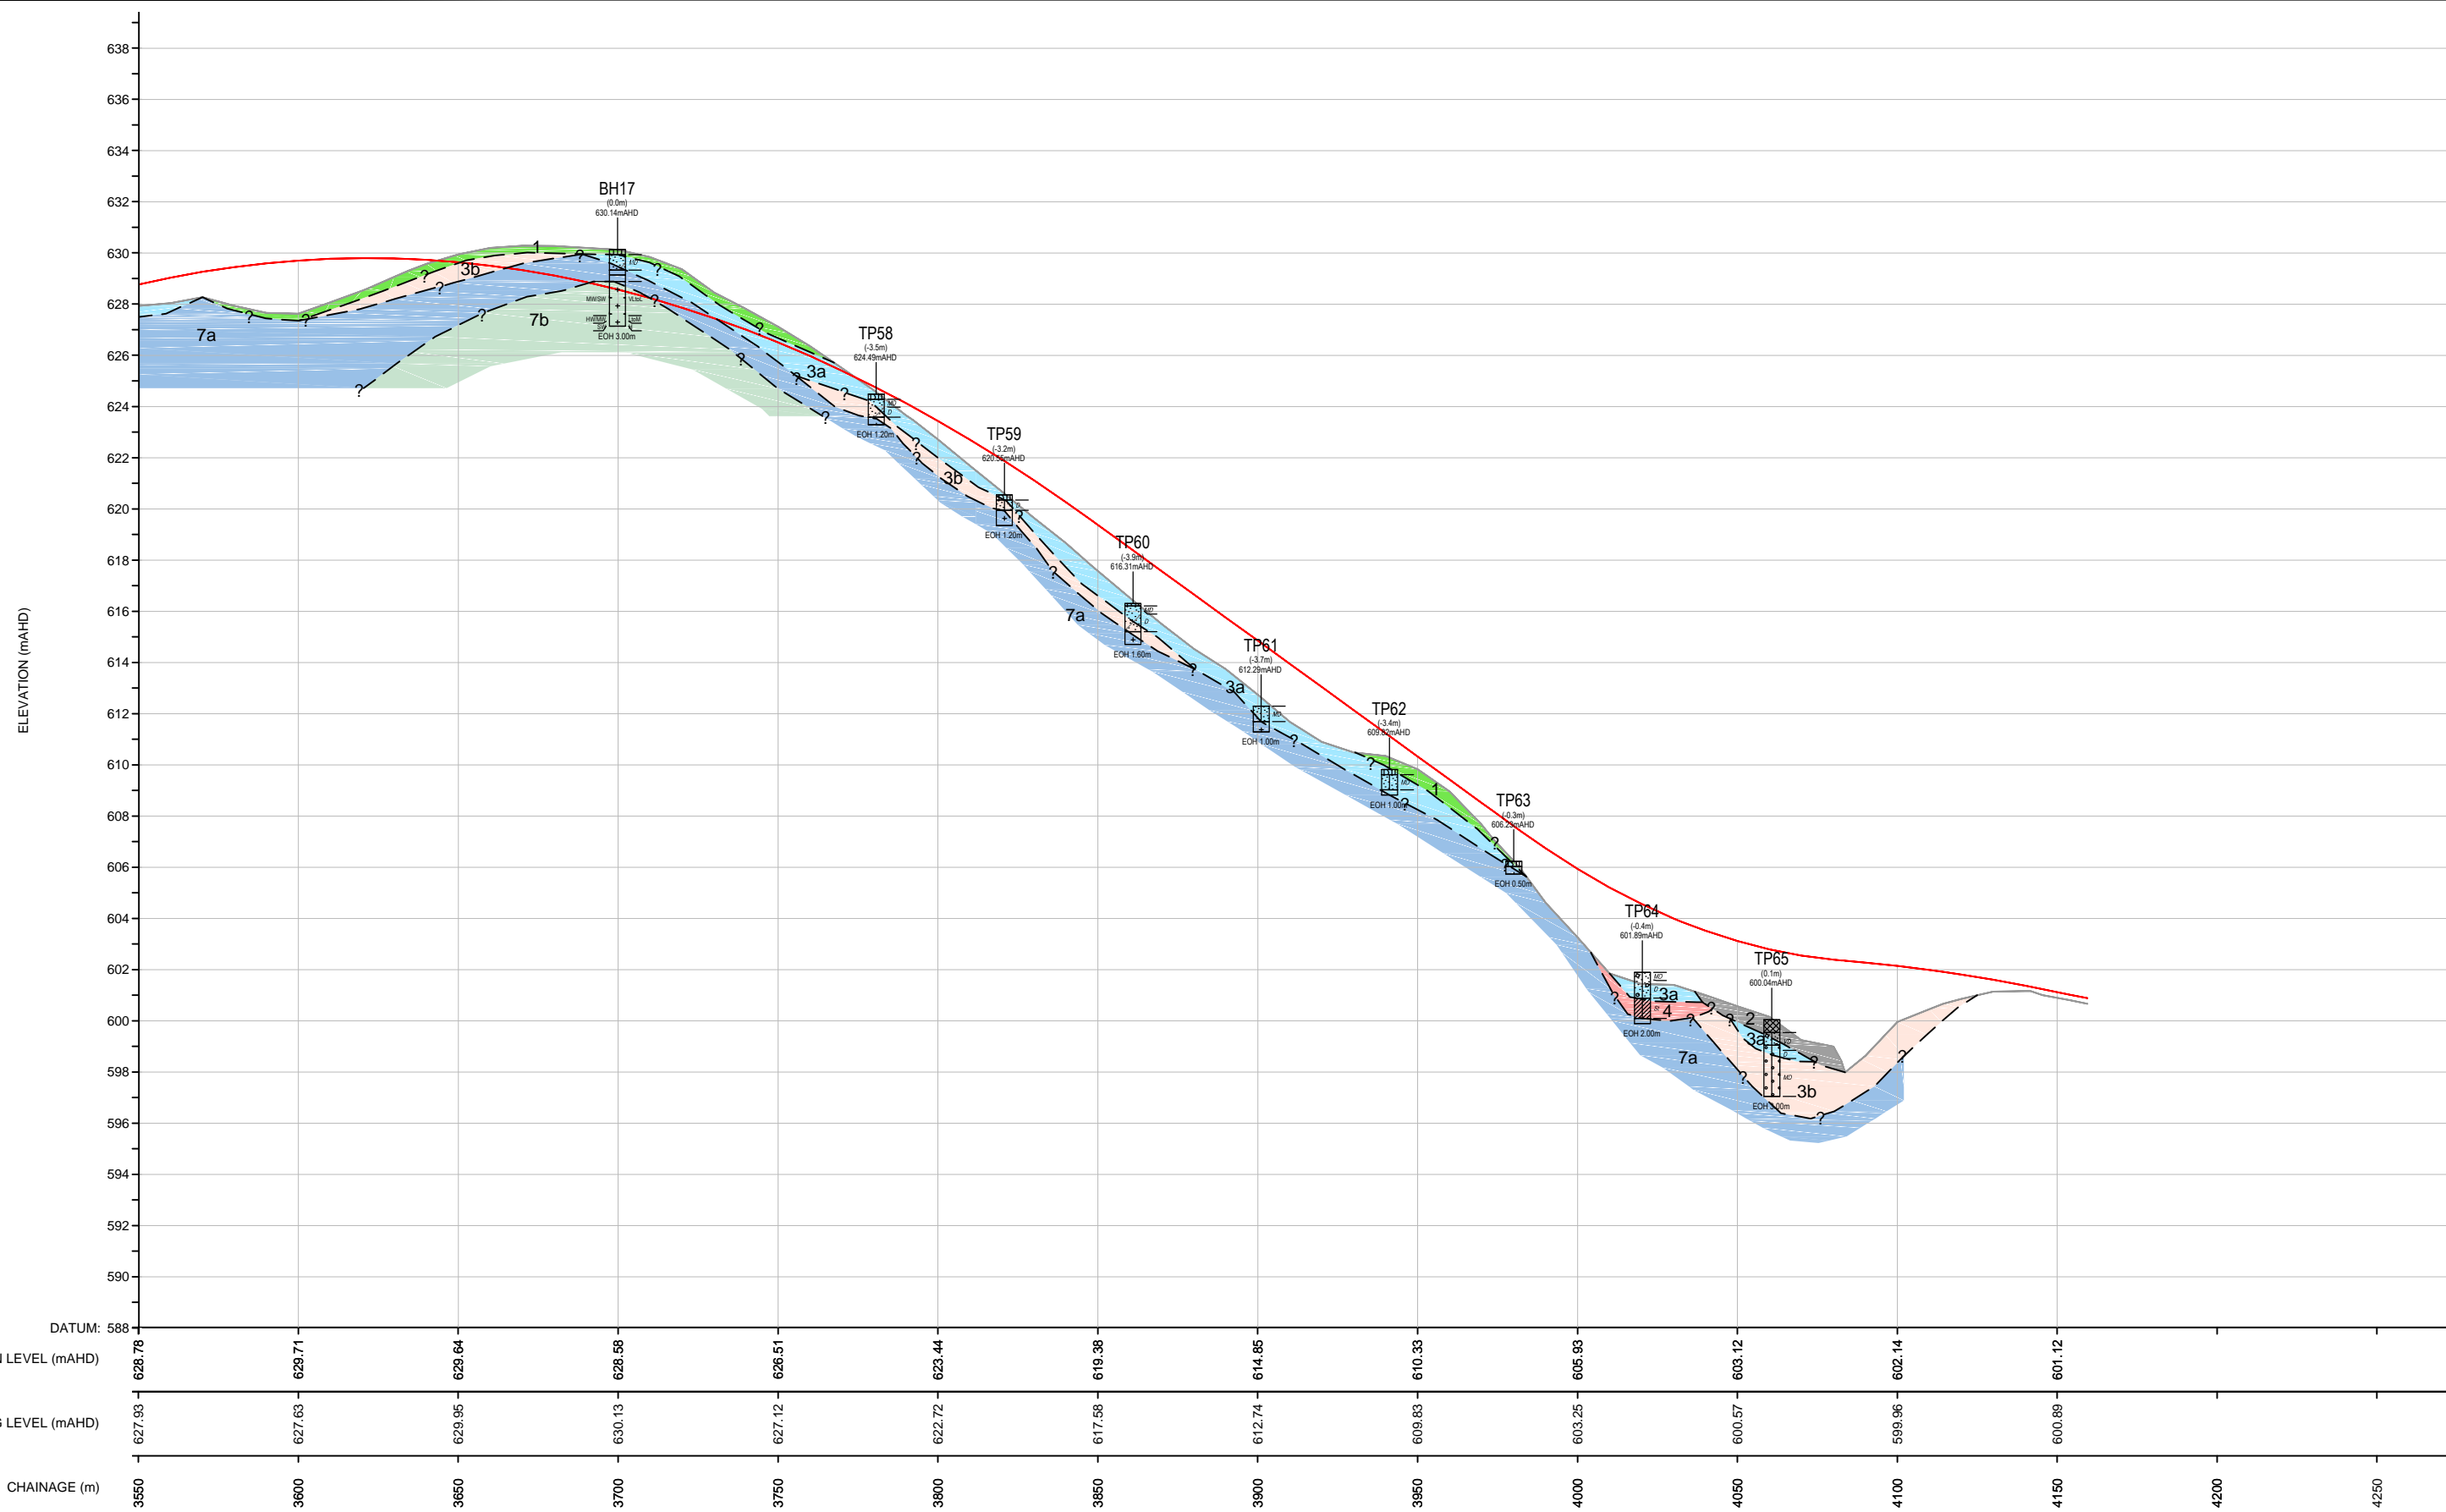
client:	OPUS INTERNATIONAL CONSULTANTS		
project:	ELLERTON DRIVE EXTENSION ELLERTON DRIVE, QUEANBEYAN NSW		
title:	GEOTECHNICAL LONG SECTION - SHEET 7 OF 7		
project no:	GEOFYSH09703AA	drawing no:	027
rev:	A

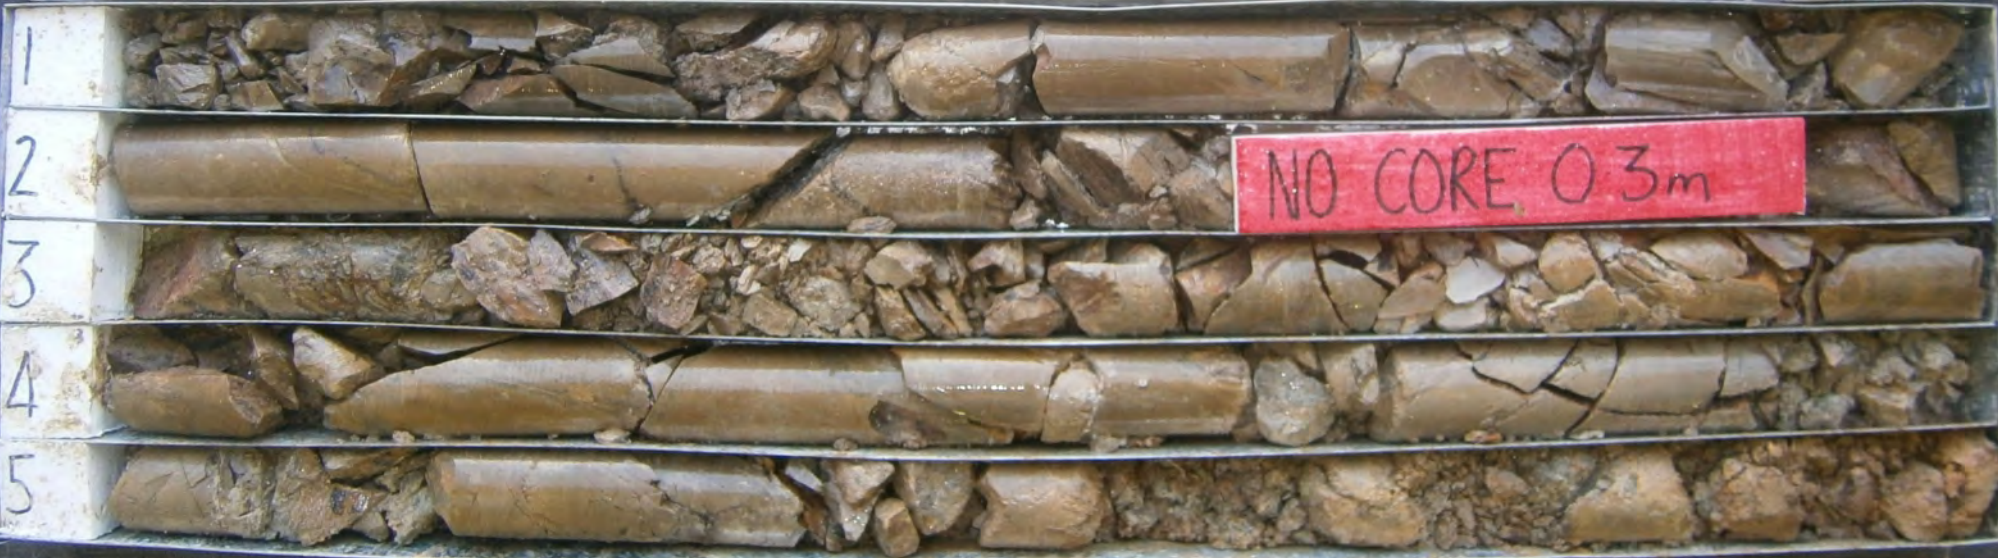
PointID : BH03 Depth Range: 1.00 - 6.00 m

drawn	SB		client:	Opus International Consultants NSW Pty Ltd		
approved	BC		project:	Ellerton Drive Extension Ellerton Drive, Quambeyan, NSW		
date	24/06/2014		title:	CORE PHOTOGRAPH BH03		
scale	N.T.S.		project no:	GEOTFYSH09703AA	fig no:	17
original size	A4		rev:

-618	4.00		SHALE: fine grained, brown, indistinctly bedded at 50°; highly jointed along defects and bedding.	XW / HW		a=0.53 d=0.71	0%	Highly Fractured Zone: 1100mm comprising closely spaced joints and partings at various orientations	
-617	5.00			SW			33%		
-616	6.00		Borehole BH03 terminated at 6.00 m Target depth	XW / MW		d=0.30	0%	Highly Fractured Zone: 1100mm comprising closely spaced joints and partings	
-615	7.00								
-614

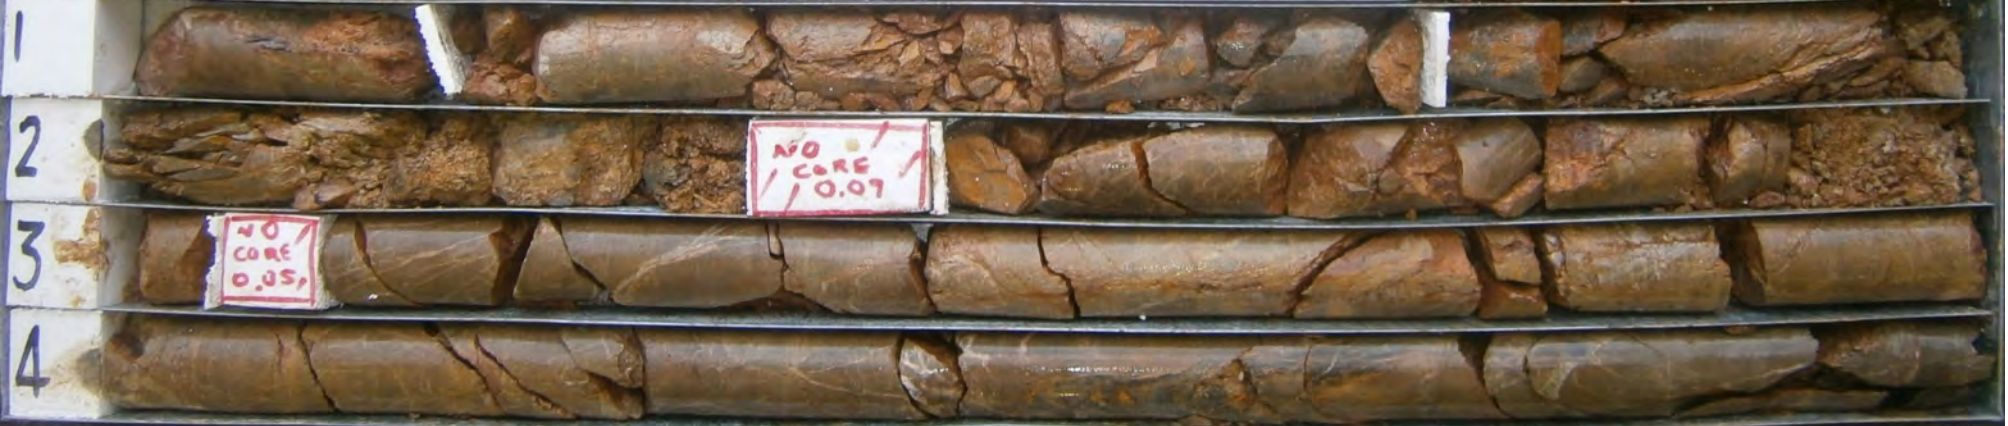
PointID : BH04 Depth Range: 0.70 - 5.00 m

GEOTFYSH09703AA BH04 START 0.7m

drawn	SB		client:	Opus International Consultants NSW Pty Ltd		
approved	BC		project:	Ellerton Drive Extension Ellerton Drive, Quانبeyan, NSW		
date	24/06/2014		title:	CORE PHOTOGRAPH BH04		
scale	N.T.S.		project no:	GEOTFYSH09703AA	fig no:	18
original size	A4		rev:

drilling information		material substance				rock mass defects							
method & support	water	depth (m)	material description	weathering & alteration	estimated strength & Is(50)	samples, field tests & Is(50) (MPa)	defect spacing (mm)	additional observations and defect descriptions					
RL (m)	graphic log	ROCK TYPE: grain characteristics, colour, structure, minor components	VL	L	M	H	VH	EH	a = axial, d = diametral	core run & RQD	particular	general	
			start coring at 0.70m										
-637		1.0	SANDSTONE: fine to medium grained, grey, distinct bedding @ approx. 55°, with a trace of interlaminated siltstone, some iron staining.	HW to MW						d=4.26	100%	JT, 70°, PL, RO, Clay CO	Highly Fractured Zone: 2530mm comprising joints, partings, seams, 70° PL, ST, SN Fe
-636		2.0									0%		
-635		3.0	NO CORE: 0.13 m	MW							0%		
-635		3.0	SANDSTONE: fine to medium grained, grey, trace of quartz veins interlaminated into sandstone.								6%
