Engineering Log - Cored Borehole

Queanbeyan City Council

Ellerton Drive Extension

Opus International Consultants NSW Pty Ltd

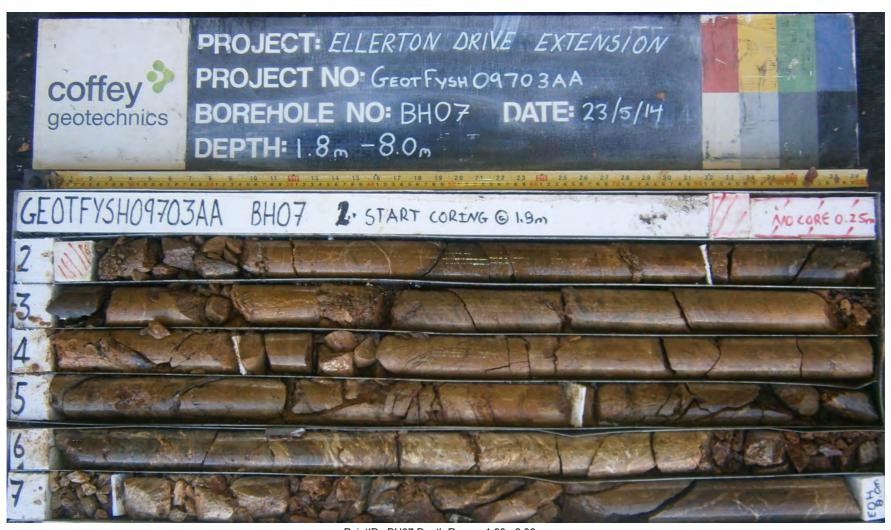
PointID: BH07 Depth Range: 1.80 - 8.00 m

client:	Opus International Consultants NSW Pty Ltd										
project:	Ellerton Dri Ellerton Drive, G										
title:	CORE PHO	OTOGRAPI 107	Н								
project no	GEOTFYSH09703AA	fig no:	21	rev:

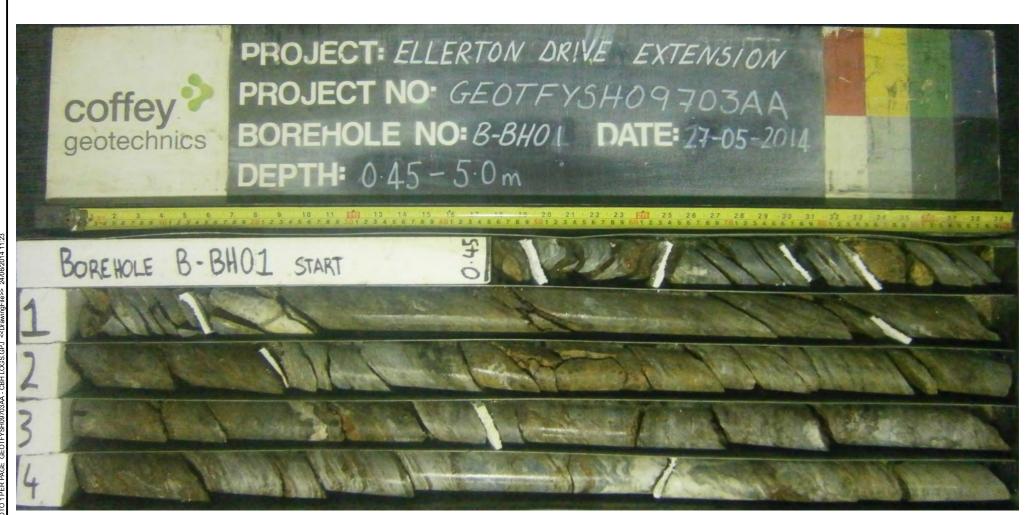
PointID: B-BH01 Depth Range: 0.45 - 5.00 m

client:	Opus International Co	onsultants N	SW Pty L	td
project:	Ellerton Dri Ellerton Drive, (ve Extensior Quanbeyan,	=	
title:		OTOGRAPH 3H01	ł	
project no:	GEOTFYSH09703AA	fig no:	1	rev:

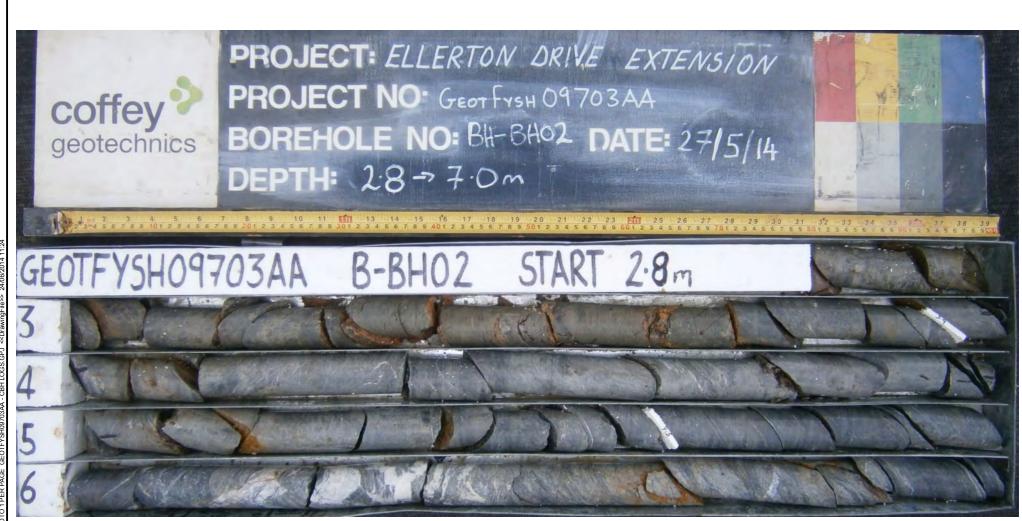
PointID: B-BH02 Depth Range: 2.80 - 7.00 m

client:	Opus International Co	onsultants N	ISW Pty L	₋td
project:	Ellerton Dr Ellerton Drive, (ve Extensio Quanbeyan,		
title:		OTOGRAP 3H02	Н	
project no	GEOTFYSH09703AA	fig no:	3	rev:

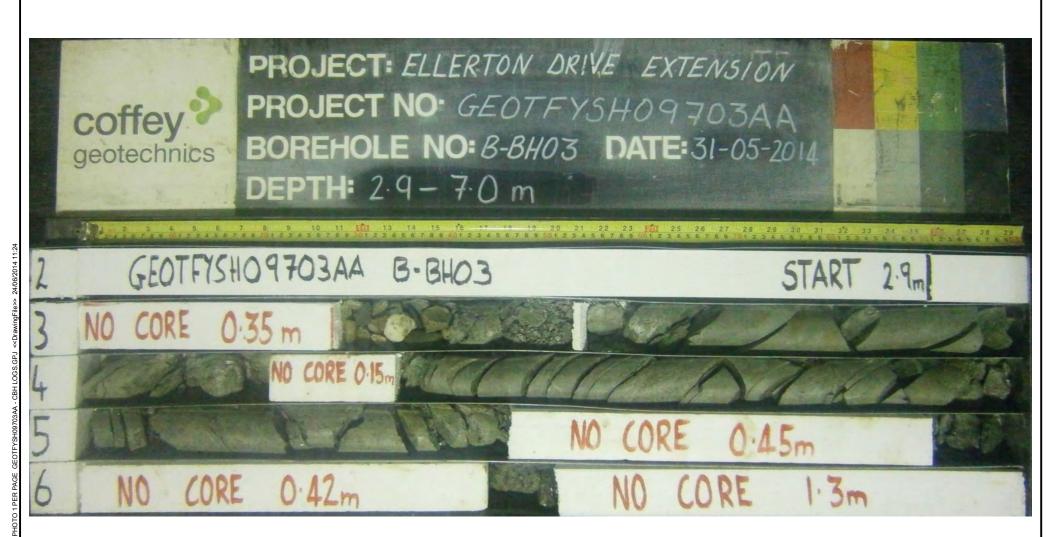
PointID: B-BH03 Depth Range: 2.90 - 7.00 m

drawn	SB		client:	Opus International Co	nsultants NS\	W Pty Ltd	
approved	ВС	coffey	project:		ve Extension	CW	
date	24/06/2014		Ellerton Drive, Quanbeyan, NSW				
scale	N.T.S.	CORE PHOTOGRAPH B-BH03					
original size	A 4		project no:	GEOTFYSH09703AA	fig no:	5	rev:

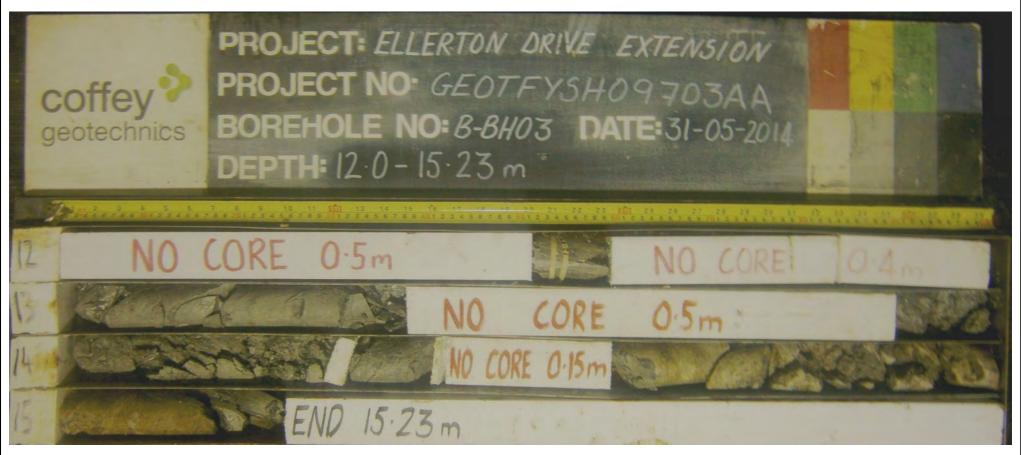
PointID: B-BH03 Depth Range: 12.00 - 15.23 m

client:	Opus International Co	onsultants NS	SW Pty L	.td
project:	Ellerton Dri Ellerton Drive, (ve Extension Quanbeyan, N		
title:		OTOGRAPH 3H03		
project no:	GEOTFYSH09703AA	fig no:	6	rev:

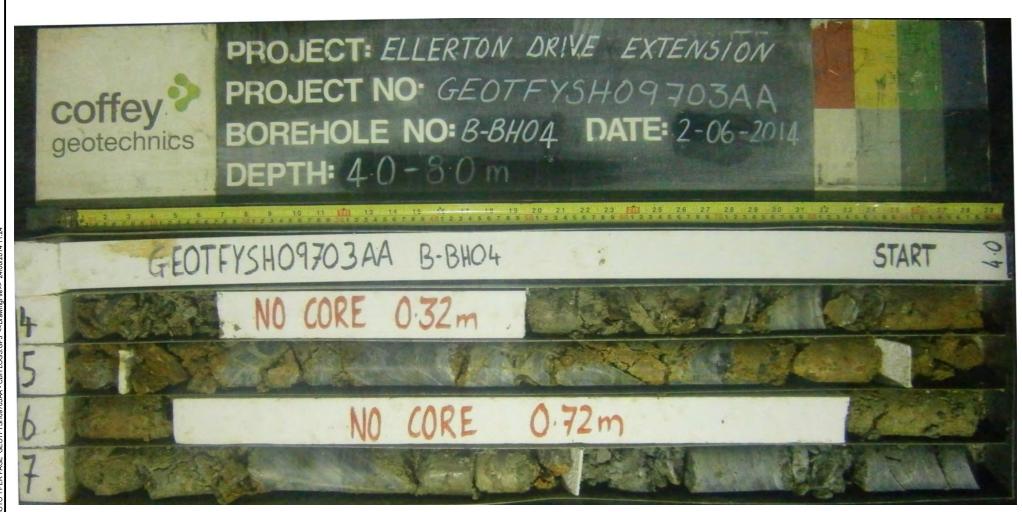
PointID: B-BH04 Depth Range: 4.00 - 8.00 m

client:	Opus International Co	onsultants NS	W Pty Ltd	
project:	Ellerton Dr Ellerton Drive, (ve Extension Quanbeyan, N	SW	
title:		OTOGRAPH 3H04		
project no	O: GEOTEYSH09703AA	fig no:	8	rev:

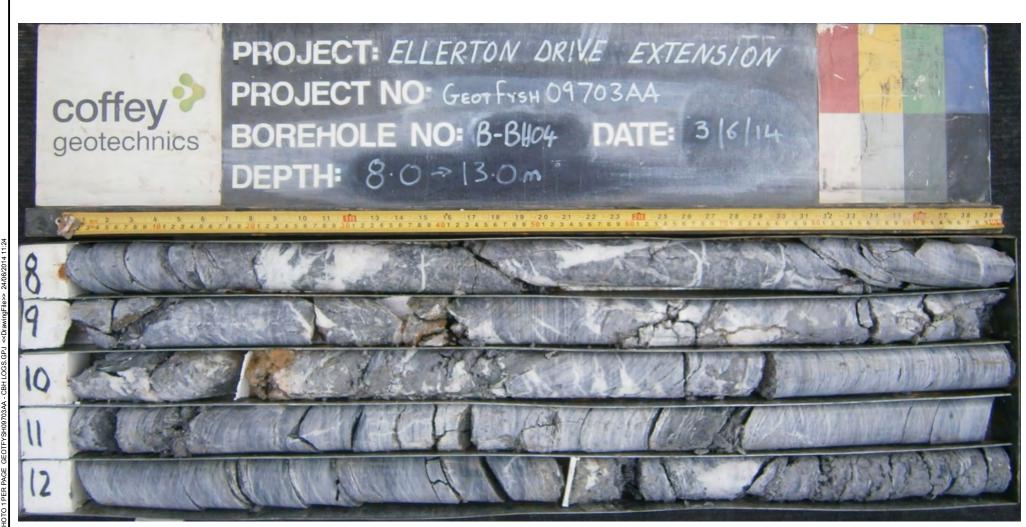
PointID: B-BH04 Depth Range: 8.00 - 13.00 m

client:	Opus International Co	onsultants N	SW Pty L	.td
project:	Ellerton Dri Ellerton Drive, (ve Extensior Quanbeyan,	=	
title:		OTOGRAPH 3H04	ł	
project no	GEOTFYSH09703AA	fig no:	9	rev:

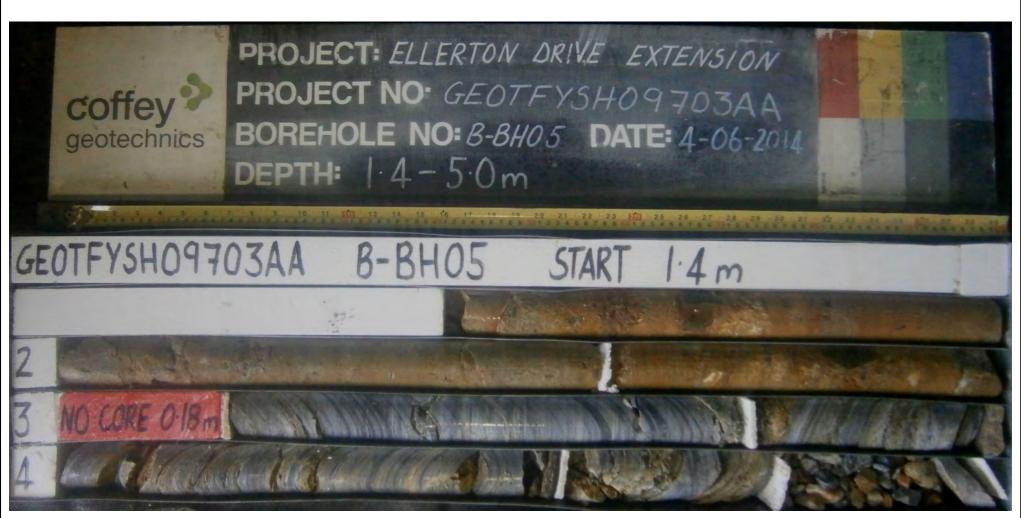
PointID: B-BH05 Depth Range: 1.40 - 5.00 m

client:	Opus International Consultants NSW Pty Ltd					
project:	project: Ellerton Drive Extension Ellerton Drive, Quanbeyan, NSW					
CORE PHOTOGRAPH B-BH05						
project no	GEOTFYSH09703AA	fig no:	rev:

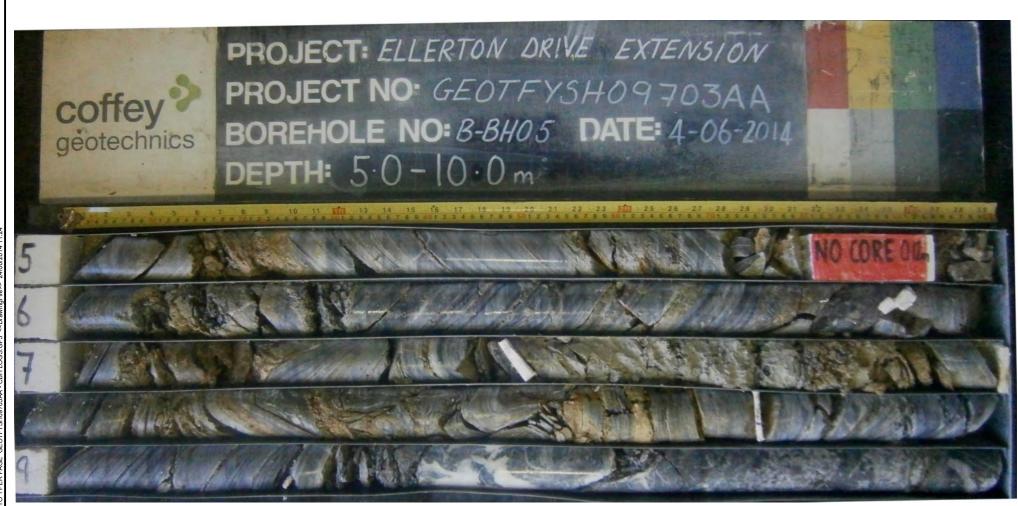
PointID: B-BH05 Depth Range: 5.00 - 10.00 m

client:	Opus International Consultants NSW Pty Ltd							
project:	oject: Ellerton Drive Extension Ellerton Drive, Quanbeyan, NSW							
title: CORE PHOTOGRAPH B-BH05								
project no:	GEOTFYSH09703AA	fig no:	12	rev:

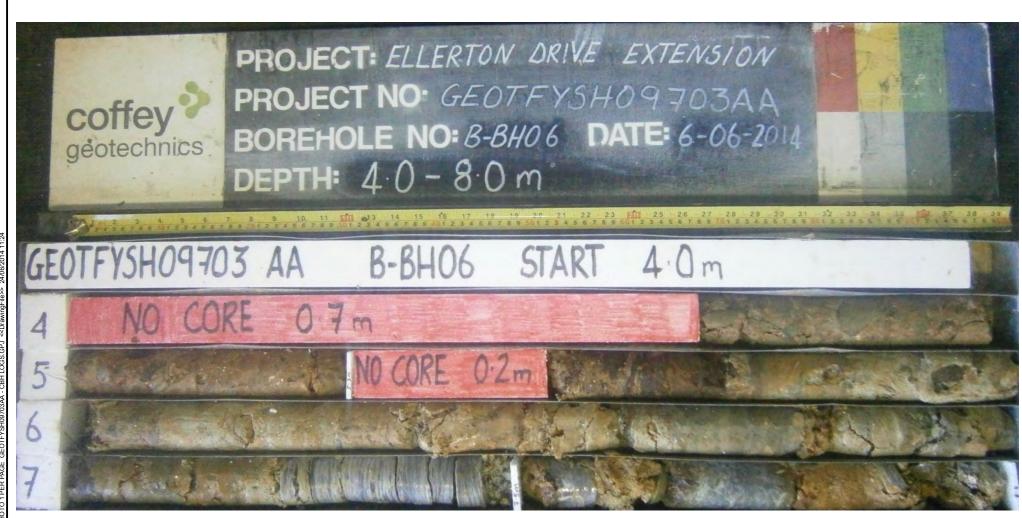
PointID: B-BH06 Depth Range: 4.00 - 8.00 m

Opus International Consultants NSW Pty Ltd											
project: Ellerton Drive Extension Ellerton Drive, Quanbeyan, NSW											
title:	CORE PHO B-B										
project no:	GEOTFYSH09703AA	fig no:	15	rev:
