# **Ordinary Meeting of Council**

**23 May 2018**

**S.1 Riverside Oval Queanbeyan and Mick Sherd Oval Bungendore - surface condition (Ref: C1865725; Author: Tegart/Geyer)**

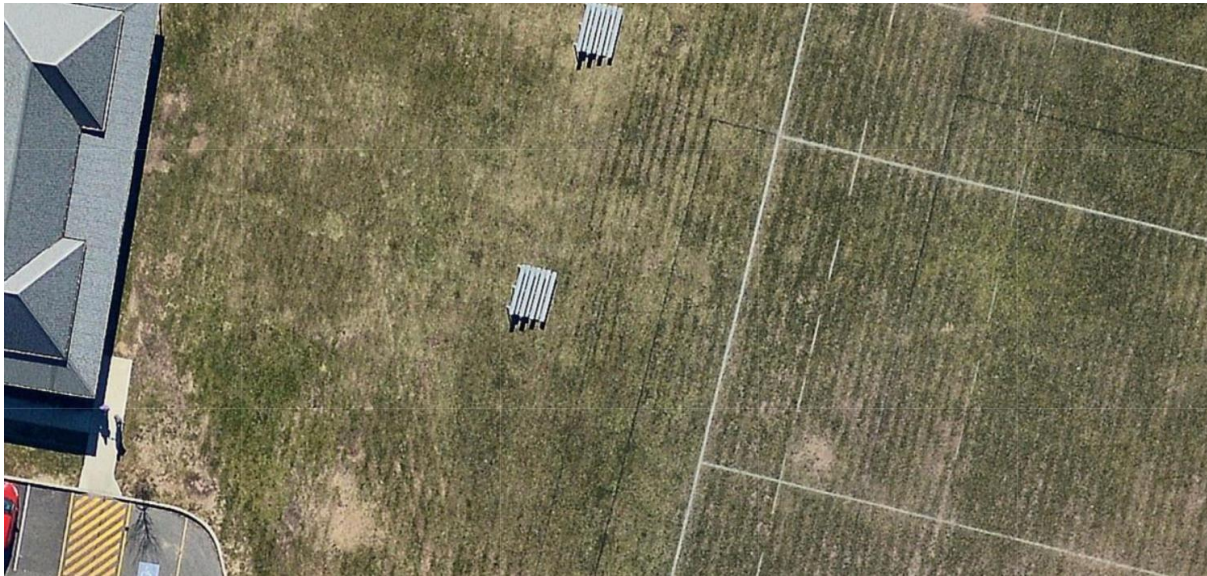
Mick Sherd Oval is unique in that it is the only field Council owns that has subsoil trickle irrigation and uses recycled water. The water treatment prohibits the use of above ground spray irrigation without isolating the field from public access. The system consists of many thin poly tubes with drippers evenly spaced across the field, just below grass root level. On close observation, the field will look corrugated with green and brown strips. Green is the irrigation lines, brown is the gap between lines.

This means all top dressing and fertilising must rely on rain to water it into the soil, and traditional methods of de-compaction cannot be applied without cutting the irrigation lines. At the request of users, Mick Sherd Oval was top dressed in spring along with other Queanbeyan ovals, however the long dry season has demonstrated the irrigation system's short comings.

There have been calls for Council to upgrade the irrigation to modern turf grass spray irrigation, however this will mean converting to potable water use, in a town where potable water is in high demand and a limited resource, or an upgrade of the sewage treatment process to a higher quality recycled water. Staff are currently installing standpipes to allow use of potable water through travelling irrigators in the short term.

Should the interim solution of utilising potable water for surface irrigation be insufficient to sustain growth to rehabilitate the surface, discussions should continue with clubs to train offsite, or utilise other grounds in Queanbeyan, through the Sports Council.
